# Learning Event UNIC 295 overbalanced during pack-down (not loaded)

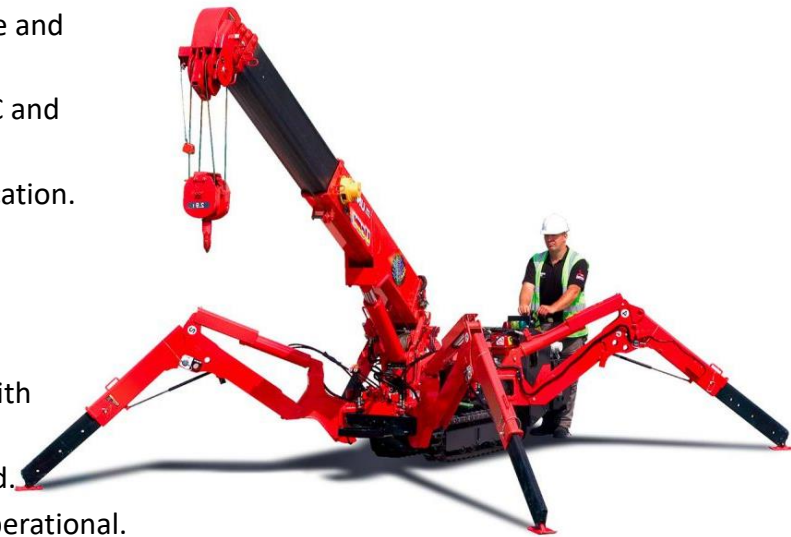
- Lifting operations had been completed and UNIC 295 crane was being packed away.
- During the pack-down process the outrigger legs were inadvertently raised before the crane boom had been centred and stowed on the machine.
- This moved the machine centre of gravity outside the crawler tracks causing the machine to tilt over, coming to rest on the raised outriggers.
- No personnel were injured or exposed in the line of fire during the event.
- No damage sustained to the boom or outriggers.

- Ensure all UNIC activities (set-up, lifting and pack-down) are in accordance with Original Equipment Manufacturer (OEM) instructions and guidance.
- UNIC 295 does not have interlocks to isolate outriggers while boom extended.
- Following OEM instructions to ensure all alarms/warning systems are fully operational.
- SWMS reviewed to reflect above and require two competent persons to set-up and pack-down the crane.
- Initiate discussion with OEM to consider technical improvements, such as interlocks.
