Kidman Park (Metcash) Residential and Mixed Use Code Amendment

ENVIRONMENTAL CONDITION – SITE CONTAMINATION STUDY

Document Quality Management Details		
Report Name:	Environmental Condition – Site Contamination Study	
Site Details:	Cnr Findon & Valetta Roads, Kidman Park	
Project Number:	J174764	
Client Name:	Fairland Group Pty Ltd	
Signatures:	Prepared By:   Andrew Durand Principal Environmental Engineer	Reviewed By:   Sarah Walkley Senior Environmental Scientist

Environmental Condition – Site Contamination Study

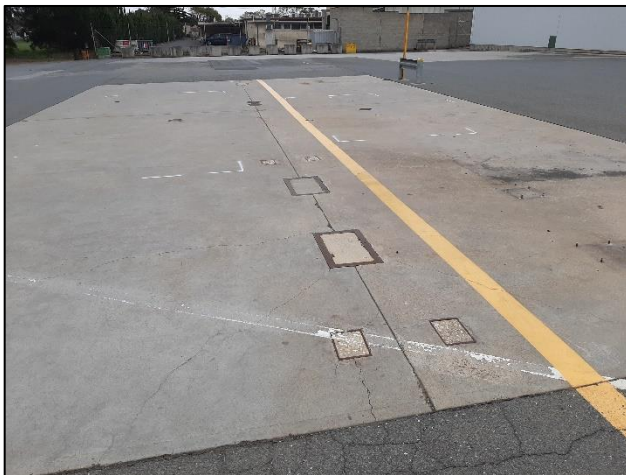
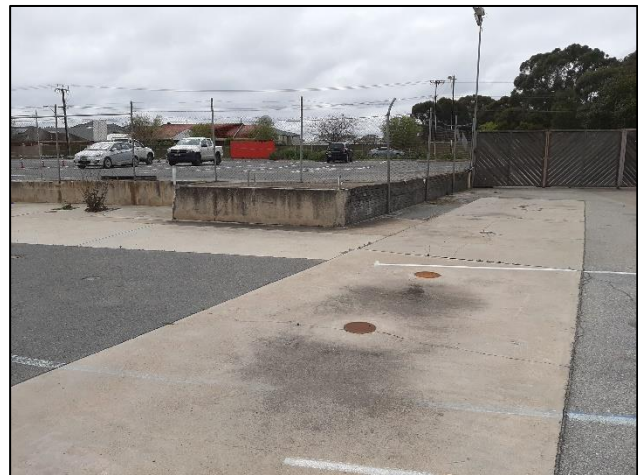
- Five underground storage tanks (USTs) containing diesel and leaded petrol and associated infrastructure. There are two areas where USTs are located. There appears to be two USTs located in the western portion of the site and at least three USTs located in the eastern portion of the site. Photographs of the two areas are presented below:

Photographs 1 & 2 – USTs in the western (left) and eastern (right) portions of the site (24 September 2021)

- Elevated results were also reported for hydrocarbons around the two UST areas. Some of the results at depth around the eastern USTs exceeded the health screening levels for vapour intrusion (assuming a residential land use). There were also soil impacts around the western USTs, but at the locations tested, the results did not exceed the adopted assessment criteria.
- Asbestos containing material was identified at one location under the former dry goods warehouse at a depth greater than 1.0m. This was in the form of cement sheet fragments, but there were also some loose fibre bundles identified.

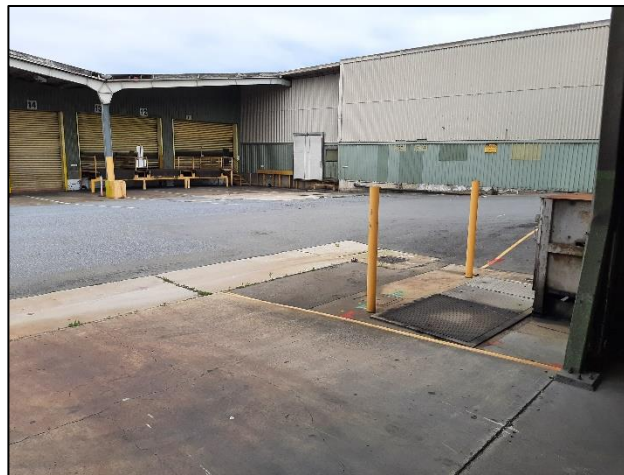
- A truck washing area including a sump and interceptor trap. There also appears to be a former rubbish compactor or similar in this area. During the 2021 site inspection, there was some evidence of staining on the ground surface in this area.

Photograph 3 – view of the interceptor adjacent the former wash bay

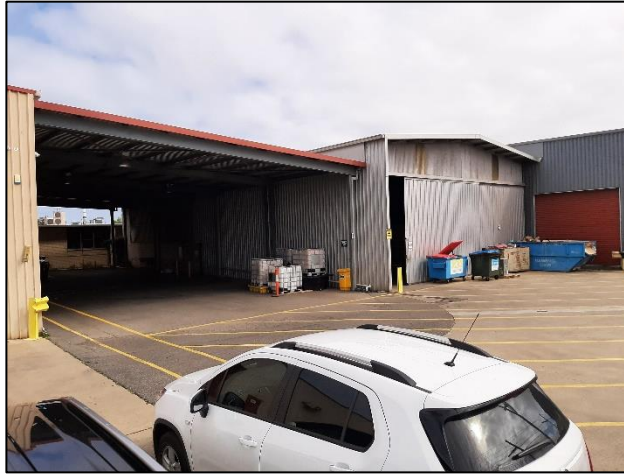
(1,000L Intermediate Bulk Containers (IBCs)) under a large canopy in the central portion of the site (refer Photograph 4). The nature of chemicals stored is not known but there was no evidence of leaks or spills in the areas visible.

Photograph 4 – view looking north west across central portion of Area 2

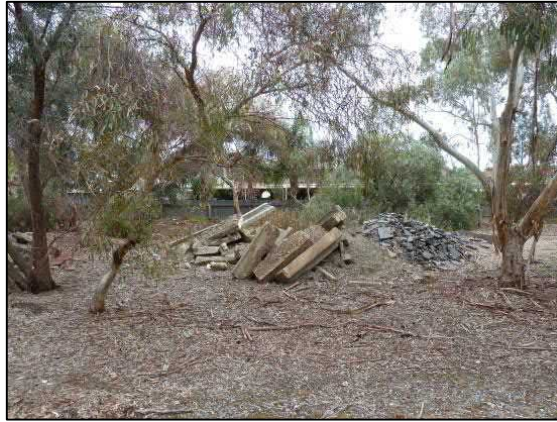
A stockpile of waste material (bricks, concrete, soil and wood) was noted to be present adjacent to the fire pump house in the south western portion of the site.

Photograph 14 – View of the stockpile in the south western portion of the site

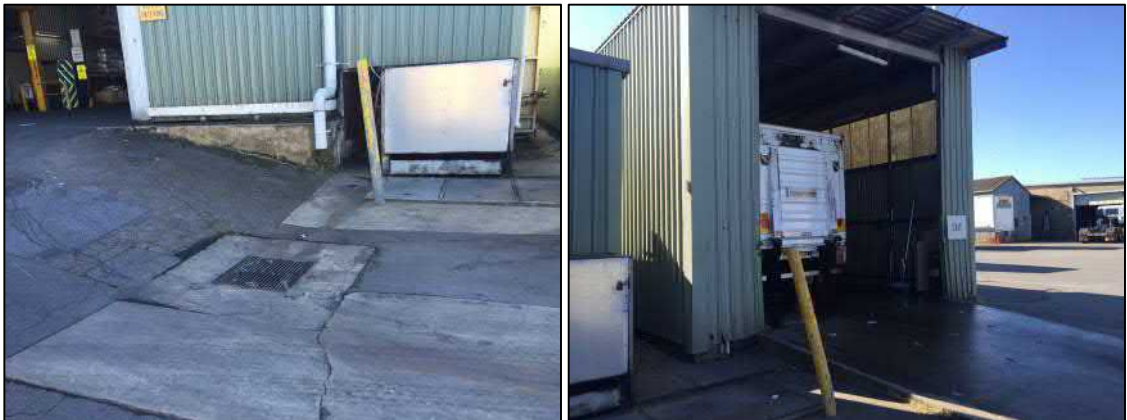
A truck wash area and associated sump and interceptor trap were present in the northern area of the site.

Photograph 16 & 17 – View of the truck wash in the north of the site

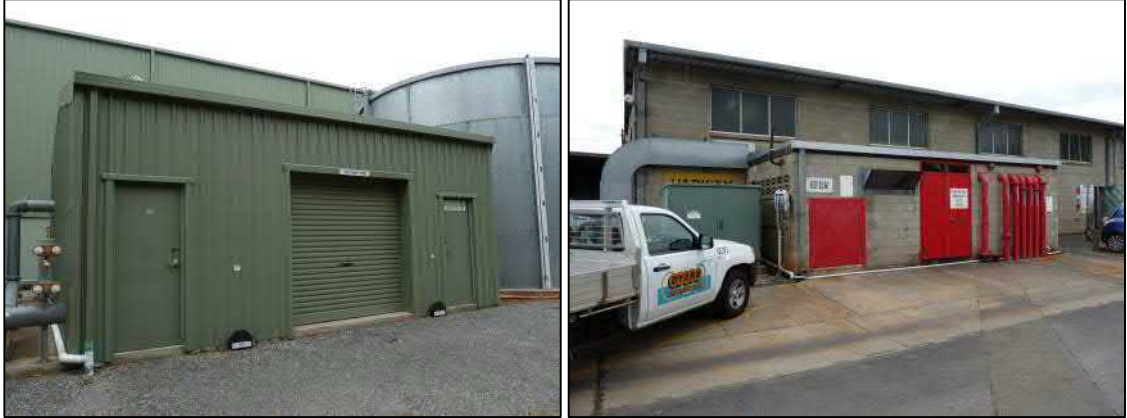
A fire pump house (containing a diesel generator and storage drum), electrical transformer and two water storage tanks are present in the south western portion of the site. A fire pump house containing a diesel generator and electrical transformer are present in the north of the site adjacent to the maintenance building. A secondary pump house is present adjacent to the main warehouse in the centre of the site.

Photograph 18 & 19 – View of the fire pump houses in the south west and north of the site

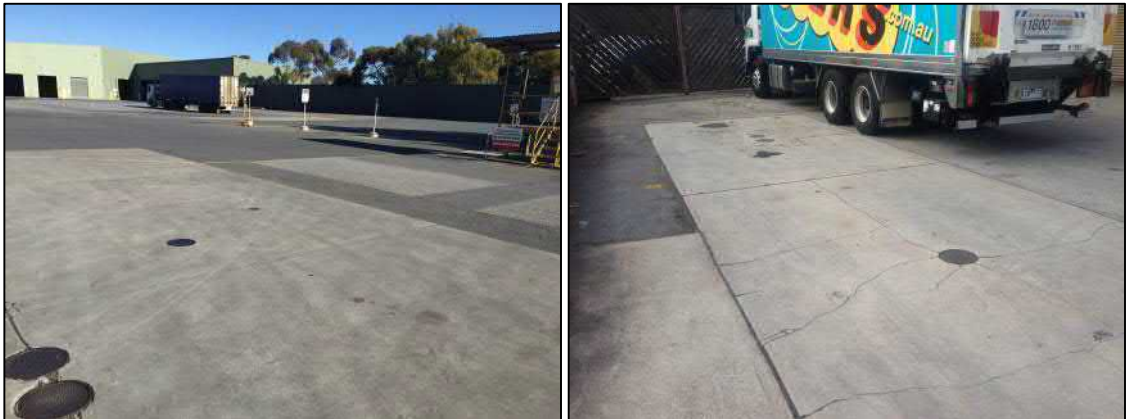
Underground storage tanks (USTs) are present in the north western and eastern portions of the site. Previous investigations undertaken in these areas have identified some fuel related impacts in soil and groundwater. Further details on the nature of the impacts along with details relating to the USTs are presented in Section 3.0.

Photograph 20 & 21 – View of the USTs in the north western and eastern portions of the site

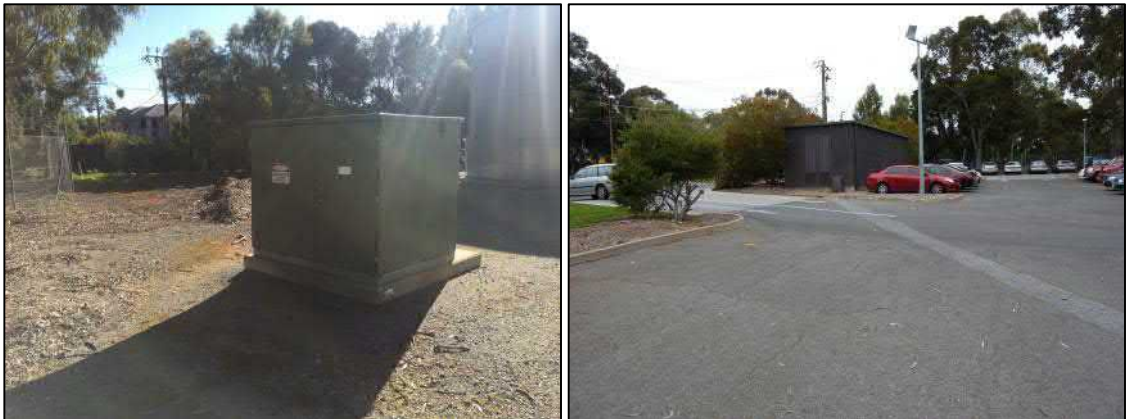
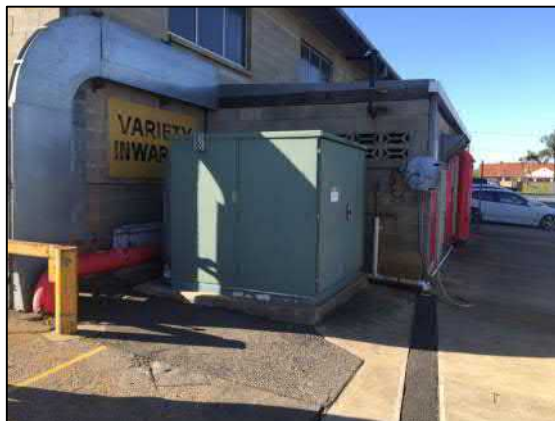
Three electrical transformers are present on site in the car park in the south east of the site, adjacent to the fire pump house in the south western portion of the site and adjacent to the fire pump house in the north east of the site. No obvious signs of leaks were evident around any of the transformers.

Photograph 24, 25 & 26– View of the forklift maintenance area in the north of the site

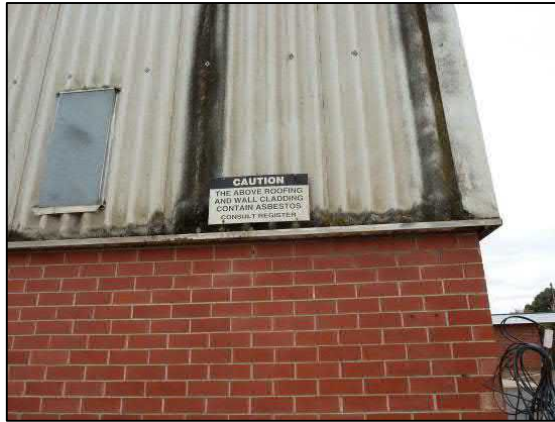
Many of the buildings were noted to contain asbestos containing materials. As asbestos register for the site was not reviewed by Greencap as part of this investigation, but one is understood to exist.

Photograph 27 – View of asbestos containing material Building 404 in the north east of the site
