SERIOUS INCIDENT ALERT

INCIDENT	Near Miss - Yanmar 5.5t Excavator – Projectile Dipper Arm Activator Pin
SUBJECT	Dipper Activator Pin flew off under pressure
INCIDENT DATE	23 rd April 2018
BUSINESS UNIT	Higgins Contractors - Wairarapa

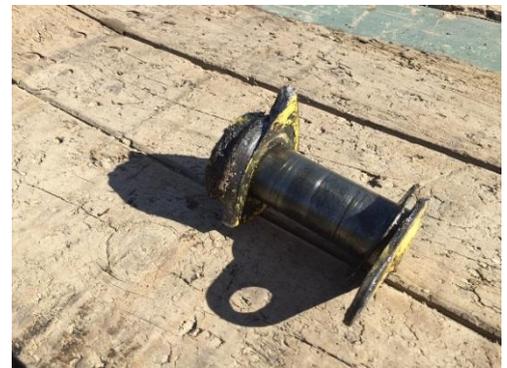
The dipper arm hydraulic cylinder pin assembly was not secured, the spacer had not been fitted to the flange of the pin assembly when the locking bolt and washer was fitted. This caused the locking bolt to come loose and fall out, followed by the pin assembly working its way out of the right hand side of the dipper arm.

At this stage it was only secured by the left hand side of the dipper arm hydraulic cylinder mount, once the dipper arm was operated it caused the left hand side mount to bend and snap off, firing the pin assembly and mount approx. 10-15m away from the excavator.

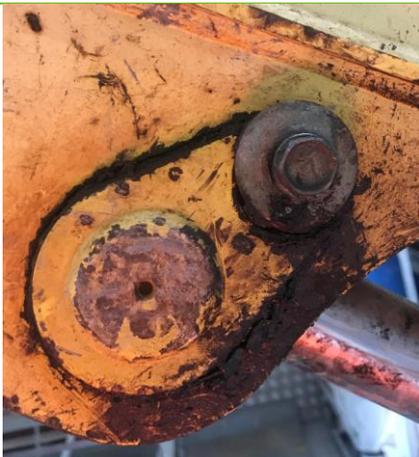
Fig 1.2

Securing bolt as per manufacturers specifications.

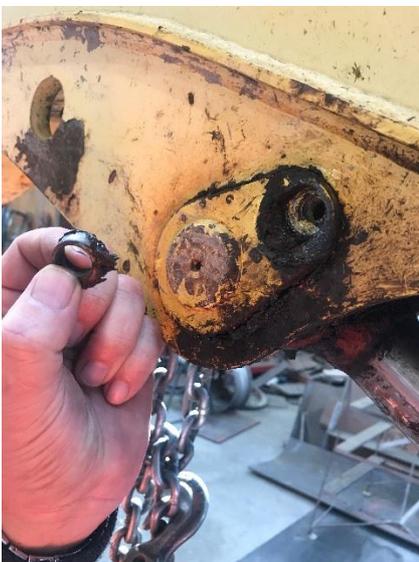
Fig 1.3

Internal washer that must be present to ensure there is no slippage of bolt.
