Appendix C Draft Native Vegetation Clearance Application

Billy Lights Point: Eyre Peninsula Desalination Plant Project Data Report - Working Draft

Clearance under the *Native Vegetation Regulations 2017*

22 May 2024

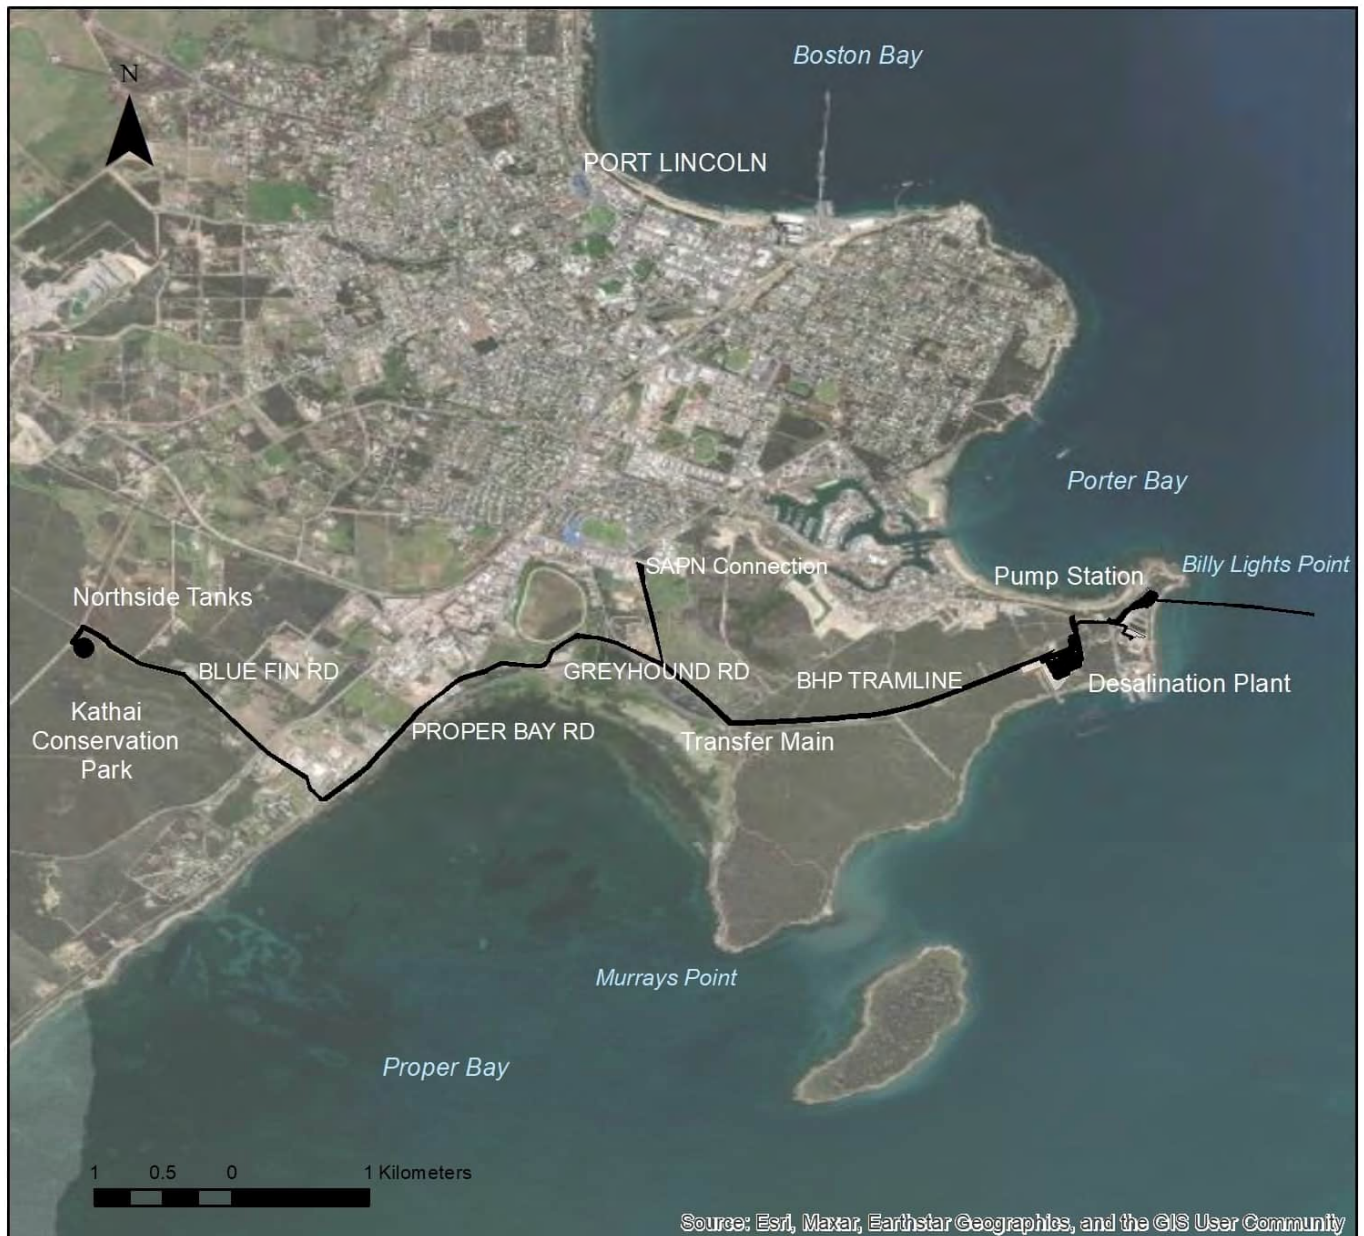
Figure 3. Desalinated water, Saline Waste/Seawater Transfer mains including SAPN connection footprint which will require removal of Native Vegetation.

The main will extend south-west from the plant and will be located immediately to the north of the former BHP trainline (Figure 3). Where it joins Greyhound Road to the west it will be located mainly in the road bed or in degraded vegetation on the northern verge. The transfer main will pass through cleared vegetation on the east side or Proper Bay Road until it joins Blue Fin Road. The main will be located in Blue Fin Road bed and verge and will pass around the corner of the Northside Hill Tanks to enter the site from the western side.

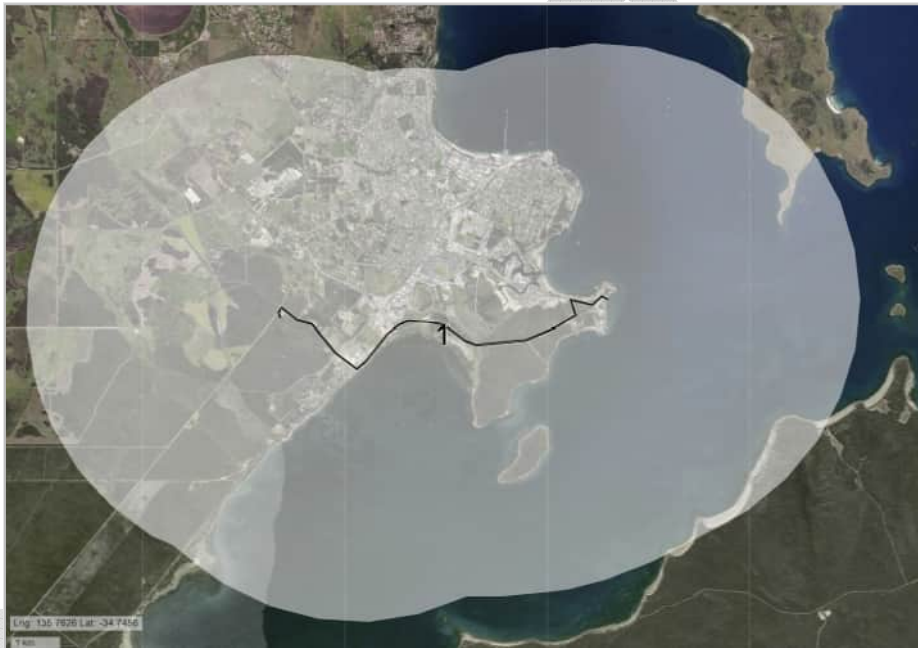
Figure 5. Protected Matters search area following route from Northside Hill tanks near Kathai Conservation Park to the Billy Lights Point Wastewater Treatment Plant, with 5 km Buffer.

The 5km buffer has been applied as specified appropriate under the Native Bushland Assessment Manual (DEW/NVC 2019). Observations from BDBSA, ALA, on-ground survey and sightings are considered reliable. Terrestrial records with a locational reliability greater than 1km or occurring prior to 1995 in the BDBSA, NatureMaps and Atlas of Living Australia, were excluded. The EPBC PMST is considered a guide to possible occurrence based on modelled and interpreted data of variable reliability. The Bushland Assessment manual (DEW/NVC 2019) requires reports from the PMST for species where the type of presence is "Species or species habitat known to occur within the area".

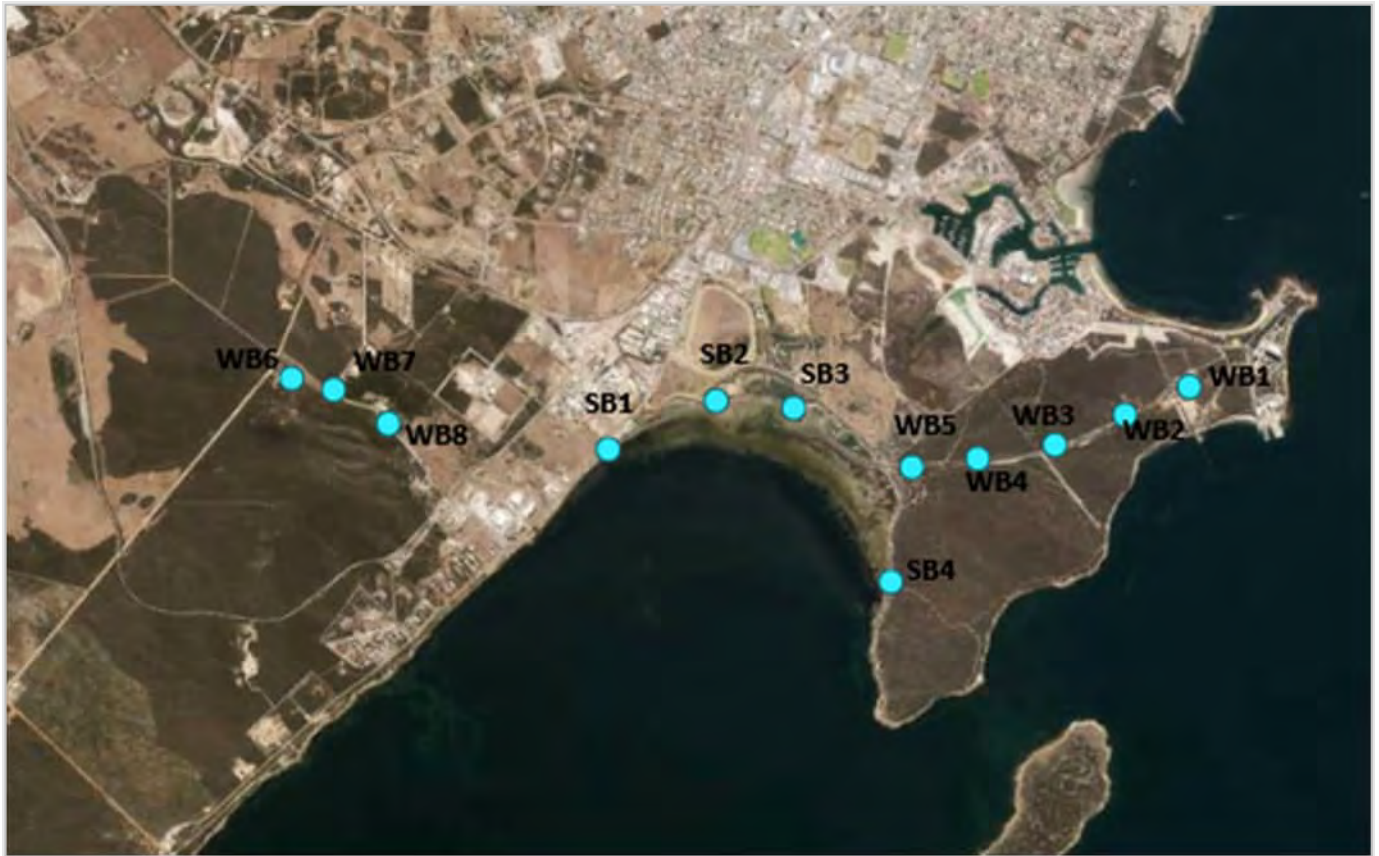
Figure 6. Location of fauna survey sites conducted in December 2023 at 8 woodland (WB) sites and 4 shoreline (SB) sites along the proposed works alignment

Lists of all fauna species observed during these surveys are provided in Appendices 1 and 2.

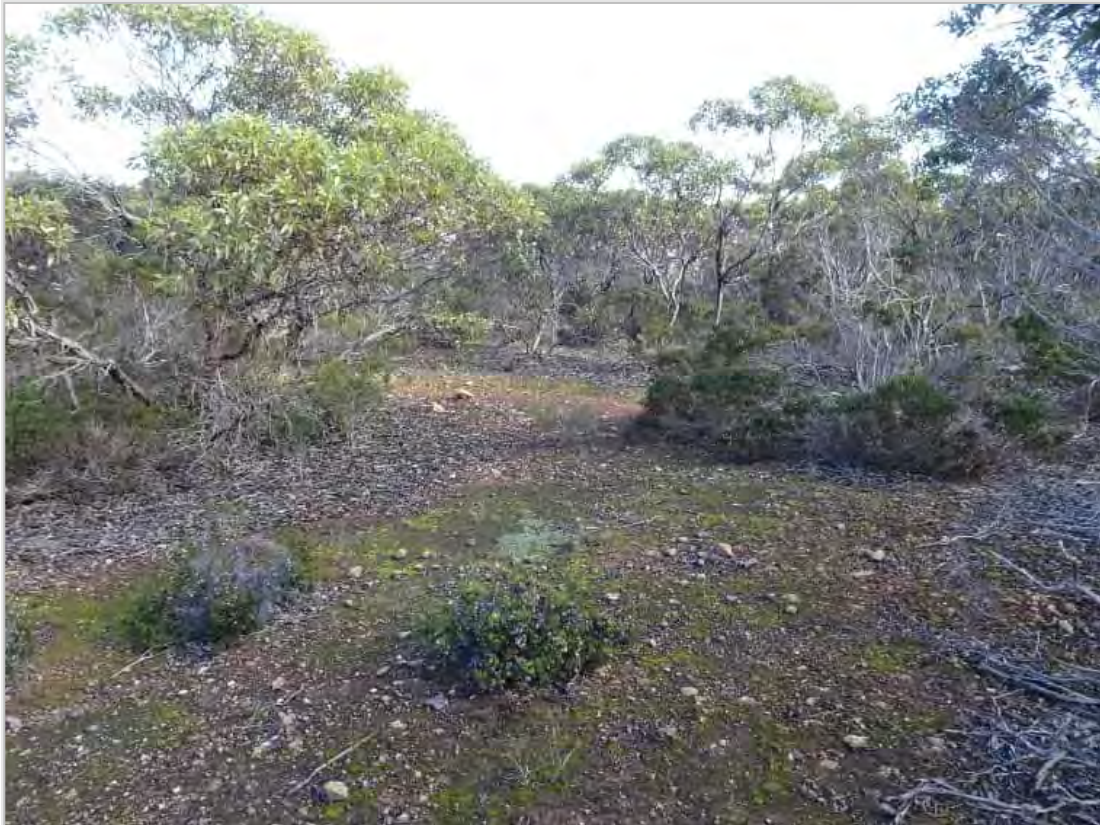
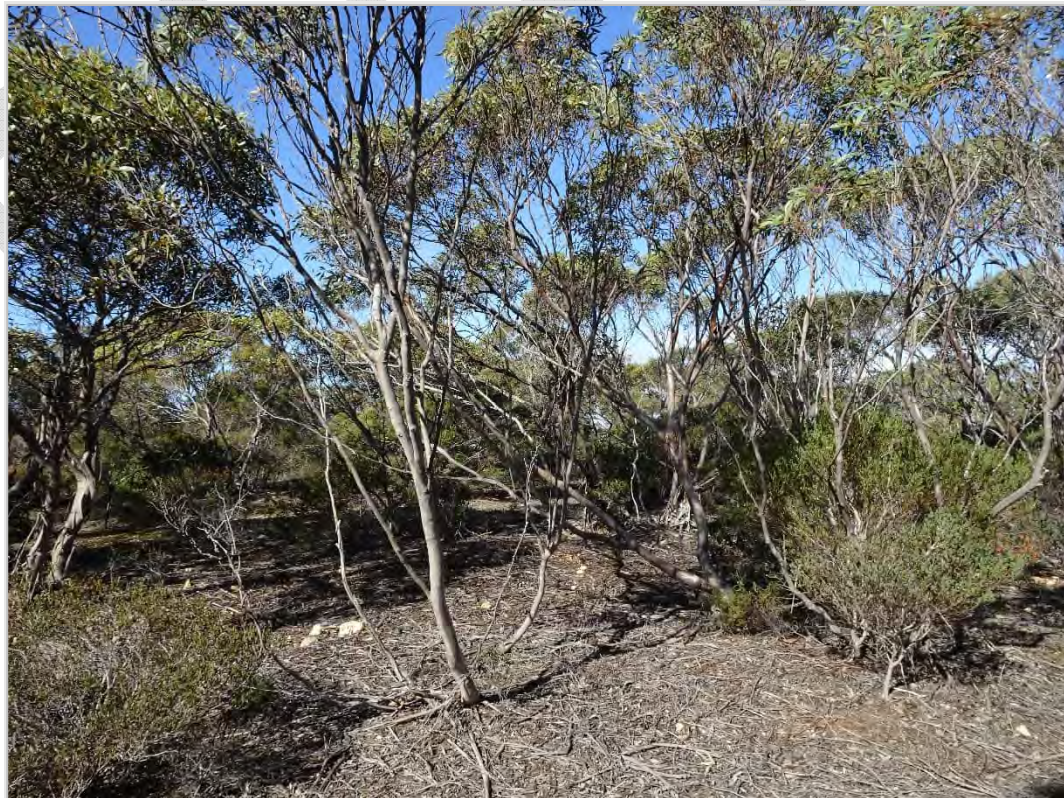
Vegetation Association	Site 1: <i>Eucalyptus conglobata</i>, <i>E. diversifolia</i>, <i>E. rugosa</i> +/- <i>E. angulosa</i>, <i>E. leptophylla</i> mallee over a shrubby understory
------------------------	--

Representative photograph of Site 1, facing west at 581093, 6154216 (WGS 84 Zone 53).

Additional representative photograph of Site 1, facing SSE at 581063, 6154231 (WGS 84 Zone 53).

General description	<p>This vegetation association occurs throughout the central and western sections of the proposed desalination plant site, where soils are deeper and heavier. The overstorey comprises <i>Eucalyptus conglobata</i> (Port Lincoln Mallee), <i>E. diversifolia</i> (Coastal White Mallee) and <i>E. rugosa</i> (White Mallee) as co-dominants, over an open low shrub understory including <i>Acrotriche patula</i> (Prickly Groundberry), <i>Lasiopetalum discolor</i> (Coast Velvet-bush), <i>Templetonia retusa</i> (Cockies Tongue) and <i>Melaleuca lanceolata</i> (Dryland Tea-tree).</p> <p>At least eight species of winter- and spring-emergent orchids were recorded, including <i>Pterostylis</i> spp. (Greenhoods), <i>Microtis</i> sp. (Onion-orchid), <i>Diuris</i> sp. (Donkey Orchid), <i>Caladenia</i> spp. (Spider-orchids) and <i>Thelymitra</i> spp. (Sun-orchids)</p> <p>Weed species are a minor component of the community and include <i>Asparagus asparagoides</i> (Bridal Creeper), <i>Pinus halepensis</i> (Aleppo Pine), <i>Casuarina glauca</i> (Swamp Oak), <i>Senecio pterophorus</i> (African Daisy) and <i>Asphodelus fistulosus</i> (Onion Weed).</p> <p>The vegetation community is in good condition.</p>

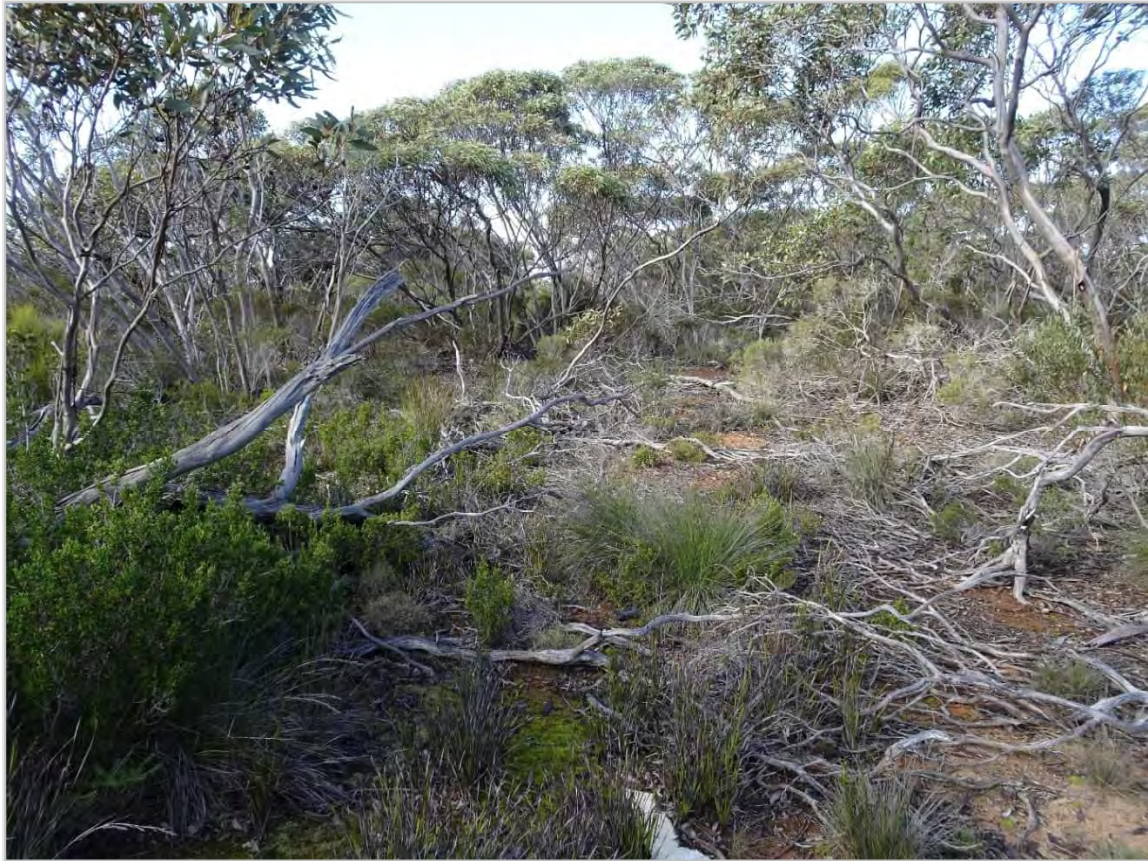
Representative photograph of Site 2, facing south-east at 581053, 6154259 (WGS 84 Zone 53).

Landscape context score	1.12	Vegetation Condition Score	57.35	Conservation significance score	1.28
Unit biodiversity Score	82.22	Area (ha)	1.7615 (Plant)	Total biodiversity Score	144.83 (Plant)

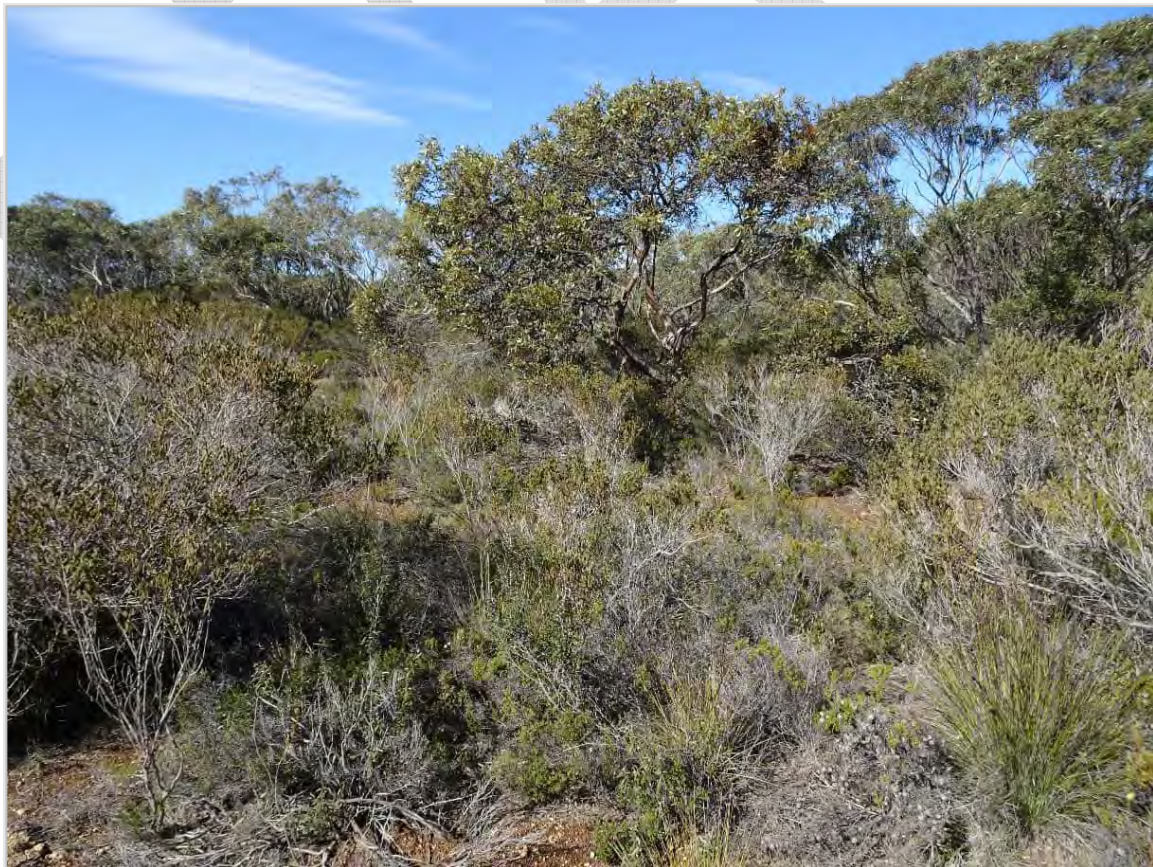
Additional representative photograph of Site 2, facing south at 581105, 6154327 (WGS 84 Zone 53).

<p>General description</p>	<p>This vegetation association occurs within the proposed desalination plant site, in areas where limestone is closer to the surface.</p> <p><i>Eucalyptus angulosa</i> (Coast Ridge-fruited Mallee), <i>E. diversifolia</i> and <i>E. conglobata</i> are co-dominant canopy species. Sedges such as <i>Gahnia deusta</i> (Limestone Saw-sedge) and <i>Lomandra collina</i> (Sand Mat-rush), and small to medium shrubs such as <i>Acrotriche cordata</i> (Blunt-leaf Groundberry) and <i>Templetonia retusa</i> are characteristic understory species.</p> <p>At least eight species of winter- and spring-emergent orchids were detected including <i>Pterostylis flavovirens</i> (Tall Greenhood), <i>P. sanguinea</i> (Blood Greenhood), <i>Acianthus pusillus</i> (Mosquito Orchid), <i>Cyrtostylis robusta</i> (Robust Gnat-orchid), <i>Microtis frutetorum</i> (Onion-orchid), <i>Thelymitra megalyptra</i> (Scented Sun-orchid), <i>T. luteocilium</i> (Yellow-tuft Sun-orchid) and <i>Caladenia campestris</i> (Spider-orchid).</p> <p>Weed species are a minor component of the community and include Bridal Creeper, Aleppo Pine and <i>Polygala myrtifolia</i> (Myrtle-leaf Milkwort).</p> <p>The vegetation community is in good condition.</p>

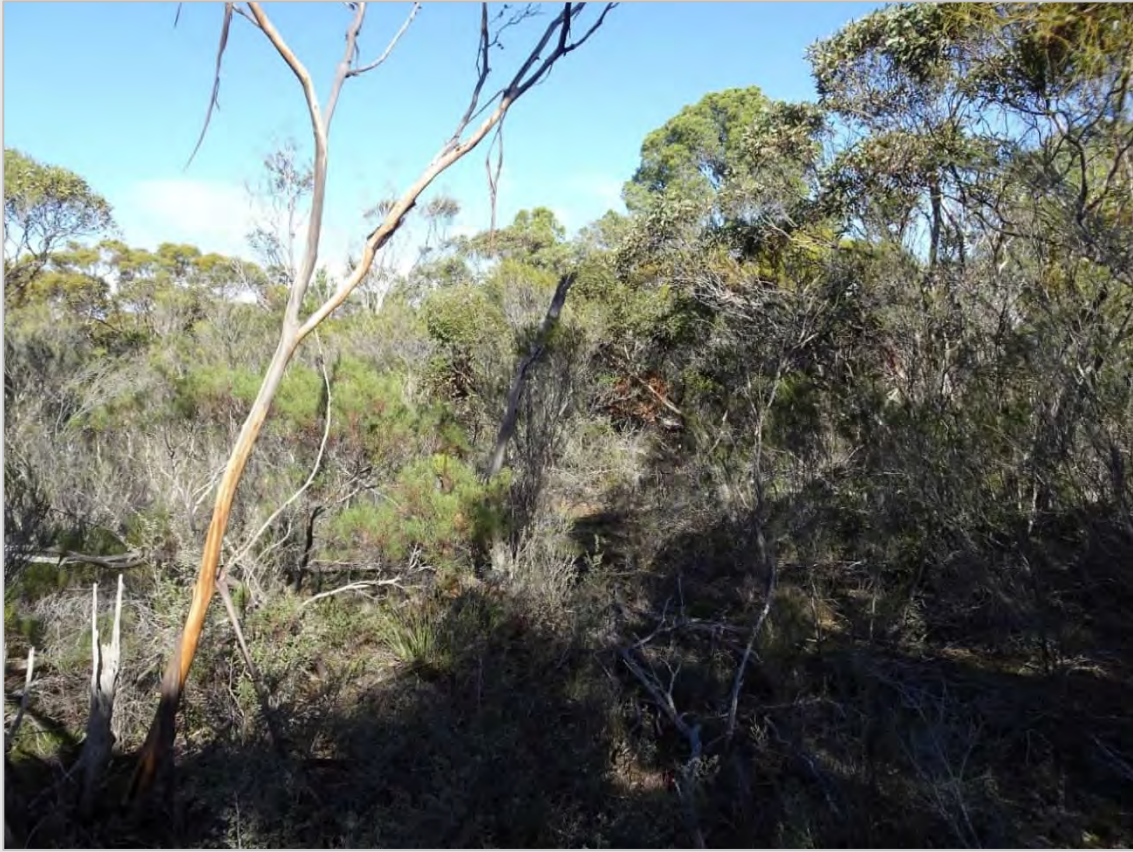
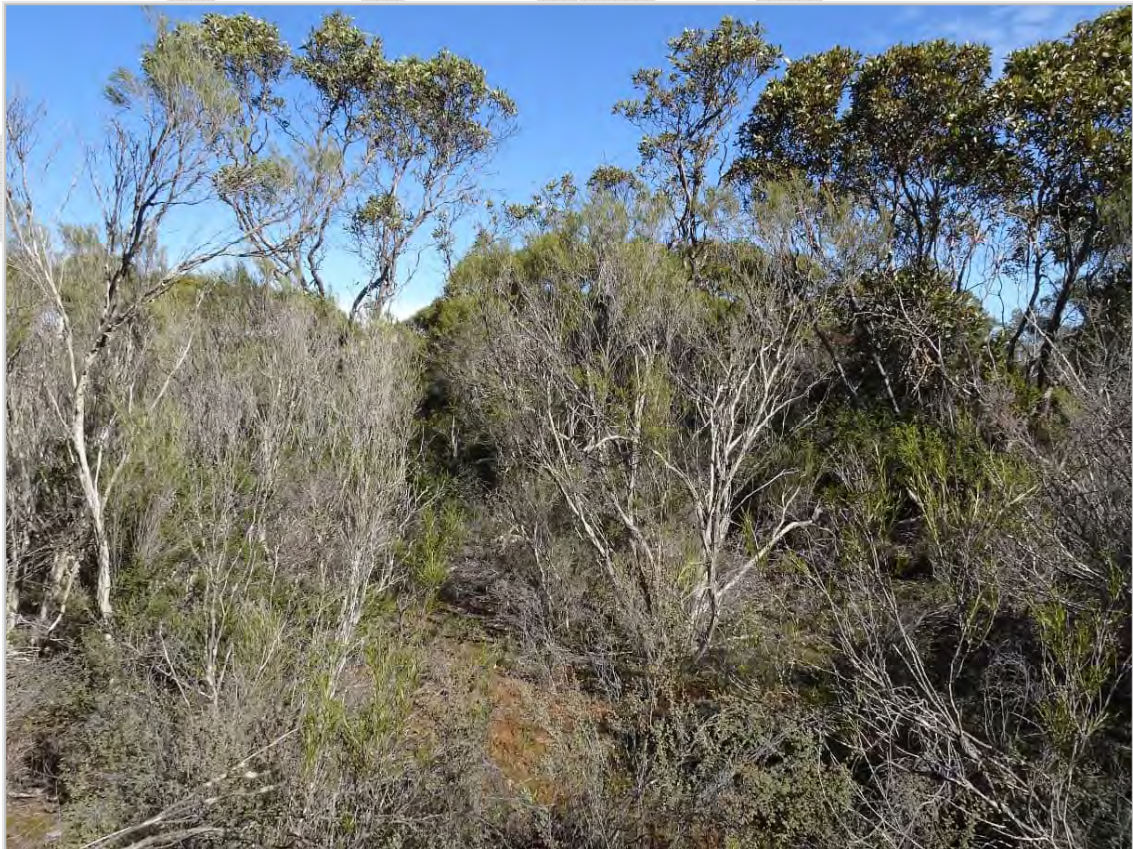
Site 3: *Eucalyptus angulosa*, *E. diversifolia* ± *E. conglobata* mallee over *Melaleuca uncinata*

Representative photograph of Site 3, facing south at 581091, 6154439 (WGS 84 Zone 53).

Additional representative photograph of Site 3, facing SW at 581103, 6154409 (WGS 84 Zone 53).

General description	<p>This vegetation association occurs in lower lying areas in the north-western section of the proposed desalination plant site.</p> <p><i>Melaleuca uncinata</i> (Broombush) and <i>M. lanceolata</i> (Dryland Teatree) become dominant understory species beneath a canopy of <i>Eucalyptus angulosa</i>, <i>E. diversifolia</i> and <i>E. conglobata</i>. Other common understory species include <i>Gonocarpus mezianus</i> (Broad-leaf Raspwort), <i>Lepidosperma viscidum</i> (Sticky Sword-sedge), <i>Templetonia retusa</i> and <i>Pomaderris flabellaris</i> (Fan Pomaderris). The groundlayer supports a variety of orchid species, including Greenhoods, Mosquitos orchids, Gnat-orchids, Onion orchids, Donkey orchids and Sun-orchids.</p> <p><i>Freesia</i> sp. was the most encountered weed species, with Bridal Creeper, Aleppo Pine, <i>Acacia cyclops</i> (Western Coastal Wattle) and <i>Moraea setifolia</i> (Thread Iris) being minor components of the association.</p> <p>The plant community has a very high diversity of native species, good structural diversity, deep leaf litter and provides good habitat value.</p> <p>The vegetation community is in very good condition.</p>

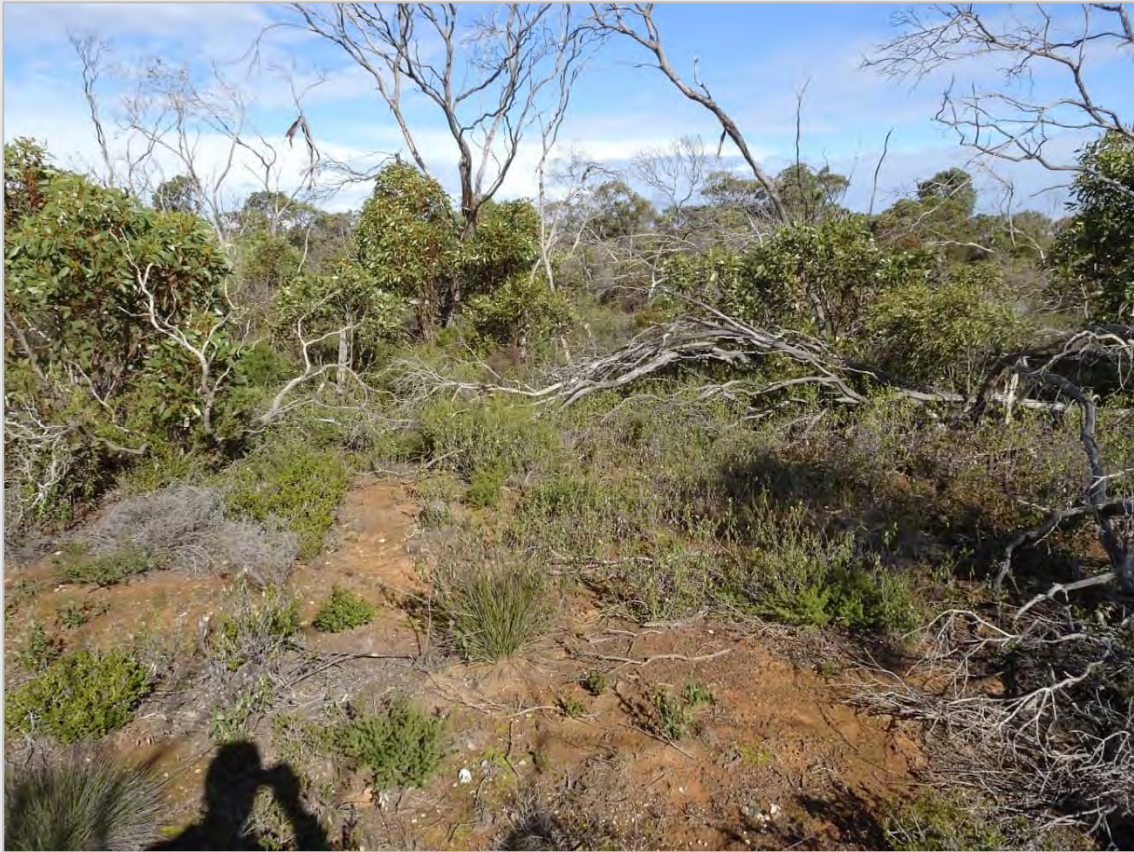
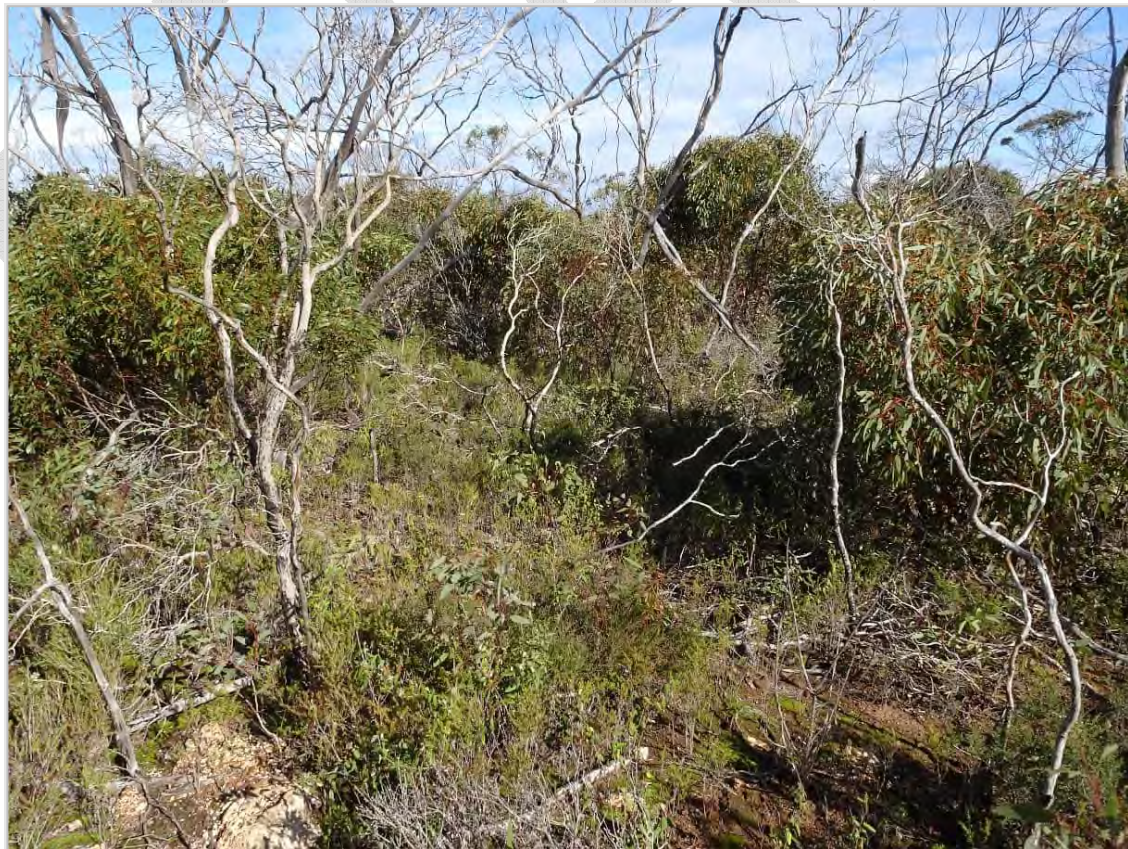
Representative photograph of Site 4, facing south at 581105, 6154511 (WGS 84 Zone 53).

Additional representative photograph of Site 4, facing south at 581118, 6154577 (WGS 84 Zone 53).

General description	<p>Vegetation association 4 occurs along the proposed access route to the north of the desalination plant. <i>Eucalyptus angulosa</i> and <i>E. diversifolia</i> provide the main canopy cover, with <i>E. conglobata</i> and <i>Eucalyptus oleosa ssp. ampliata</i> (Red Mallee) also present. Velvet-bushes (<i>Lasiopetalum</i> spp.), <i>Eutaxia microphylla</i> (Common Eutaxia), <i>Templetonia retusa</i> and <i>Acacia spinescens</i> (Spiny Wattle) are common in the understory. Several species of spring-flowering orchids were observed in the groundlayer.</p> <p>Weed cover is low but includes scattered plants of Bridal Creeper, Myrtle-leaf Milkwort and Western Coastal Wattle.</p> <p>The community has a high diversity of native plant species and is regenerating well after a fire approximately 8 years ago. It is of high habitat value with good structural diversity and fallen timber and debris.</p> <p>The vegetation community is in very good condition.</p>

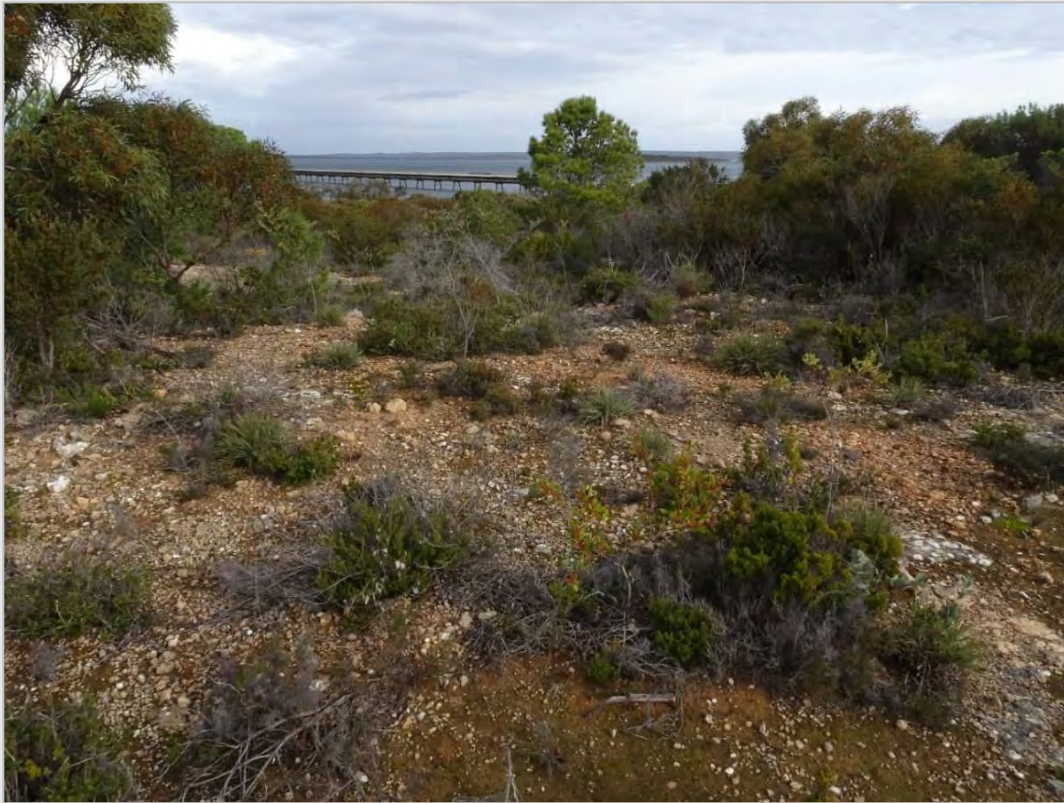
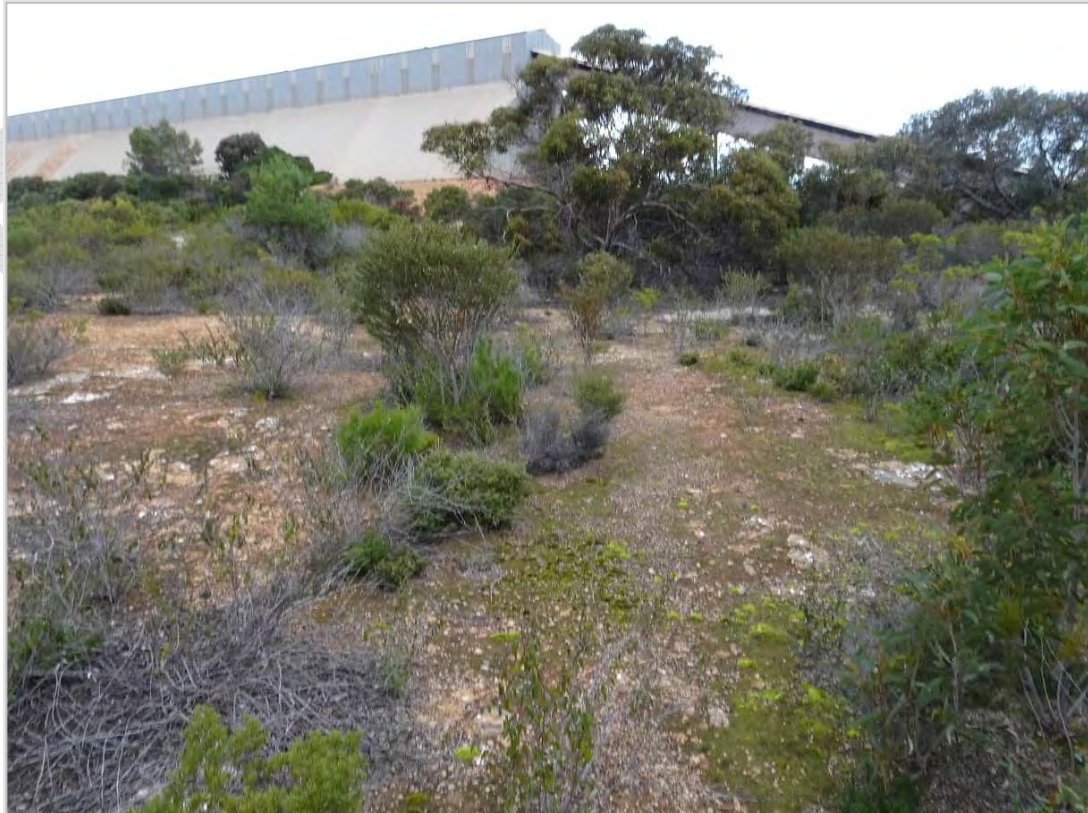
Representative photograph of Site 6, facing south at 581133, 6154152 (WGS 84 Zone 53).

Representative photograph of Site 6, facing south at 580979, 6154257 (WGS 84 Zone 53).

General description	<p>Vegetation association 6 comprises areas where areas where previous clearance has occurred but natural regeneration of the mallee community is occurring.</p> <p>The canopy layer is sparse and dominated by <i>Eucalyptus diversifolia</i> and <i>E. rugosa</i> and the understory supports regenerating shrub species such as <i>Alyxia buxifolia</i> (Sea Box), <i>Templetonia retusa</i> and several species of wattles. Two species of spring-flowering orchids were observed (<i>Caladenia</i> sp. and <i>Microtis</i> sp.).</p> <p>The community has a moderate diversity of native species, represented by shrubs, sedges, vines and grasses.</p> <p>Exotic species include Bridal Creeper, Aleppo Pine, Swamp Oak, Onion Weed and Western Coastal Wattle, each being a minor component of the community.</p> <p>The vegetation community is in moderate condition.</p>				
Threatened species or community	<p><u>State-listed vegetation community:</u> Not considered a threatened ecosystem</p> <p><u>State-threatened flora observed:</u></p> <ul style="list-style-type: none"> • State Rare Alcock's Wattle (<i>Acacia alcockii</i>) <p><u>Nationally- and State-threatened fauna that might utilise this vegetation community:</u></p> <ul style="list-style-type: none"> • Nationally Vulnerable: Diamond Firetail • State Vulnerable: Yellow-tailed Black Cockatoo • State Rare: Purple-gaped Honeyeater, Elegant Parrot, Western Gerygone, Shy Heathwren, Peregrine Falcon and Rock Parrot. <p>The Rock Parrot was observed within this vegetation association. The State Endangered Eastern Osprey and White-bellied Sea Eagle occur nearby, but vegetation at the site is not their preferred nesting habitat.</p> <p>The State Rare Bush Stone-curlew, White-winged Chough and Painted Buttonquail have been recorded within 5 km of the site but are unlikely to use degraded habitats with little leaf litter.</p>

Landscape context score	1.12	Vegetation Condition Score	36.49	Conservation significance score	1.12
Unit biodiversity Score	45.77	Area (ha)	0.6391 (Plant)	Total biodiversity Score	29.25 (Plant)

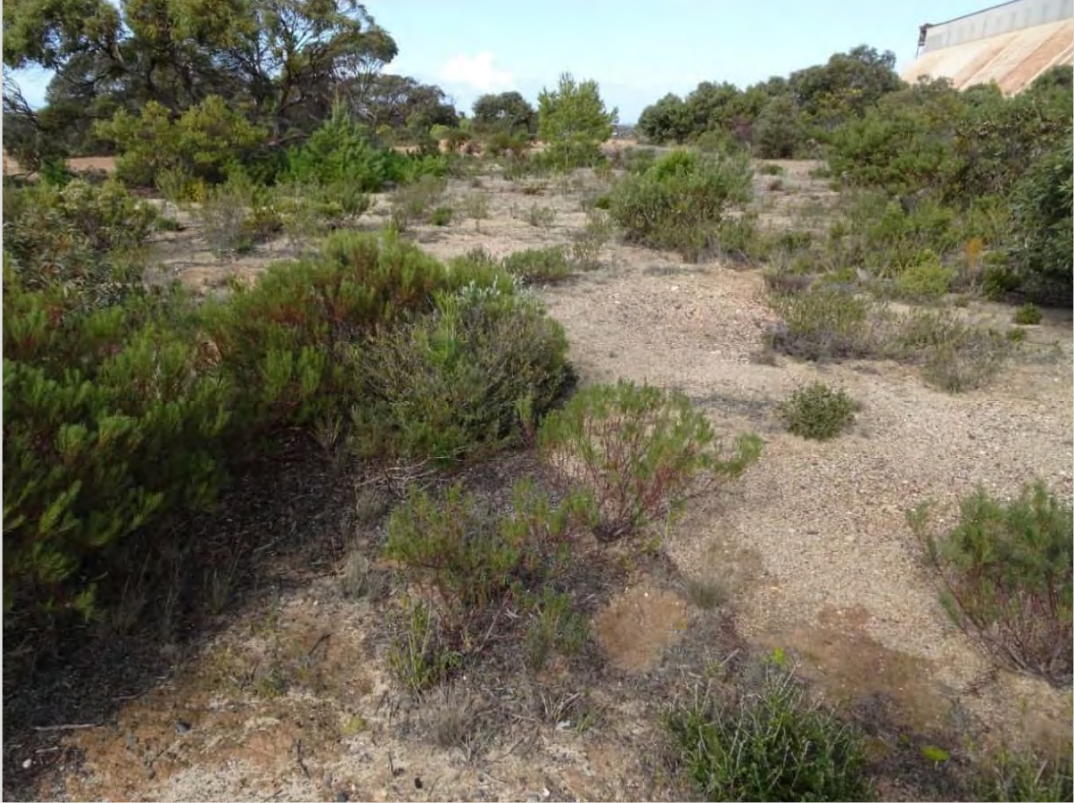
Vegetation Association	Site 6a: <i>Eucalyptus diversifolia</i> recovering open to very open mallee

<p data-bbox="177 1025 1394 1059"><i>Representative photograph of Site 6a, facing south at 580988, 6154224 (WGS 84 Zone 53).</i></p>					
General description	<p>This plant community is a more degraded version of vegetation association 6, occurring in the vicinity of the existing infrastructure at the site and along the southern road verge of St Andrews Drive.</p> <p>Both the canopy and shrub layers are sparser due to previous clearance and disturbance, but several species are naturally regenerating.</p> <p>The vegetation community is in poor to moderate condition.</p>				
Threatened species or community	<p>State-listed vegetation community: Not considered a threatened ecosystem</p> <p>State-threatened flora observed:</p> <ul style="list-style-type: none"> • State Rare Alcock's Wattle (<i>Acacia alcockii</i>) <p>Nationally- and State-threatened fauna that might utilise this vegetation community:</p> <ul style="list-style-type: none"> • Nationally Vulnerable: Diamond Firetail • State Vulnerable: Yellow-tailed Black Cockatoo • State Rare: Purple-gaped Honeyeater, Elegant Parrot, Western Gerygone, Rock Parrot, Peregrine Falcon <p>The State Endangered Eastern Osprey and White-bellied Sea Eagle occur nearby, but vegetation at the site is not their preferred nesting habitat.</p> <p>The State Rare Bush Stone-curlew, White-winged Chough and Painted Buttonquail have been recorded within 5 km of the site but are unlikely to rely on this plant community.</p>

Landscape context score	1.12	Vegetation Condition Score	31.76	Conservation significance score	1.12
Unit biodiversity Score	39.84	Area (ha)	0.0034 (MIPS) 0.7339 (Plant)	Total biodiversity Score	0.14 (MIPS) 29.24 (Plant)

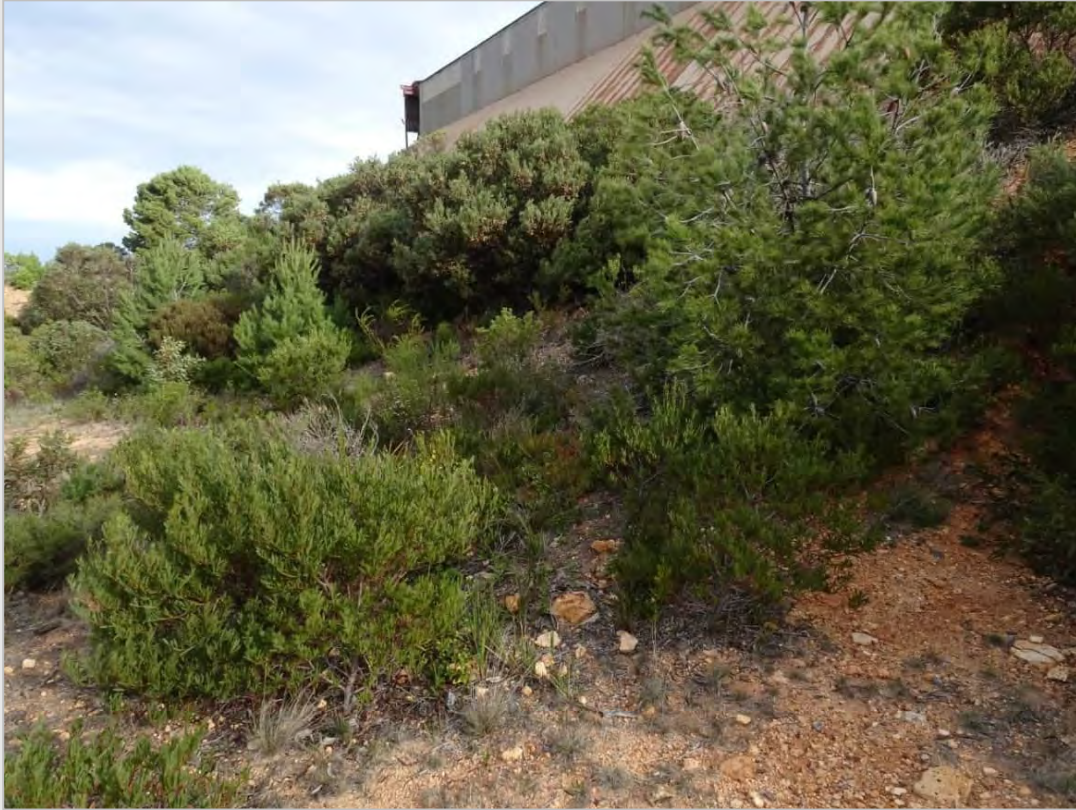
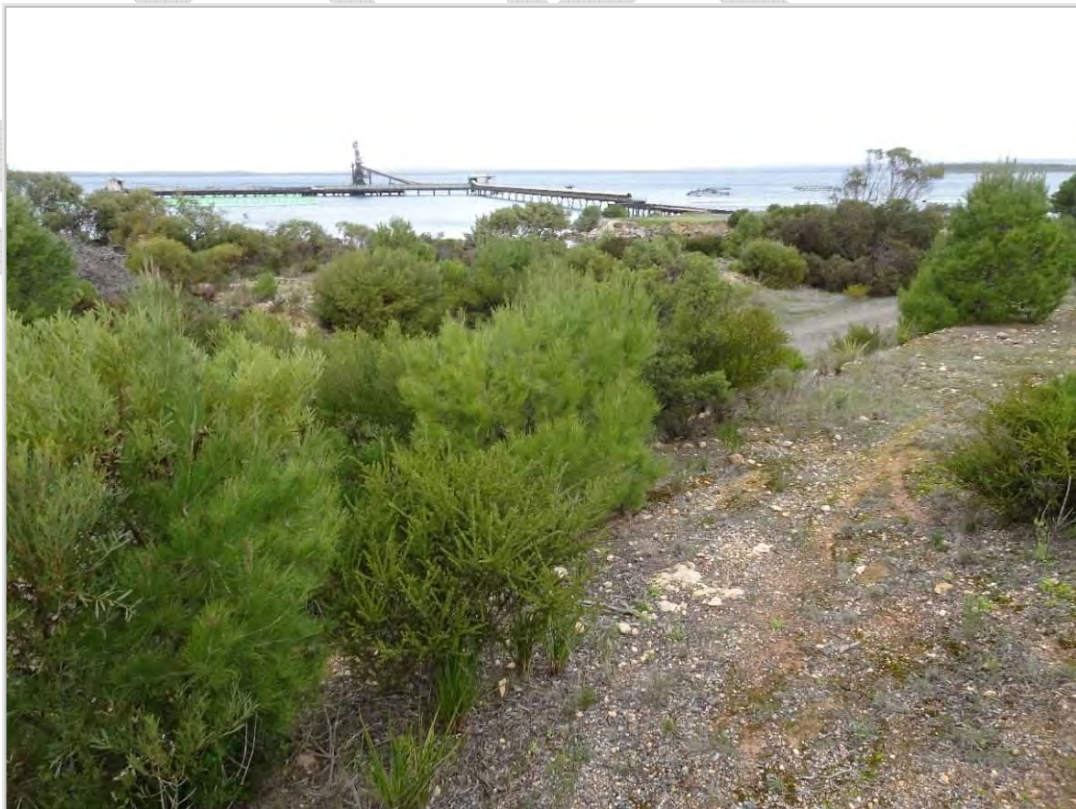
Site 7: *Acacia cyclops, *Pinus halepensis shrubland/woodland

Representative photograph of Site 7, facing south at 581000, 6154136 (WGS 84 Zone 53).

Representative photograph of Site 7, facing south at 581059, 6154120 (WGS 84 Zone 53).

General description	<p>This plant community occurs in highly disturbed areas adjacent to the disused BHP shed and associated tracks and infrastructure. It has been cleared in the past and is now dominated by exotic trees and shrubs (<i>Acacia cyclops</i> (Western Coastal Wattle), <i>Pinus halepensis</i> (Aleppo Pine), <i>Rhamnus alaternus</i> (Blowfly Bush) and <i>Lycium ferocissimum</i> (African Boxthorn)).</p> <p>Although sparse, the understory supports a medium diversity of regenerating native species including <i>Eucalyptus diversifolia</i> (Coastal White Mallee), several <i>Acacia</i> species, <i>Pomaderris obcordata</i> (Wedge-leaf Pomaderris), <i>Templetonia retusa</i> (Cockies Tongue), <i>Carpobrotus rossii</i> (Native Pigface), and a variety of small shrubs, forbs and grasses.</p> <p>The vegetation community is in poor to moderate condition.</p>				
Threatened species or community	<p><u>State-listed vegetation community:</u> Not considered a threatened ecosystem</p> <p><u>State-threatened flora observed:</u></p> <ul style="list-style-type: none"> • State Rare Port Lincoln Mallee (<i>Eucalyptus conglobata</i>) <p><u>Nationally- and State-threatened fauna that might utilise this vegetation community:</u></p> <ul style="list-style-type: none"> • Nationally Vulnerable: Diamond Firetail • State Vulnerable: Yellow-tailed Black Cockatoo • State Rare: Purple-gaped Honeyeater, Elegant Parrot, Western Gerygone, Rock Parrot, Peregrine Falcon. <p>Given the poor condition of the vegetation and limited structural diversity it is unlikely to provide important habitat for most of these species.</p> <p>The State Endangered Eastern Osprey) and White-bellied Sea Eagle occur nearby, but vegetation at the site is not their preferred nesting habitat.</p> <p>The State Rare Bush Stone-curlew, White-winged Chough and Painted Buttonquail have been recorded within 5 km of the site but are unlikely to rely on this plant community.</p>

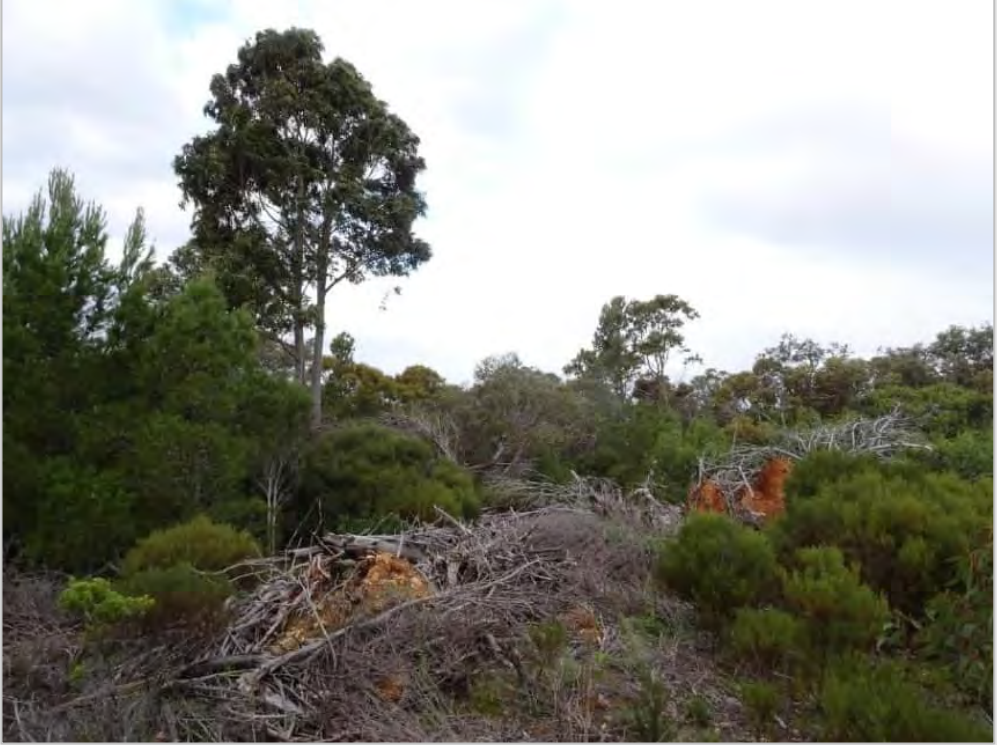
Vegetation Association	Site 8: Planted <i>Eucalyptus</i> spp., *<i>Pinus halepensis</i> woodland

<p><i>Representative photograph of Site 8, facing south-east at 581036, 6154416 (WGS 84 Zone 53).</i></p>					
General description	<p>Plant association 8 occurs adjacent to an old shed and a section of the southern road verge along St Andrews Drive. It comprises areas where some planting has been undertaken with non-indigenous <i>Eucalyptus</i> species but there is natural regeneration occurring underneath.</p> <p>The community supports a medium diversity of native species including regenerating <i>Eucalyptus diversifolia</i> (Coastal White Mallee) and <i>E. conglobata</i> (Port Lincoln Mallee), as well as several species of <i>Acacia</i>. The understory comprises a variety of shrubs (e.g. <i>Lasiopetalum</i> spp. (Velvet-bushes), <i>Acrotriche</i> spp. (Ground-berries)), vines, daisies and native grasses.</p> <p>Exotic species are a significant component and include <i>Pinus halepensis</i> (Aleppo Pine), <i>Asparagus asparagoides</i> (Bridal Creeper), <i>Polygala myrtifolia</i> (Myrtle-leaf Milkwort), <i>Scabiosa atropurpurea</i> (Pincushion) and <i>Piptatherum miliaceum</i> (Rice Millet).</p> <p>The vegetation community is in poor to moderate condition.</p>

Threatened species or community	<p><u>State-listed vegetation community:</u> Not considered a threatened ecosystem</p> <p><u>State-threatened flora observed:</u></p> <ul style="list-style-type: none"> • State Rare Port Lincoln Mallee (<i>Eucalyptus conglobata</i>) <p><u>Nationally- and State-threatened fauna that might utilise this vegetation community:</u></p> <ul style="list-style-type: none"> • Nationally Vulnerable: Diamond Firetail • State Vulnerable: Yellow-tailed Black Cockatoo • State Rare: Purple-gaped Honeyeater, Elegant Parrot, Western Gerygone, Rock Parrot and Peregrine Falcon <p>Given the poor condition of the vegetation and limited structural diversity it is unlikely to provide important habitat for most of these species.</p> <p>The Eastern Osprey, White-bellied Sea Eagle, Bush Stone-curlew, Painted Buttonquail and White-winged Chough occur nearby, but vegetation at the site is not their preferred habitat.</p>

Landscape context score	1.12	Vegetation Condition Score	30.50	Conservation significance score	1.12
Unit biodiversity Score	38.26	Area (ha)	0.0182 (Plant) 0.003 (Transfer)	Total biodiversity Score	0.70 (Plant) 0.11 (Transfer)

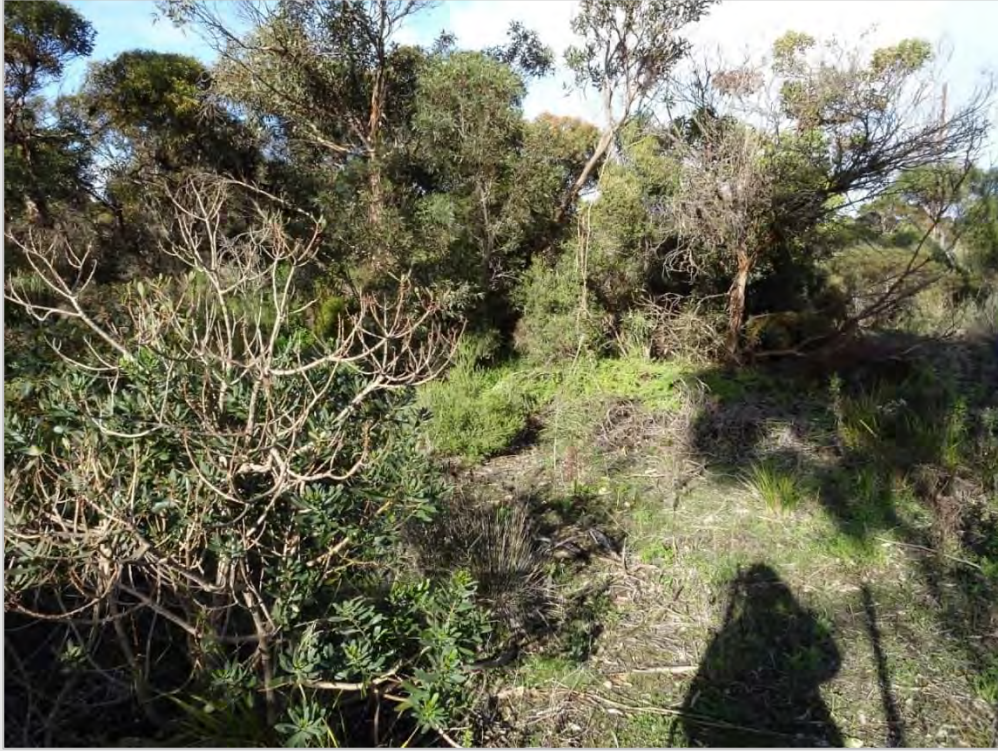
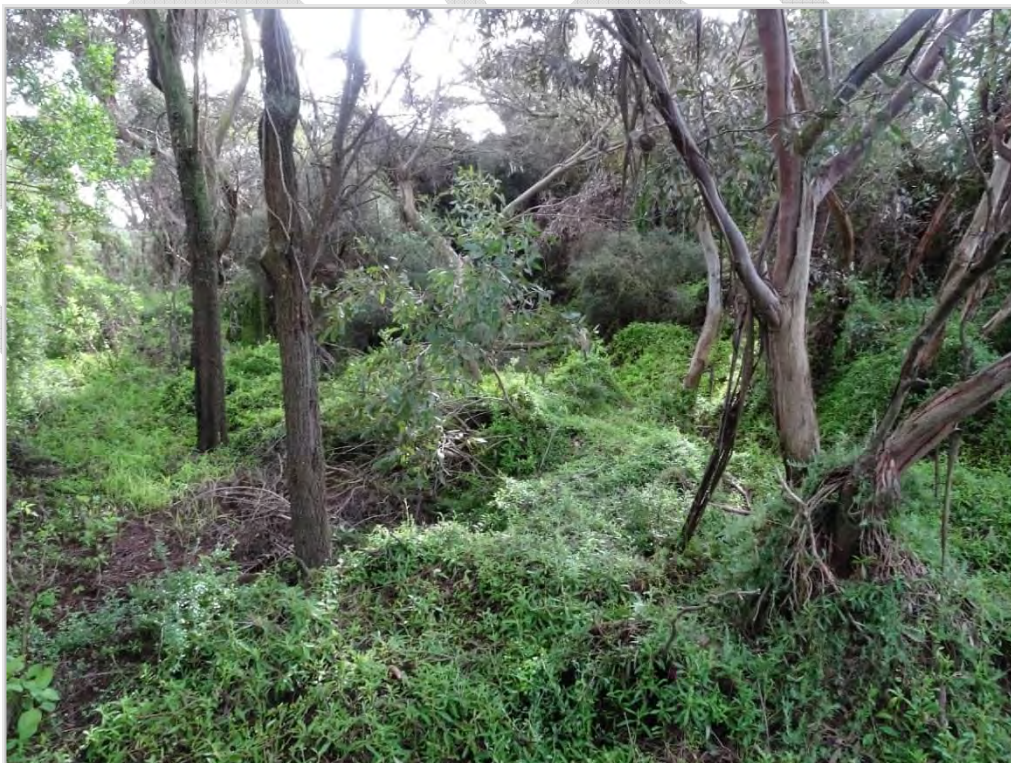
**Site WW1: *Eucalyptus rugosa*, *E. diversifolia* ± *E. alboburpurea* mallee with emergent
planted species**

Representative photograph of Site WW1, facing south at 581384, 6154601 (WGS 84 Zone 53).

Representative photograph of Site WW1, facing north-east at 581539, 6154733 (WGS 84 Zone 53).

General description	<p>This plant community occurs along the northern, western and southern edges of the Wastewater Treatment Plant. The overstorey is principally <i>Eucalyptus diversifolia</i> (Coastal White Mallee) and <i>E. rugosa</i> (White Mallee), with scattered patches of <i>E. albopurpurea</i> (Purple-flowered Mallee Box) and scattered emergent planted Eucalypt species. The principal dominants in the understory are <i>Melaleuca lanceolata</i> (Dryland Tea-tree) and <i>Myoporum insulare</i> (Common Boobialla). There are small, lower lying sections where water accumulates during winter, and moisture-loving species such as <i>Melaleuca brevifolia</i> (Short-leaf Honey-myrtle) and <i>Atriplex paludosa ssp. cordata</i> (Marsh Saltbush) occur. Vine lifeforms, such as <i>Tetragonia implexicoma</i> (Bower Spinach), <i>Cassytha melantha</i> (Coarse Dodder-laurel), <i>Clematis microphylla</i> (Old Man's Beard) and <i>Comesperma volubile</i> (Love Creeper) are prominent features of this vegetation.</p> <p>The most abundant weed species are <i>Lycium ferocissimum</i> (African Boxthorn) and <i>Oxalis pes-caprae</i> (Soursob), with <i>Juncus acutus</i> (Spiny Rush) and <i>Watsonia</i> sp. present as minor components.</p> <p>The vegetation community is in moderate to good condition.</p>
