Appendix C Draft Native Vegetation Clearance Application

Billy Lights Point: Eyre Peninsula Desalination Plant Project Data Report - Working Draft

Clearance under the *Native Vegetation Regulations 2017*

22 May 2024

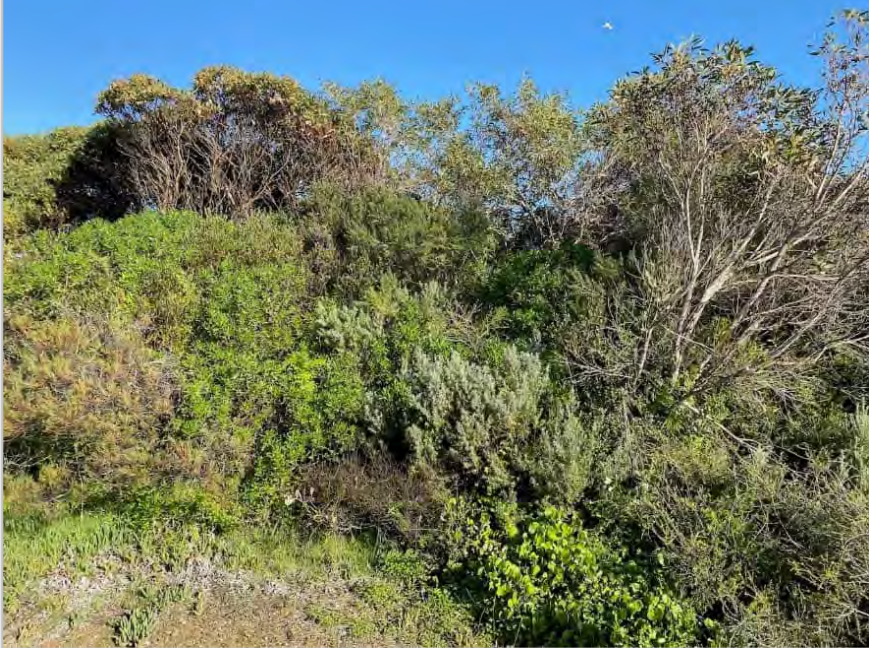
Vegetation Association	Site WW4: <i>Eucalyptus conglobata</i> + <i>E. diversifolia</i> mallee over dense understory of <i>Myoporum insulare</i>, <i>Olearia axillaris</i> and <i>Tetragonia implexicoma</i>

<p data-bbox="320 882 1254 913">Photo 7146 facing west at Latitude 135.891395/ Longitude -34.78552</p>				
General description	<p data-bbox="352 934 1461 1211">Vegetation association WW4 occurs along the coast east of the Wastewater Treatment Plant sedimentation ponds. The overstorey becomes dominated by <i>Eucalyptus diversifolia</i> and <i>E. conglobata</i> with scattered <i>E. oleosa</i>, <i>E. angulosa</i> and emergent <i>E. leptophylla</i>. <i>Myoporum insulare</i>, <i>Olearia axillaris</i>, <i>Templetonia retusa</i> and <i>Leocopogon parviflorus</i> shrubs along with <i>Tetragonia implexicoma</i> and <i>Threlkeldia diffusa</i> (Coast Bonefruit) are prominent features of the dense understory and groundlayer. The mallee thins out along the coastal frontage where sedges such as <i>Gahnia deusta</i>, <i>Lepidospermum viscidum</i> and <i>Ficinia nodosa</i>, and tussocks of <i>Austrostipa stipoides</i> grow amongst the shrublayer.</p> <p data-bbox="352 1225 1366 1328">Bridal Creeper occurs throughout the understory, but other weed species are a minor component and include very sparse individuals of African Boxthorn and African Daisy. Soursob grows mostly along the edges of the walkway.</p> <p data-bbox="352 1339 1366 1406">The plant association has a medium to high diversity of native species including many regenerating species, very high structural diversity, and moderate weed cover.</p> <p data-bbox="352 1417 962 1449">The vegetation community is in good condition.</p>

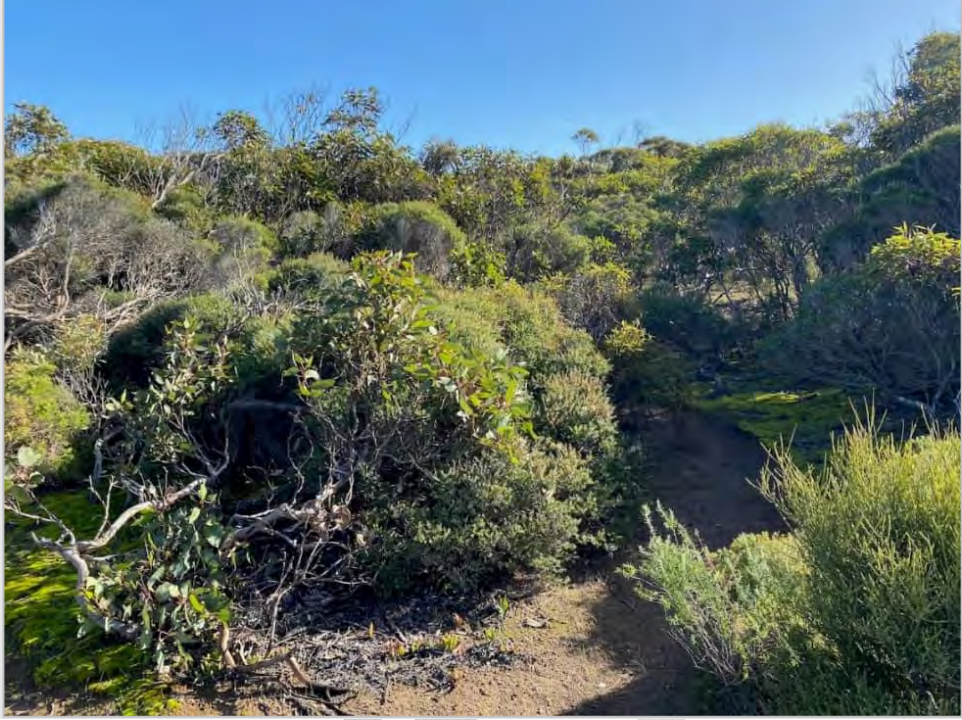
Vegetation Association	Site WW5: <i>Eucalyptus diversifolia</i>, <i>E. conglobata</i> mallee over <i>Pomaderris paniculosa</i>, <i>Alyxia buxifolia</i>, <i>Exocarpos aphyllus</i> and <i>Melaleuca lanceolata</i>

<p data-bbox="304 965 1270 1003">Photo 7257, facing west at Latitude 135.892051 / Longitude -34.76006</p>					
General description	<p>Vegetation association WW5 occurs between the coast and the decommissioned ponds of the Wastewater Treatment Plant. The overstorey is similar to that of WW4, being dominated by <i>Eucalyptus diversifolia</i> and <i>E. conglobata</i>, but the groundlayer becomes more open, and the predominant shrubs are <i>Pomaderris paniculosa</i>, <i>Alyxia buxifolia</i>, <i>Exocarpos aphyllus</i> and <i>Melaleuca lanceolata</i>. Moss covers the ground beneath the mallee, and two species of winter-flowering orchids (<i>Cyrtostylis robusta</i> and <i>Pterostylis erythroconcha</i>) were observed.</p> <p>The most abundant weed is Bridal Creeper which occurs scattered throughout the mallee understory. Other exotic species such as African Daisy and Box Thorn are present as minor components and Soursob grows mostly along the edges of the walking track.</p> <p>The plant association has a medium to high diversity of native species including many regenerating species, very high structural diversity, and moderate weed cover.</p> <p>The vegetation community is in good condition.</p>

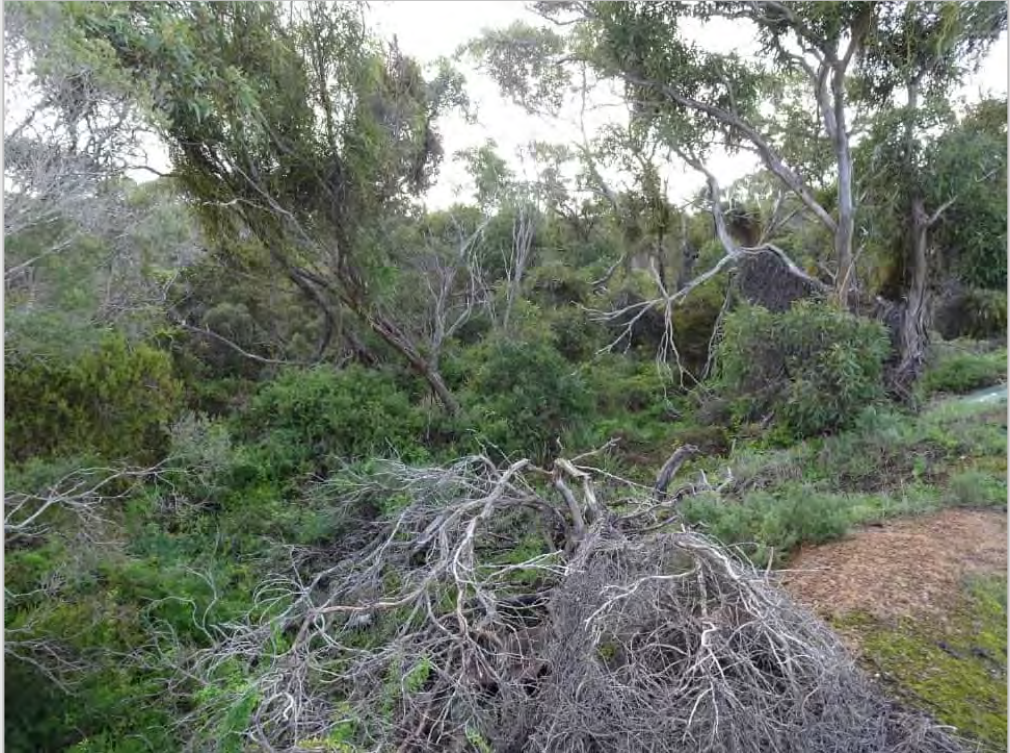
<p><i>Representative photograph of Site RC1, facing NE at 579139, 6153850 (WGS 84 Zone 53).</i></p>					
General description	<p>Vegetation association RC1 occurs at the western end of a large expanse of mallee between the proposed desalination plant and Greyhound Rd. The canopy is dominated by <i>Eucalyptus albopurpurea</i> over <i>Rhagodia crassifolia</i>, <i>Melaleuca lanceolata</i> and a dense cover of <i>Tetragonia implexicoma</i>. There are some dense patches of <i>Austrostipa elegantissima</i> in more open areas, but the remaining groundlayer is highly disturbed and invaded by exotic annual grasses. Bridal Creeper and African Daisy are also present.</p> <p>The plant association has a moderate diversity of native plant species and good structural diversity but the groundlayer is disturbed by rubbish dumping and weed invasion.</p> <p>The vegetation community is in moderate condition.</p>

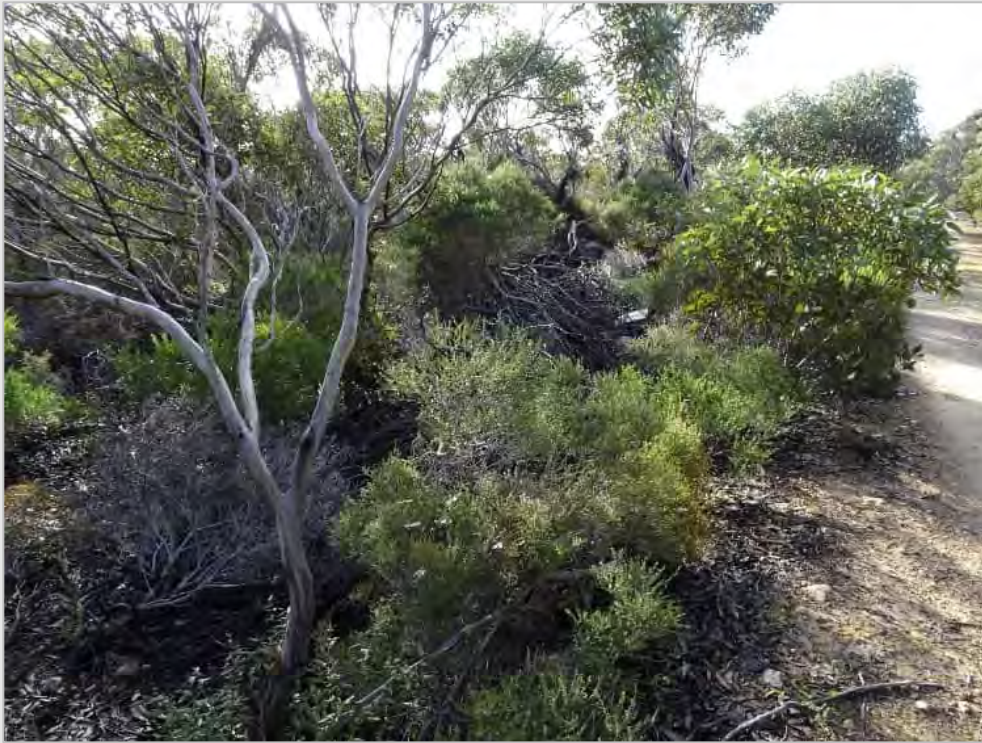
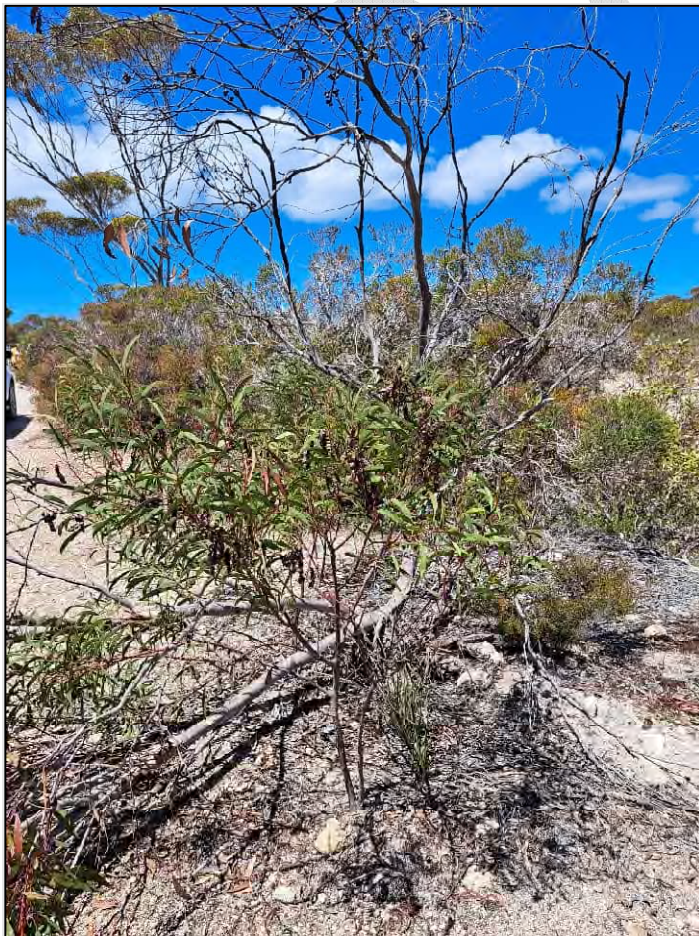
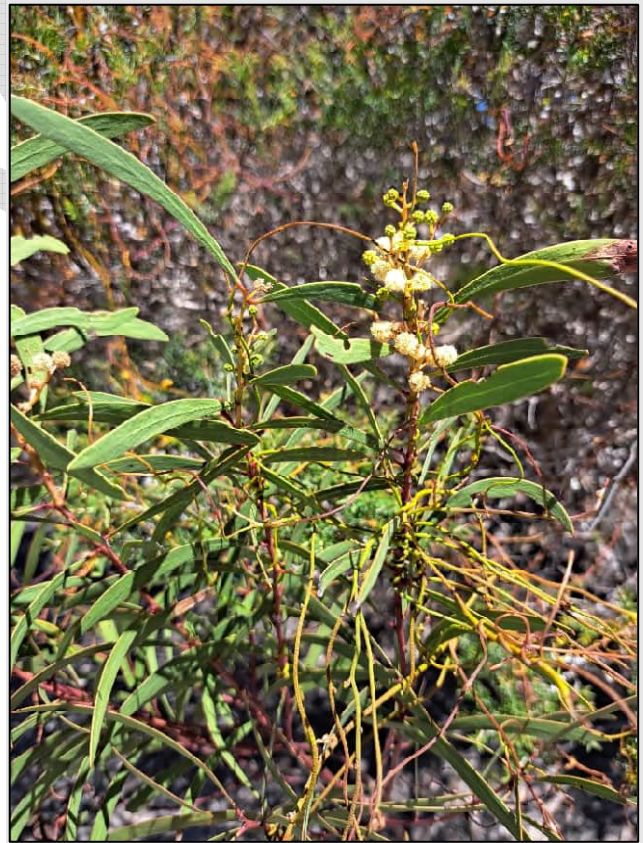
Representative photograph of Site RC2, facing NE at 579228, 6153858 (WGS 84 Zone 53).

Acacia alcockii stand growing on the southern side of the existing track

General description	<p>Vegetation association RC2 occurs on the northern side of the rail corridor, within a large expanse of mallee between the proposed desalination plant and Greyhound Rd. The community is characterised by a canopy dominated by <i>Eucalyptus globata</i> ssp. <i>globata</i> and <i>E. diversifolia</i> ssp. <i>diversifolia</i> over dense patches of <i>Melaleuca lanceolata</i> and more open areas supporting low shrubs such as <i>Lasiopetalum discolor</i>, <i>Acacia triquetra</i> (Mallee Wreath Wattle), <i>Templetonia retusa</i>, <i>Dodonaea</i> species and patches of <i>Gahnia deusta</i>. Five species of orchid were recorded in the association (<i>Caladenia capillata</i>, <i>C. campestris</i>, <i>Thelymitra megcalyptra</i>, <i>Microtis</i> sp. and <i>Pterostylis flavovirens</i>).</p> <p>Apart from very sparsely scattered plants of Bridal Creeper, Sour-sob and Hair's Tail Grass, weed cover is very low.</p> <p>The plant association has a high diversity of native plant species, many of which are regenerating, with good structural diversity and deep leaf litter.</p> <p>The vegetation community is in excellent condition.</p>

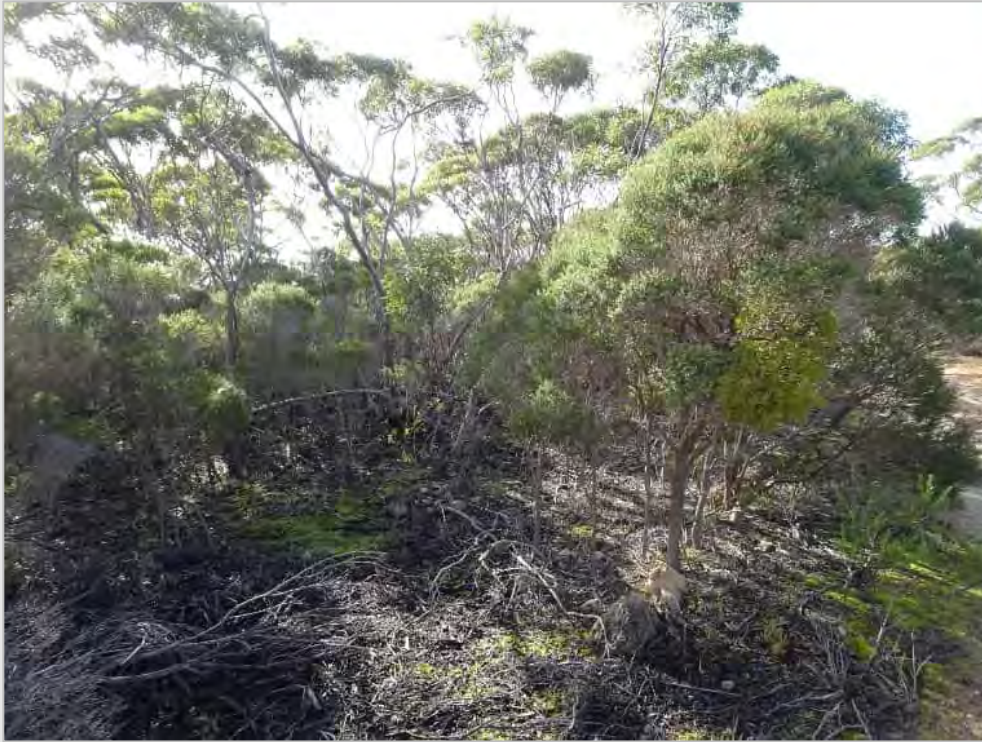
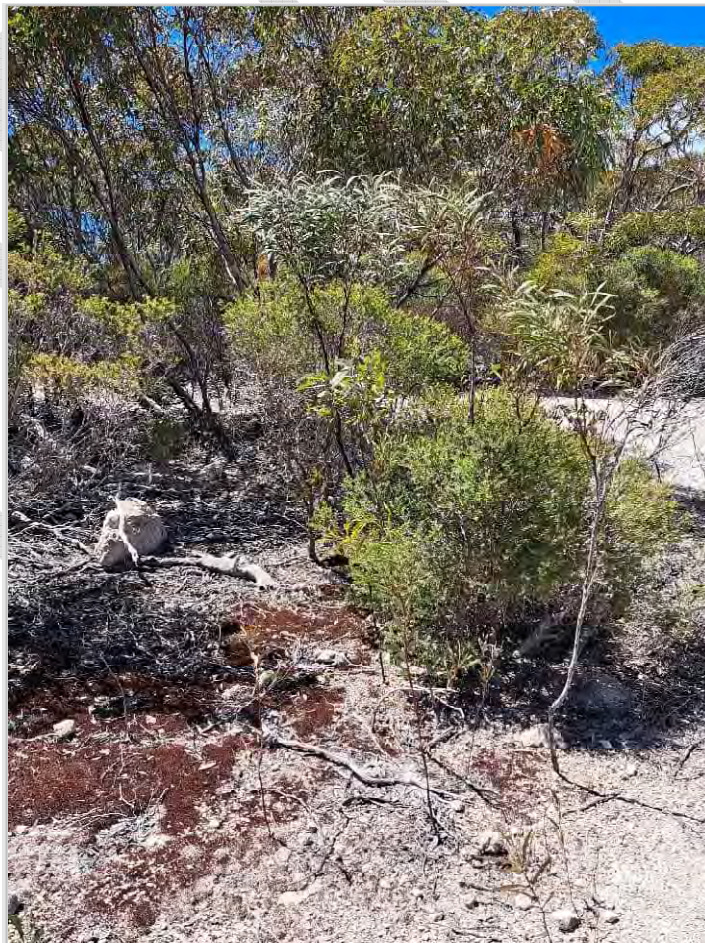
**Site RC3: *Eucalyptus rugosa*, *E. gracilis*, *E. oleosa* ± *E. conglobata*, *E. diversifolia* mallee
over a shrubby understorey**

Representative photograph of Site RC3, facing NE at 579435, 6153868 (WGS 84 Zone 53).

*Stand of *Acacia alcockii* along the northern side of the track*

General description	<p>Vegetation association RC3 occurs on the northern side of the rail corridor, within a large expanse of mallee between the proposed desalination plant and Greyhound Rd. <i>Eucalyptus gracilis</i>, <i>E. oleosa ssp. ampliata</i> and <i>E. rugosa</i> are the dominant canopy species, generally with a dense understorey of <i>Melaleuca lanceolata</i> shrubs, many supporting mistletoe (<i>Amyema melaleucae</i>). <i>Eucalyptus conglobata</i> is a minor overstorey component in areas that intergrade between communities RC2 and RC3. <i>Acacia nematophylla</i>, <i>Eutaxia microphylla</i>, <i>Acacia triquetra</i> and <i>Dianella</i> species are common in the understorey. Four orchid species were observed within the proposed clearance area: <i>Caladenia capillata</i>, <i>C. campestris</i>, <i>Microtis sp.</i> and <i>Pterostylis flavovirens</i>.</p> <p>Apart from very sparsely scattered plants of Bridal Creeper and Sour-sob, weed cover is generally very low.</p> <p>The plant association has a high diversity of native plant species, many of which are regenerating, with good structural diversity and deep leaf litter.</p> <p>The vegetation community is in excellent condition.</p>

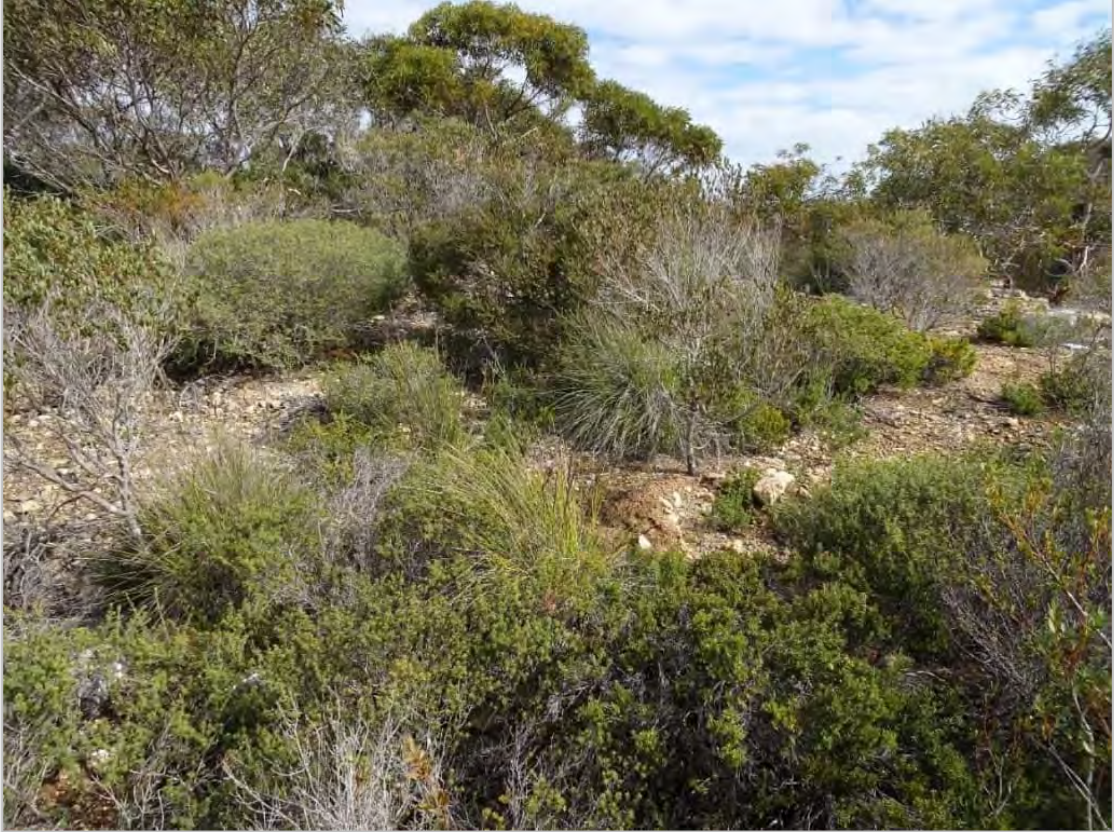
Vegetation Association	Site RC4: <i>Eucalyptus diversifolia</i> with a heathy understorey on limestone

<p data-bbox="209 1037 1362 1070">Representative photograph of RC4, facing SW at 580801, 6154218 (WGS 84 Zone 53).</p>					
General description	<p data-bbox="352 1088 1430 1249">Vegetation association RC4 occurs within a small patch on the northern side of the track, where <i>Eucalyptus diversifolia</i> dominates over a dense cover of low and medium shrubs and sedges. <i>Eucalyptus conglobata</i> is present as a minor overstorey component. <i>Acrotriche</i> spp., <i>Melaleuca lanceolata</i>, <i>Gahnia deusta</i>, <i>Pomaderris obcordata</i> and <i>Templetonia retusa</i> are common understory species.</p> <p data-bbox="352 1256 1410 1323">Weed cover is low and includes sparse plants of Bridal Creeper, Aleppo Pine and Western Coastal Wattle.</p> <p data-bbox="352 1335 1390 1402">The plant association has a moderate-high diversity of native plant species, with several regenerating species.</p> <p data-bbox="352 1413 963 1447">The vegetation community is in good condition.</p>

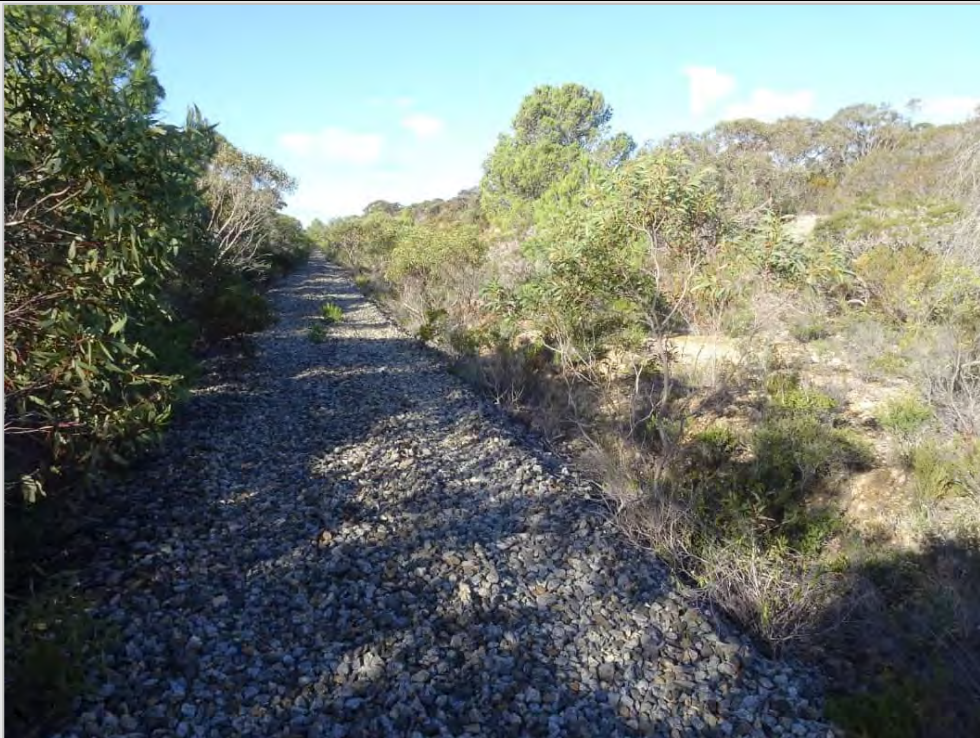
Vegetation Association	Site RC6: <i>Eucalyptus diversifolia</i>, <i>E. conglobata</i>, <i>E. gracilis</i>, <i>E. rugosa</i>, <i>Pinus halepensis</i> regenerating mallee
------------------------	--

Representative photograph of Site RC6, facing East at 579506, 6153858 (WGS 84 Zone 53).

General description	<p>Vegetation association RC6 occurs between the track and the rail corridor, where mallee vegetation is recovering well after past disturbances, but still contains open bare areas and has a greater incursion of weeds. <i>Eucalyptus diversifolia</i>, <i>E. conglobata</i>, <i>E. gracilis</i> and <i>E. rugosa</i> are the main native canopy species, with several species of <i>Acacia</i>, <i>Dodonaea</i> and <i>Melaleuca</i> regenerating in the understory.</p> <p>Dominant weed species include Aleppo Pine and Pincushion, with Bridal Creeper, Western Coastal Wattle and <i>Phalaris</i> sp. (Canary Grass) present as minor components.</p> <p>The plant association has a moderate-high diversity of native plant species, and very good regeneration, but lower structural diversity compared to adjacent mature mallee communities.</p> <p>The vegetation community is in moderate condition.</p>

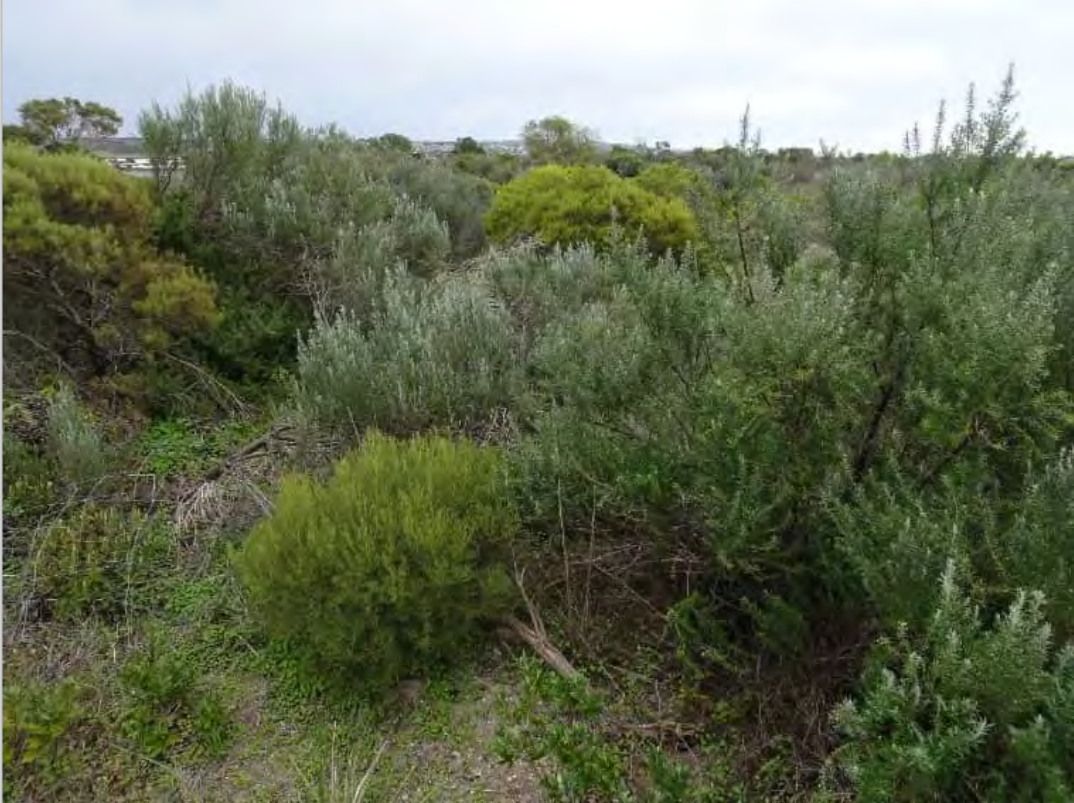
Vegetation Association	Site RC7: <i>Olearia axillaris</i>, <i>Leucopogon parviflorus</i> coastal shrubland

<p style="text-align: center;"><i>Representative photograph of Site RC7, facing NW at 579041, 6153877 (WGS 84 Zone 53).</i></p>					
General description	<p>Vegetation association RC7 occurs west of the mallee communities, along either side of Greyhound Rd. It is a coastal shrubland community with an overstorey principally composed of <i>Acacia nematophylla</i>, <i>Leucopogon parviflorus</i> and <i>Olearia axillaris</i>. <i>Rhagodia spp.</i> and <i>Pomaderris paniculosa</i> are prevalent in the understorey.</p> <p>Sour-sob is the most dominant weed with Bridal Creeper, Western Coastal Wattle and <i>Euphorbia terracina</i> (False Caper) present as minor components.</p> <p>The plant association has a high diversity of native plant species.</p> <p>The vegetation community is in moderate to good condition.</p>

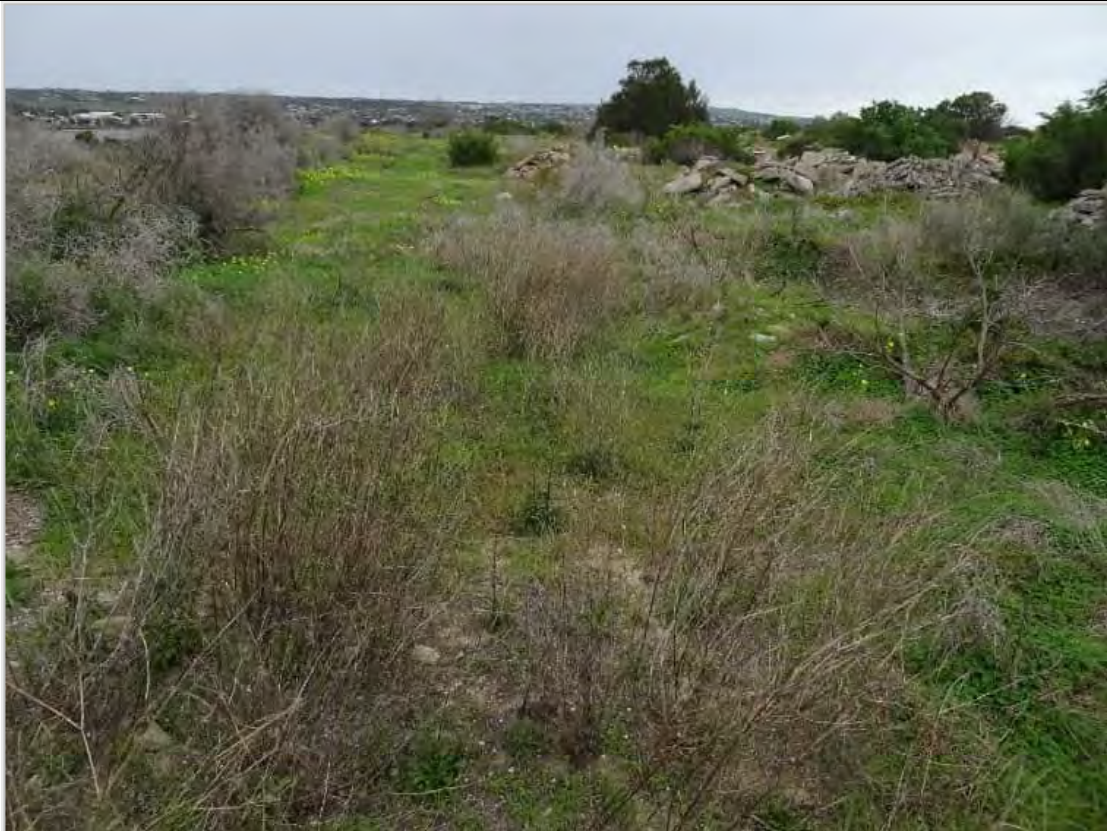
Vegetation Association	Site RC8: *<i>Lycium ferocissimum</i> open shrubland
------------------------	---

Representative photograph of Site RC8, facing NW at 578971, 6153970 (WGS 84 Zone 53).

General description	<p>Plant association RC8 occurs north of Greyhound Rd in highly disturbed areas where introduced Boxthorn (<i>Lycium ferocissimum</i>) is prominent and the understorey is dominated by introduced grasses and forbs (Pincushion and False Caper).</p> <p>Regenerating native shrub species such as <i>Acacia cupularis</i>, <i>A. nematophylla</i>, <i>Adriana quadripartita</i> (Coast Bitter-bush) and <i>Olearia axillaris</i> occur as scattered individuals.</p> <p>The plant association has a low diversity of native plant species, with a very high burden of high-threat weeds.</p> <p>The vegetation community is poor condition.</p>				
Threatened species or community	<p><u>State-listed vegetation community:</u> No</p> <p><u>State-threatened flora observed:</u> None</p> <p><u>Nationally- and State-threatened fauna that are likely to utilise this community:</u> None.</p> <p>This highly degraded community is unlikely to provide significant habitat for threatened fauna.</p>

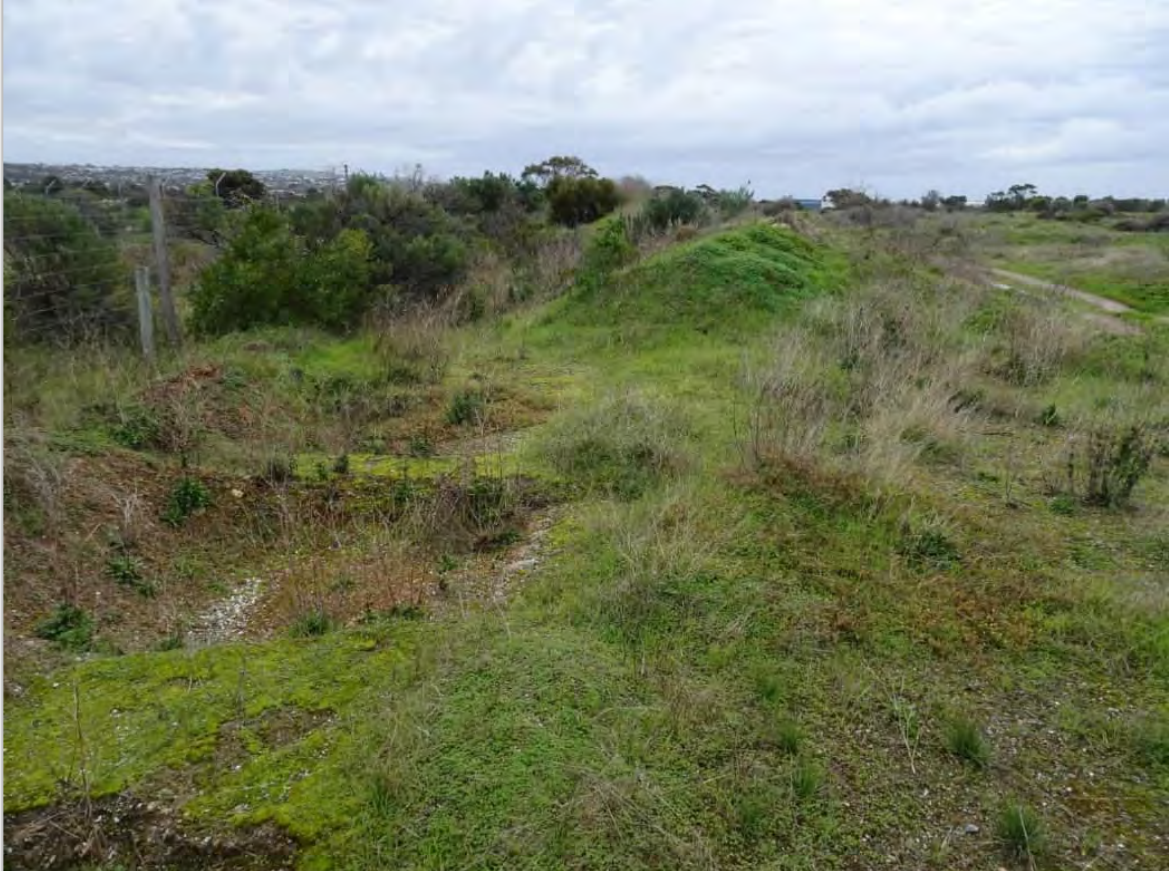
Vegetation Association	Site RC10: <i>Olearia axillaris</i>, <i>Acacia nematophylla</i> disturbed coastal shrubland

<p style="text-align: center;"><i>Representative photograph of Site RC10, facing NNW at 578654, 6154278 (WGS 84 Zone 53).</i></p>					
General description	<p>This degraded coastal shrubland occurs north of Greyhound Road where there has been past clearance. The overstorey is quite sparse and comprised mostly of <i>Olearia axillaris</i>, <i>Acacia nematophylla</i> with regenerating <i>Leucopogon parviflorus</i>, <i>Adriana quadripartita</i> and various chenopod shrubs. Native plant species diversity is moderate to high.</p> <p>The ground layer is heavily invaded by grassy and herbaceous weeds such as Coastal Galenia, Bridal Creeper and Sour-sob.</p> <p>The vegetation community is in moderate condition.</p>				
Threatened species or community	<p><u>State-listed vegetation community:</u> No</p> <p><u>State-threatened flora observed:</u> None</p> <p><u>Nationally- and State-threatened fauna that may use this community:</u></p> <ul style="list-style-type: none"> • State Rare: Elegant Parrot, Rock Parrot and Peregrine Falcon. <p>This disturbed coastal shrubland is not preferred habitat for the Nationally Vulnerable Diamond Firetail, State Endangered Eastern Osprey and White-bellied Sea Eagle, State Vulnerable Yellow-tailed Black Cockatoo and Brown Quail, or the State Rare Purple-gaped Honeyeater, White-winged Chough, Western Gerygone, Shy Heathwren, Painted Buttonquail and Bush Stone-curlew.</p>

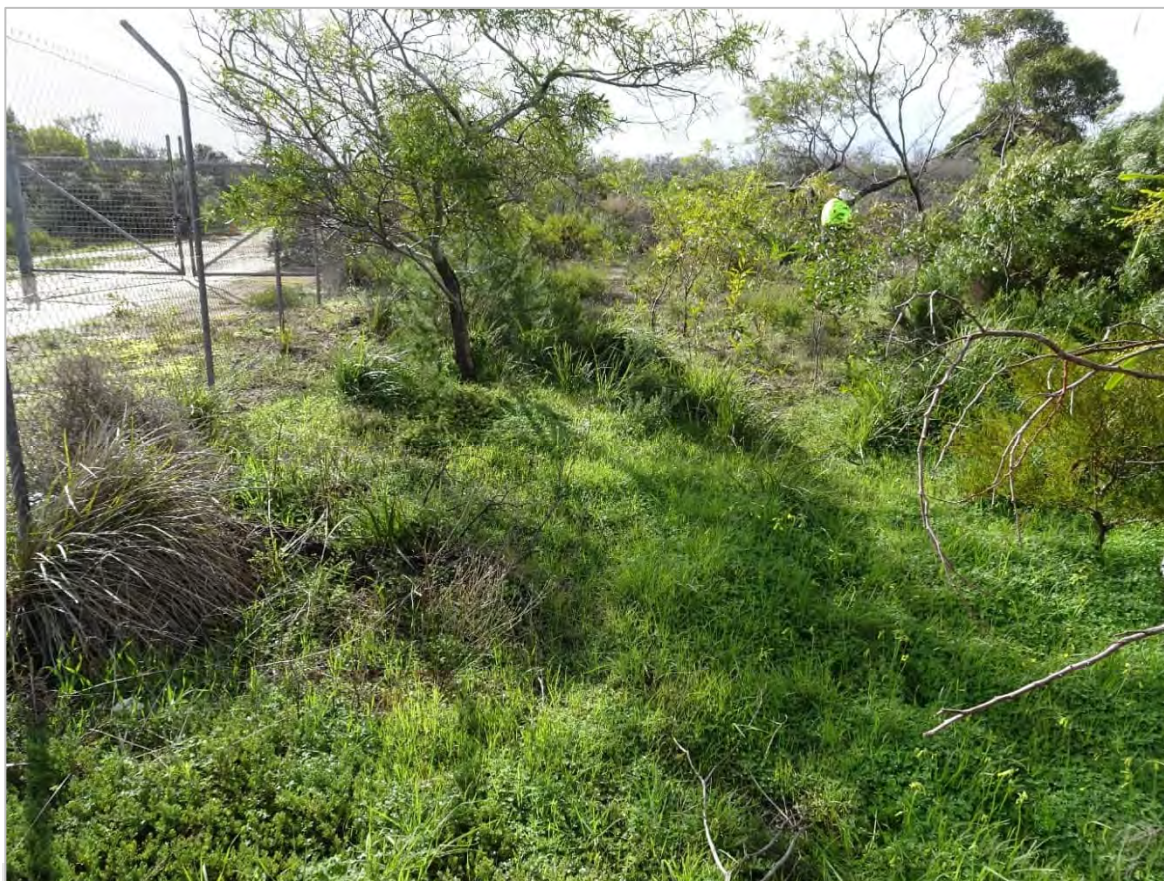
Vegetation Association	Site RC11: *<i>Acacia saligna</i>, <i>A. paradoxa</i> shrubland with emergent <i>Pinus halepensis</i>
------------------------	--

Representative photograph of Site RC11, facing NW at 578593, 6154568 (WGS 84 Zone 53).

General description	<p>Plant community RC11 is present along the powerline alignment on the spur heading north from the transfer pipe.</p> <p>It occurs on a very disturbed low dune considered likely to have once been a coastal mallee community. It is now dominated by <i>Acacia paradoxa</i> (Kangaroo Thorn), with the introduced <i>Acacia saligna</i> (Golden Wreath Wattle) and <i>Pinus halepensis</i> also significant in the overstorey. The understorey supports native shrub and sedge lifeforms including several <i>Acacia</i> species, <i>Adriana quadripartita</i>, <i>Rhagodia crassifolia</i> and <i>Dianella brevicaulis</i>, but also with a heavy load of grassy and herbaceous weeds.</p> <p>The plant association has a moderate diversity of native plant species, with a high burden of high-threat weeds (e.g. Bridal Creeper, Myrtle-leaf Milkwort, Blowfly Bush, Sour-sob, African Boxthorn and <i>Asparagus declinatus</i> (Bridal Veil).</p> <p>The vegetation community is in poor condition.</p>

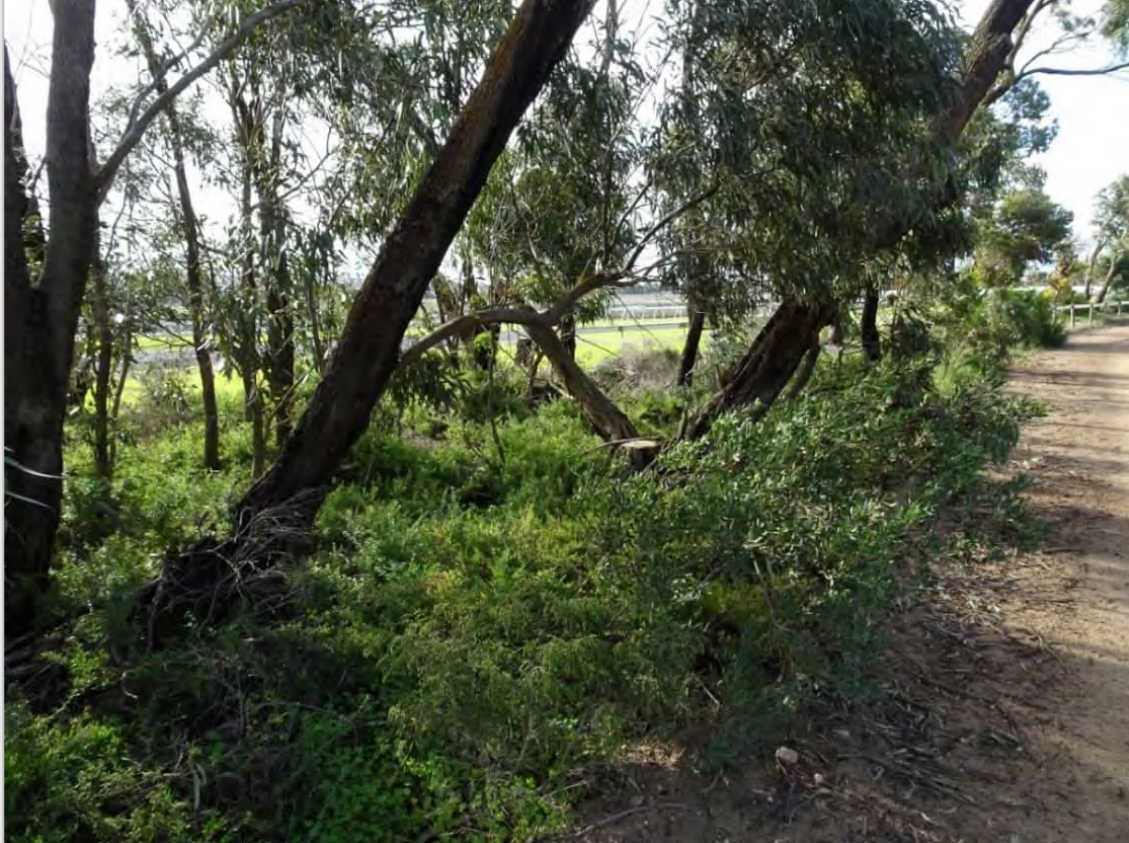
Vegetation Association	Site RC12: Planted <i>Eucalyptus spp.</i>, <i>Casuarina sp.</i> over disturbed coastal shrubland

<p style="text-align: center;"><i>Representative photograph of Site RC12, facing N at 577990, 6154382 (WGS 84 Zone 53).</i></p>					
General description	<p>This plant association occurs to the south-east of the racecourse and near the intersection of Greyhound and Proper Bay roads. It is a degraded version of the coastal shrubland (RC7), where the disturbed remnant community persists beneath overstorey plantings of non-indigenous <i>Eucalyptus</i> and <i>Casuarina</i> species, and exotic Aleppo Pine and Western Coast Wattle.</p> <p><i>Enchylaena tomentosa</i> and <i>Rhagodia candolleana</i> are the most common native shrubs, and there are several regenerating species including <i>Leucopogon parviflorus</i>, <i>Melaleuca halmaturorum</i>, <i>Acacia nematophylla</i> and <i>A. paradoxa</i>,</p> <p>Sour-sob is dominant in the groundlayer, and Bridal Creeper is also present.</p> <p>The vegetation community is in moderate condition.</p>

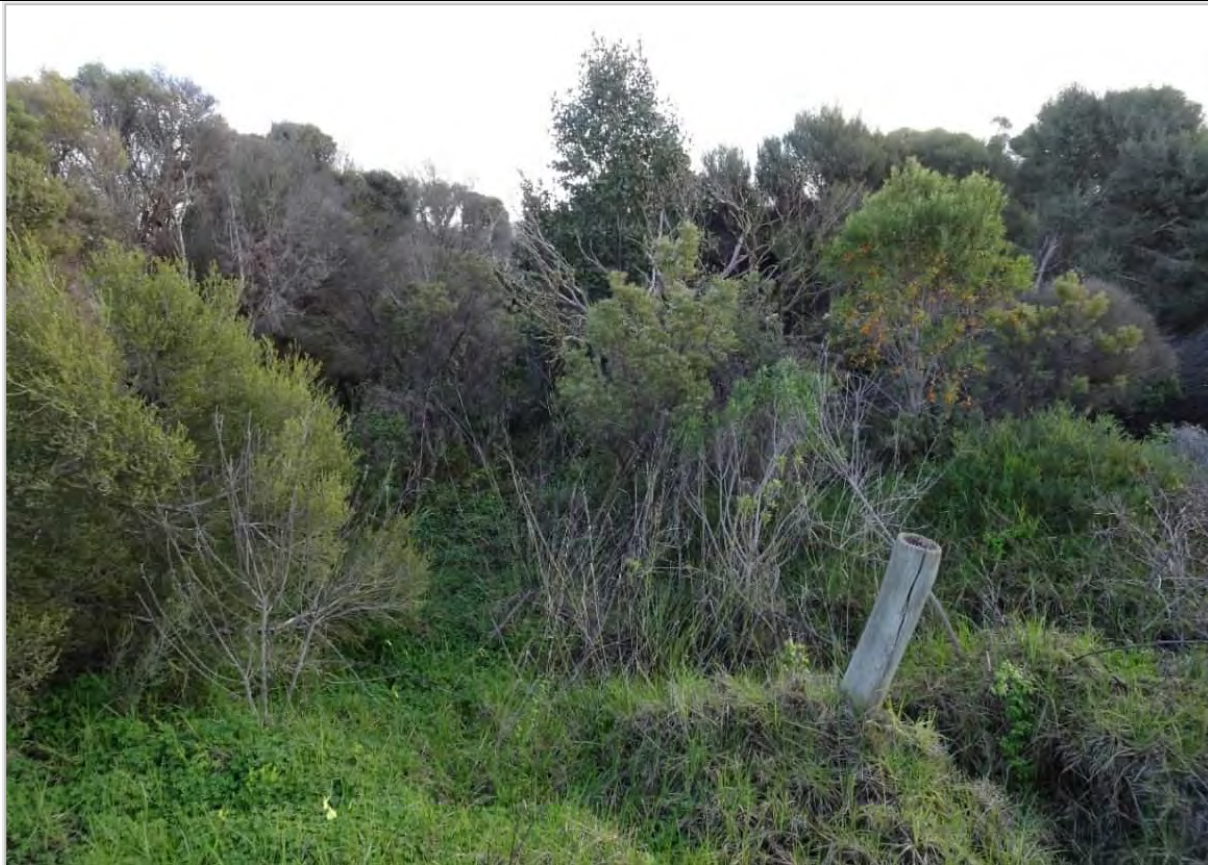
Vegetation Association	Site RC13: <i>Melaleuca halmaturorum</i> woodland
------------------------	--

Representative photograph of Site RC13, facing W at 577948, 6154311 (WGS 84 Zone 53).

General description	<p>This saline wetland system occurs south of the racecourse on the northern side of Greyhound Road, and along the powerline spur heading north from the transfer pipe.</p> <p>It consists of an overstorey of <i>Melaleuca halmaturorum</i> (Swamp Paper-bark) over <i>Distichlis distichophylla</i> (Emu-grass) and the small/medium chenopod shrubs <i>Rhagodia candolleana</i> and <i>Threlkeldia diffusa</i> (Coast Bonefruit), with several highly threatening weeds, including *<i>Juncus acutus</i> (Spiny Rush), Bridal Creeper, Olive and African Boxthorn.</p> <p>Native species diversity and the community has a medium-high level of structural diversity, with good canopy cover.</p> <p>The vegetation community is in moderate condition.</p>				
Threatened species or community	<p><u>State-listed vegetation community:</u> No</p> <p><u>State-threatened flora observed:</u> None</p> <p><u>Nationally- and State-threatened fauna that may use this community:</u></p> <ul style="list-style-type: none"> • State Rare: Elegant Parrot, Rock Parrot, and Peregrine Falcon. <p>The wetland community is not preferred habitat for the Nationally Vulnerable Diamond Firetail, the State Vulnerable Yellow-tailed Black Cockatoo and Brown Quail, or the State Rare Purple-gaped Honeyeater, White-winged Chough, Western Gerygone, Shy Heathwren, Painted Buttonquail and Bush Stone-curlew.</p> <p>Given the site's proximity to busy roads, it is highly unlikely to support the State Endangered Eastern Osprey and White-bellied Sea Eagle.</p>

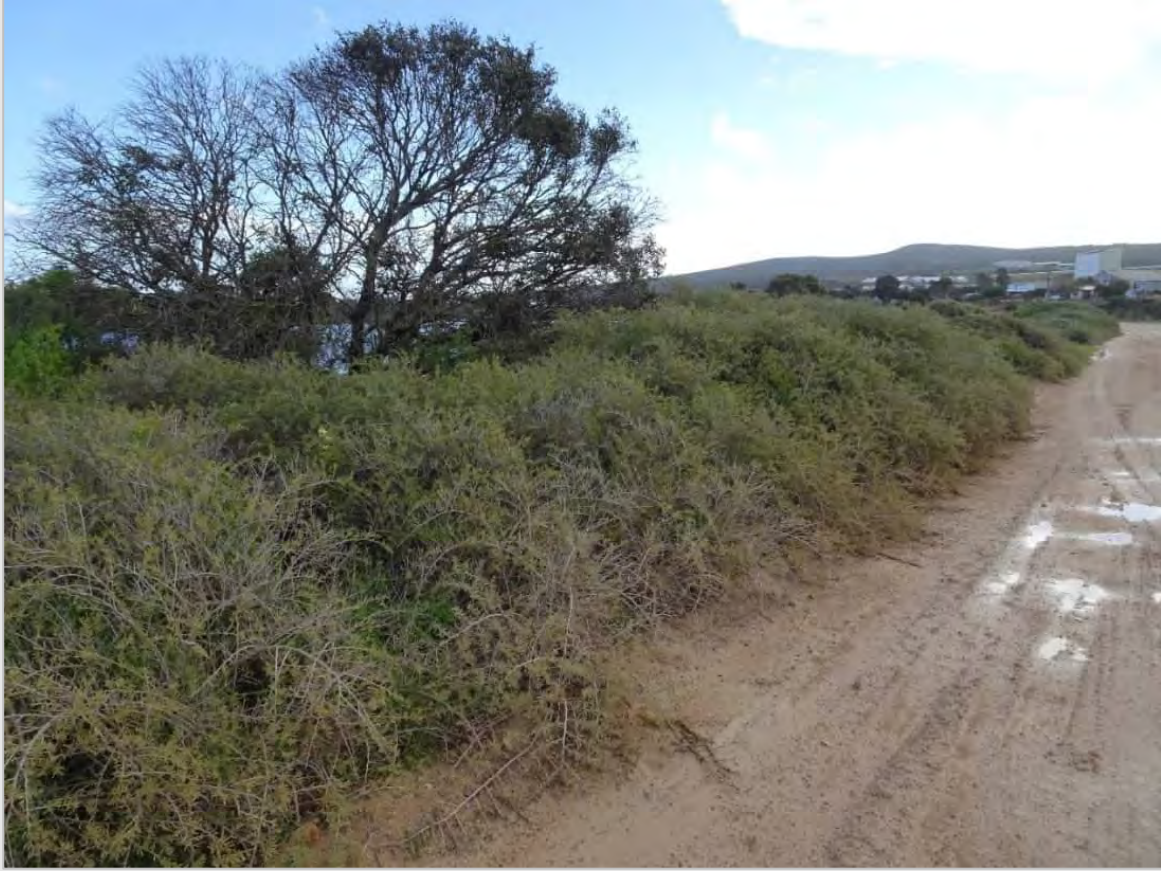
Vegetation Association	Site RC14: <i>Nitraria billardieri</i> shrubland

<p><i>Representative photograph of Site RC14, facing W at 577790, 6154287 (WGS 84 Zone 53).</i></p>					
General description	<p>Plant community RC14 occurs as a narrow strip on the southern side of Greyhound Rd, south of the racecourse.</p> <p>The coastal shrubland has a moderate diversity of native species with an overstorey dominated by <i>Nitraria billardieri</i> (Nitre Bush) over <i>Suaeda australis</i> (Austral Seablite).</p> <p>Three SA Declared weeds Spiny Rush, Bridal Creeper and African Boxthorn occur in the association.</p> <p>The vegetation community is in moderate condition.</p>				
Threatened species or community	<p><u>State-listed vegetation community:</u> No</p> <p><u>State-threatened flora observed:</u> None</p> <p><u>Nationally- and State-threatened fauna that may use this community:</u></p> <ul style="list-style-type: none"> • State Rare: Elegant Parrot, Rock Parrot, Painted Buttonquail and Peregrine Falcon. <p>Coastal shrubland is not preferred habitat for the Nationally Vulnerable Diamond Firetail, the State Vulnerable Yellow-tailed Black Cockatoo or Brown Quail, or the State Rare Purple-gaped Honeyeater, Western Gerygone, Shy Heathwren, White-winged Chough and Bush Stone-curlew. Given the site's proximity to busy roads, it is highly unlikely to support the State Endangered Eastern Osprey and White-bellied Sea Eagle.</p>

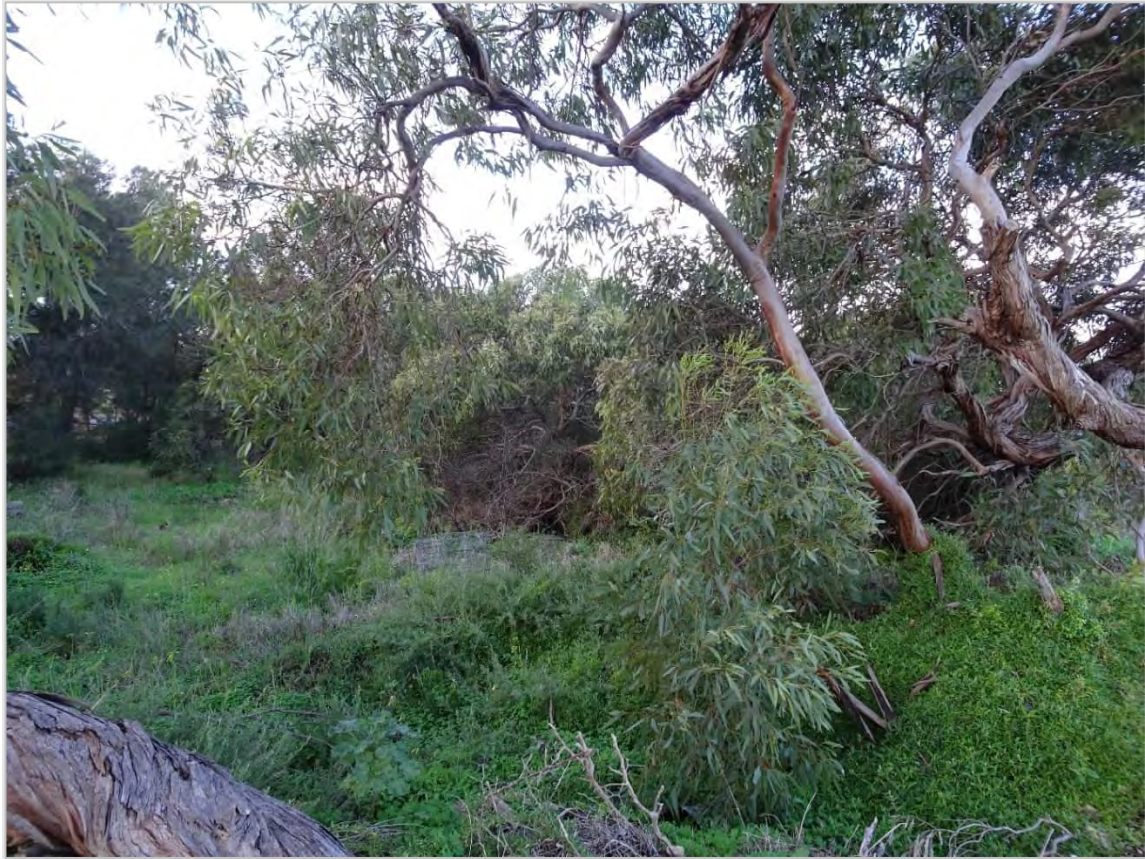
Vegetation Association	Site RC15: <i>Eucalyptus albopurpurea</i>, <i>E. diversifolia</i> disturbed mallee
------------------------	---

Representative photograph of Site RC15, facing North at 578481, 6155053 (WGS 84 Zone 53).

General description	<p>This highly disturbed <i>Eucalyptus albopurpurea</i> and <i>Eucalyptus diversifolia</i> mallee community occurs at the northernmost end of the powerline alignment on the spur heading north from the transfer pipe.</p> <p>Whilst the overstorey trees are generally in good condition, the understorey is highly degraded and generally dominated by introduced grass, herb and climber weeds.</p> <p>Native species diversity is low and includes some understorey shrubs and groundcovers such as <i>Rhagodia crassifolia</i>, <i>Pimelea serpyllifolia</i>, <i>Exocarpos aphyllus</i> and <i>Tetragonia implexicoma</i>.</p> <p>The community contains several high threat weeds (Bridal Creeper, Aleppo Pine, African Box Thorn, Sour Sob and Swamp Oak).</p> <p>The vegetation community is in poor condition.</p>				
Threatened species or community	<p><u>State-listed vegetation community:</u> No</p> <p><u>State-threatened flora observed:</u> None</p> <p><u>Nationally- and State-threatened fauna that may use this community:</u></p> <ul style="list-style-type: none"> • State Vulnerable Yellow-tailed Black Cockatoo • State Rare: Elegant Parrot, Rock Parrot, White-winged Chough, Western Gerygone <p>The degraded understorey is unlikely to provide suitable habitat for the Nationally Vulnerable Diamond Firetail, the State Vulnerable Brown Quail, or the State Rare Purple-gaped Honeyeater, Peregrine Falcon, Shy Heathwren, Painted Buttonquail and Bush Stone-curlew.</p>

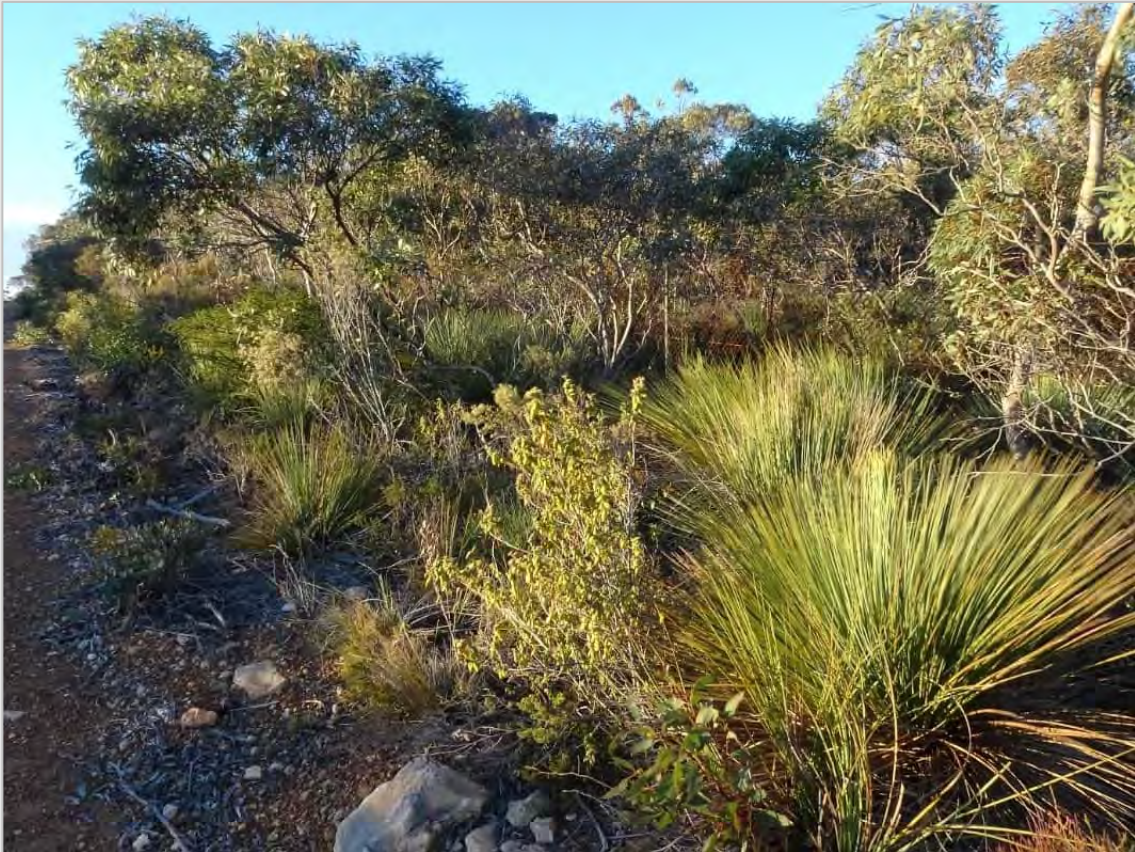
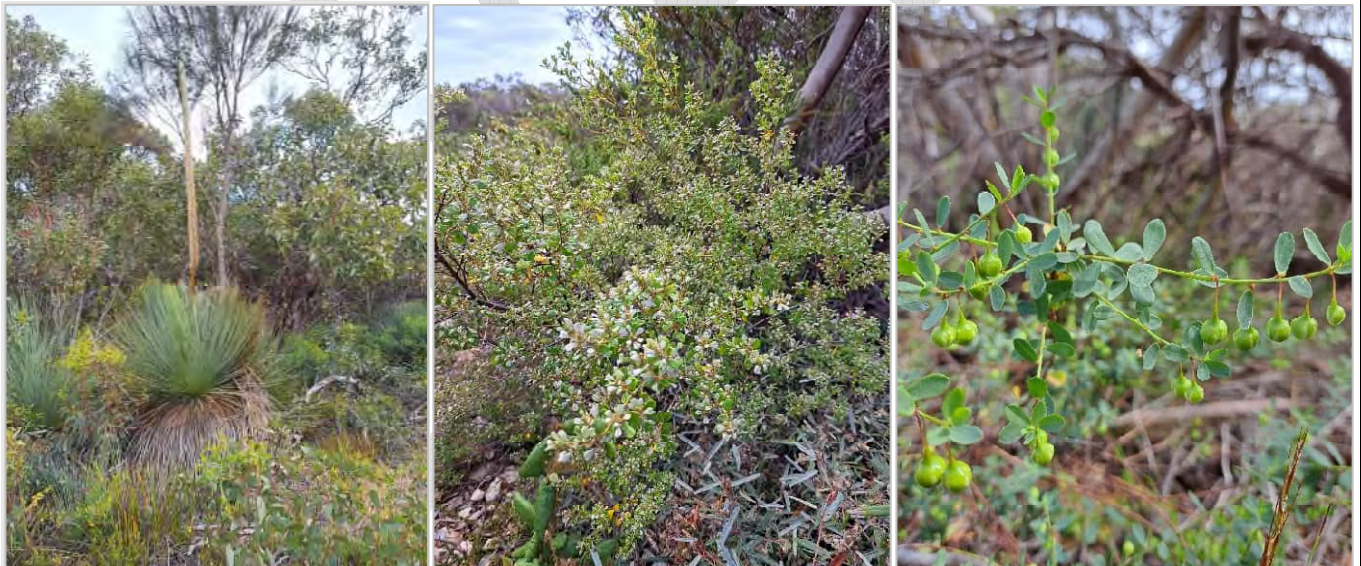
Site TR1: *Eucalyptus diversifolia*, *E. albopurpurea* mallee with emergent *Allocasuarina verticillata*

Representative photograph of Site TR1, facing SSE at 575172, 6154560 (WGS 84 Zone 53).

Threatened flora recorded in TR1: Tate's Grass Tree (left), Spoon-leaved Spyridium (centre) and Snowdrop Spurge (right)

General description	<p>Vegetation Association TR1 is present around the existing Northside Hill tank site at the western end of Blue Fin Rd. <i>Eucalyptus diversifolia</i> and <i>Eucalyptus albopurpurea</i> are co-dominant canopy species with some emergent <i>Allocasuarina verticillata</i>. The understorey is a highly diverse heathy shrub, comprising <i>Pomaderris obcoradta</i>, <i>Xanthorrhoea seMIPslana</i>, <i>Acrotriche cordata</i>, <i>Acacia myrtoifolia</i>, <i>A. paradoxa</i>, <i>Hibbertia devitata</i>, <i>Lepidospermum viscidum</i> and <i>Lasiopetalum</i> species. Two species of orchids (<i>Diuris</i> sp. and <i>Microtis</i> sp.) were detected in spring surveys.</p> <p>Weed incursions are minor and include scattered plants of Bridal Creeper, Freesias, Sour-sob, African Daisy and Aleppo Pine.</p> <p>The plant community has very high structural and native plant species diversity, with many regenerating species, and offers good fauna habitat.</p> <p>The vegetation community is in excellent condition.</p>
