Appendix C Draft Native Vegetation Clearance Application

Billy Lights Point: Eyre Peninsula Desalination Plant Project Data Report - Working Draft

Clearance under the *Native Vegetation Regulations 2017*

22 May 2024

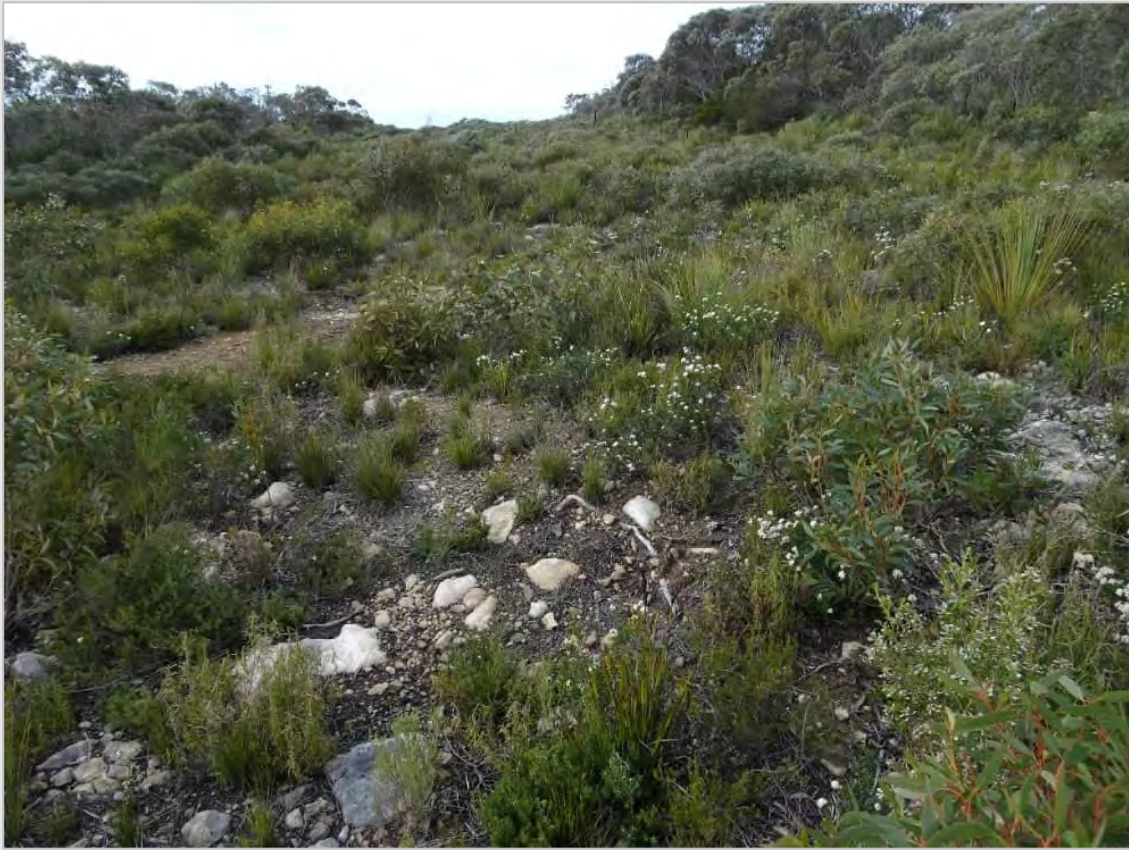
Representative photograph of Site TR2, facing SE at 575191, 6154581 (WGS 84 Zone 53).

General description	<p>Plant Association TR2 occurs to the north-east of Blue Fin Rd, and represents a similar suite of species to that of TR1, except that it is regularly slashed for fire risk mitigation. At the time of the site visit in October 2023, the area had very recently been slashed to a height of approximately 15cm.</p> <p>Weed incursions are minor and include scattered plants of Bridal Creeper, Onion weed and <i>Centaurea melitensis</i> (Malta Thistle).</p> <p>Although a highly diverse understorey remains, the plant community is regularly disturbed by slashing and has very low structural diversity.</p> <p>The vegetation community is in moderate condition.</p>				
Threatened species or community	<p><u>State-listed vegetation community:</u> No</p> <p><u>State-threatened flora observed:</u></p> <ul style="list-style-type: none"> • State Rare Spoon-leaved Spyridium (<i>Spyridium daphnoides</i>) <p>Given their prevalence in Vegetation Association TR1, it is likely that <i>Xanthorrhoea seMIPslana</i> spp. <i>tateana</i> (SA Rare) also occurs in Association TR2, however this was not possible to confirm because the plants had been recently slashed.</p> <p>Two plants of <i>Spyridium daphnoides</i> were detected during surveys in October 2023 (waypoints 413), however there are likely to be more along the proposed pipeline route.</p> <p><u>Nationally- and State-threatened fauna that may use this community:</u></p> <ul style="list-style-type: none"> • Nationally Vulnerable: Diamond Firetail • State Vulnerable: Little Eagle • State Rare: Purple-gaped Honeyeater, Western Gerygone and Peregrine Falcon. <p>The community is likely to support the Nationally Vulnerable Diamond Firetail which prefers open habitats and high grass cover and was observed nearby. The Little Eagle and Peregrine Falcon may perch in adjacent trees and hunt over open vegetation. Species which prefer dense canopy and/or understory with good leaf litter cover (i.e. EP Southern Emu-wren, White-winged Chough, Shy Heathwren, Painted Buttonquail) are unlikely to occur in this vegetation type.</p>

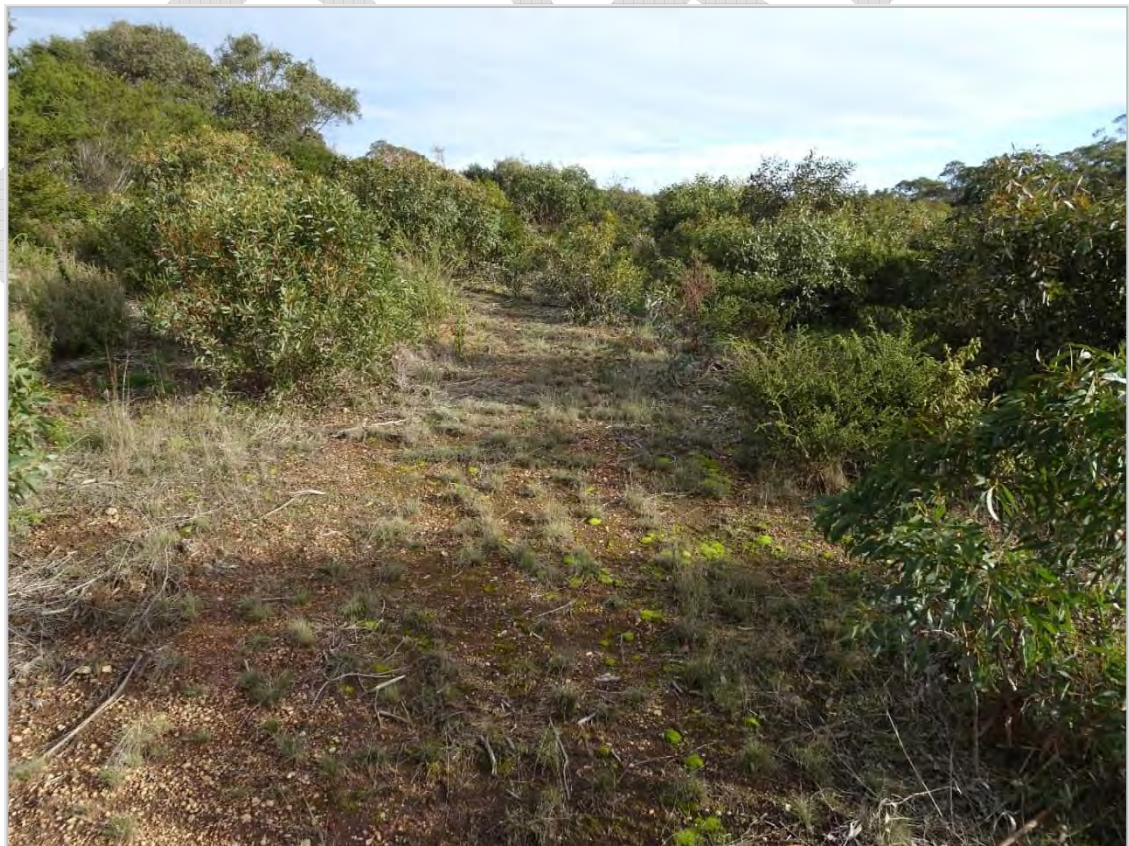
Representative photograph of Site TR2, facing NW at 575463, 6154346 (WGS 84 Zone 53).

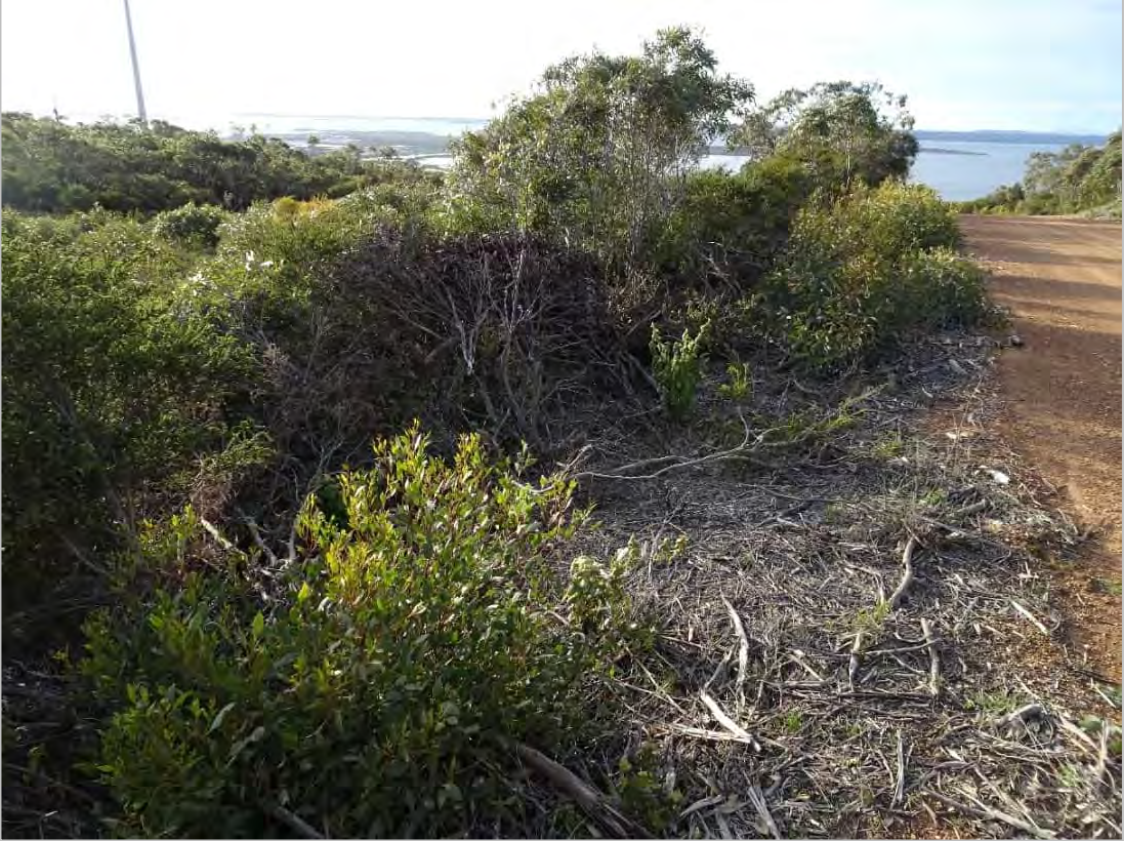
Vegetation Association	Site TR3: <i>Eucalyptus diversifolia</i> ± <i>E. albopurpurea</i> mallee over dense <i>Acacia paradoxa</i>

<p><i>Representative photograph of Site TR3, facing E at 575404, 6154372 (WGS 84 Zone 53).</i></p>					
General description	<p>Association TR3 occurs along the roadsides of Blue Fin Rd, east of the intersection with Kathai Drive. The mallee overstorey becomes more open, but is still principally <i>Eucalyptus diversifolia</i> and <i>E. albopurpurea</i>. There is a dense mid-shrub layer of <i>Acacia paradoxa</i> with a lower diversity and cover of native heath species, likely as a result of previous disturbance, including clearance and fire.</p> <p>Vegetation in close proximity to the road verge is often highly disturbed by grading activities and invaded by weeds such as Rice Millet, Sour-sob and Pincushion. Bridal Creeper, Box Thorn and Myrtle-leaf Milkwort are present in the understory.</p> <p>The vegetation community is in moderate condition.</p>

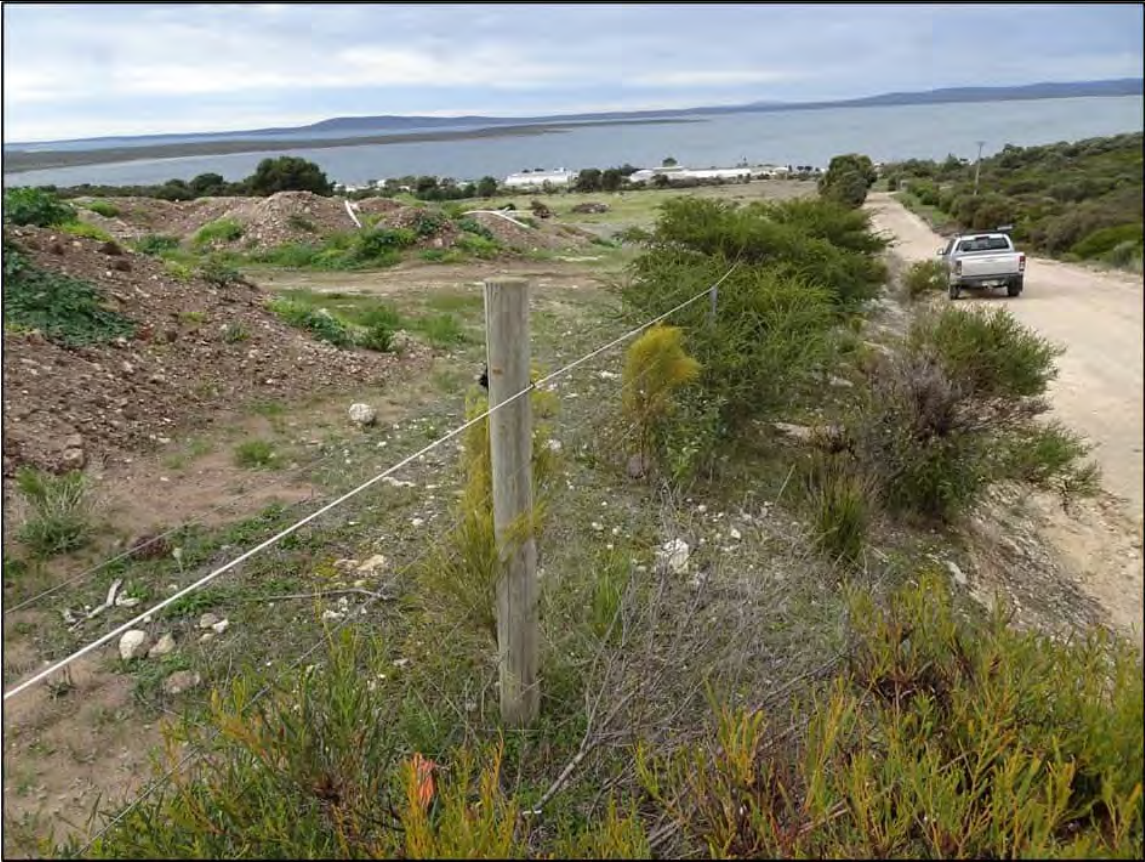
Vegetation Association	Site TR4: <i>Acacia paradoxa</i>, <i>A. cupularis</i> very open disturbed shrubland

<p data-bbox="197 1055 1378 1093"><i>Representative photograph of Site TR4, facing E at 575952, 6154031 (WGS 84 Zone 53).</i></p>					
General description	<p>Association TR4 represents sections of recovering roadside vegetation along the eastern end of Blue Fin Rd.</p> <p>Native shrub species are regenerating, with a moderate diversity, but generally very low cover. These areas would formerly have been mallee, and so are considered to be highly disturbed.</p> <p>Weeds are dominated by Pincushion, but also include Bridal Creeper, African Daisy, False Caper and Onion Weed.</p> <p>The vegetation community is in poor condition.</p>				
Threatened species or community	<p><u>State-listed vegetation community:</u> No</p> <p><u>State-threatened flora observed:</u></p> <ul style="list-style-type: none"> • State Rare Snowdrop Spurge (<i>Lysiandra calycina</i>) <p>One plant of <i>Lysiandra calycina</i> was recorded in this plant association during surveys in July 2021. A subsequent survey in October 2023 found no plants within the proposed impact area along the northern side of Blue Fin Rd.</p> <p><u>Nationally- and State-threatened fauna that may use this community:</u></p> <p>This highly disturbed community is unlikely to provide significant habitat for threatened fauna.</p>

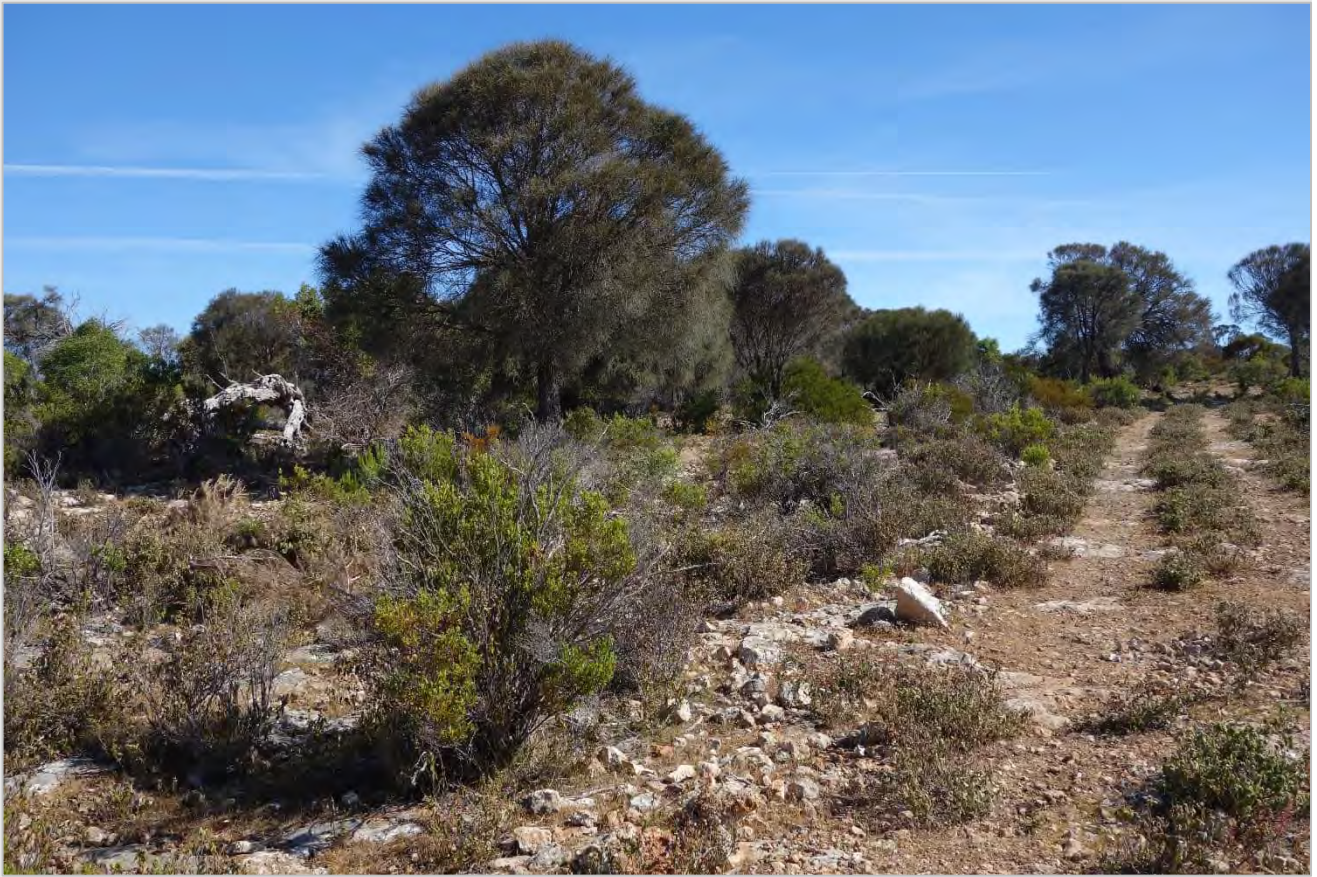
Figure 13. Potential benchmark community for Drooping Sheoak Grassy Woodland. Photo 9288 facing south at Wpt 433.

Several potential benchmark sites were identified to the north and north-west of the proposed offset area. These sites demonstrate a canopy density and community composition consistent with the key diagnostic characteristics for the EPBC-listed Drooping Sheoak Grassy Woodland ecological community (Figure 13). These reference sites could help to guide and set targets for rehabilitation in SEB offset areas.

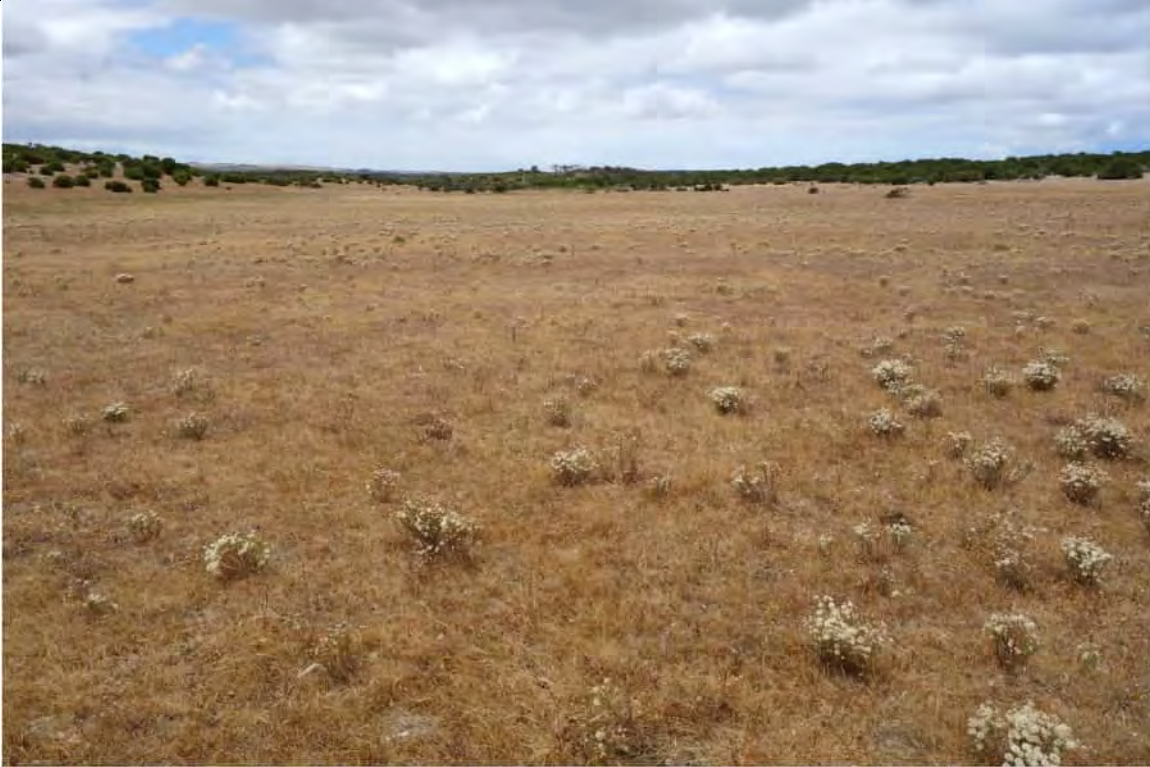
A2: Very open derived *Vittadenia* spp. and *Asteridea athrixoides* herbland/ *Rytidosperma* spp. grassland

Photo 9304 facing east at Wpt 437 (Latitude -34.787035, Longitude 135.532098)

General description	<p>Plant community A2 is a native herbland/grassland dominated by native grasses (<i>Austrostipa exilis</i> (Heath Spear-grass), <i>Austrostipa scabra ssp. falcata</i> (Rough Spear-grass), <i>Rytidosperma caespitosum</i> (Common Wallaby-grass) and daisies (<i>Asteridea athrixioides</i> (Wirewort), <i>Vittadinia megacephala</i> (Giant New Holland Daisy) and <i>V. australasica</i> (Sticky New Holland Daisy)). It supports a medium diversity of native species including <i>Pimelea serpyllifolia</i> (Thyme Riceflower), <i>Wahlenbergia gracilentia</i> (Annual Bluebell) and <i>Acaena echinata</i> (Sheep's Burr), with patches of <i>Goodenia radicans</i> (Shiny Swamp Mat), <i>Schoenus nitens</i> (Shiny Bog-rush) and mosses in areas that retain moisture. Shrubs such as <i>Leucopogon parviflorus</i> (Coast Beard-heath), <i>Olearia axillaris</i> (Coast Daisy-bush) and <i>Exocarpos syrticola</i> (Coast Cherry) are very sparse and often heavily grazed.</p> <p>An area of approximately 12 ha at Wpt 437 has unusually deep topsoil with little exposed limestone. Small piles of scattered rocks near the edges indicate that the land was cleared of rocks and trees. The previous landholder has confirmed that the area was subject to historical cropping.</p> <p>Exotic grasses and herbs such as <i>Vulpia</i> spp. (Fescue), <i>Rostraria cristata</i> (Annual Cat's-tail), <i>Lysimachia arvensis</i> (Pimpernel), <i>Trifolium campestre</i> (Hop Clover), <i>Bellardia trixago</i> (Mediterranean Linseed), <i>Asphodelus fistulosus</i> (Onion Weed) and <i>Carthamus lanatus</i> (Saffron Thistle) are prominent. There is a small stand of <i>Eucalyptus gomphocephala</i> (Tuart Gums) planted as shade trees north of wpt 437.</p> <p>The SA Declared weed <i>Echium plantagineum</i> (Salvation Jane) is present as a minor component of the association. Significant patches of <i>Marrubium vulgare</i> (Horehound) are found in the north-western part of the community around waypoint 438.</p> <p>Grazing pressure is high with large numbers of kangaroos seen nearby, and there are areas of significant soil disturbance caused by rabbits. The introduced White Italian Snail (<i>Theba pisana</i>) is abundant and known to inhibit the recruitment of native plants by feeding on germinating seedlings.</p> <p>The plant association is in poor to moderate condition with a medium diversity of native species, no canopy cover, very high grazing pressure and moderate levels of weed invasion.</p>

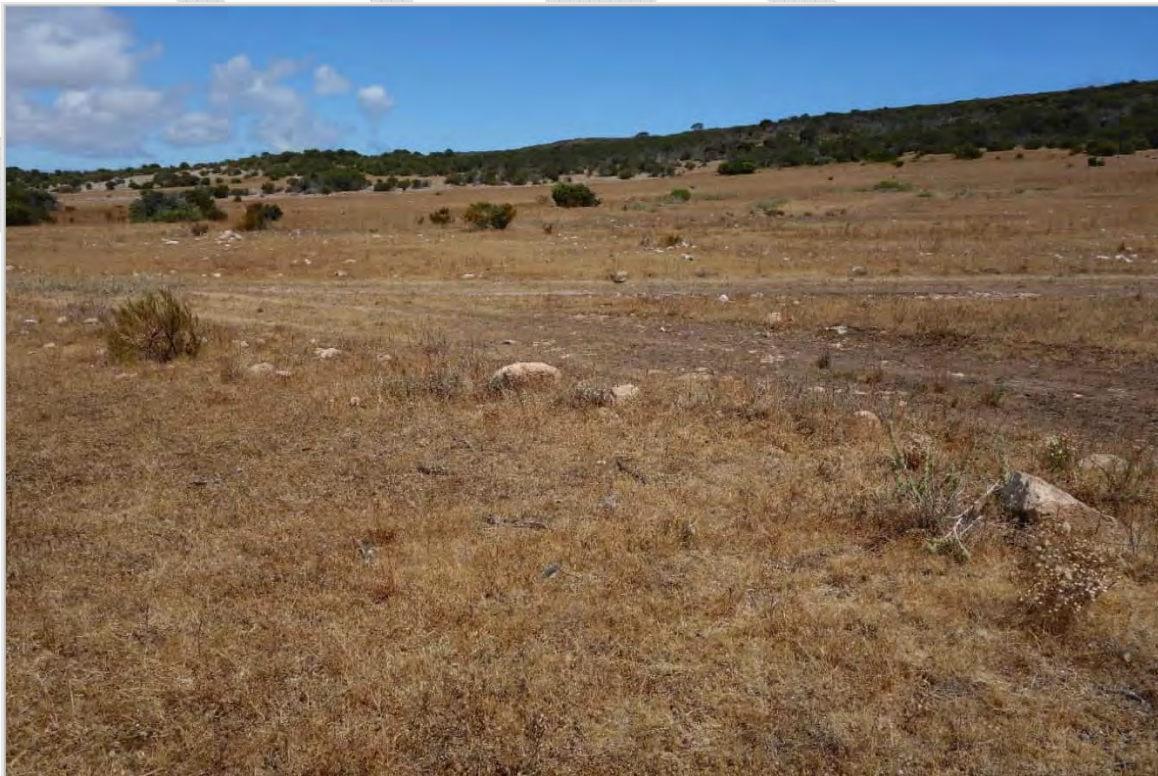
Photo 9308 facing south-west at Wpt 438 (Latitude -34.781966, Longitude 135.523802)

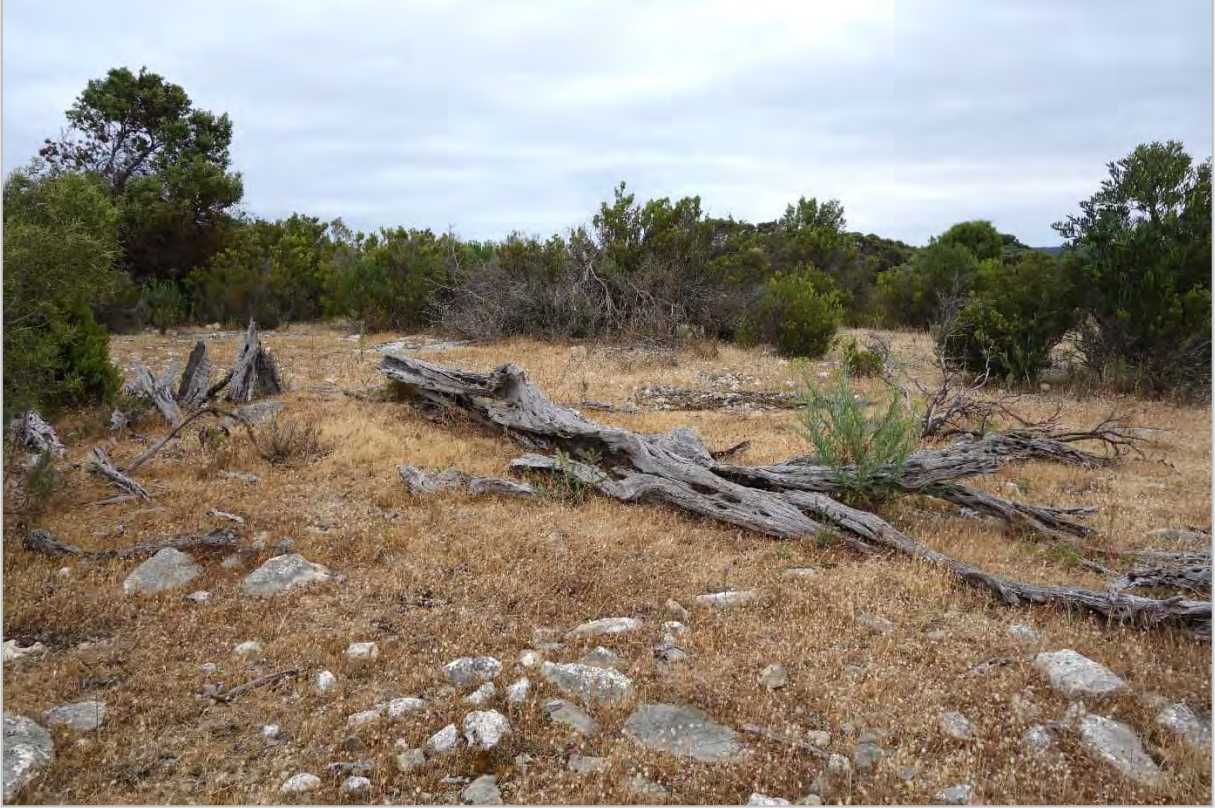
A3: Derived *Leucopogon parviflorus* open shrubland on rises and lower slopes

Photo 9323 facing west at Wpt 442 (Latitude -34.786964, Longitude 135.540067)

General description	<p>Plant community A3 is a regenerating shrubland which occupies the areas between the highly degraded open grassland/herblands and the east facing slopes of coastal woodland vegetation. Is characterised by a very open to mid-open shrubland dominated by <i>Leucopogon parviflorus</i>, <i>Acacia longifolia</i> var. <i>sophorae</i> and <i>Exocarpos syrticola</i> over a herbland of native daisies, native grasses and mosses, with exotic annual grasses and herbs. Sheoak stumps and fallen trunks are widespread, indicating that the community was once an <i>Allocasuarina verticillata</i> woodland. Exposed limestone outcrops are prominent. Shrub cover varies from quite sparse in the north-western parts to moderately dense in the south-east.</p> <p>The vegetation association has a medium diversity of native species which includes several regenerating shrub species (<i>Pittosporum angustifolium</i> (Native Apricot), <i>Olearia axillaris</i>, <i>Melaleuca lanceolata</i> (Dryland Tea-tree), <i>Pimelea serpyllifolia</i>, <i>Rhagodia candolleana</i> (Sea-berry Saltbush), <i>Acrotriche patula</i> (Prickly Ground-berry), <i>Lasiopetalum discolor</i> (Coast Velvet-bush) and <i>Dodonaea viscosa subsp. spatulata</i> (Sticky Hop-bush). The community also supports a variety of other native lifeforms such as vines (<i>Clematis microphylla</i>), lilies (<i>Bulbine semibarbata</i> (Small Leek-lily)), sedges (<i>Gahnia deusta</i> (Limestone Saw-sedge), <i>Gahnia lanigera</i> (Black Grass Saw-sedge), forbs (<i>Asteridea athrioides</i>, <i>Vittadinia australasica</i>, <i>Dichondra repens</i> (Kidney Weed)), grasses (<i>Austrostipa exilis</i>, <i>Rytidosperma caespitosum</i>) and mosses.</p> <p>Prominent introduced species include <i>Lagurus ovatus</i> (Hair's Tail Grass), Fescue, Onion Weed, Mediterranean Linseed, Hop Clover and <i>Melilotus indicus</i> (King Island Melilot). High risk weeds present in parts of the community include *<i>Acacia cyclops</i> (Western Coast Wattle- recorded as <i>A. longifolia</i> ssp. <i>longifolia</i> in scoresheet), Horehound, <i>Senecio pterophorus</i> (African Daisy), <i>Echium plantagineum</i> (Salvation Jane), <i>Asparagus asparagoides</i> (Bridal Creeper) and <i>Dittrichia graveolens</i> (Stinkweed). Some of these were outside the survey quadrat and do not appear on the scoresheet.</p> <p>Grazing pressure is high with large numbers of kangaroos observed in the area and there is significant soil disturbance by rabbits. The introduced White Snail is abundant throughout the community.</p> <p>The plant association is in moderate condition with a medium diversity of native species, little tree canopy, very high grazing pressure and moderate levels of weed invasion.</p>

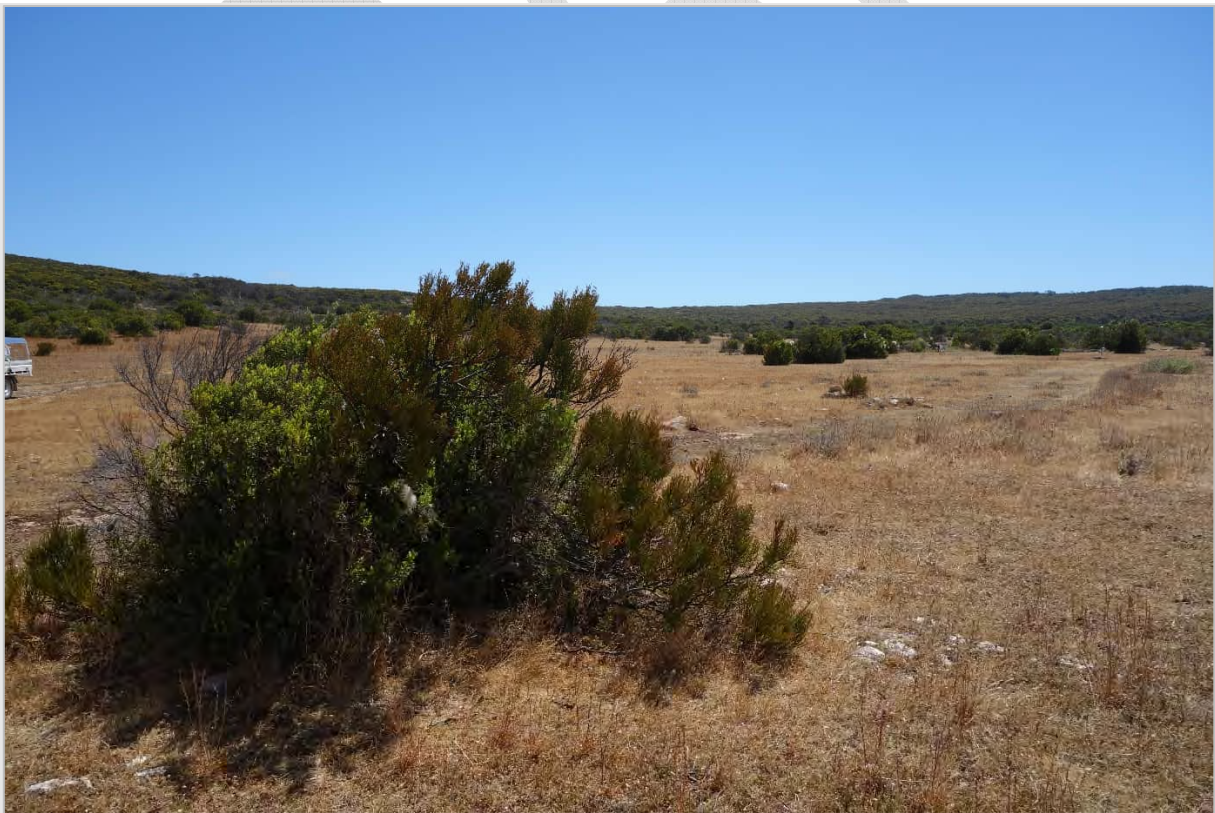
Photo 9309 facing north at Wpt 438 (Latitude -34.781966, Longitude 135.523802)

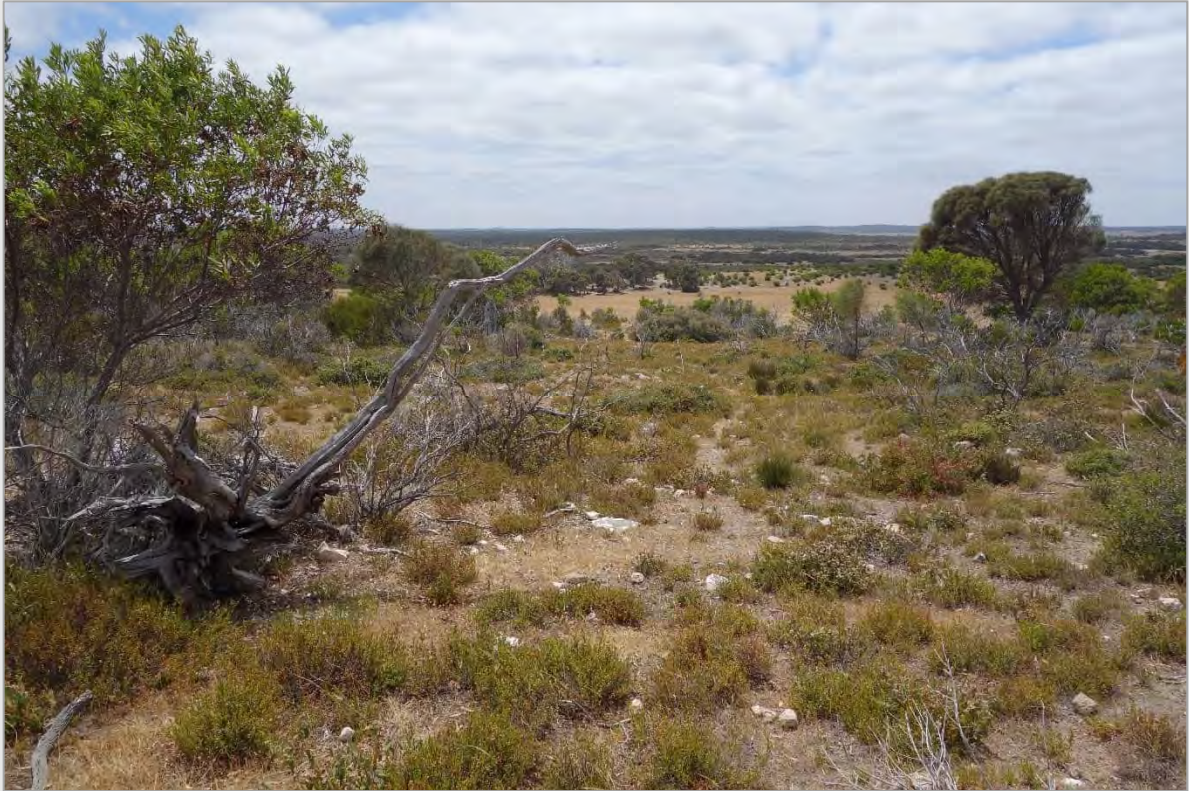
A4: *Allocasuarina verticillata* very open woodland over *Lasiopetalum discolor*, *Acrotriche patula* and *Hibbertia devitata* low shrubland

Photo 9333 facing north at Wpt 445 (Latitude -34.789431, Longitude 135.530189)

General description	<p>Plant community A4 occurs on calcareous soils of the east-facing mid-slopes above the derived shrubland and herbland communities.</p> <p>Varying age classes of <i>Allocasuarina verticillata</i> occur mostly as sparsely scattered trees, although there are some small stands where the species becomes more dense, particularly in the north-western parts. Large fallen trunks and logs indicate that the canopy layer was once dominated by <i>Allocasuarina verticillata</i>. The introduced <i>Acacia cyclops</i> (listed as <i>Acacia longifolia ssp. longifolia</i> in the BAM scoresheet) now forms the dominant canopy layer in some areas.</p> <p>The low shrub layer comprises <i>Lasiopetalum discolor</i>, <i>Olearia axillaris</i>, <i>Hibbertia devitata</i> (Smooth Guinea-flower), <i>Leucopogon parviflorus</i> and <i>Acrotriche patula</i> with dense patches of <i>Gahnia lanigera</i>. Calcrete rocks are present on the soil surface and interspersed with the vegetation.</p> <p>Native species diversity is high and comprises a suite of other species that are characteristic of the EPBC-listed <i>Drooping Sheoak Grassy Woodland on calcrete of the Eyre Yorke Block Bioregion</i> community (e.g. <i>Pittosporum angustifolium</i>, <i>E. diversifolia</i>, <i>Pimelea serpyllifolia</i>, <i>Acacia cupularis</i> (Cup Wattle), <i>A. triquetra</i> (Mallee Wreath Wattle), <i>A. spinescens</i> (Spiny Wattle), <i>Pomaderris paniculosa</i> (Coast Pomaderris), <i>Clematis microphylla</i>, <i>Dianella brevicaulis</i>, <i>Asteridea athrioides</i>, <i>Austrostipa spp.</i> and <i>Rytidosperma spp.</i>).</p> <p>The most dominant weed, <i>Acacia cyclops</i> (recorded as <i>A. longifolia ssp. longifolia</i> in scoresheet), is the subject of SA Water's ongoing weed management program across the basin. Non-native grasses and herbs are a minor component of the ground layer.</p> <p>Grazing pressure is generally less than on the lower slopes but remains high in more open areas.</p> <p>The vegetation association is generally in good condition with a high diversity of native species, low to moderate cover of canopy and fallen timber and low levels of weed invasion outside of *<i>A. cyclops</i> patches.</p>

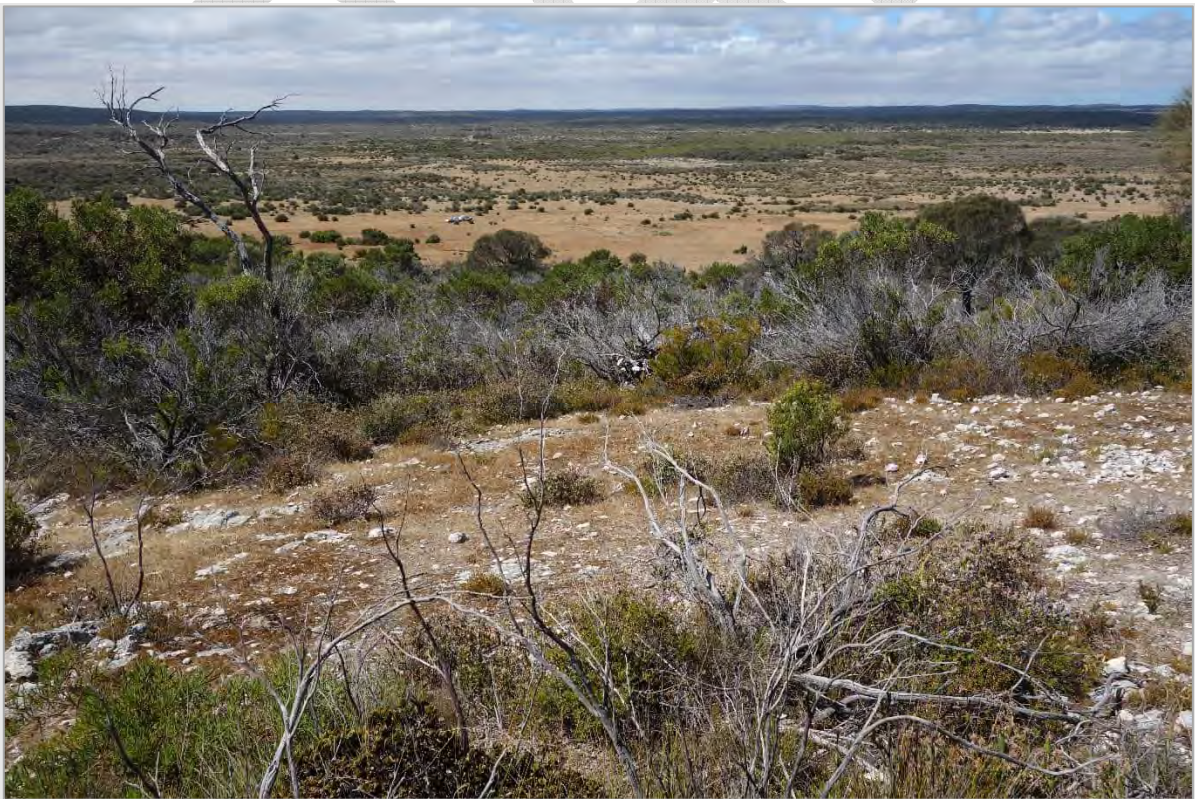
Photo 9314 facing north at Wpt 439 (Latitude -34.784794, Longitude 135.522079)

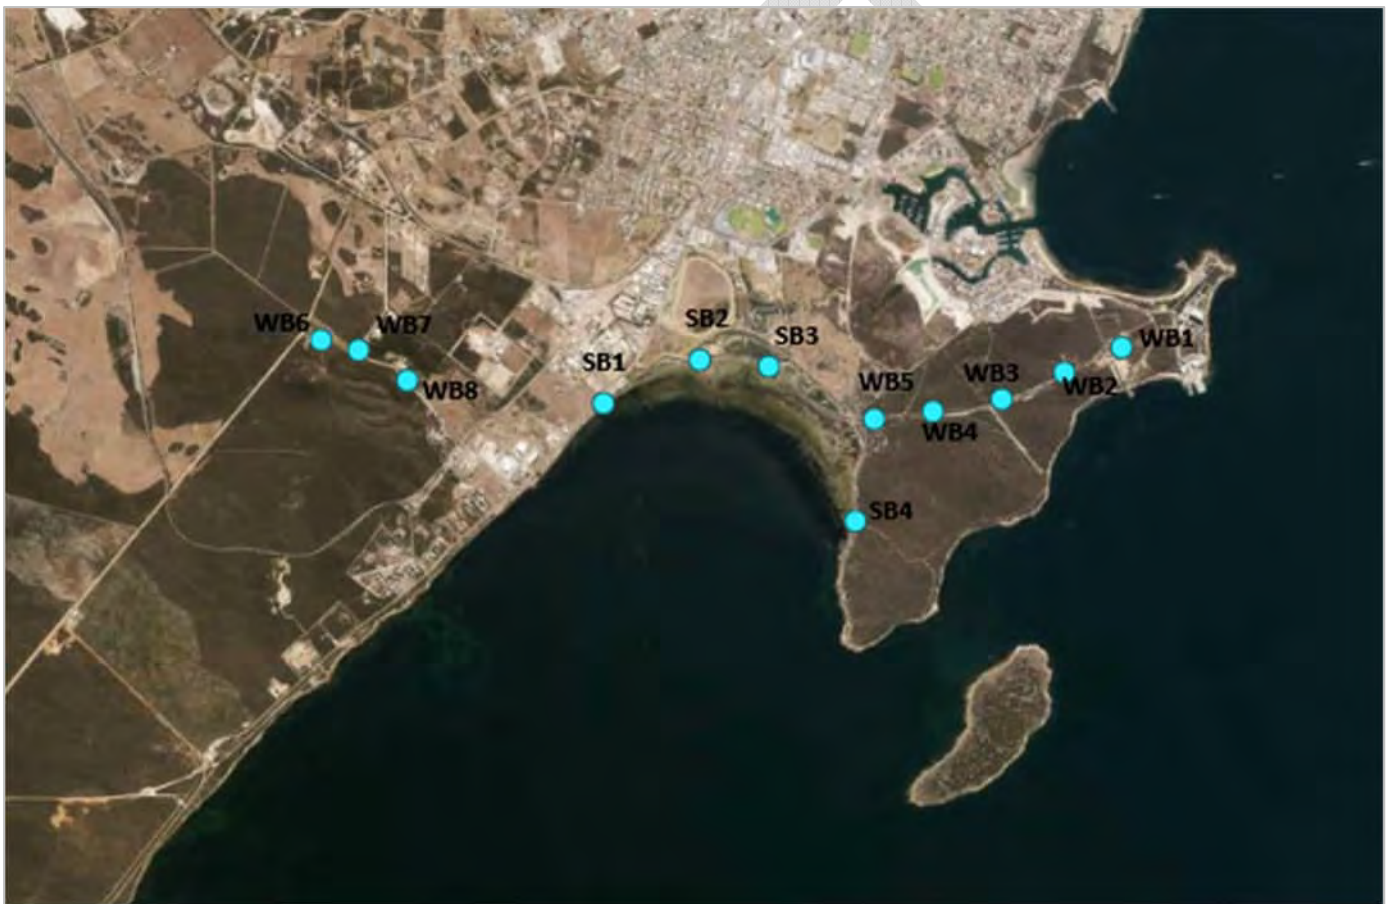
Figure A1: locations of systematic survey sites for woodland (WB) and shore birds (SB).

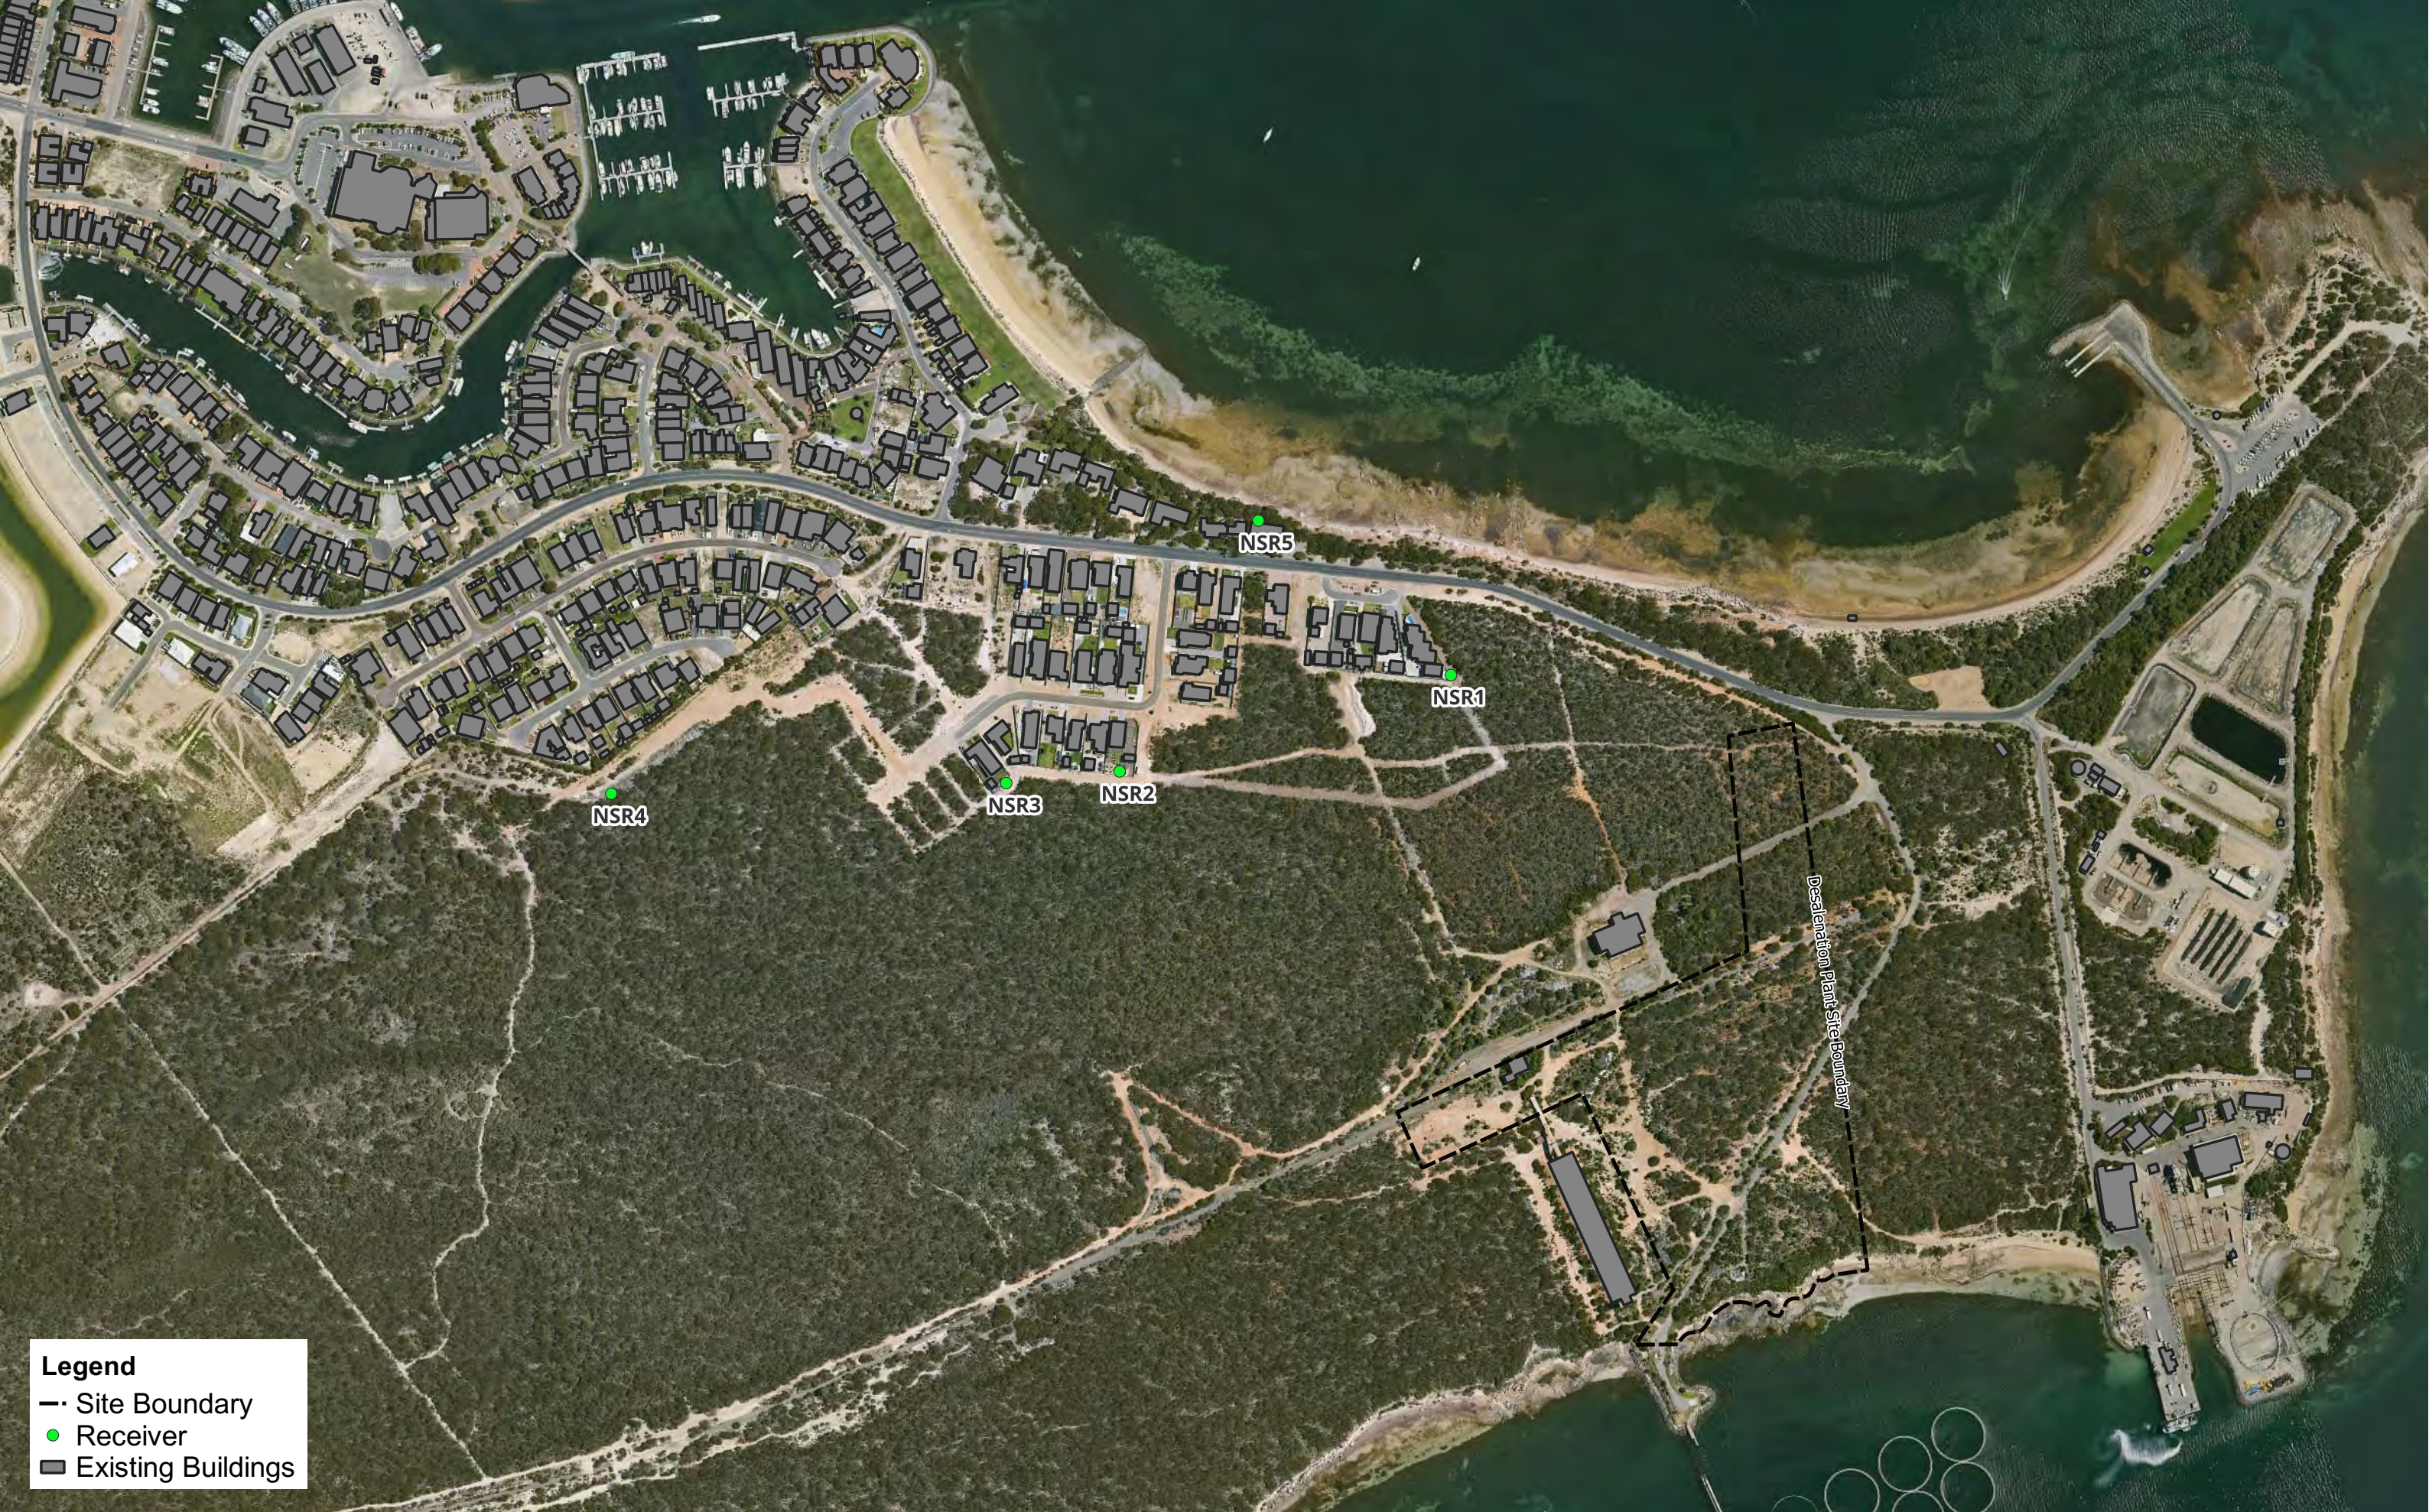
Figure 2-1	Author: CB		<p>1:5,000 at A3</p>	<h2>New Eyre Peninsula Desalination Project</h2> <p>Project area and assessed receiver locations</p>	
Date: 16/05/2024	Approved by: CJ				
To be read in conjunction with WSP document: <small>Map Source: Metro Maps</small>		<small>© WSP Australia Pty Ltd ("WSP"). Copyright in the drawings, information and data recorded ("the information") is the property of WSP. This document and the information are solely for the use of the authorised recipient and this document may not be used, copied or reproduced in whole or part for any purpose other than that which it was supplied by WSP. WSP makes no representation, undertakes no duty and accepts no responsibility to any third party who may use or rely upon this document or the information. NCS: Certified Quality System to ISO 9001. IS APPROVED FOR AND ON BEHALF OF WSP Australia Pty Ltd</small>
