Appendix C Draft Native Vegetation Clearance Application

Billy Lights Point: Eyre Peninsula Desalination Plant Project Data Report - Working Draft

Clearance under the *Native Vegetation Regulations 2017*

22 May 2024

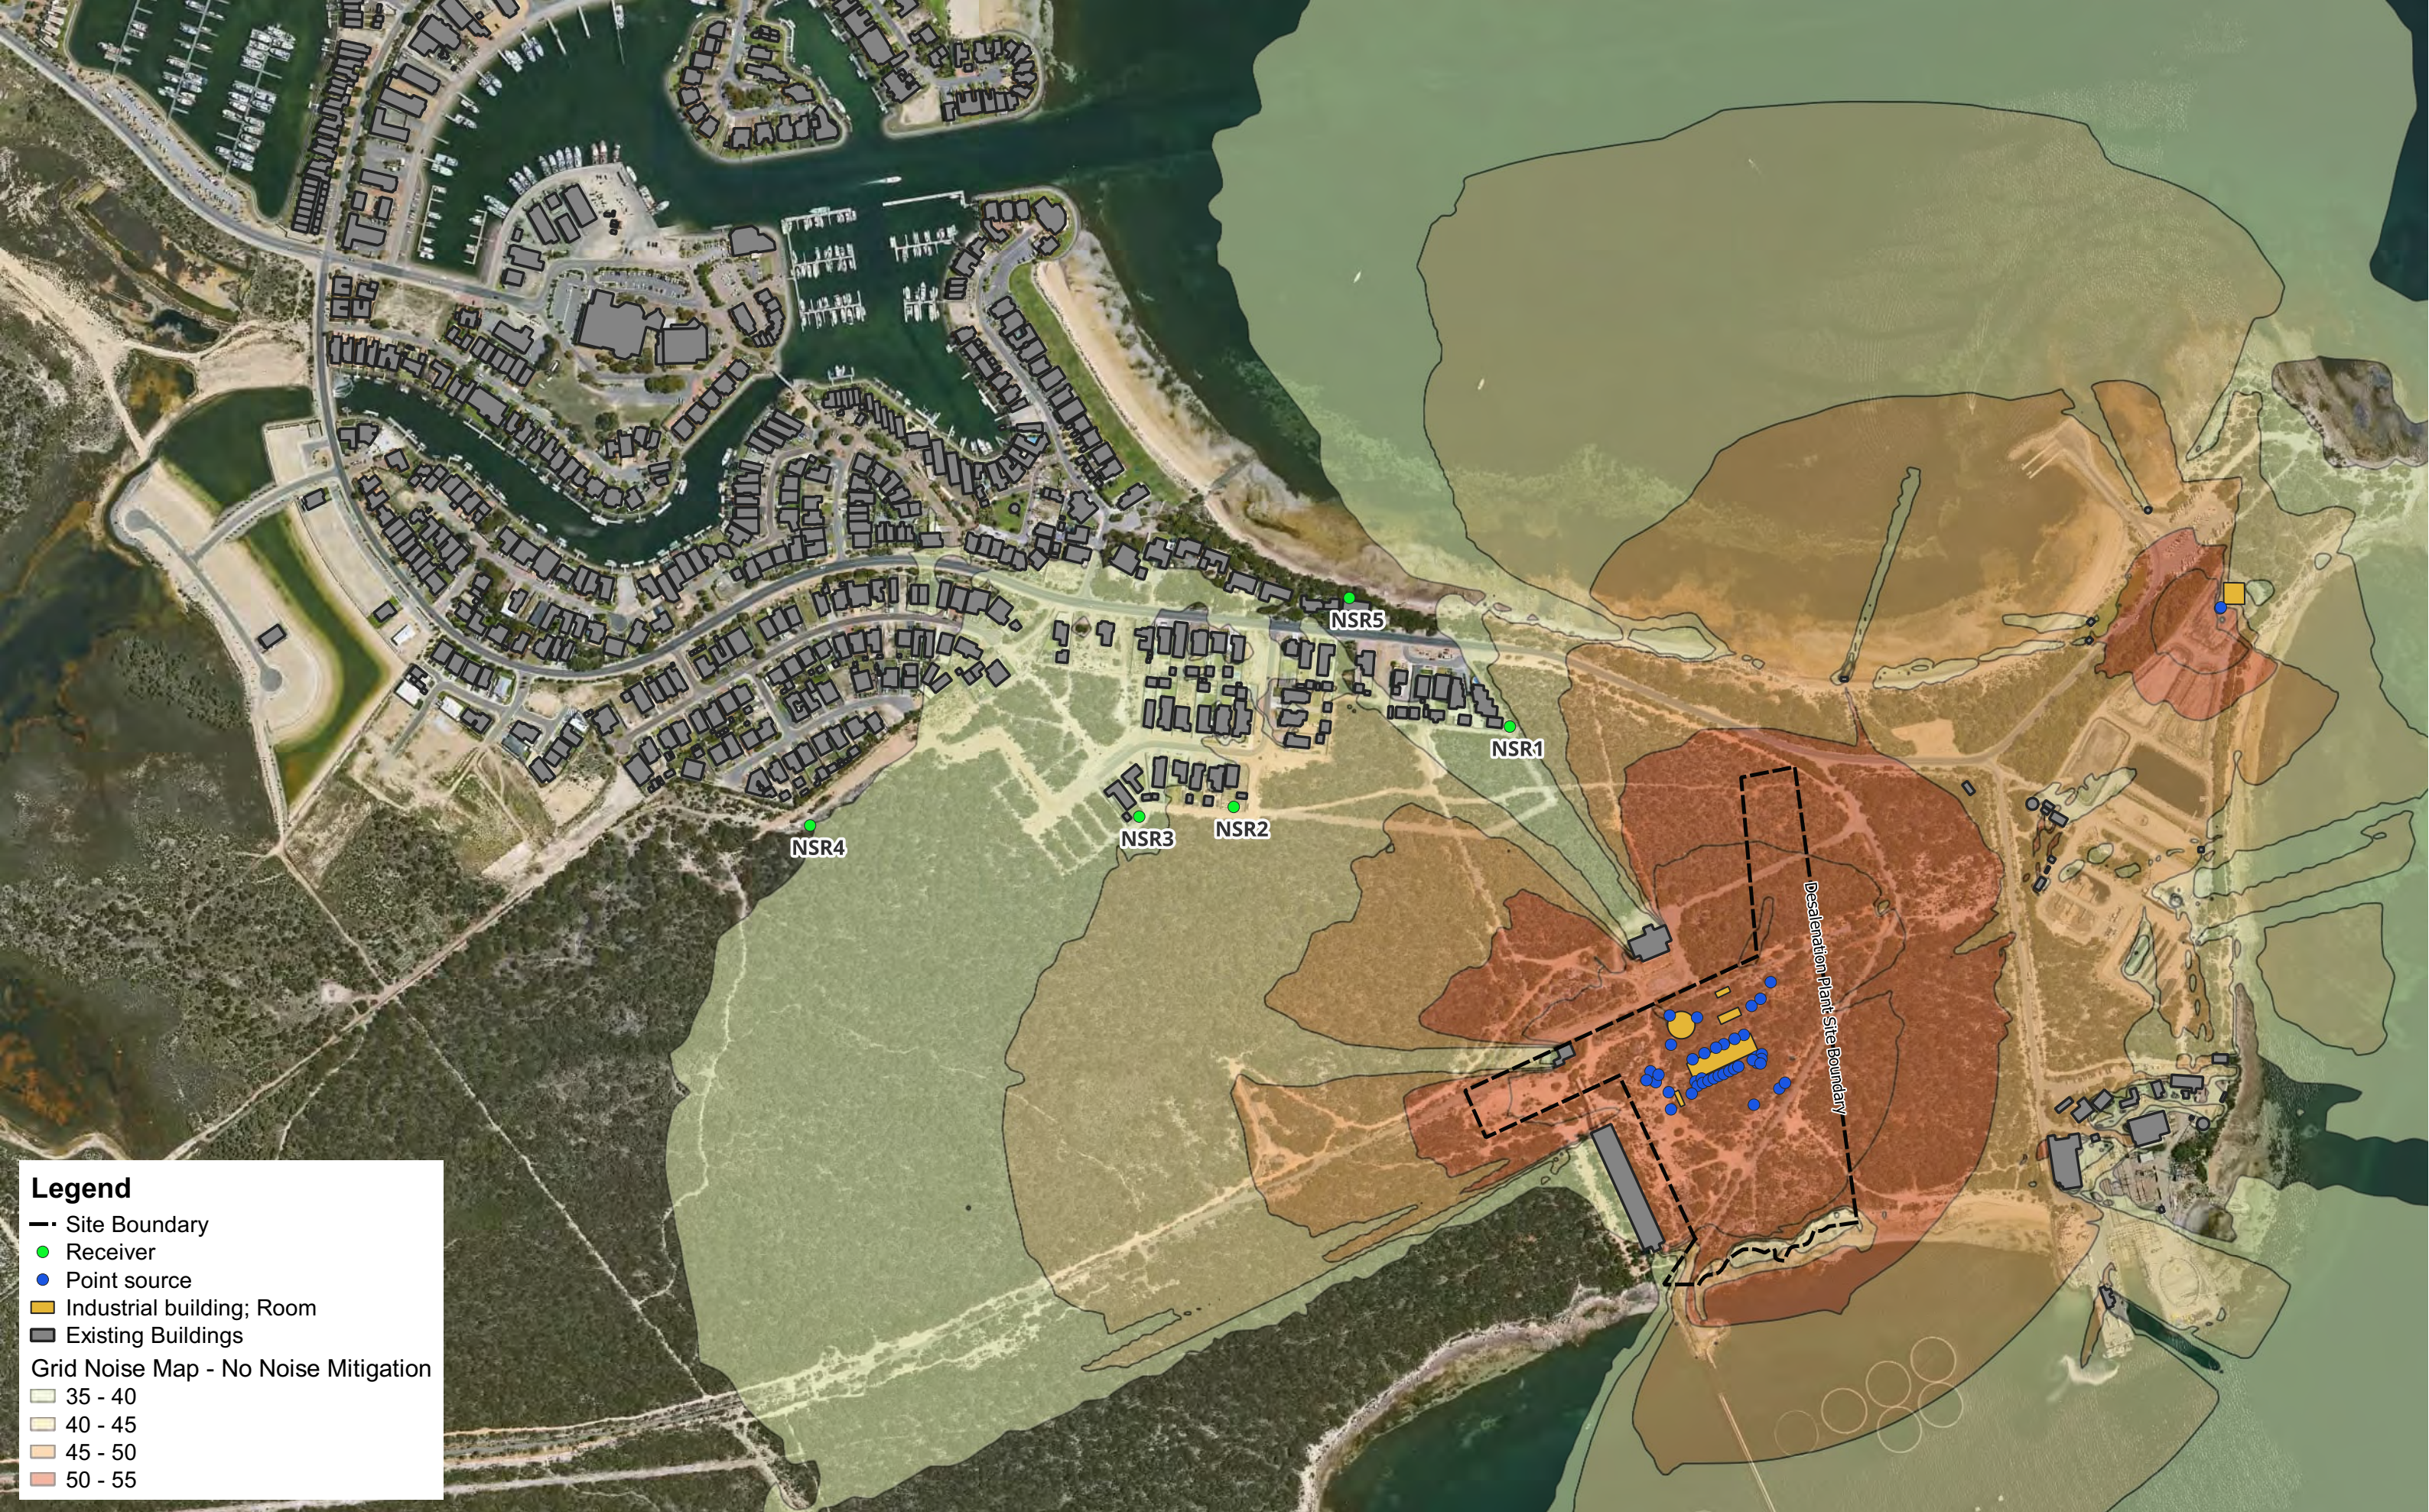
Noise levels from operation of the Project are highest at the nearest locations within the Port Lincoln Residential Zone. Buildings and sites further to the west are less affected.

WSP note that a 5 dB(A) character penalty has been conservatively applied when the noise at the receiver is dominated by a source which may attract a character penalty.

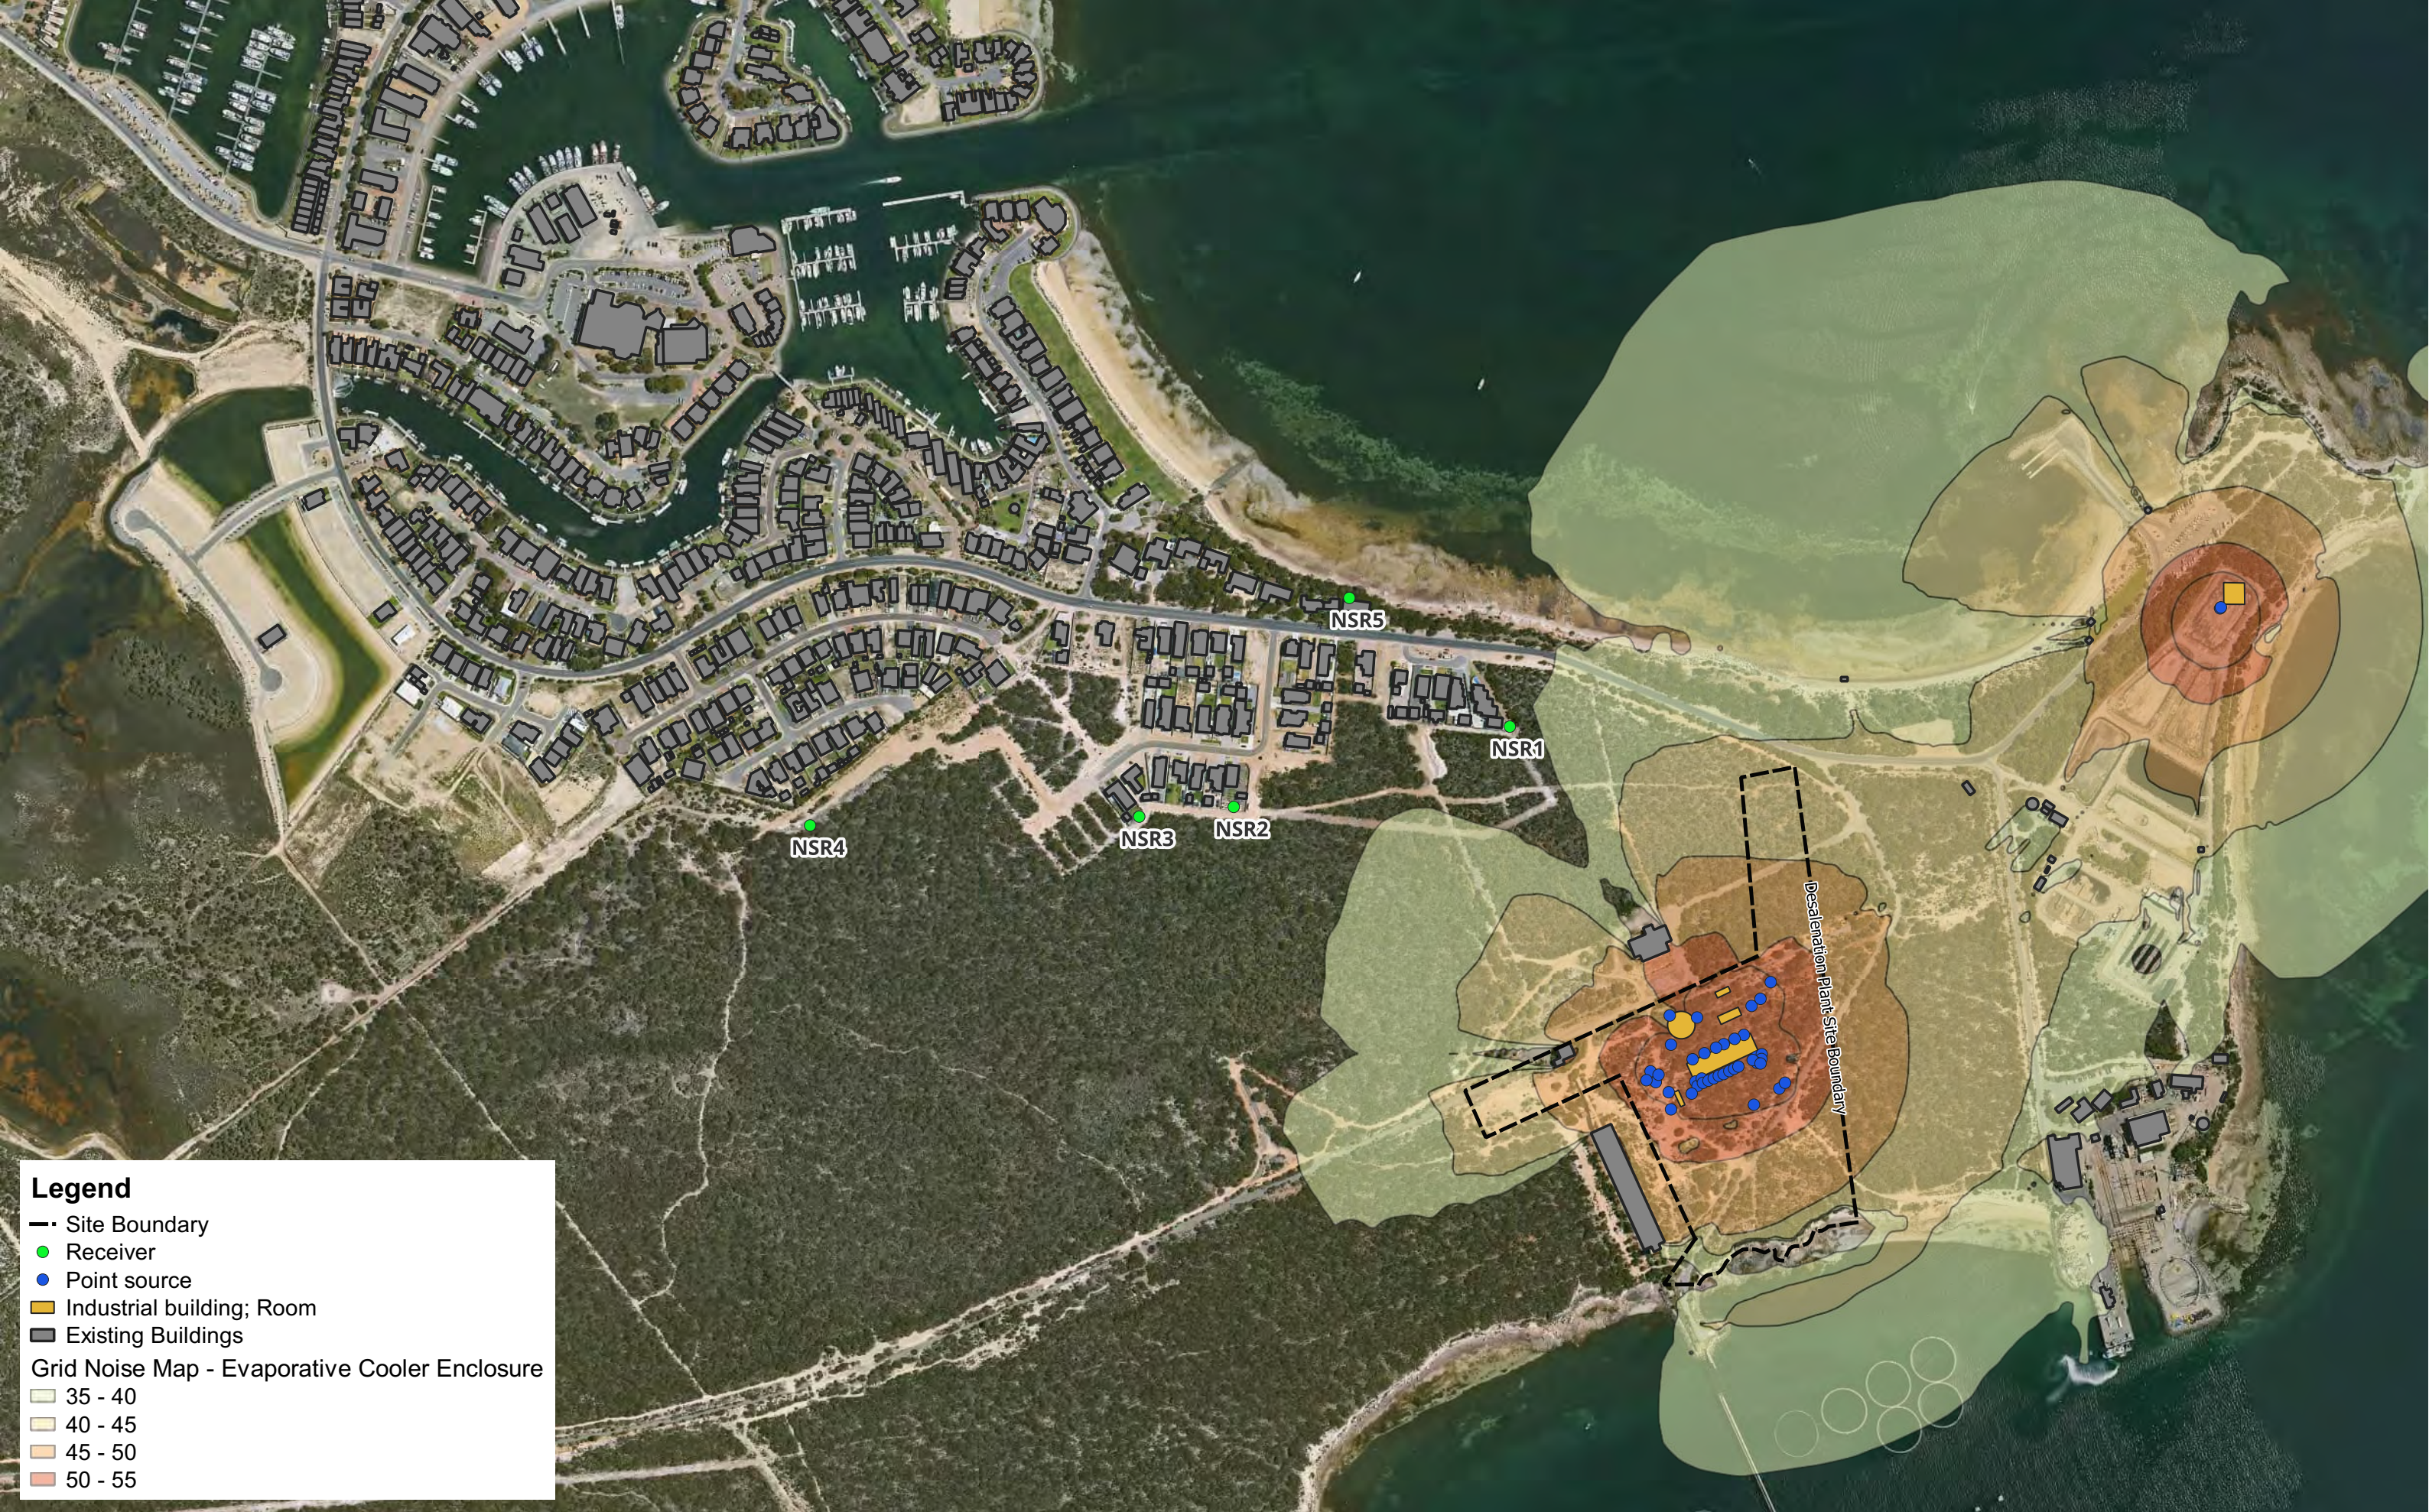
Grid Noise Map - Evaporative Cooler Enclosure

- 35 - 40
- 40 - 45
- 45 - 50
- 50 - 55

Predicted noise propagation from the Site following the implementation of either of the two assessed mitigation measures is provided as contour plots in Figure 3.2 and Figure 3.3.

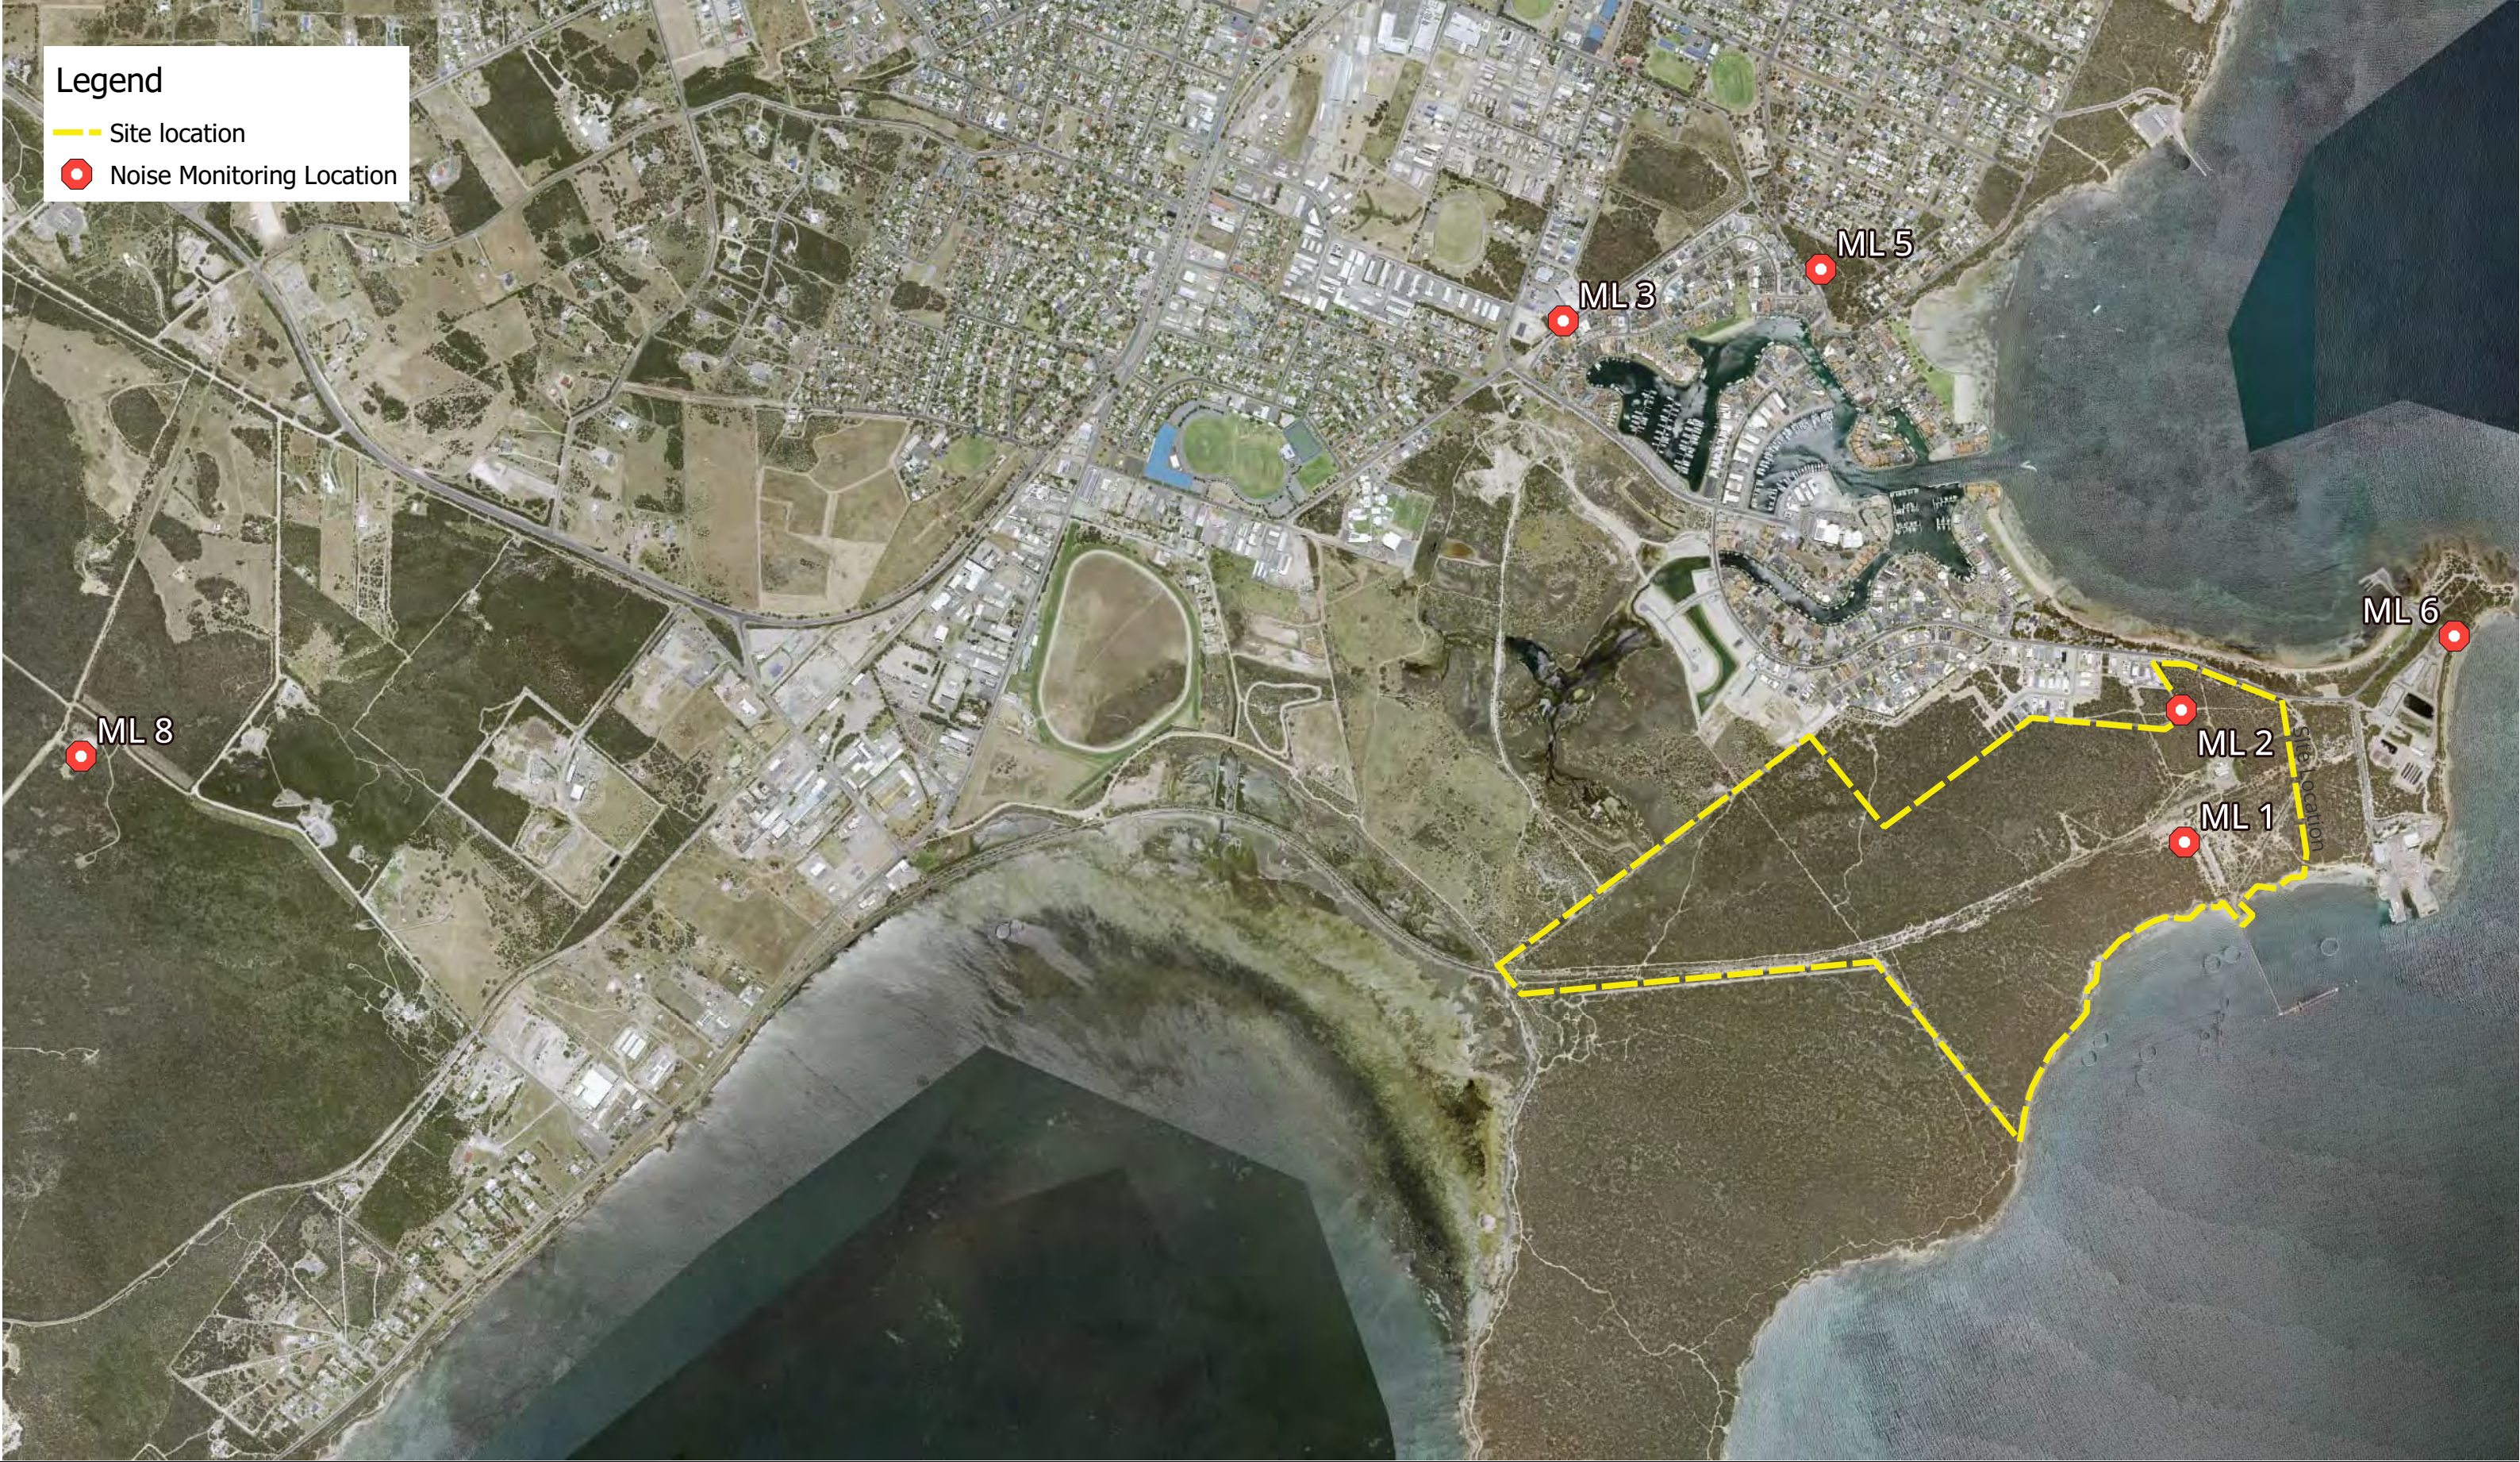
Figure 1 Noise Monitoring Locations (ML)

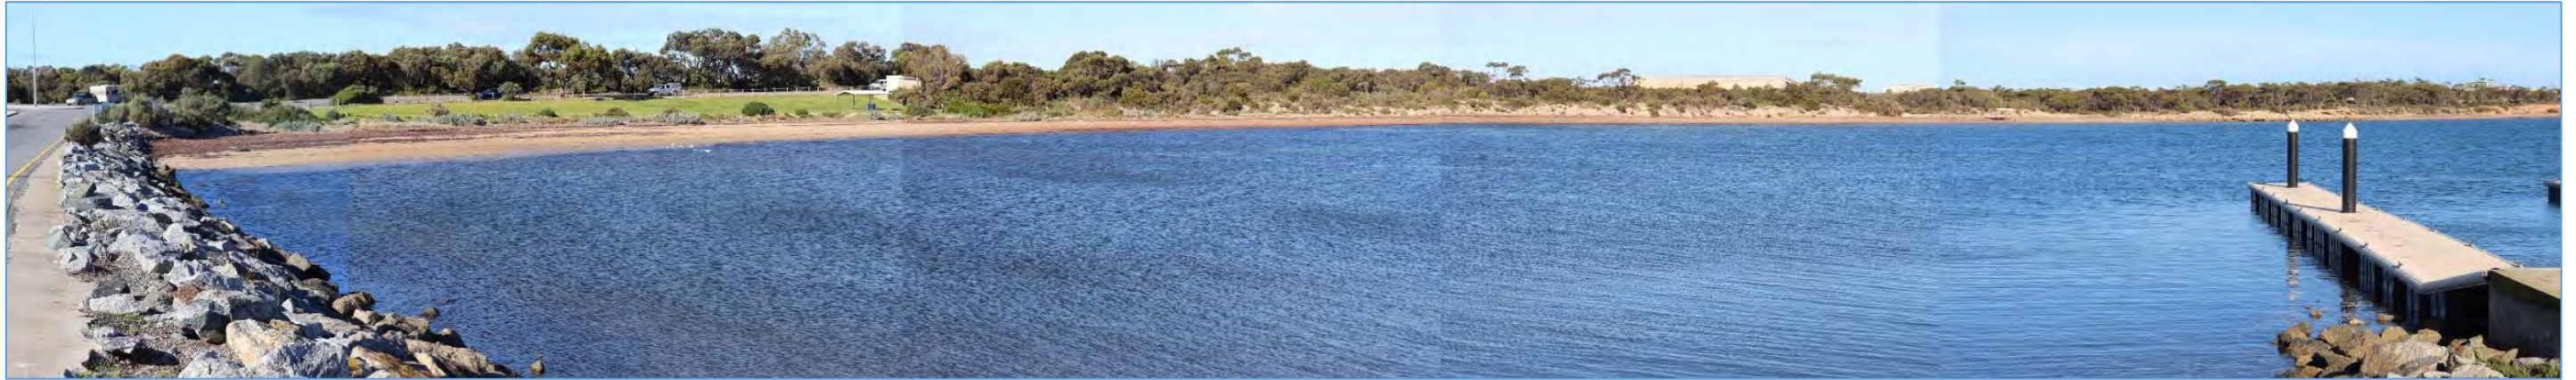
Image 1: Panoramic view at Billy Lights Point and ex-BHP sand storage shed.

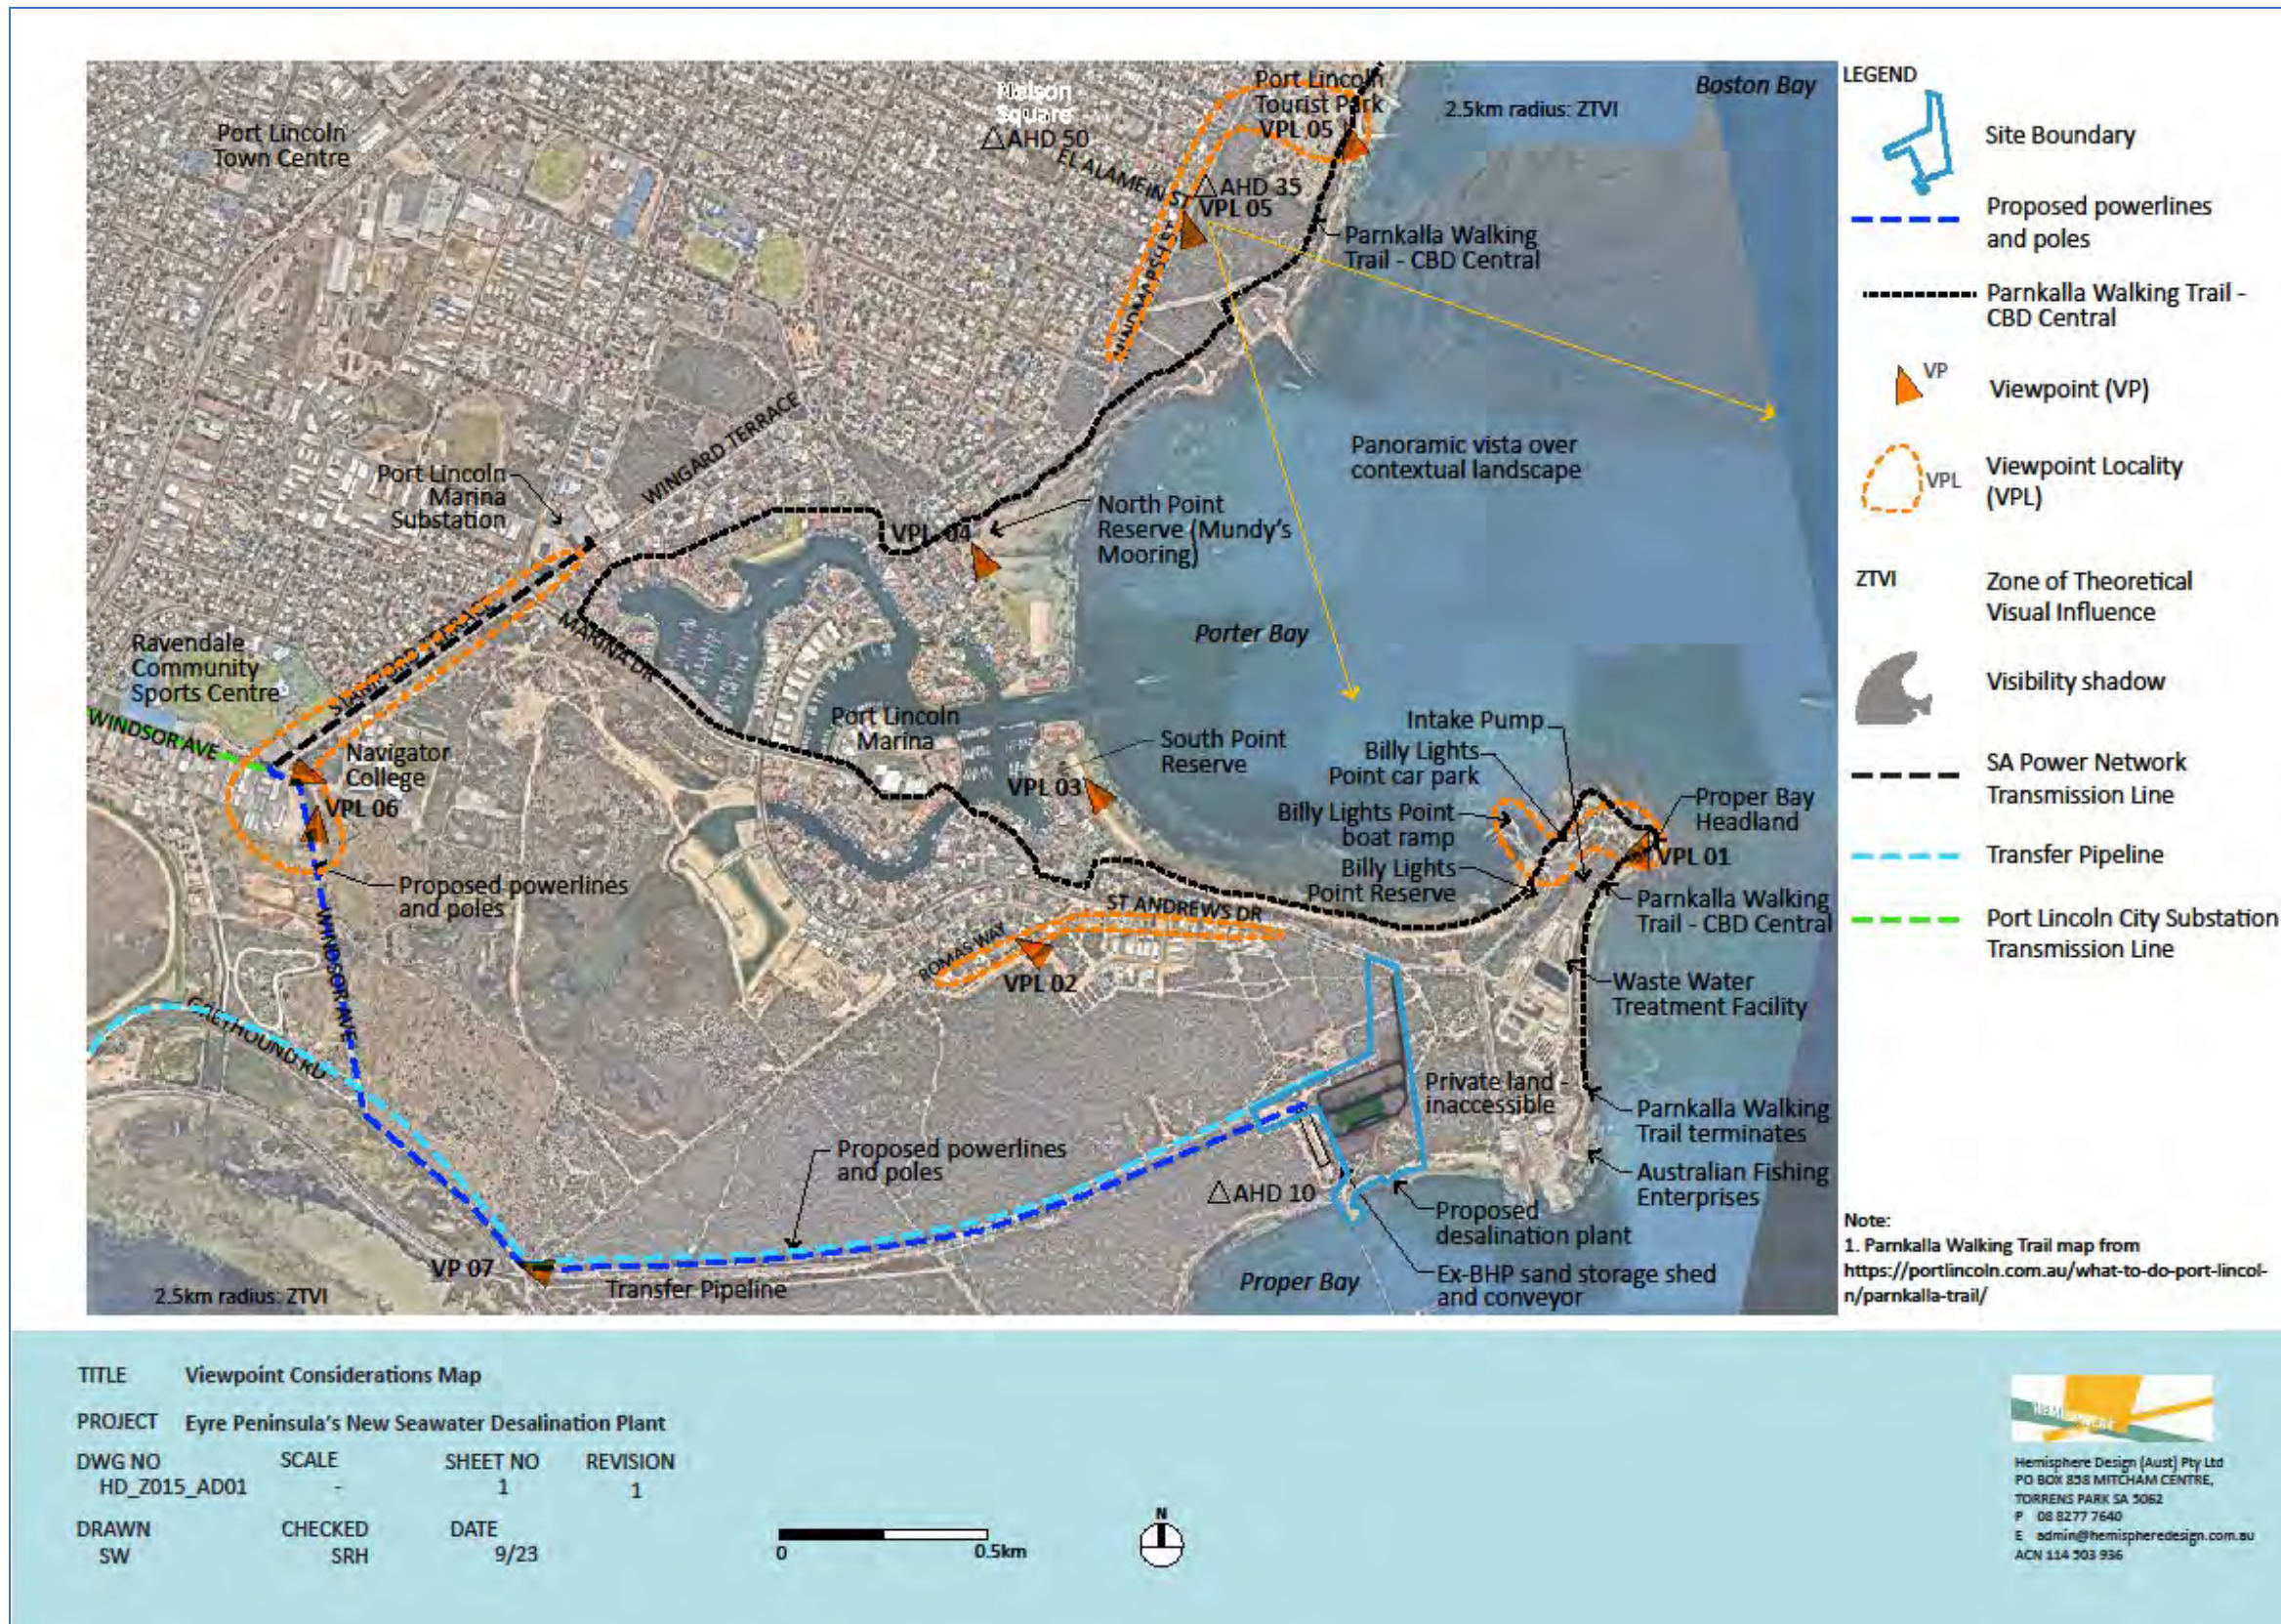
Figure 1: Viewpoints Visited (Dwg No. HD_2015_AD01 Sheet No. 1)

Seven predetermined viewpoints within the 2.5km ZTVI were visited, and consideration was given to all likely visual impacts of The Project.

A desktop evaluation was undertaken using Google Earth aerial photography, and Google Earth ‘street view’ to identify the likely Zone of Theoretical Visual Influence. The ZTVI is the defined geographical area within which modification to the contextual landscape as a result of The Project could be potentially discernible or visible. Given the nature of the contextual landscape, a 2.5km radius from the centre of the site of the desalination plant was adopted as the likely furthest extent of the likely ZTVI. (Refer: Figure 1 Viewpoints Visited (Dwg No. HD_ Z015_AD01 Sheet No. 1)).

However, it is acknowledged that the proposed 33 kV powerlines and associated poles to be installed at either 11m or 13m high will have a separate visibility shadow which will be limited within a narrow visual field or corridor from the point of installation at Windsor Avenue running south-east to the proposed site. (Refer: Figure 1 Viewpoints Visited (Dwg No. HD_ Z015_AD01 Sheet No. 1)).

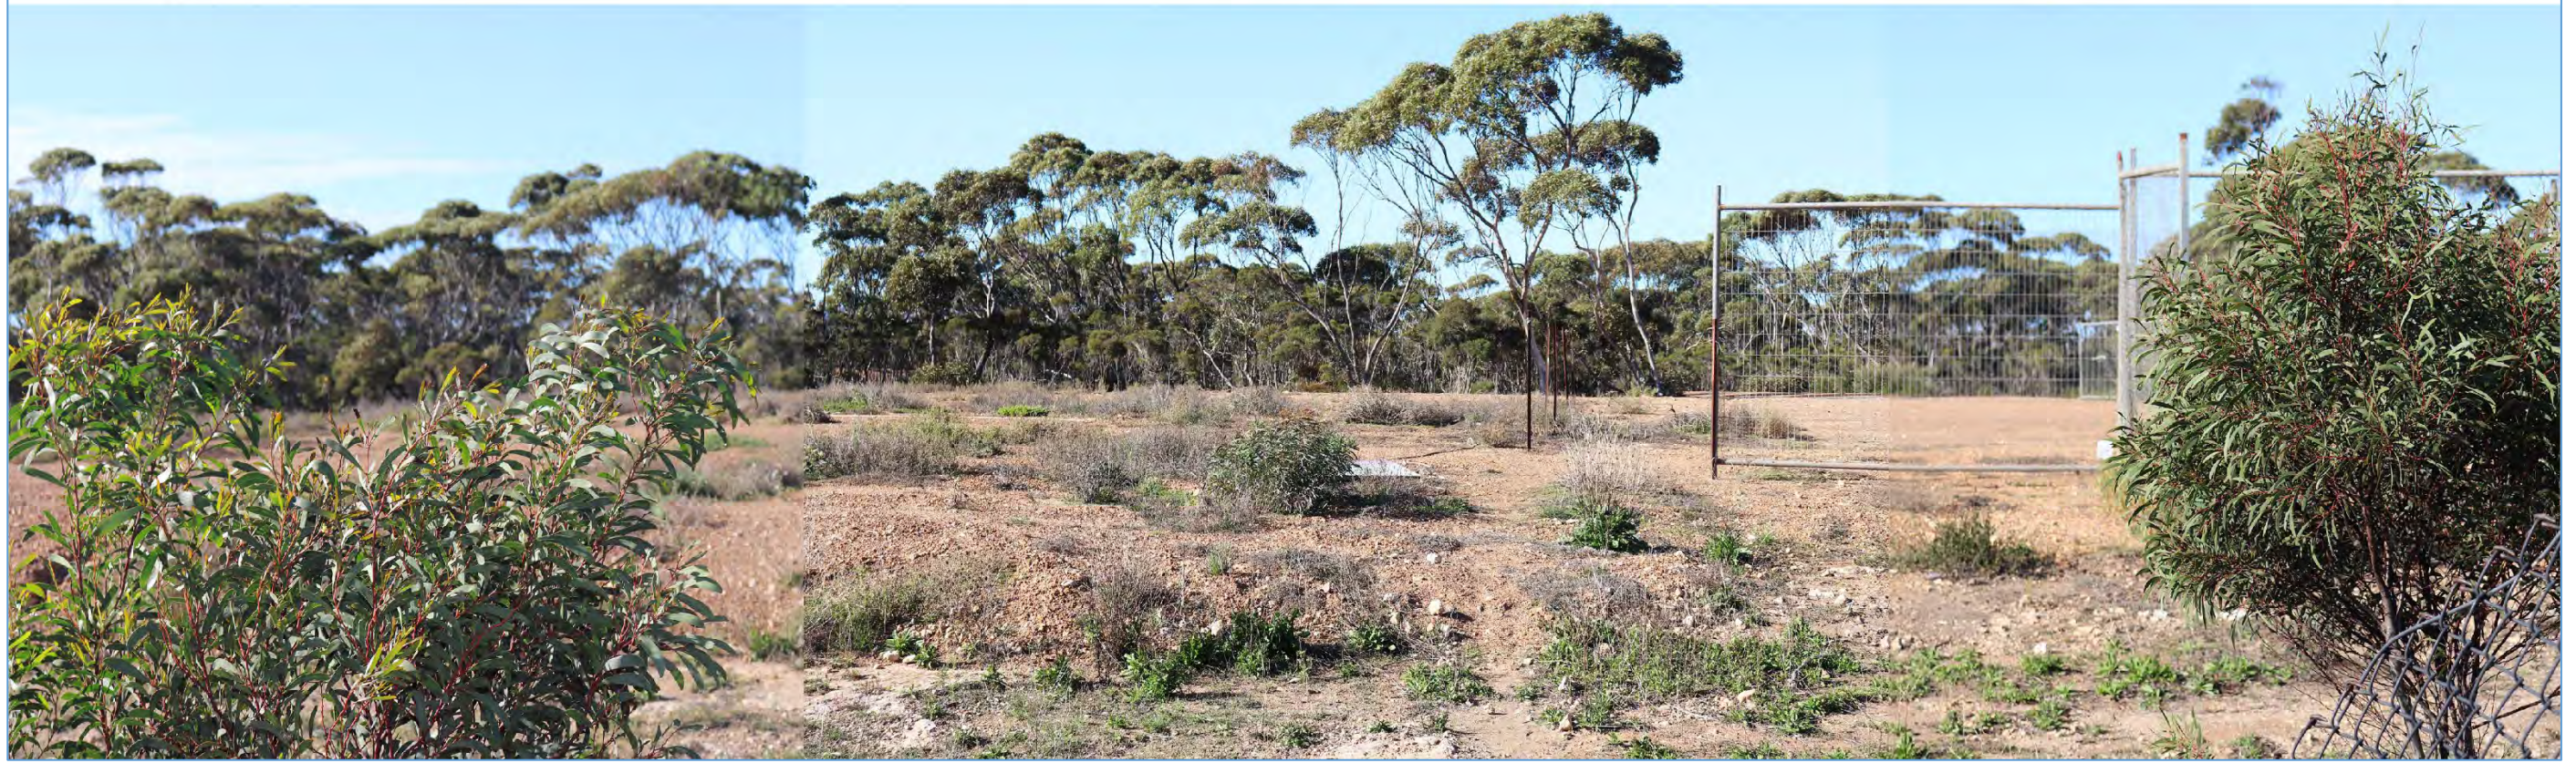
Image 4: VPL 02 – Romas Way, south of St Andrews Drive, view southeast

Properties facing southeast along both Romas Way and Cove View Drive. Views of the proposed site and the ex-BHP sand storage shed and conveyor are concealed by dense foreground plantings of coastal native trees and shrubs. Not considered to be a Sensitive Receptor.

Views of the proposed site, ex-BHP sand storage shed and conveyor are concealed by dense foreground plantings.

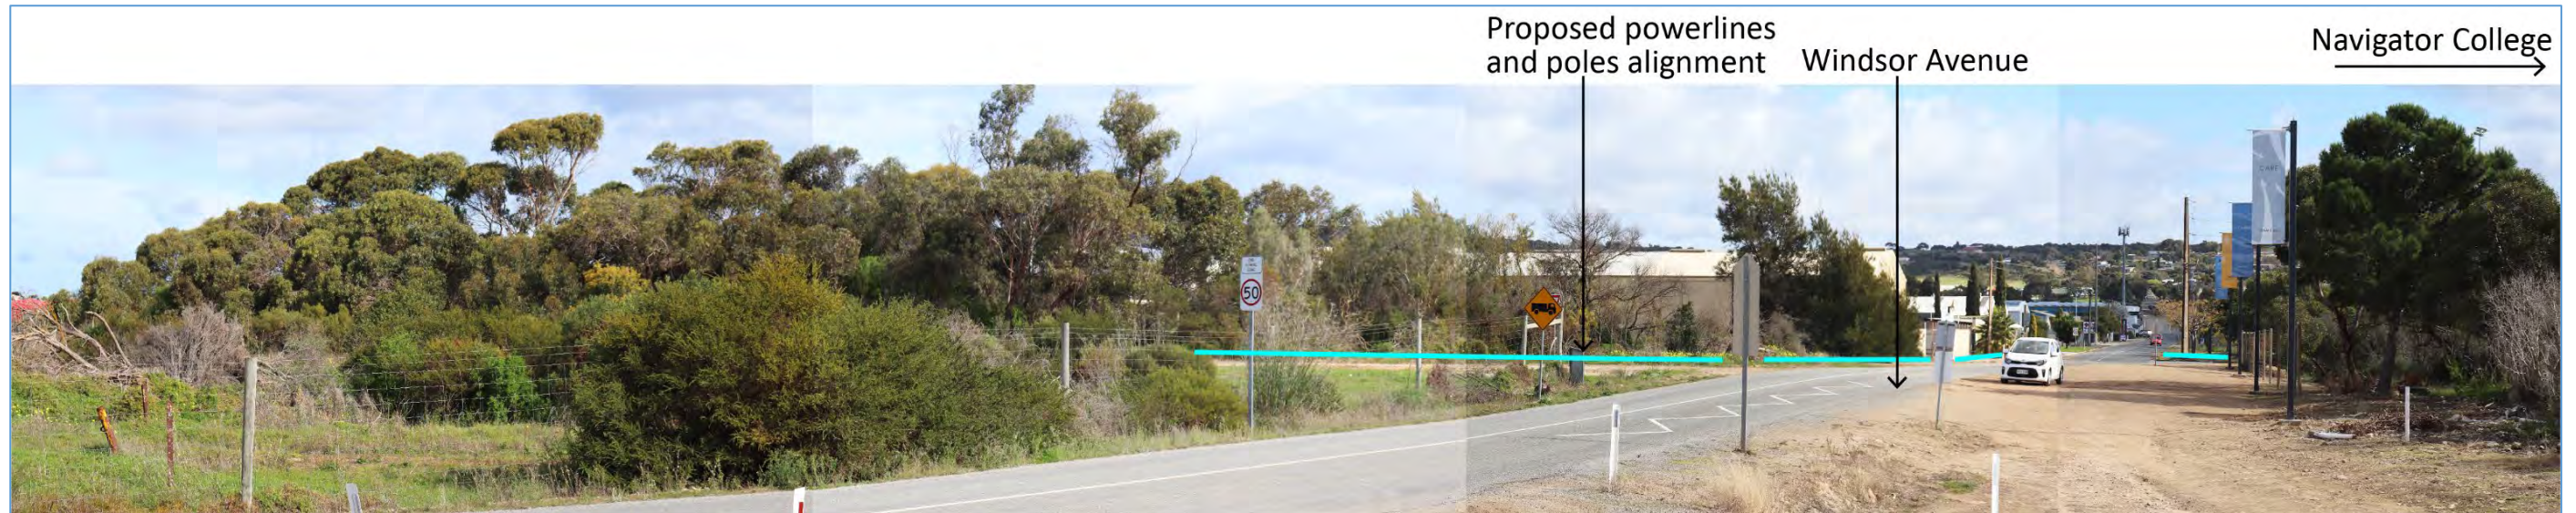
Image 8: VPL 06 – Windsor Avenue, view west

Adjacent Navigator College, the proposed 33 kV powerlines and poles that will be erected will be conspicuous features. This location is a Sensitive Receptor (SR 03) and is thus considered further in the assessment below.

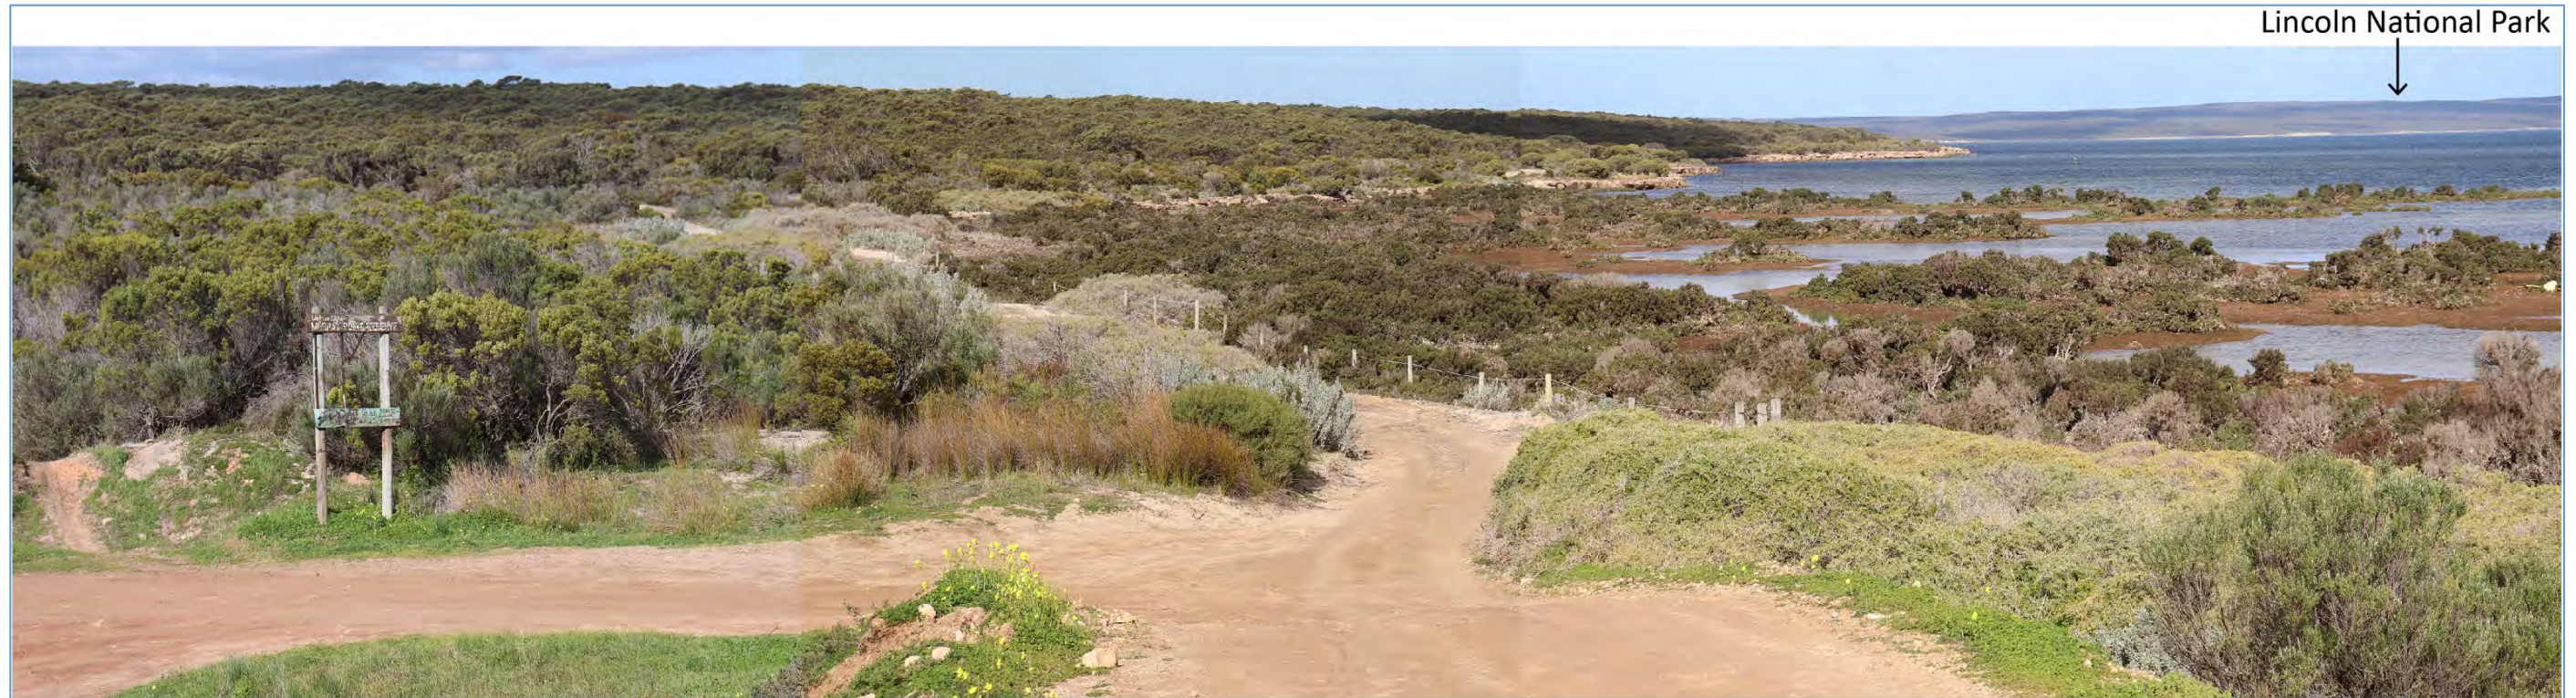
Image 9: VPL 07 – Greyhound Road, view south

At a point along Greyhound Road looking east along the redundant tram line, views received at this viewpoint confirmed that the proposed 33 kV powerlines and poles that will be erected will be conspicuous. This location is a Sensitive Receptor (SR 04) and is thus considered further in the assessment below.
