Appendix C Draft Native Vegetation Clearance Application

Billy Lights Point: Eyre Peninsula Desalination Plant Project Data Report - Working Draft

Clearance under the *Native Vegetation Regulations 2017*

22 May 2024

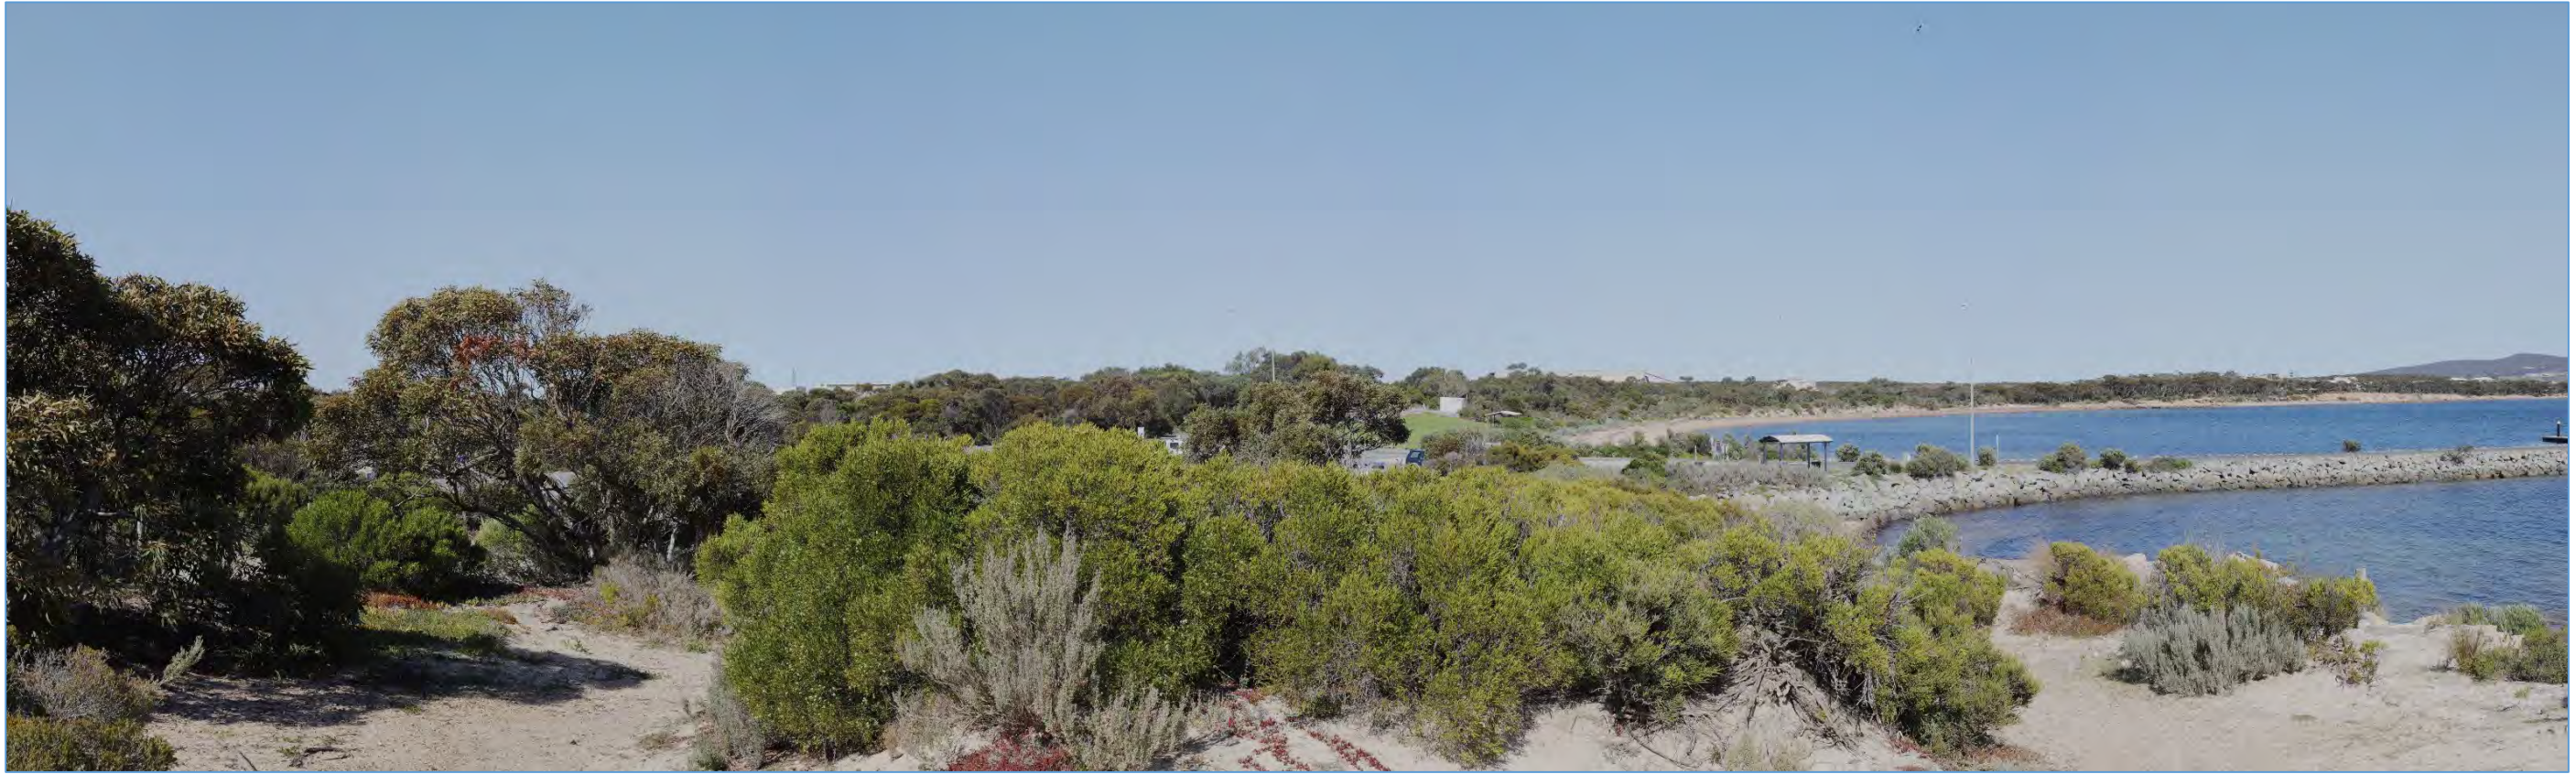
Image 11: SRL 01 – Billy Lights Point Reserve at Proper Bay Headland, view southwest

Location	View direction	Distance from Project Site(s)
Proper Bay Headland, centred on the Billy Lights Reserve, the Parnkalla Trailhead and the boat and trailer car park and slipway	South, southwest	Approximately 880m
Landscape and setting		Visual exposure at receptor
<p>From within the receptor locality multiple viewpoints through an intermittent 360° field of vision are available. The views south to The Project location are relatively incidental. The more significant views are received from the elevated Parnkalla Trailhead car park looking north over Porter Bay, Boston Bay and further north to Boston Bay Island and south across Proper Bay to Lincoln National Park.</p> <p>A quintessential South Australian coastal scene epitomised by the expansive views over an extended coastal foreshore where waves of native vegetation lap the ochre sand beaches drawing the eye of the observer up and over to the distant undulating horizon. Gnarly windswept plantings of mature evergreen natives contain the eye to the west, instilling a poignant and evocative reminder of the once dominant pre-settlement coastal landscape, a landscape sharply juxtaposed against the encroaching urban footprint of new residential development and the sprawling Port Lincoln Marina development.</p>		<p>Low.</p> <p>The proposed site is obscured by the dense expanse of mature native trees and shrubs that envelop the site on all sides.</p> <p>Refer Figure 3: Section – Sensitive Receptor Locality 01 (Dwg No. HD_Z015_section)</p>

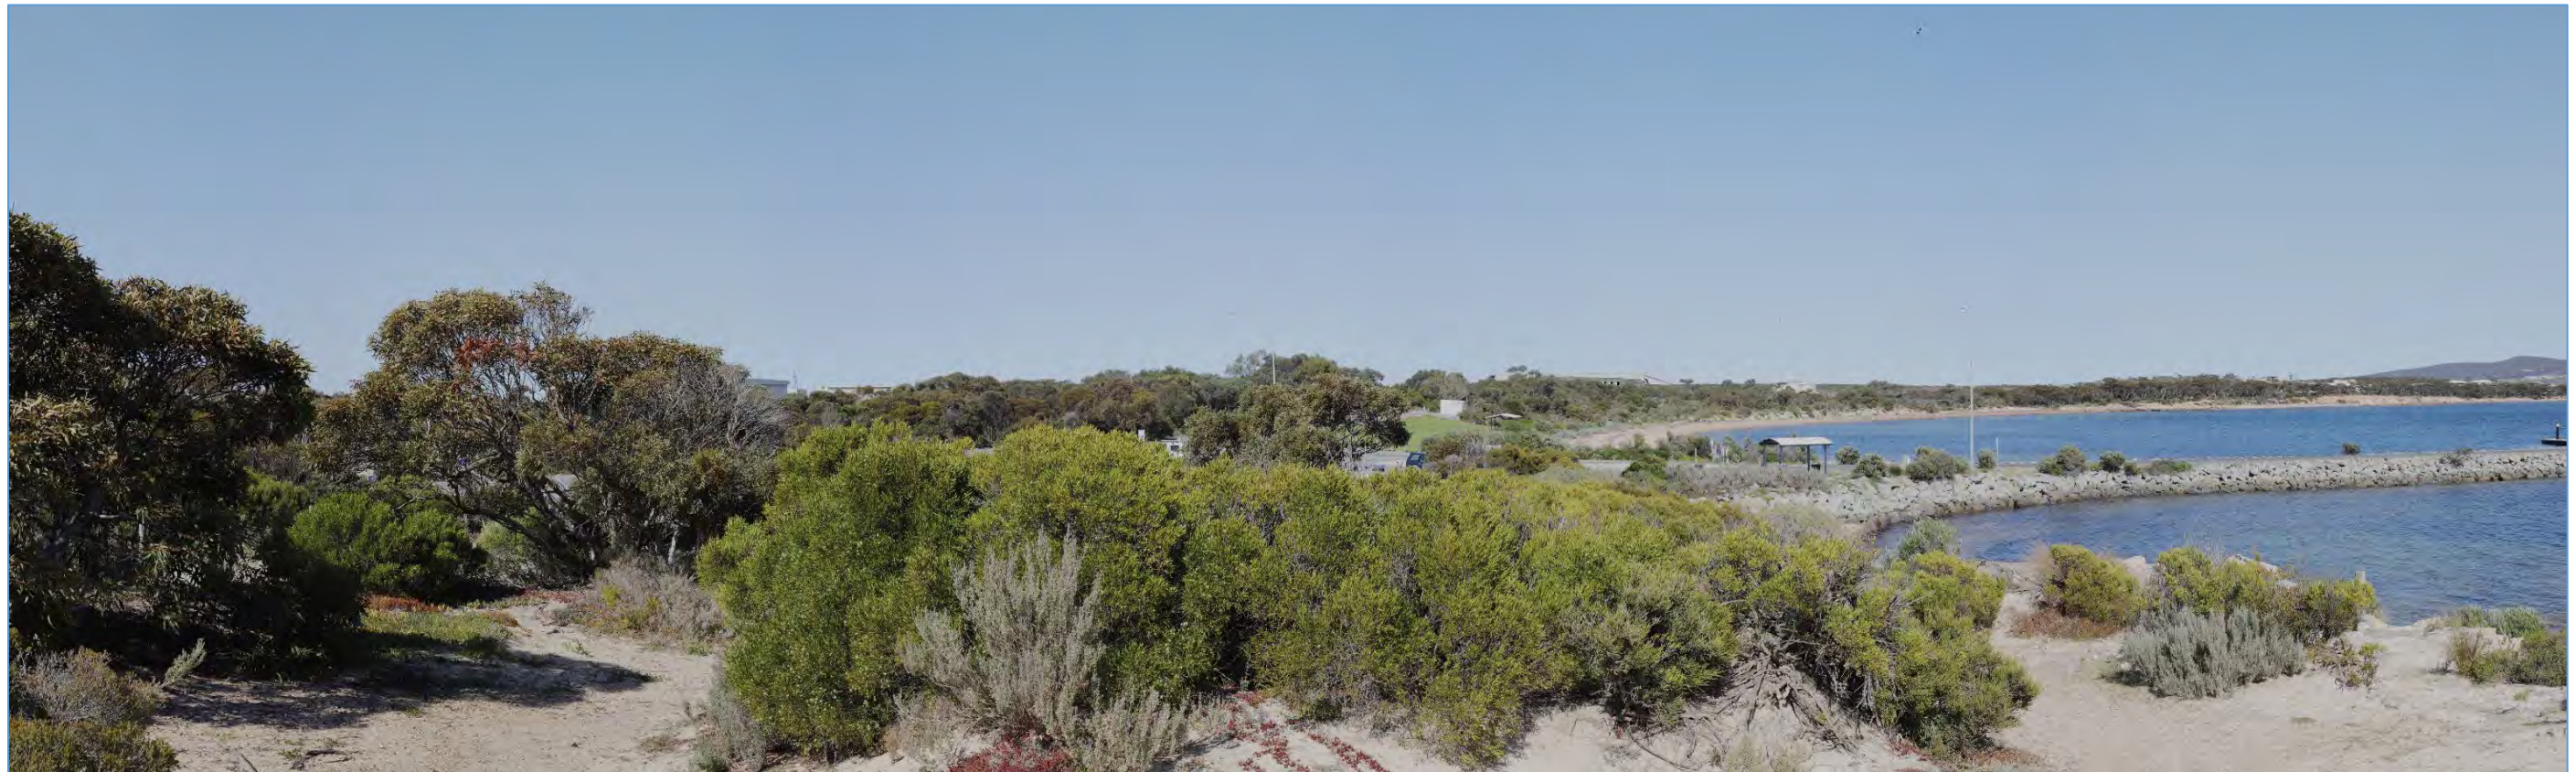
Image 12: SRL 01 – Photomontage view of The Project from Billy Lights Point Reserve at Proper Bay Headland, view southwest

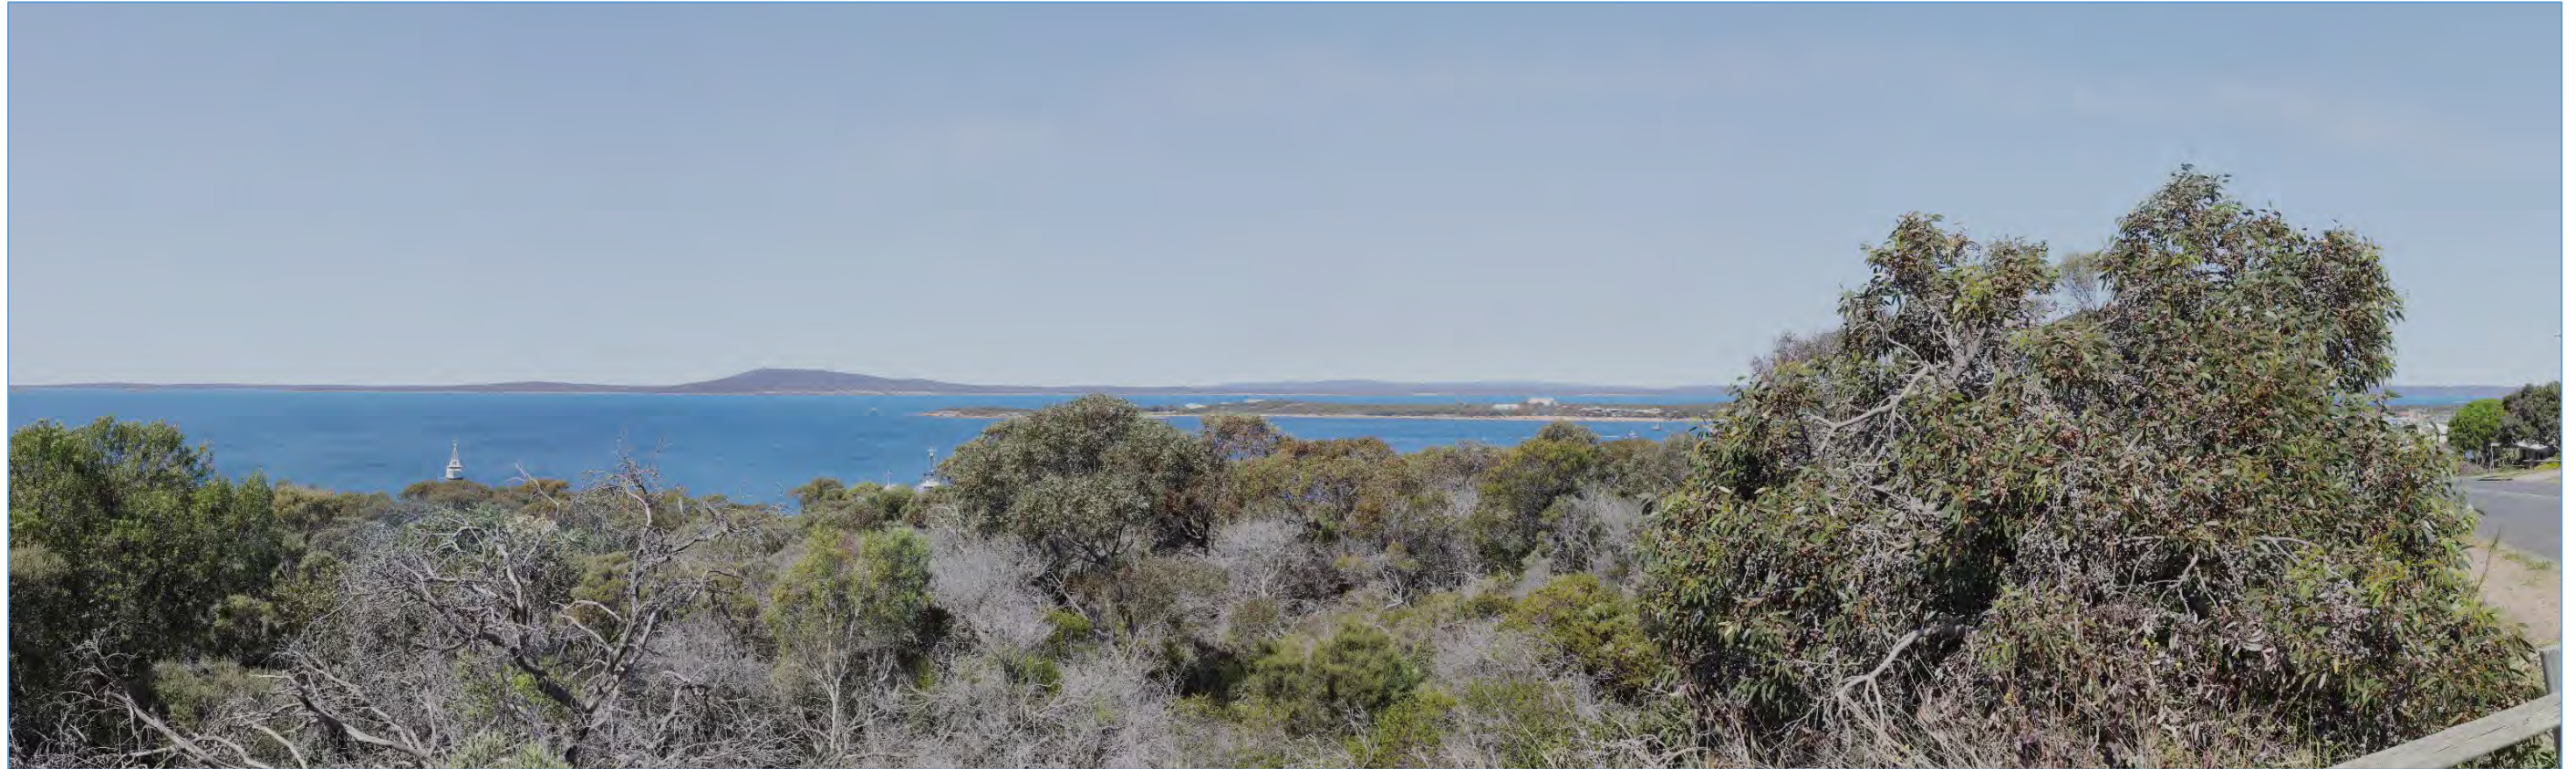
Image 13: SRL 02 – View from elevated vantage point at Hindmarsh Street, view south

Location	View direction	Distance from Project Site(s)
Hindmarsh Street and Port Lincoln Tourist Park	180° + across a south, southwest and west vista	Approximately 2.5km
Landscape and setting		Visual exposure at receptor
<p>Numerous vistas south from elevated vantage points along the north-south orientated Hindmarsh Street east of the township and the Port Lincoln Tourist Park located at the northern headland that encloses Porter Bay. This receptor locality is over 2.5km north of the proposed site.</p> <p>The sweeping elevated vistas along Hindmarsh Street draws the eye of the observer over the sprawling and vapid Port Lincoln Marina, beyond the densely vegetated Proper Bay headland to the distant Lincoln National Park which silhouettes and traces the skyline. In a landscape where the contrived ‘natural’ landscape (as opposed to the resettlement indigenous landscape) prevails, the visual interplay between the distant Lincoln National Park landform and sea scape is sharp and visually exhilarating, across the elongated foreshore plumes of breaking wave cast spray high into the sky creating a foaming mist that shrouds the more rugged</p>		<p>Low to negligible.</p> <p>From over 2.5km the proposed site is indiscernible within the wider contextual landscape and from within the immediate locality.</p>

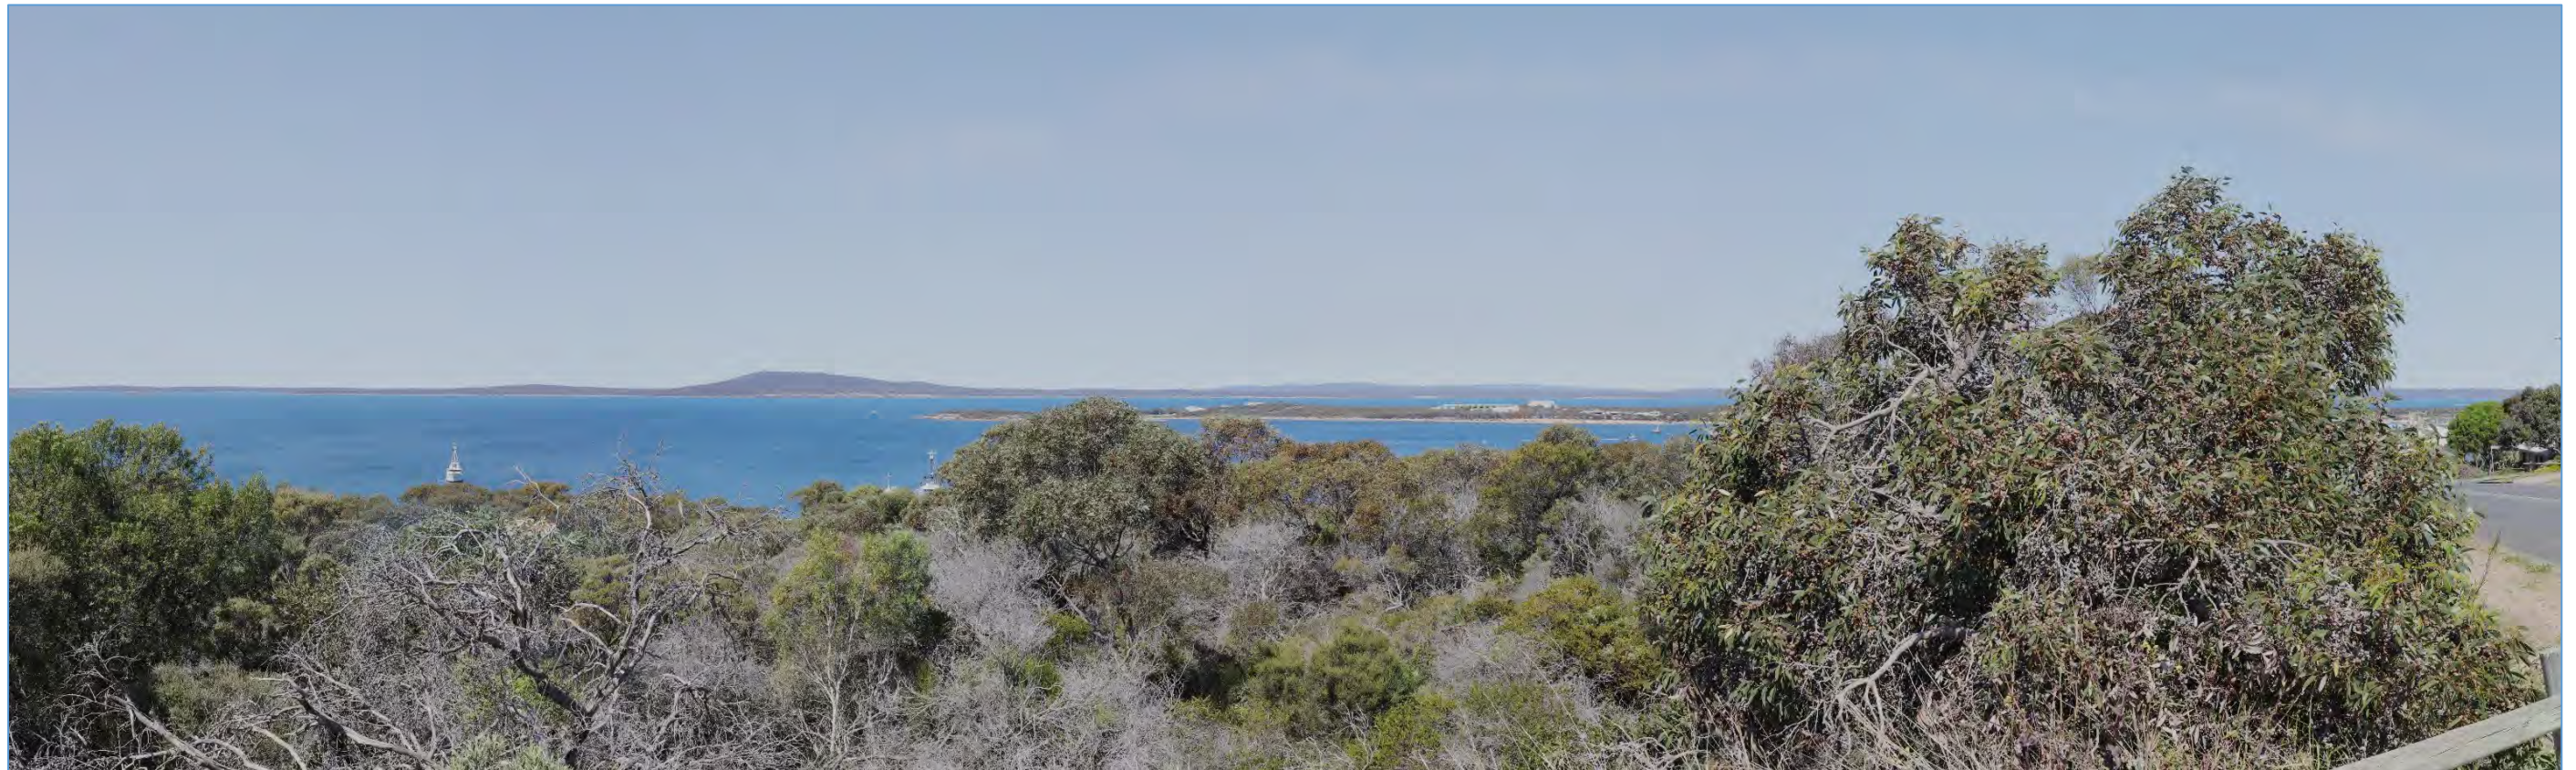
Image 14: SRL 02 – Photomontage view of The Project from elevated vantage point at Hindmarsh Street, view south

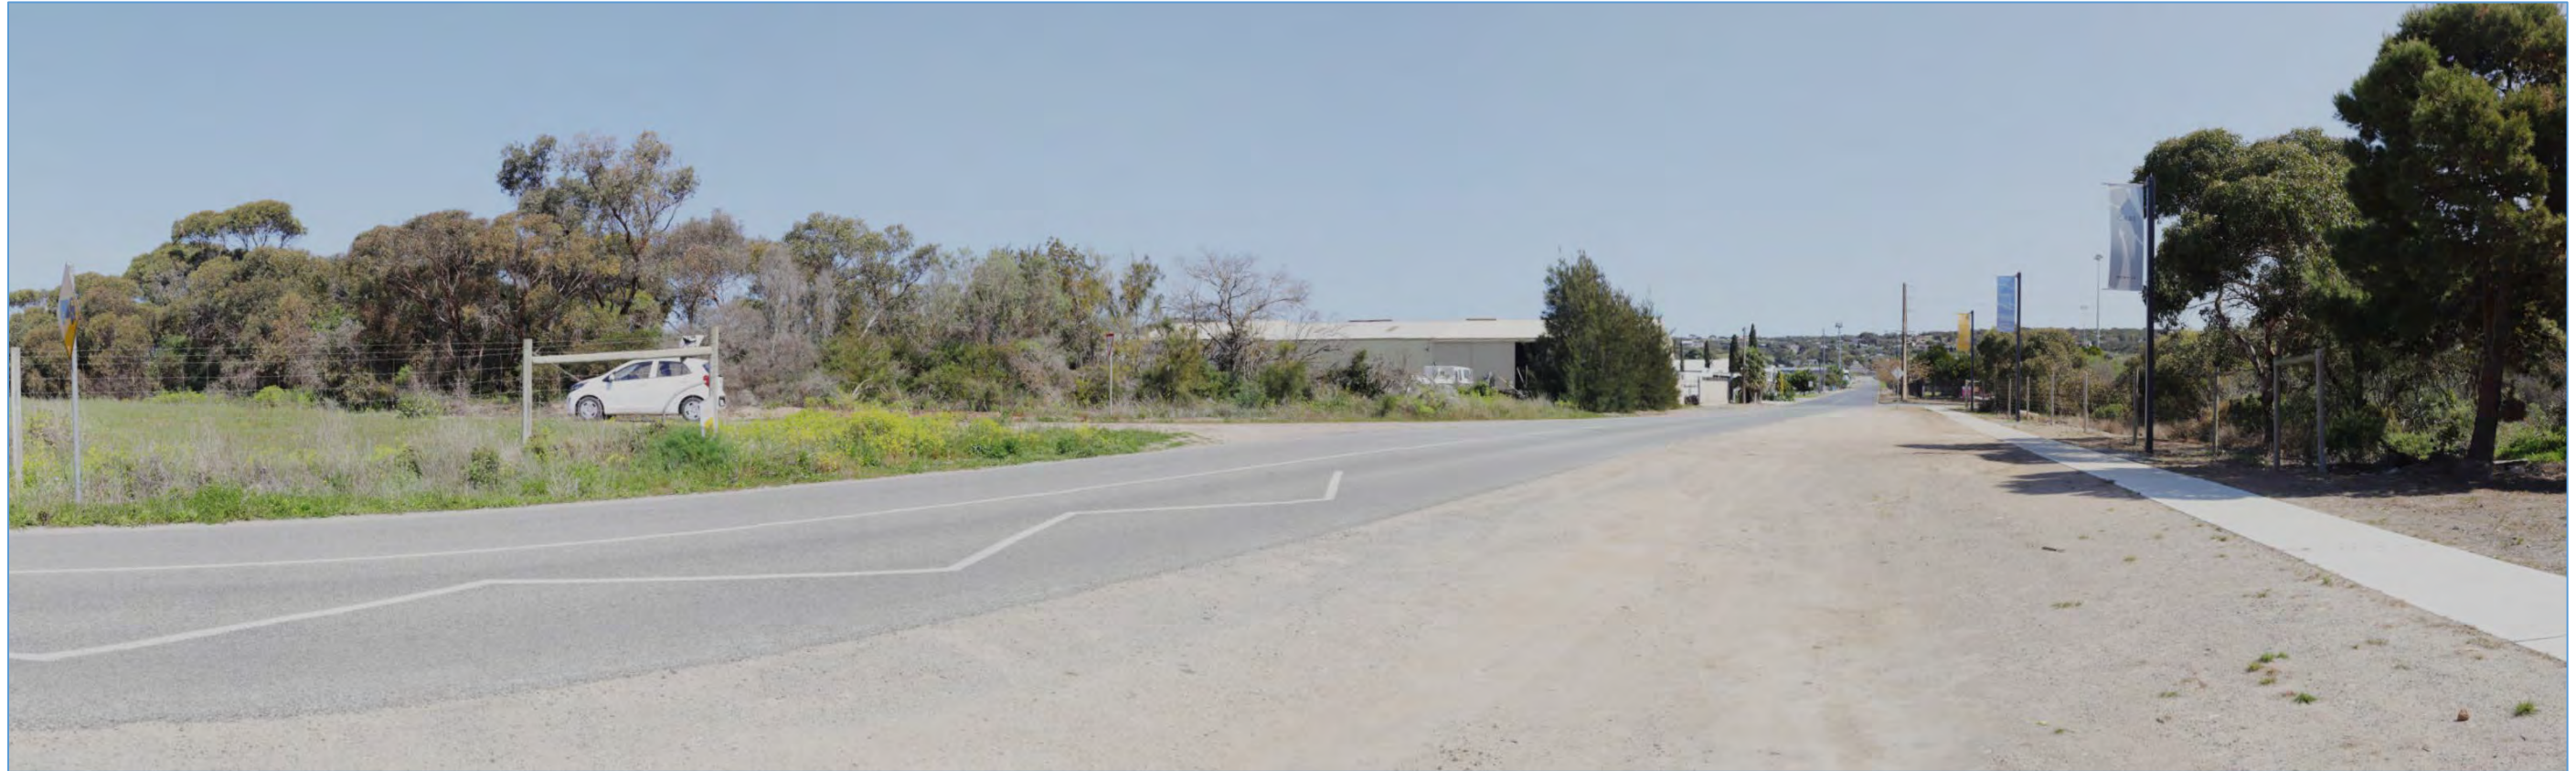
Image 15: SR 03 - View from Windsor Avenue, view west

Location	View direction	Distance from Project Site(s)
Windsor Avenue – South	West	2.6km
Landscape and setting		Visual exposure at receptor
<p>A landscape character of low scenic quality to moderate scenic quality.</p> <p>The township urban fringe juxtaposed against the indigenous landscape of the wider Proper Bay headland. Contained views over a foreground dominated by light industrial land use activities comprising of large sheds, small factories and storage yards enclosed by weldmesh and colour bond fencing. A relatively ordered streetscape where the procession of large stobie poles from Stamford Terrace and towering light columns of Ravensdale Oval dominate the street scene.</p> <p>The recently constructed Navigator College is pleasing to the eye and an inoffensive, subtle built form statement.</p> <p>Travelling south the landscape transitions from urban fringe to coastal native, the departure from a bitumen to unpaved road surface is an obvious visual threshold. The immediate foreground view of shipping containers, building material and other incongruous waste elements within the adjacent large storage yard</p>		<p>High to moderate within the immediate locality.</p>

The proposed 33 kV powerline and pole option will be a prominent and obvious addition to the locality and wider contextual landscape as they traverse the planar landform in a southern and easterly direction to reach the proposed desalination plant.

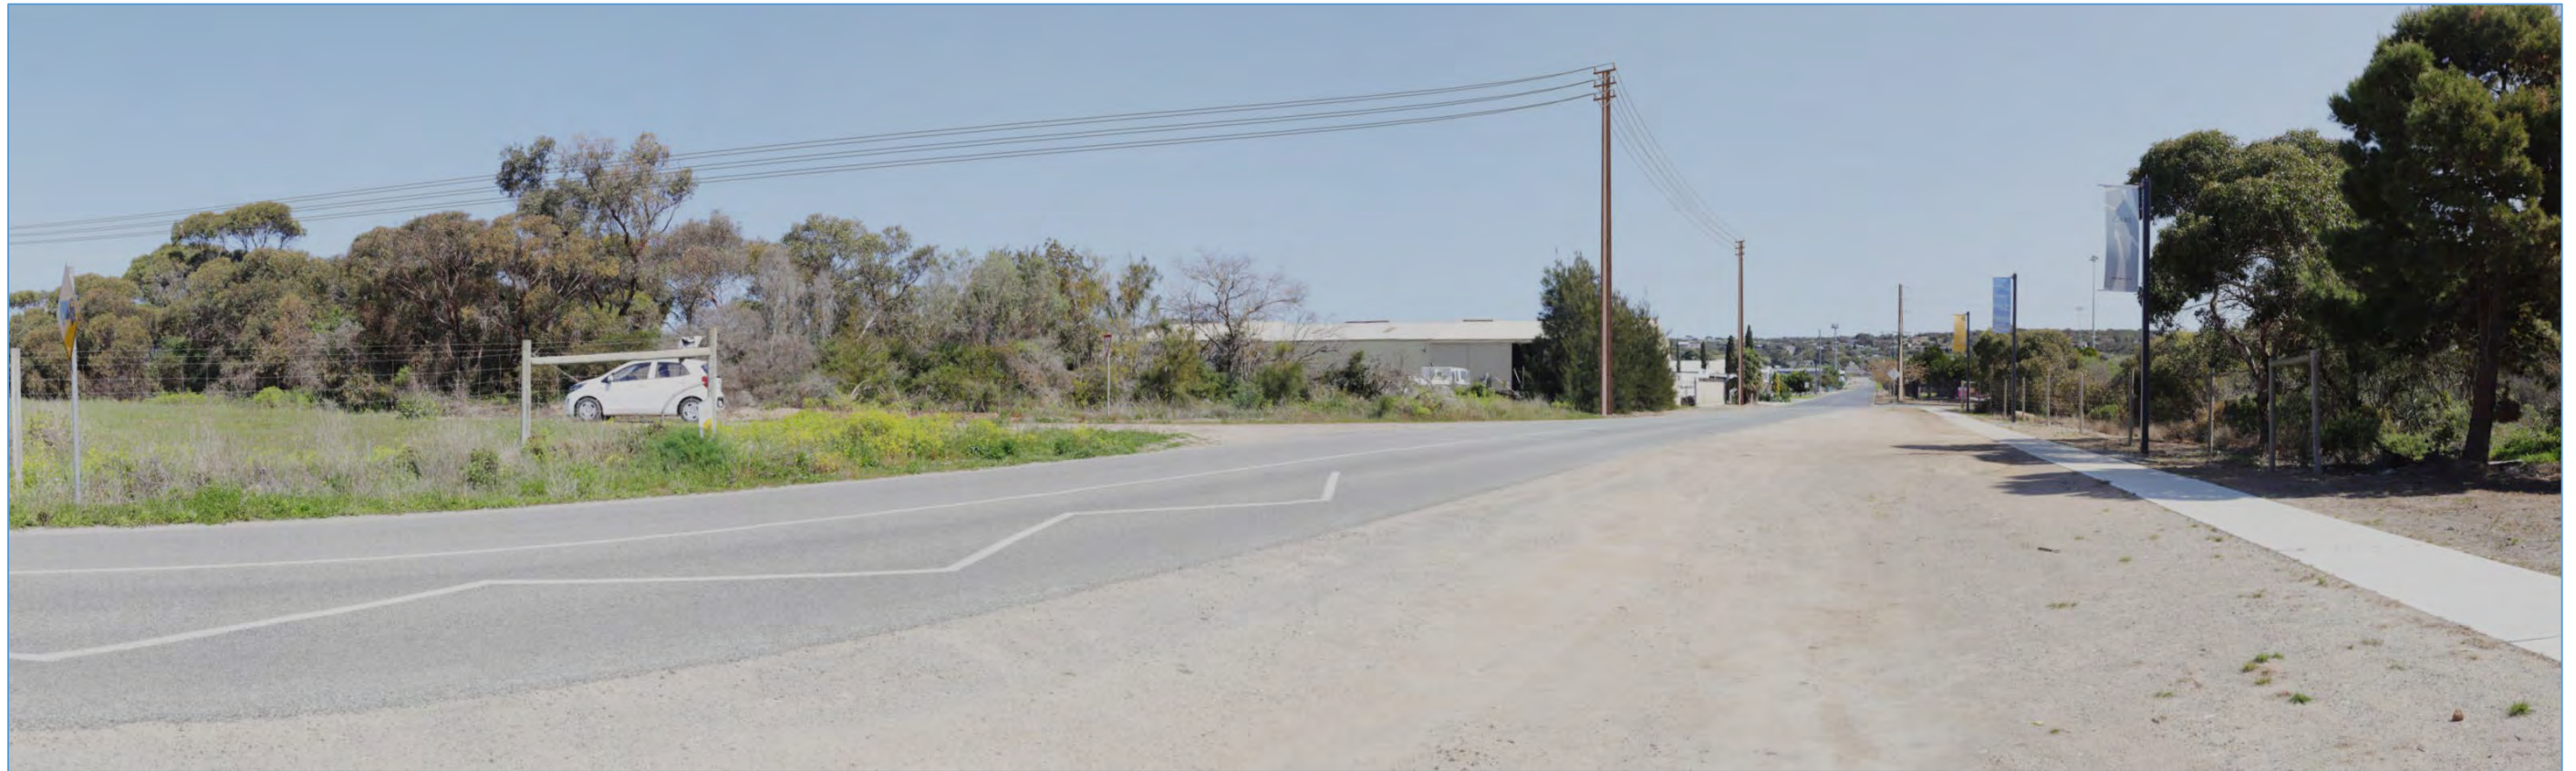
Image 16: SR 03 - Photomontage view of The Project powerlines from Windsor Avenue, view west

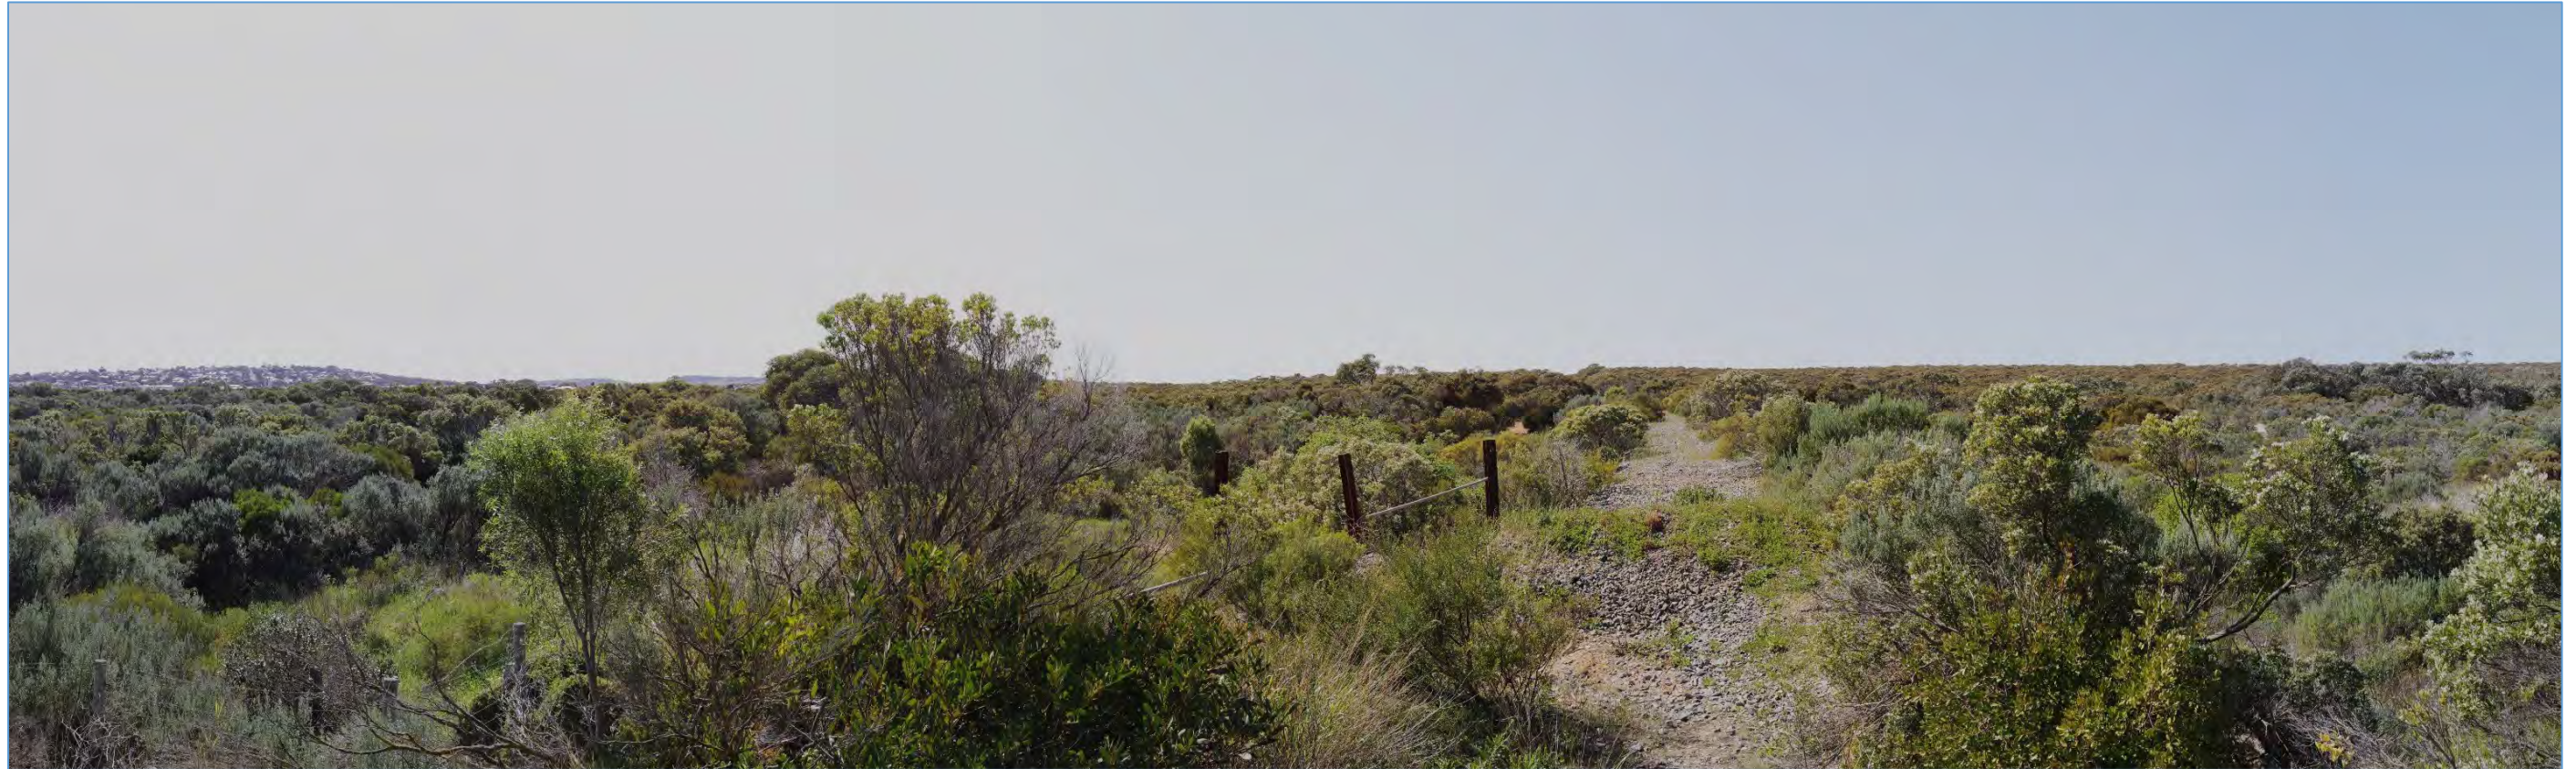
Image 17: SR 04 – Greyhound Road, view east

Location	View direction	Distance from Project Site(s)
Greyhound Road south at the intersection with the disused BHP tram line	East	2km
Landscape and setting		Visual exposure at receptor
<p>A coastal landscape where native coastal plantings draw the eye through a 180° sweeping vista across Proper Bay to the distant Lincoln National Park. To the north and west the subtly rising landforms blanketed by dense native vegetation silhouettes the horizon. The moving cloudscape projects shadows across the landform creating a kaleidoscope of colours where the tones and hues of the ‘canvas’ of shrubs and groundcovers sharply contrast with the shimmering blue greys of the tranquil coastal foreshore and enveloping horizon beyond.</p> <p>A locality where remnant tram line infrastructure and ad hoc post and wire fencing detract from the otherwise pleasing visual qualities of this serene setting.</p>		<p>The subtle undulation across a mainly planar foreground devoid of large trees delivers a high degree of visual exposure within this locality. However, the degree of visitation is likely to be low and infrequent.</p>

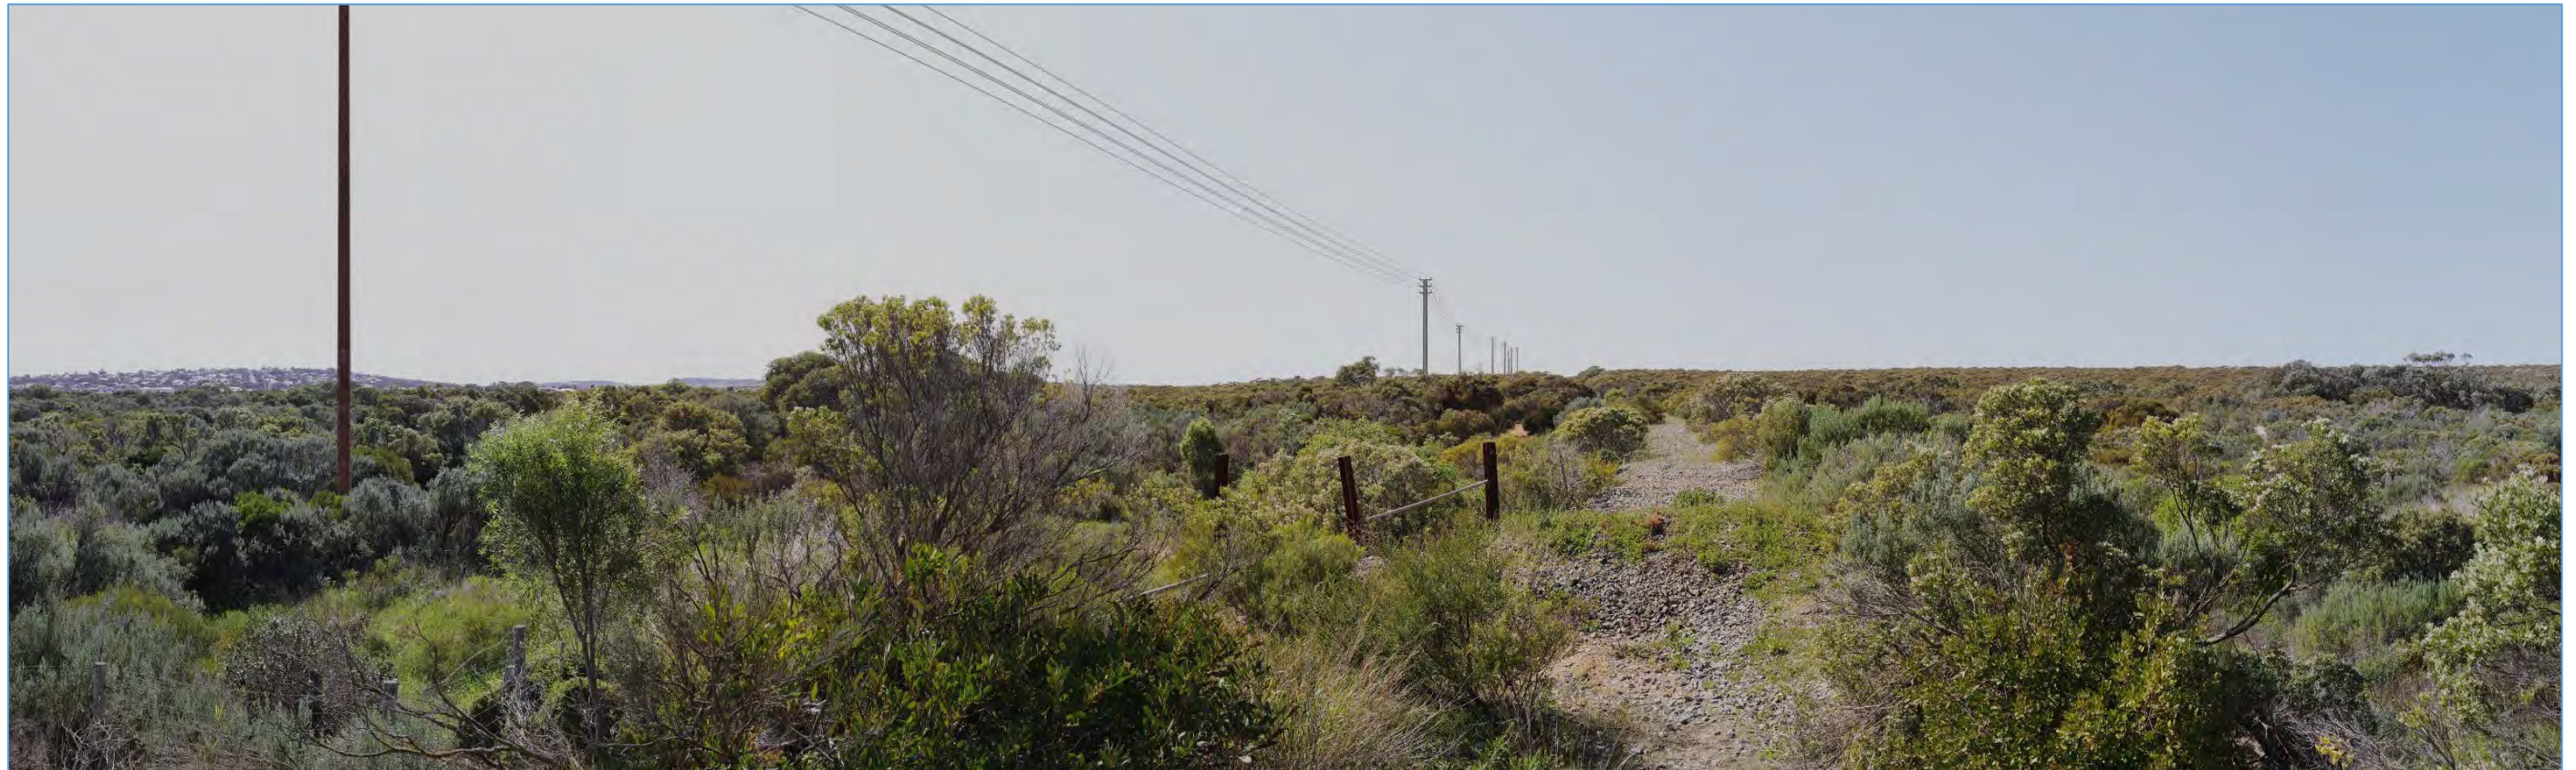
Image 18: SR 04 – Photomontage view of The Project powerlines from Greyhound Road, view east

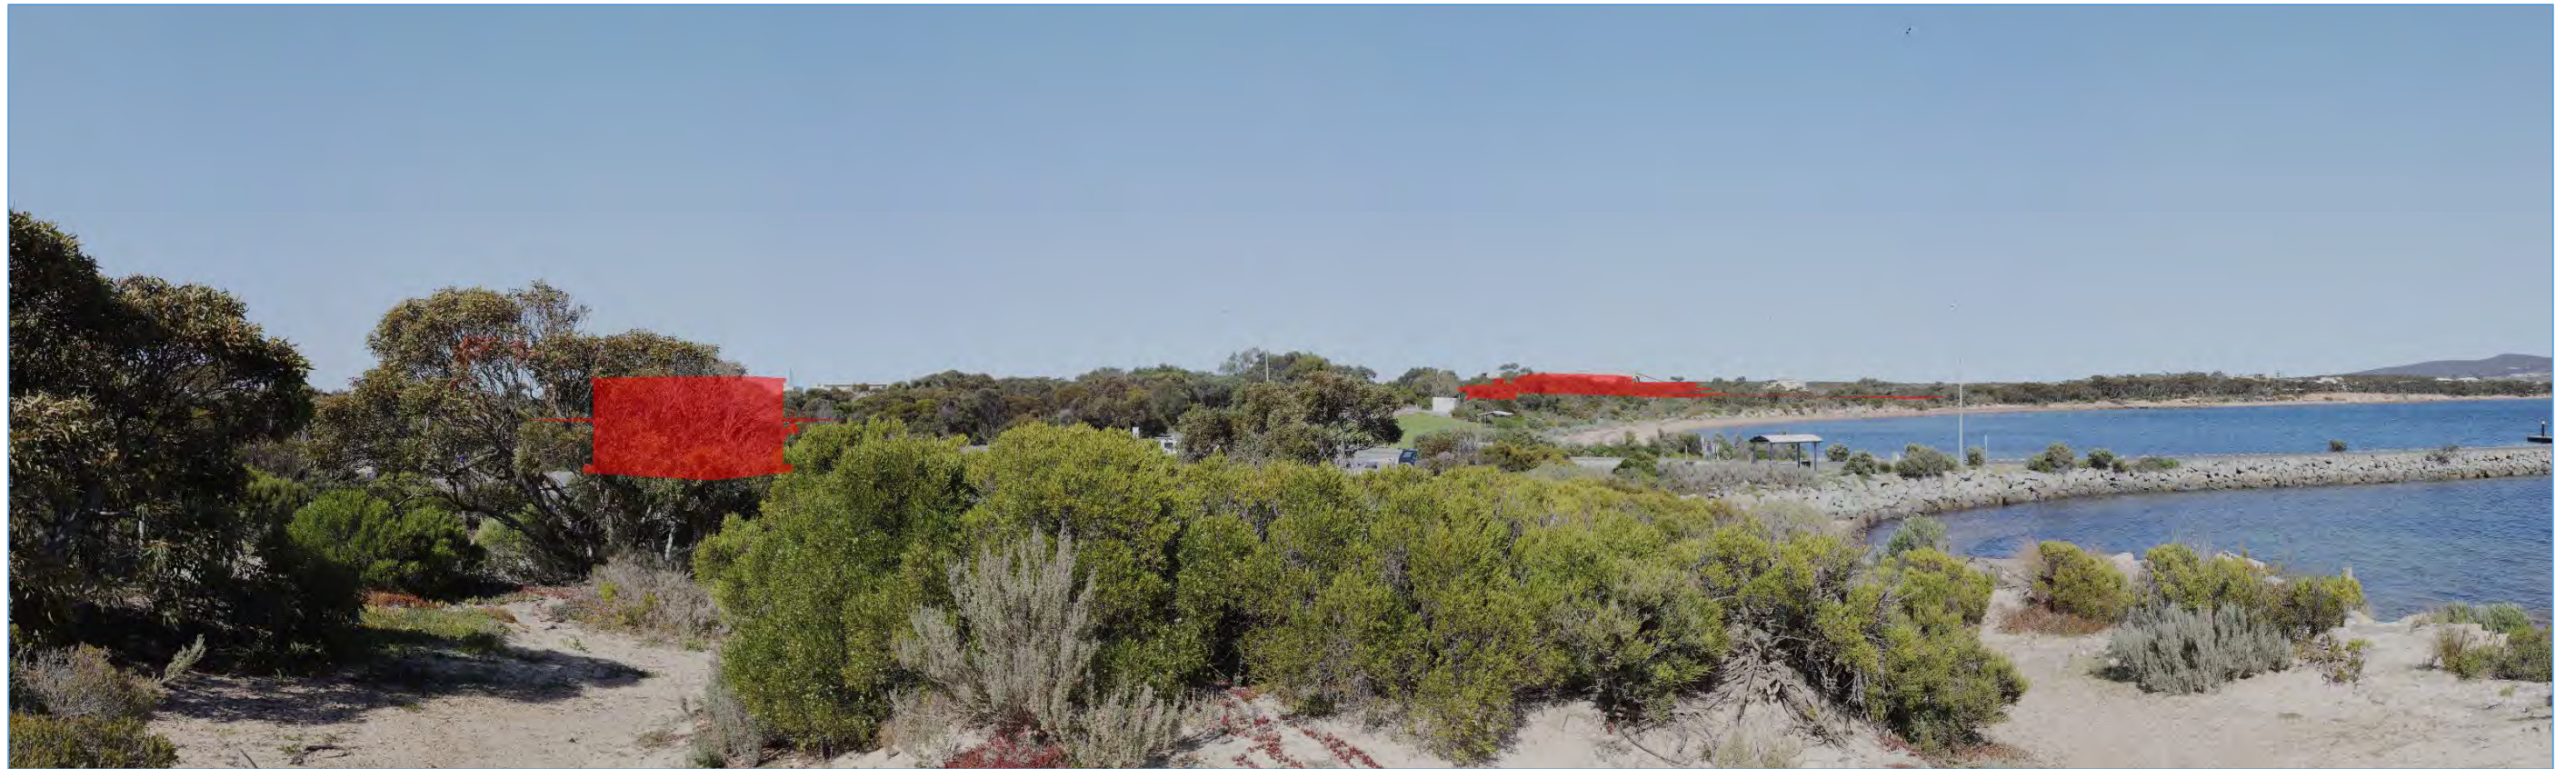
Image 19: SRL01 - View southwest from Billy Lights Point Reserve – x-ray image indicating The Project's desalination plant and intake pumping station

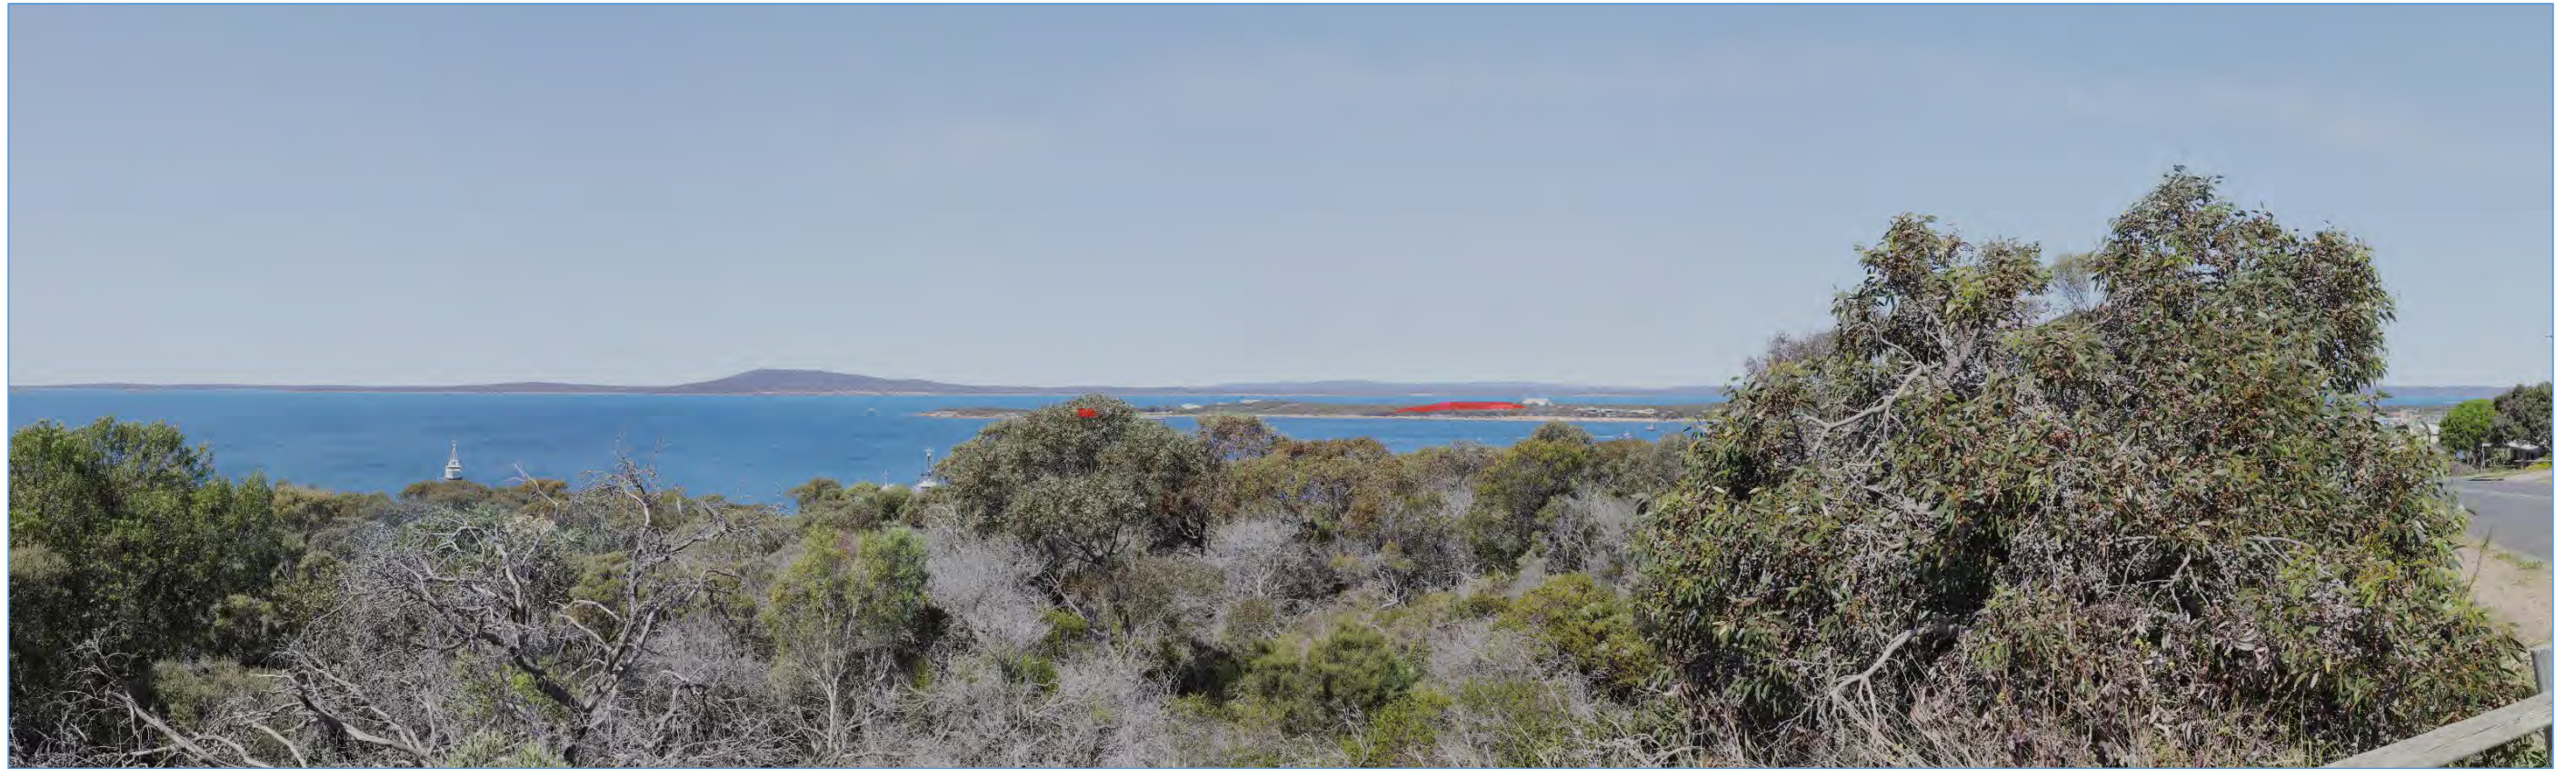
Image 20: SRL 02 – View from elevated vantage point at Hindmarsh Street, view south - x-ray image indicating The Project's desalination plant and intake pumping station
