Appendix C Draft Native Vegetation Clearance Application

Billy Lights Point: Eyre Peninsula Desalination Plant Project Data Report - Working Draft

Clearance under the *Native Vegetation Regulations 2017*

22 May 2024

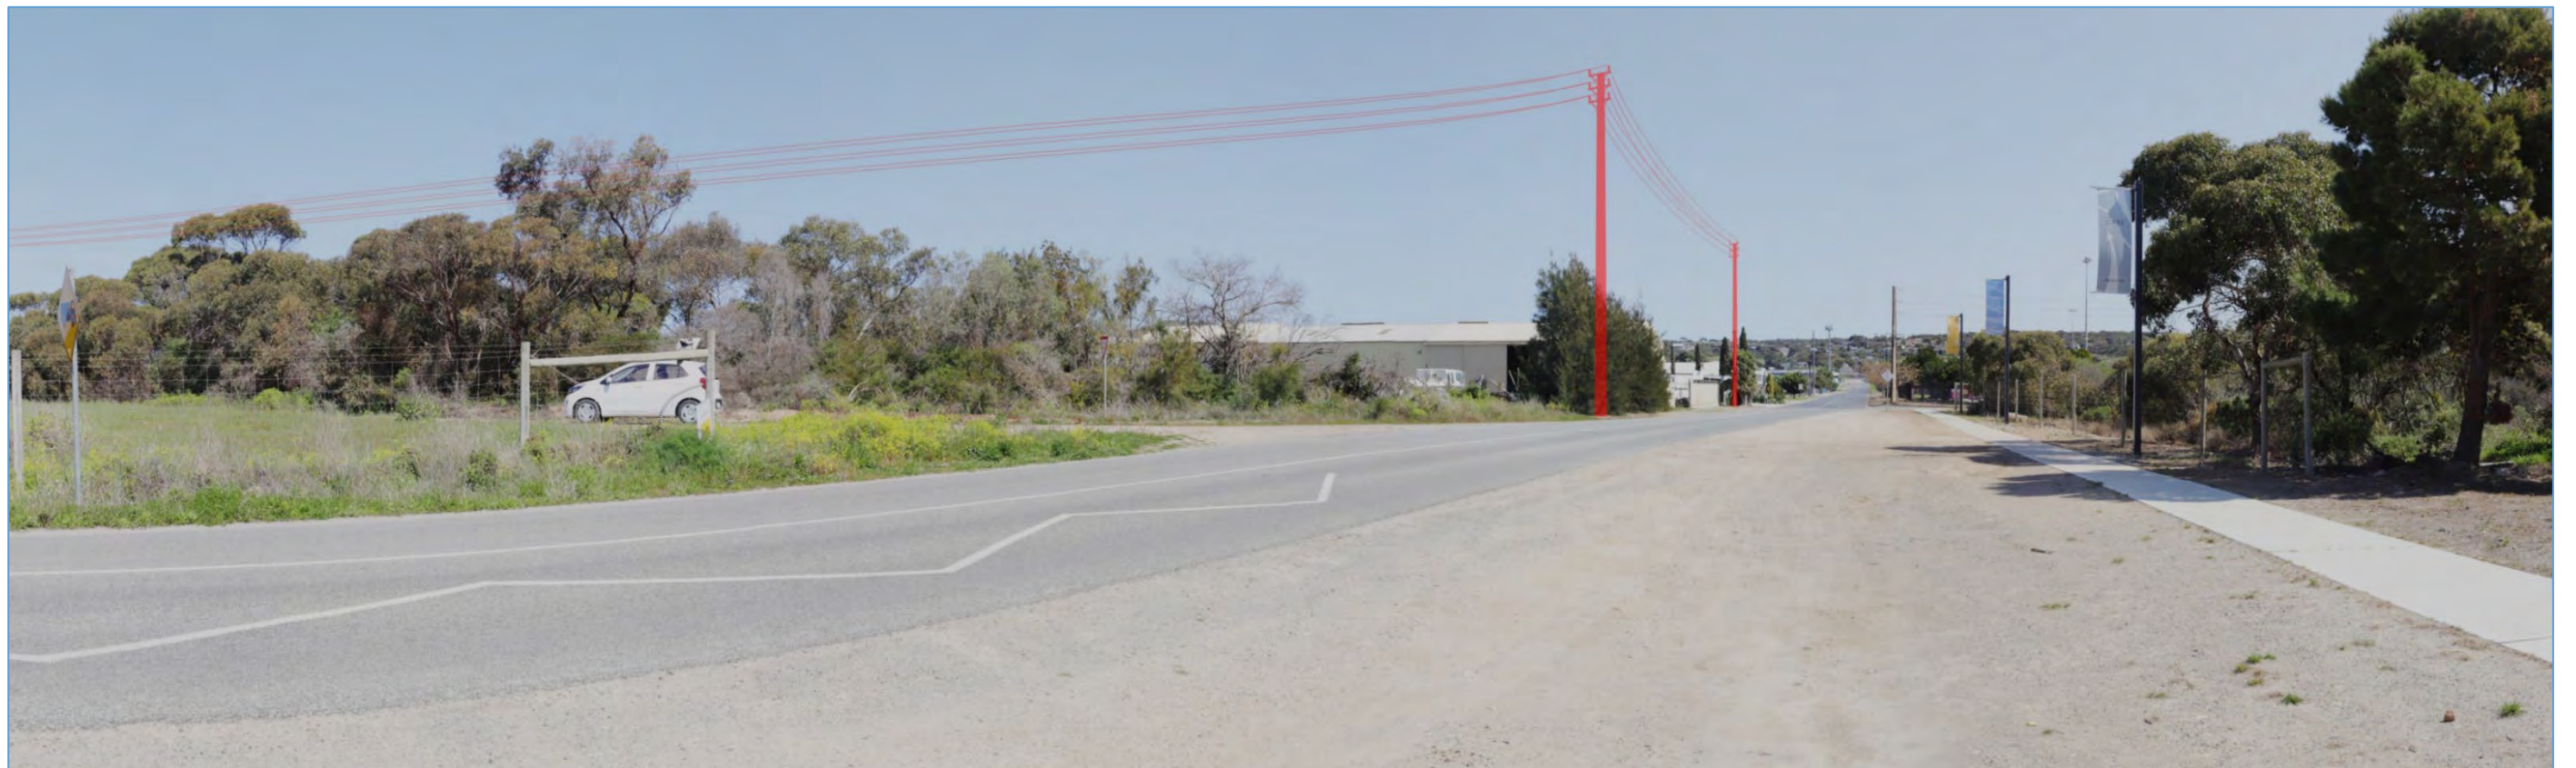
Image 21: SR 03 - View from Windsor Avenue, view west – x-ray image indicating The Project's powerlines

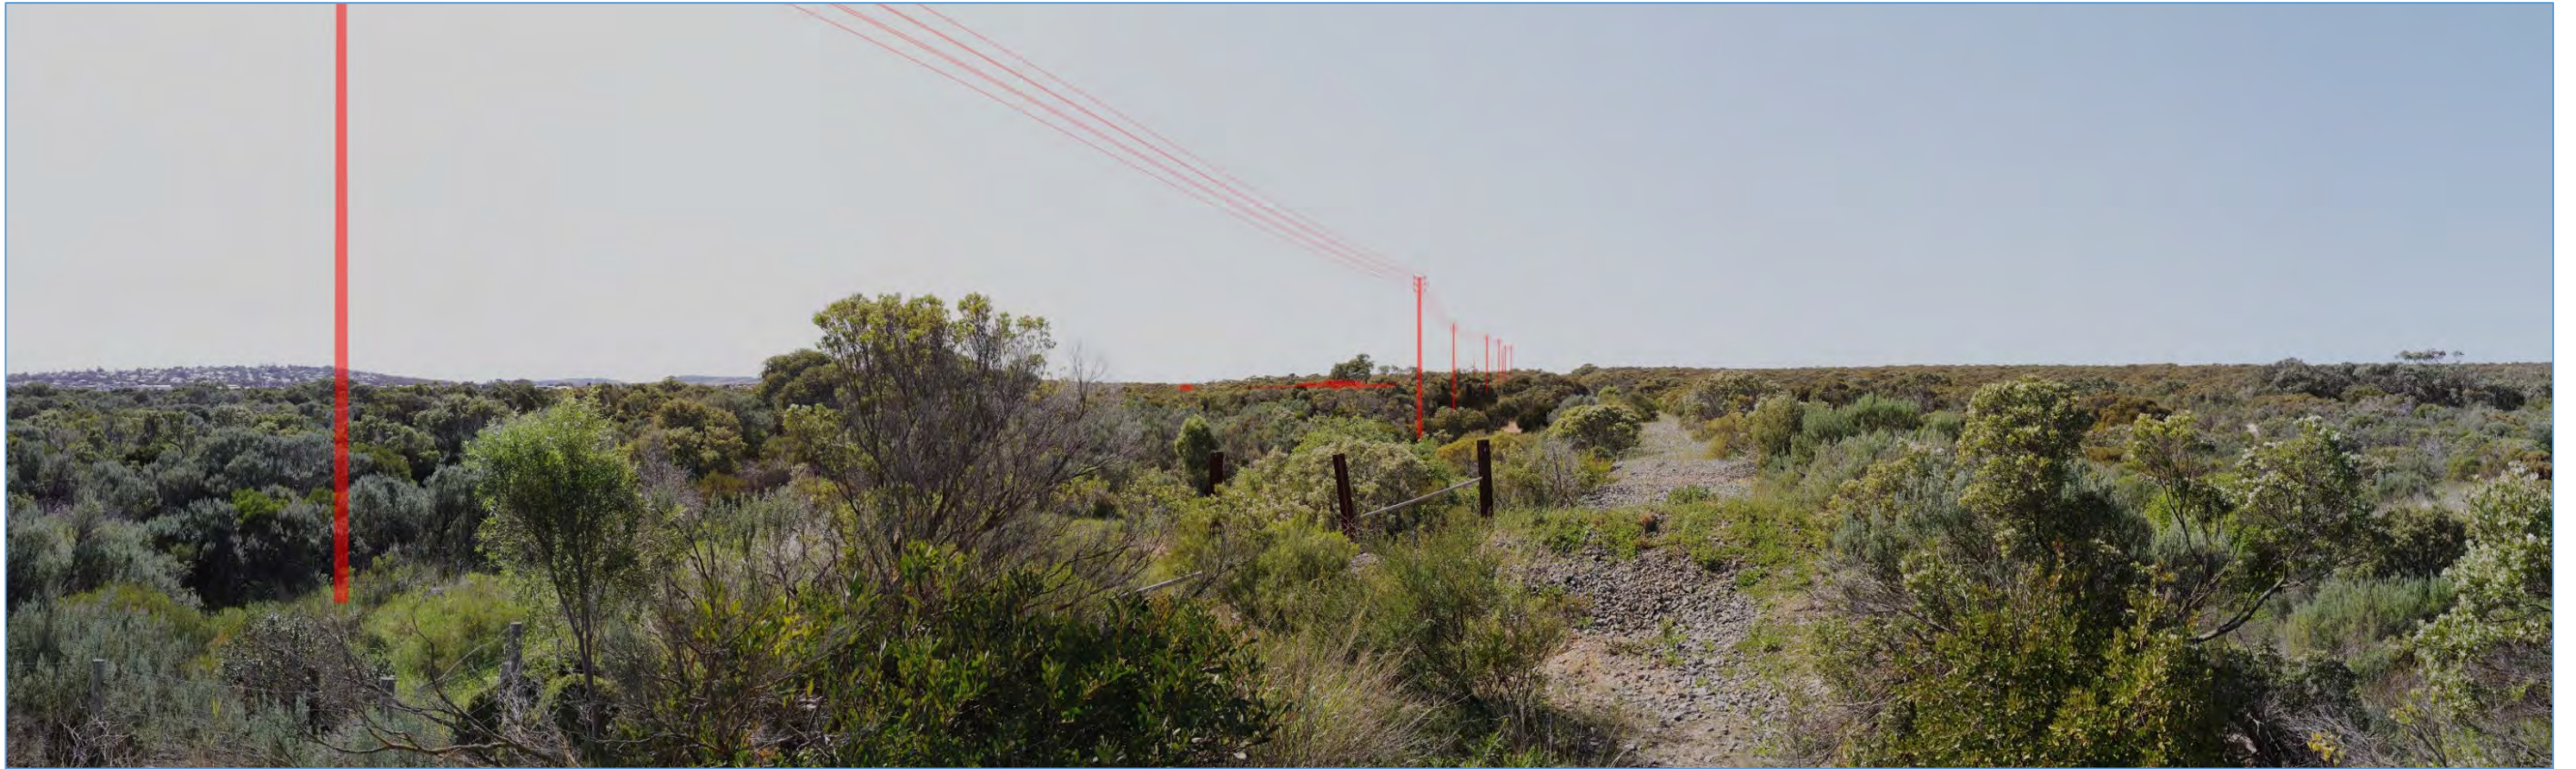
Image 22: SR 04 – Greyhound Road, view east – x-ray image indicating The Project's powerlines
