LIFTING MATTERS

Q3 2021

JIB SAFETY

Safely erecting, using and
removing fly jib extensions

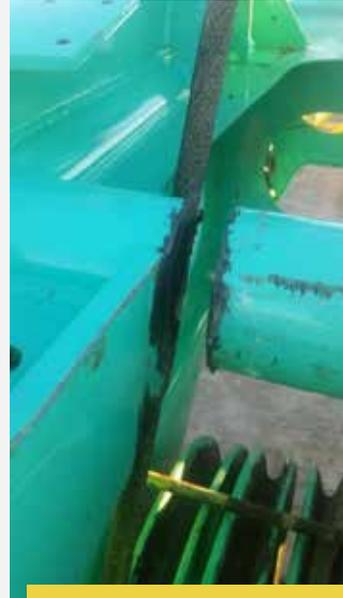
The wire rope can act like a saw blade on boom sections or laces if reeved improperly.

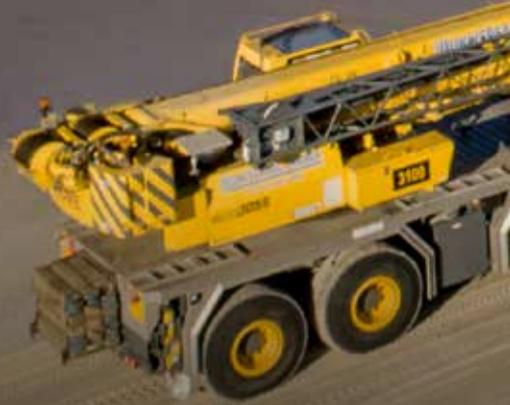
Stowing a HTC fly jib

It is important that the reeving of the wire rope is correct, to be sure it is retained by the guide pins and that retaining clips are secure on the guide pins. The wire rope can act like a saw blade on boom sections or laces if reeved improperly.

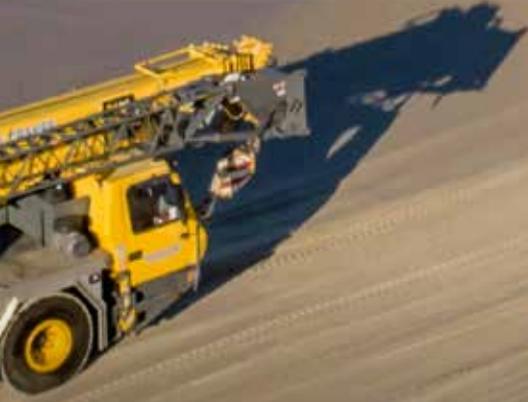
When disassembling the fly jib ensure that the boom is retracted to the position so it can be stowed correctly on the support ramp and aligns with the stowage pins.

When disassembling the fly jib ensure that the boom is retracted to the position so it can be stowed correctly on the support ramp and aligns with the stowage pins.

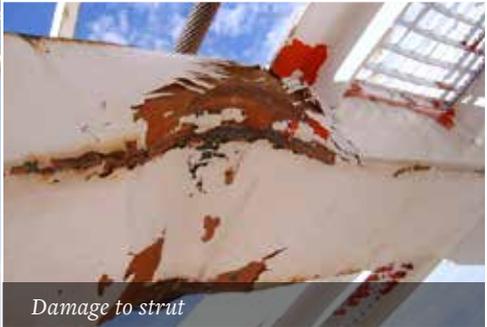
Damage to strut

The primary cause of the incident was luffing the fly down too far.

Masts have rotated over causing damage

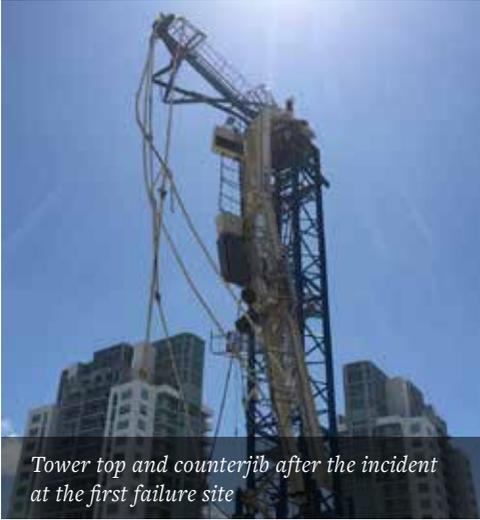
Tower top and counterjib after the incident at the first failure site

remained intact. The cause of the failure was the same in all three cases: the detachment of the crane jib from its turntable due to turbulent wind loads. Once the jib started falling, the two jib pendants were released. The forces on the tower top apex from the jib pendants decreased from the maximum to zero in a short amount of time. The two tower top columns toward the counterjib failed because of the transient load change on the tower top.

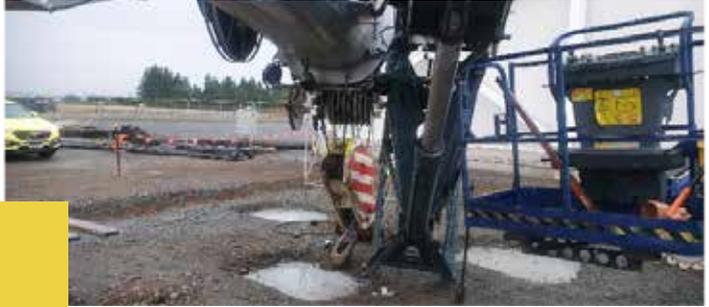
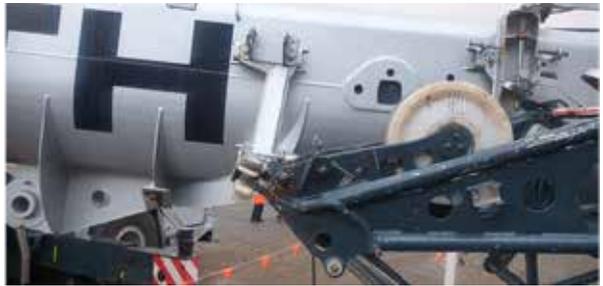
In early 2021, a Grove GMK-5130-2 with 28.5t counterweight complete with a 3.6m heavy duty ISS panel jib was being used to rotate and place concrete panels on a site in Christchurch, New Zealand.

The Operator started the process by removing the ancillary hook and rooster sheave. He then raised the deflection sheave, before slowly releasing the safety mechanism of the front connection. However, the Operating Instructions Lattice Extension for Grove was not referred to during the operation, resulting in several steps of the process being skipped. These steps included releasing the rear connection, swinging the ISS on to the main boom head, and pinning it to the right-hand side, before releasing the front connection.

Missing these steps resulted in the 825kg jib falling and crushing the operator against the top rail of the EWP.

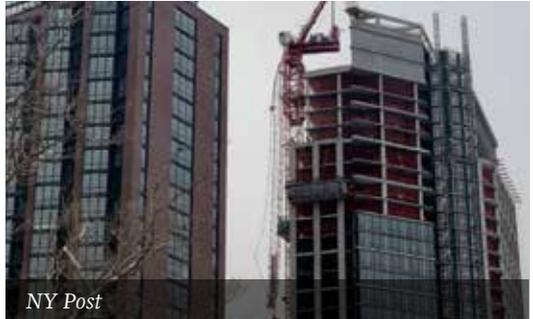
The jib of a Potain luffing tower crane dropped in February 2021 due to a failed luffing mechanism. The crane was located at the site of a 31-storey luxury high-rise development in Brooklyn, New York.

when the crane's boom experienced a partial collapse." It is estimated the portion of the crane that collapsed measured 175 feet (approx. 53m).

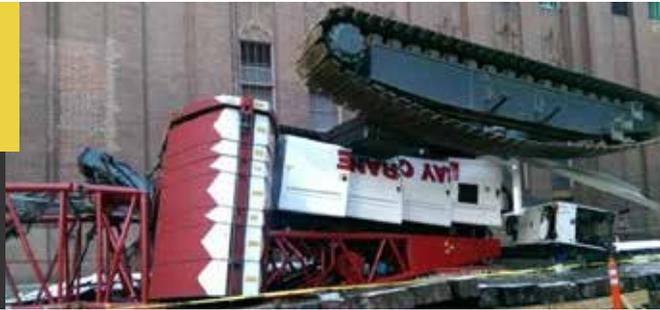
A Liebherr LR-1300 crawler crane collapsed in New York in February 2016, resulting in a fatality and multiple injuries. It had been positioned to replace generators and cooling towers on the roof of a 25-storey building.

Due to inclement weather conditions (high winds and snow), it was decided to lay down the 371ft luffing jib and 194ft boom. With the boom angle at 69.4° (less than the manufacturer's recommended 75°) and the luffing jib at 45° , the Operator began to lower the crane. The wind increased, flipping the boom and jib towards the ground, overturning the crane at 1800.

An investigation into the incident by the Occupational Safety and Health Administration (OSHA) found "the crane tipped over or overturned as it failed to remain stable under a decreasing boom angle and increasing wind". It was also found that the crane hirer was aware of impending weather conditions the day before the incident but did not take preventative action to stow/park the crane overnight. ■

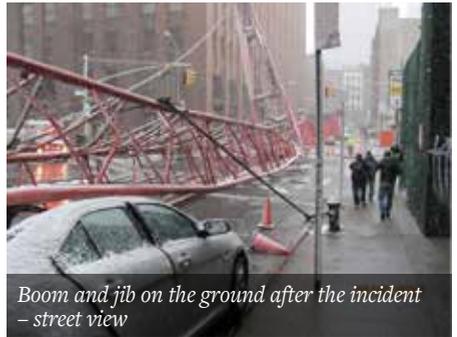
Boom and jib on the ground after the incident – street view

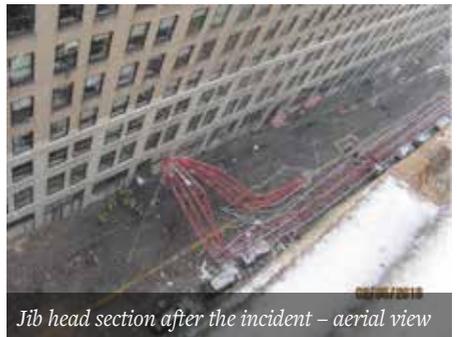
As it collapsed, the jib head hit several buildings causing damage. The boom of the crane fell onto a motorist's parked car resulting in a fatality of the owner standing nearby, and injuries to two others in nearby vehicles. The crane operator sustained minor injuries.

Jib head section after the incident – aerial view

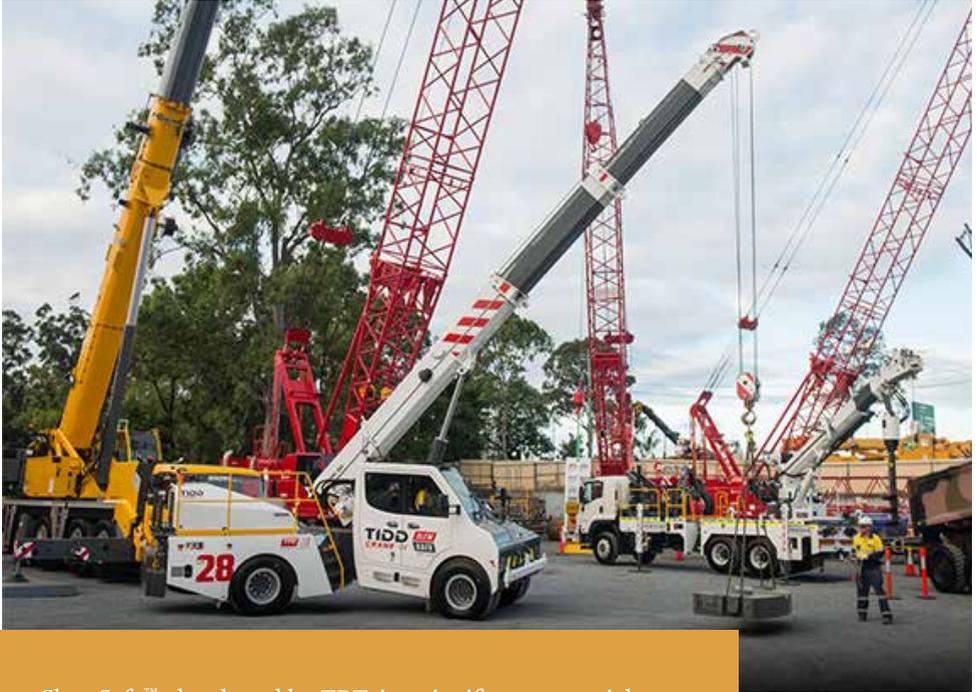
Slew Safe™, developed by TRT, is a significant new pick and carry safety feature. It is designed to minimise the risk of a crane rollover when the crane is lifting on uneven surfaces.

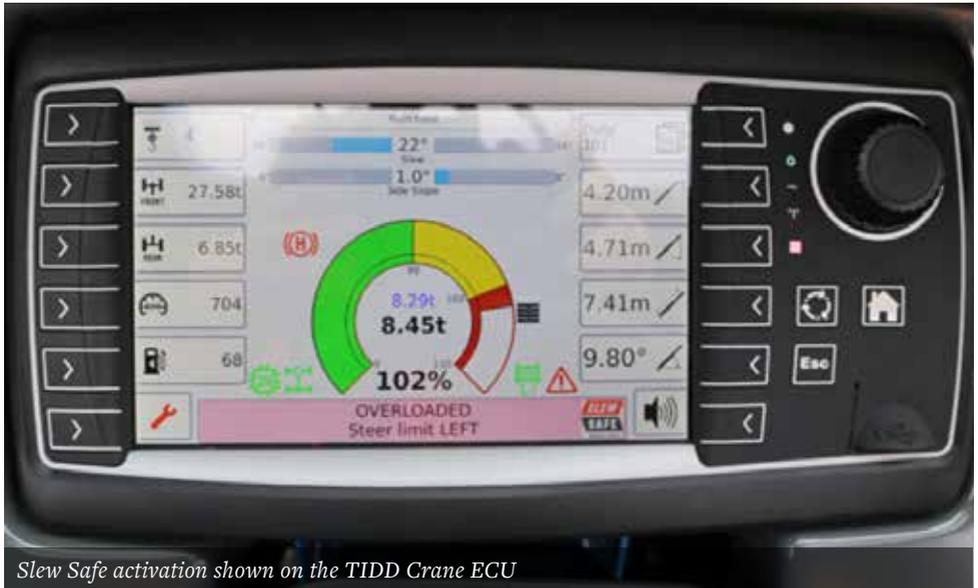
- Constant audible alarm both inside and outside the cabin to warn the operator and dogman of overload
-

In addition, the inbuilt LMI restricts operation in the unsafe direction allowing the operator to reconfigure the load or put the load down, causing them think about how to do it safely or do it another way (visually tracks and states on indicator 66% and 75% charts). This system cannot be overridden and will help prevent crane rollovers from occurring on sites across Australia.
