# DROPPED OBJECT

## Risk of Injury

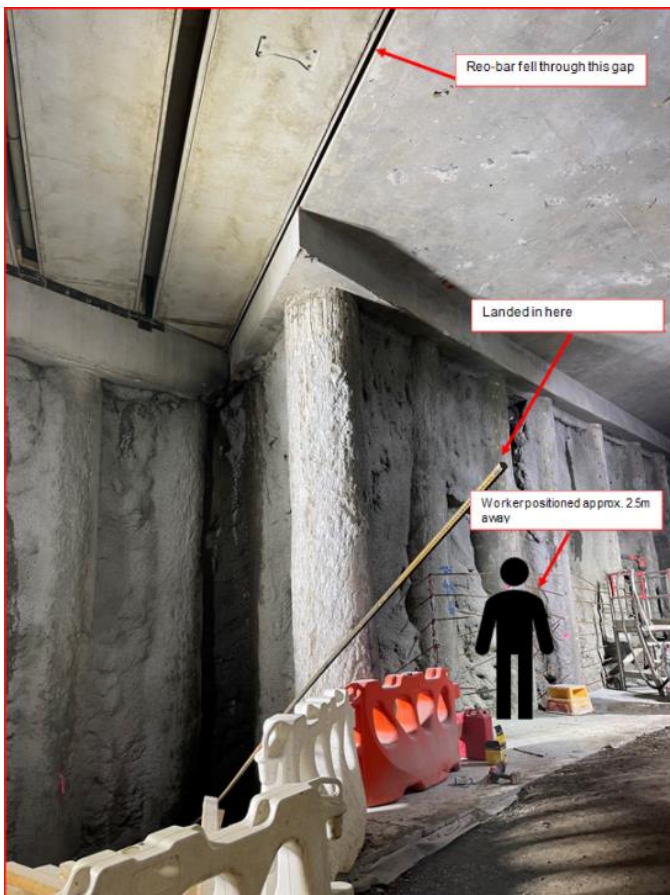
A length of reinforcement bar (6 metre x 24mm) rolled off a plinth through a 30mm wide gap and fell 6 metres to the ground below.

At the time a worker was around 2.5 metres away from where the bar landed. The worker was shaken but not impacted or injured.

The Safe Work Method Statement (SWMS) stated that all voids were to be covered.

Application of this control happened in part but not completely with one gap left exposed.

- The significant learnings to note are the importance of thorough work area inspections prior to the commencement of works, and verification of works at completion. In this instance, specifically the verification that all penetrations were covered prior to the work area being opened to workgroups.
- The SWMS identified the risk of dropped objects and associated controls (voids to be covered), however this control was not implemented in full as required.
- Supervisor and workers to ensure that works carried out in accordance with the SWMS.
- Ensure an adequate housekeeping regime to routinely remove disused construction materials from the work area.
