Detailed Site Investigation

Pieces 501 and 502 Gillman
208 Eastern Parade, Gillman
North Arm Road, Dry Creek
South Australia

Prepared for: Department for Infrastructure and Transport
Date: 3 June 2024
Reference: JC1406_DSI.03_FINAL
Version: 03

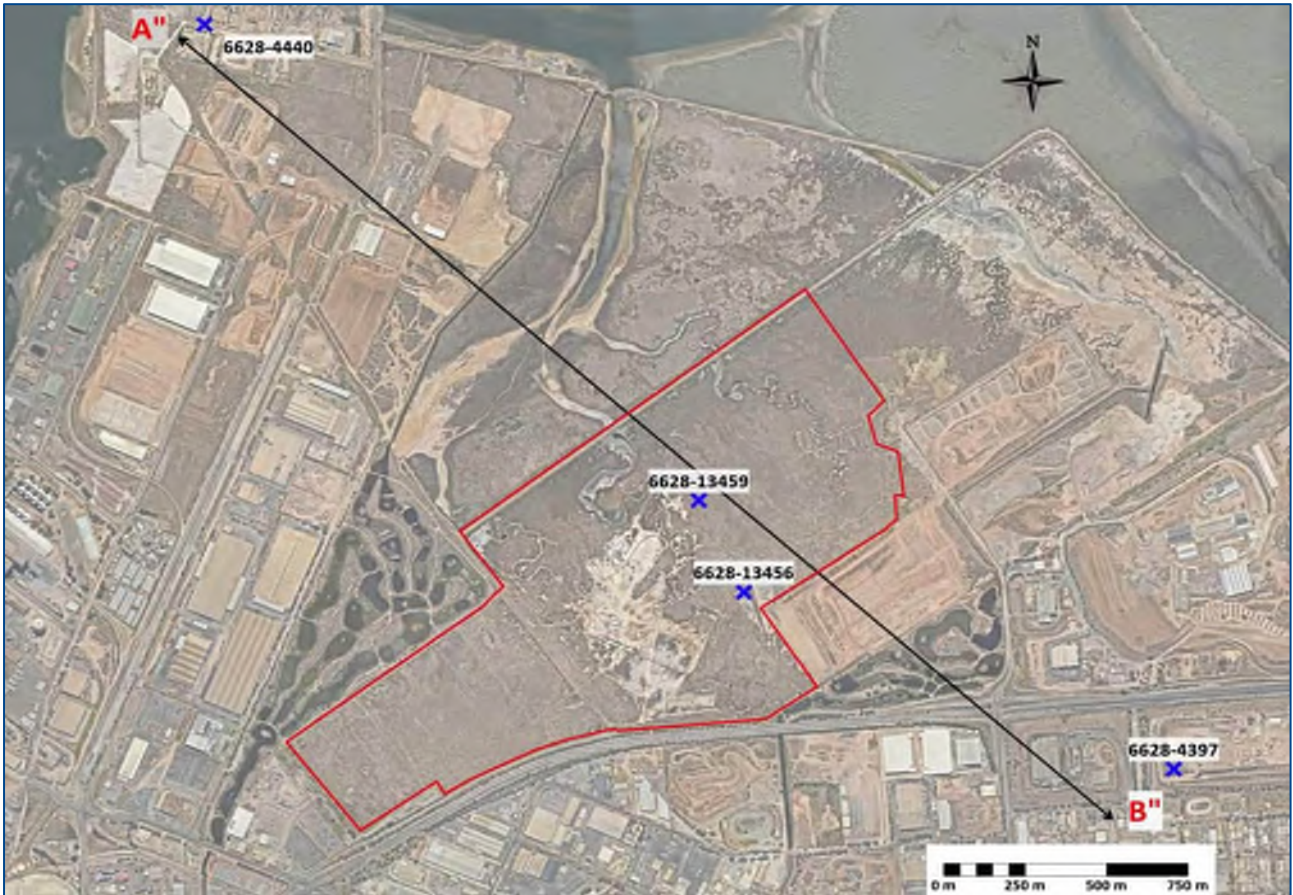
Figure 3: Site Location Relative to Historic Cross Section.

Past investigations have investigated the geology of the broader area, with the site captured between points A” and B” as shown on Figure 3. An indicative cross section shows that the geology of the site comprises Quaternary sediments representative of the St Kilda, Pooraka, Glanville and Hindmarsh formations (Figure 4; Belperio & Rice, 1989). The St Kilda and Glanville formations are similar and comprise silty fine-grained sands with shell debris and decomposed seaweeds. The Pooraka formation comprises sandy clay or clayey to sandy silt, with typically stiff clay. The Hindmarsh formation is predominantly a mottled red brown, yellow brown and grey, stiff to hard clay.

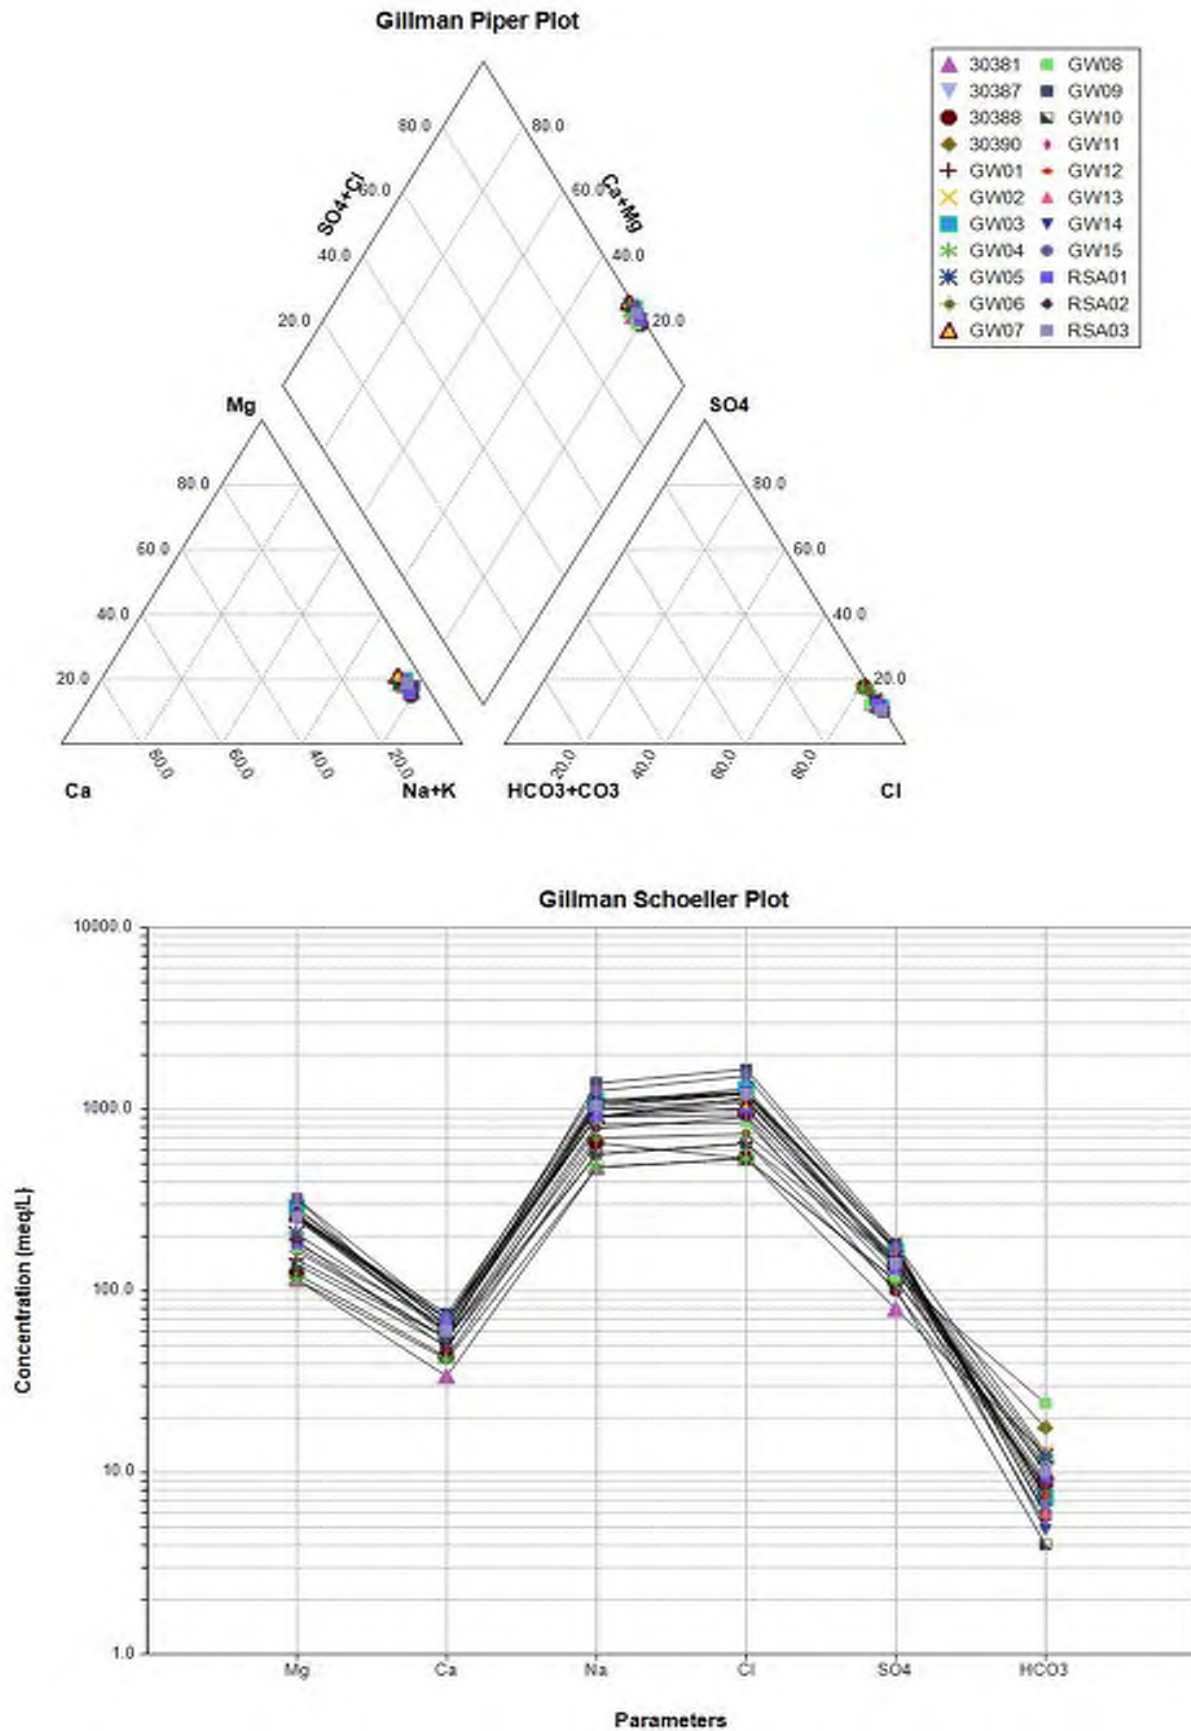
Figure 12: Piper and Schoeller Plots - Groundwater

indicating that the source of groundwater within the site area is of the same origin. Relatively parallel lines on the Schoeller plot demonstrate that the groundwater quality is likely influenced by freshwater recharge (e.g. rainwater) or evaporation, either of which would change the salinity of groundwater without significant alteration of the proportions of major ions.

Small variations between wells are noted in the proportions of HCO_3 relative to the other anions, which may indicate direct recharge is occurring in some locations as a HCO_3 may be derived from dissolved CO_2 . Small variations in the proportions of sulfate relative to the other anions is also apparent which may be due to the effects of ASS materials varying between locations. These minor variations do not change the overall signatures significantly due to the very high dominance of chloride and sodium ions.

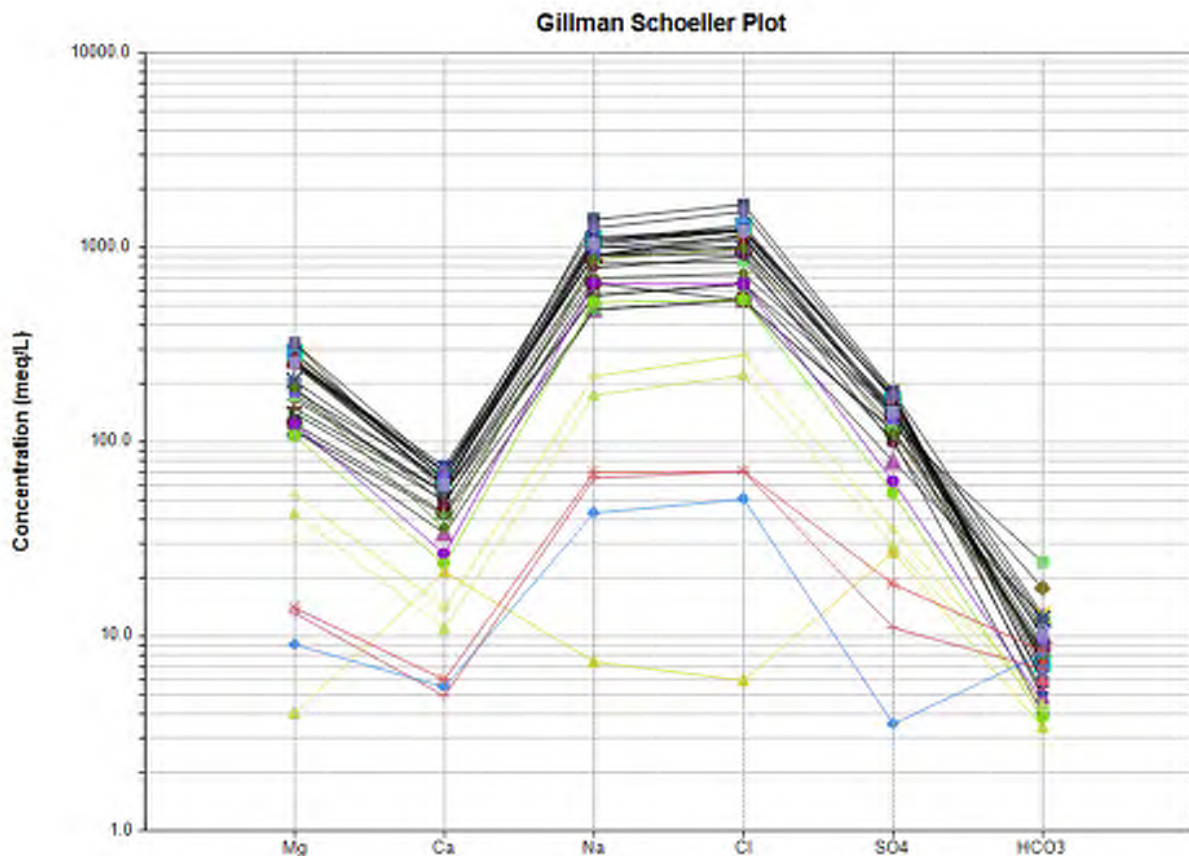
Figure 14: Piper and Schoeller Plots Combined Groundwater & Surface Water

Figure 14 present combined sets of surface water and groundwater signatures. With the exception of SW-5 explained above, all signatures show a consistency on the Piper and parallel lines on the Schoeller plot. This suggests that groundwater and surface water are interconnected with the surface water in the ponds receiving fresh water from stormwater discharges which does not alter major ion proportion significantly.

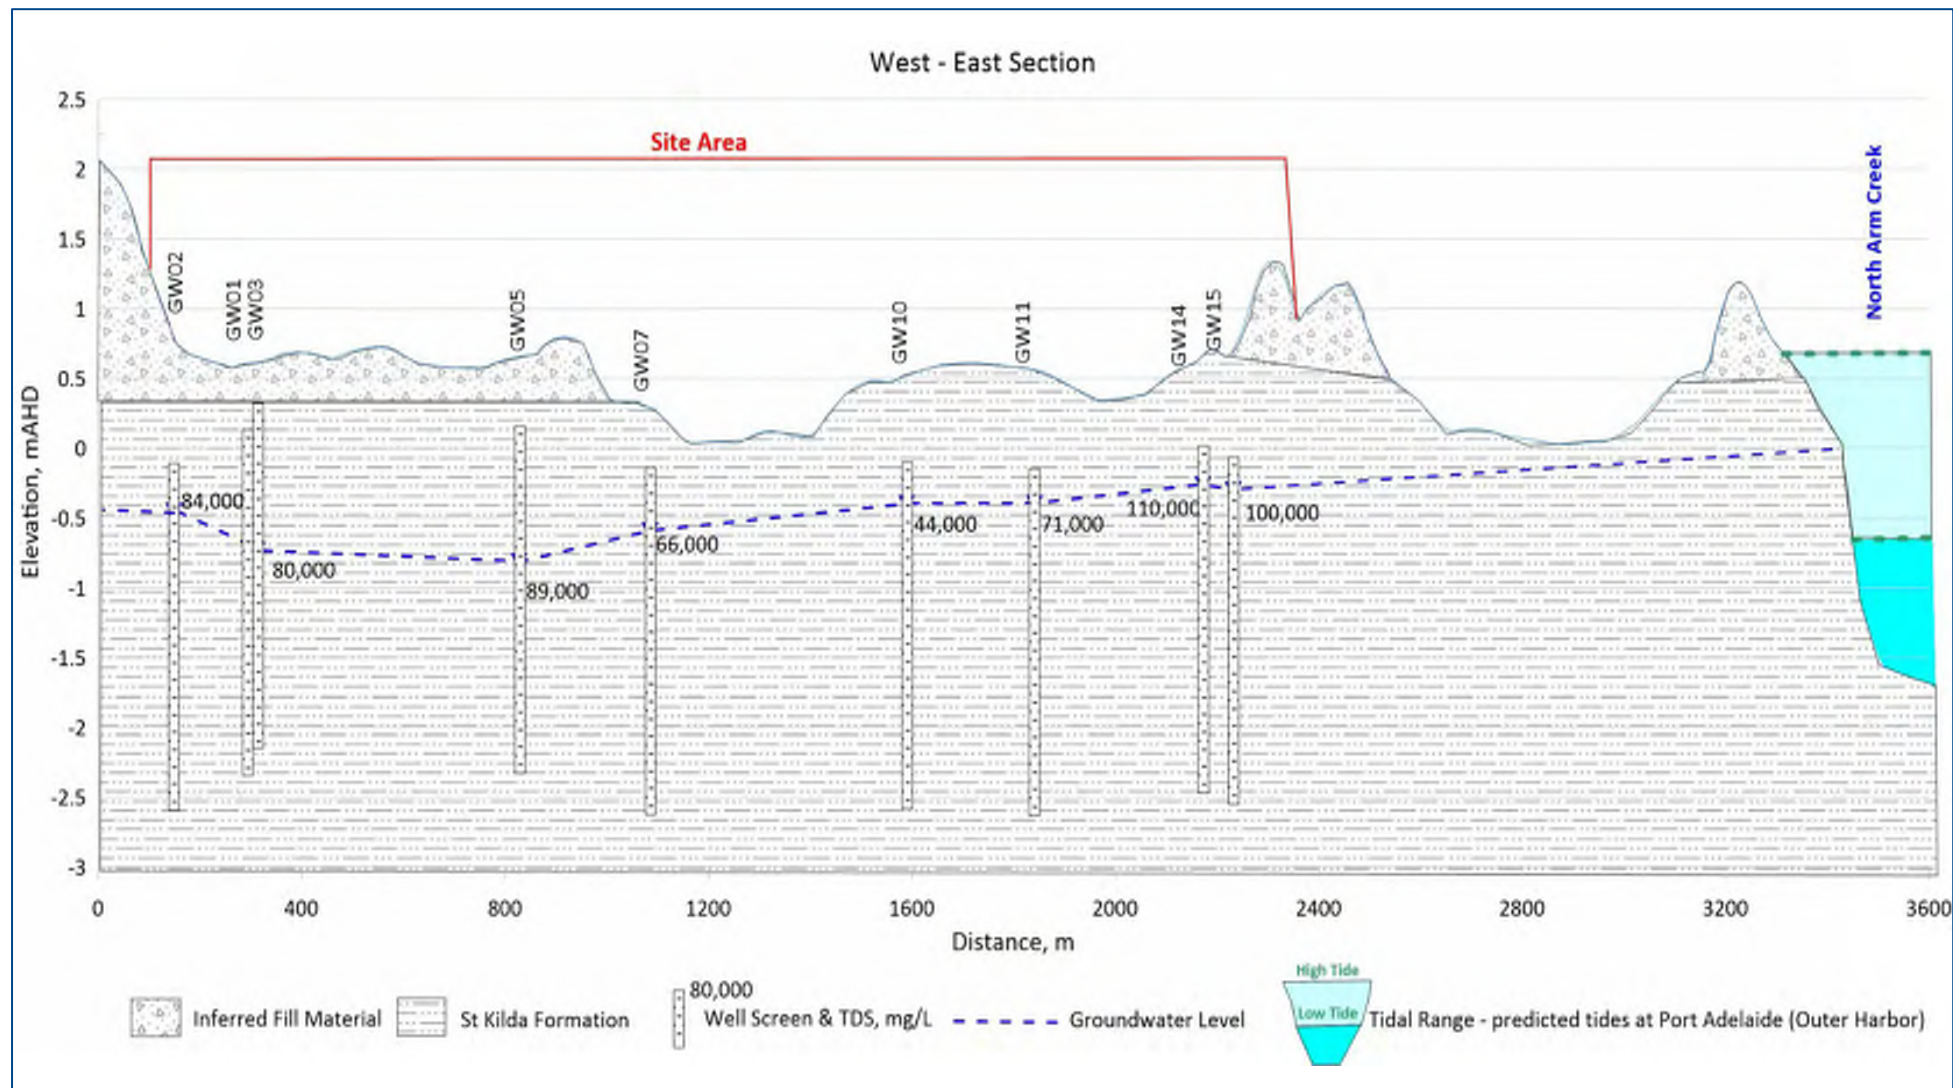
Figure 15: West-East Schematic Cross Section

A comparison of groundwater and surface water hydrochemistry as well as concentrations of chemicals of concern confirms some level of interaction and potential 'exchange' of chemicals. Seasonal surface water release and flooding in some parts of the site may result in infiltration and recharging groundwater, i.e. impacting on groundwater. On the other hand, during seasonal groundwater level rise groundwater may be exposed at the surface, causing some water logging and mixing with surface water causing surface water impacts. Additional investigations including water level gauging and sampling conducted during the wet season would improve the understanding of the surface water and groundwater interaction.
