SERIOUS INCIDENT ALERT

INCIDENT	Near Miss - Yanmar 5.5t Excavator – Projectile Dipper Arm Activator Pin
SUBJECT	Dipper Activator Pin flew off under pressure
INCIDENT DATE	23 rd April 2018
BUSINESS UNIT	Higgins Contractors - Wairarapa

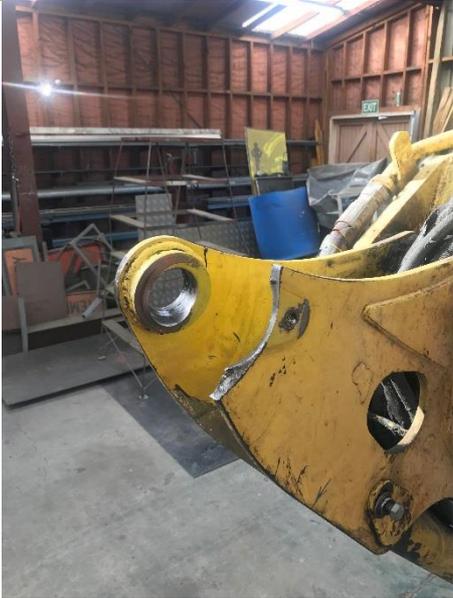
Fig 1.3

The dipper arm hydraulic cylinder pin assembly was not secured, the spacer had not been fitted to the flange of the pin assembly when the locking bolt and washer was fitted. This caused the locking bolt to come loose and fall out, followed by the pin assembly working its way out of the right hand side of the dipper arm.

Internal washer that must be present to ensure there is no slippage of bolt.

- Re-inspect all Excavator, check and confirm;
 - That all securing bolts and washer configuration are as Per manufacturer's instructions and not any another configuration.
 - Ensure Daily pre-starts are undertaken and include inspection of these securing bolts and reporting of any crack/damage/deterioration in the housing.
