# Road Structures Inspection Manual

## Part 2: Deterioration of Structures

Government of South Australia  
Department of Planning,  
Transport and Infrastructure

Department of Planning, Transport and Infrastructure, South Australia

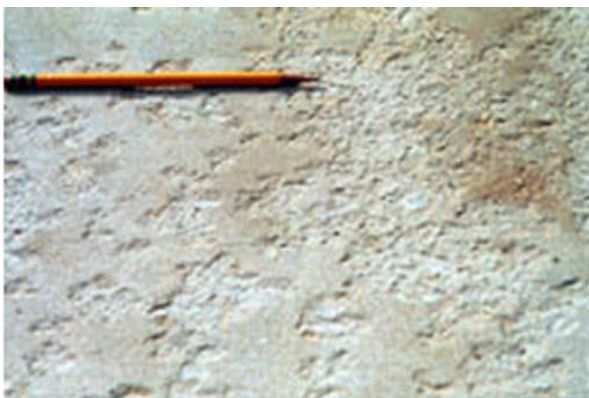
Scaling is the gradual and continuous flaking or loss of surface mortar and aggregate over irregular areas to a depth of approximately 5mm. It is prone to occur in poorly finished or overworked concrete where too many fines and not enough entrained air is found near the surface.

Scaling is distinguished from spalling (refer Section 1.2.5) due to the difference in concrete depth affected – scaling is rather superficial, whereas spalling extends through the entire cover to the reinforcement (and possibly deeper). It is most commonly found on horizontal surfaces exposed to the weather and to traffic, in splash and tidal zones near the ground line, but can also be present elsewhere.

Figure 1: Concrete scaling

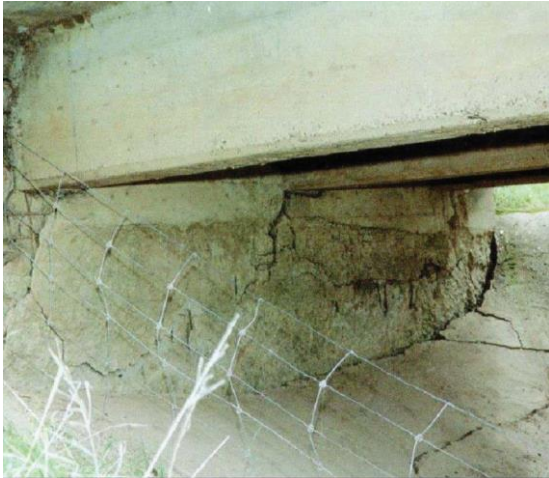
Disintegration is the physical deterioration or breaking down of the concrete into small fragments or particles. The deterioration usually starts in the form of scaling and, if allowed to progress beyond the level of very severe scaling, results in disintegration.

Figure 2: Disintegration of concrete

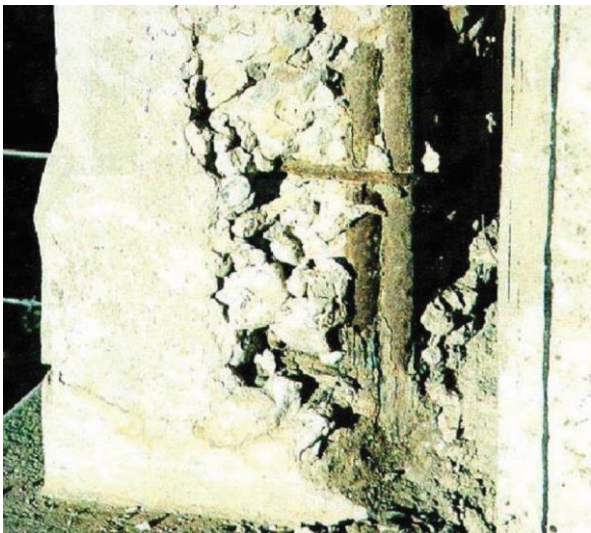
Corrosion is the deterioration of reinforcement by the process of oxidation. Corrosion can also occur in the presence of high Chloride ion concentration such as when the concrete is immersed in sea-water or exposed to salt-spray. Corrosion may appear as a rust stain on the concrete surface initially. In the advanced stages, the surface concrete above the reinforcement can crack, delaminate and spall-off exposing the underlying reinforcement.

Figure 3: Corrosion of reinforcement in concrete

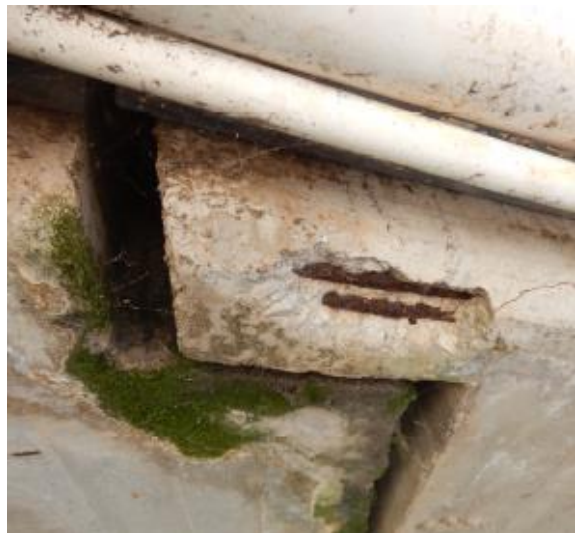
Figure 4: Corrosion of reinforcement in concrete

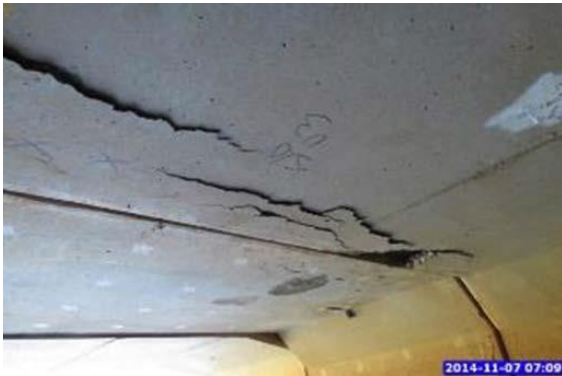
Delamination is defined as a discontinuity in the surface concrete which is substantially separated but not completely detached from the main mass of concrete. Visibly, the concrete may appear to have a solid surface, however, the delamination can be identified by the hollow sound if the concrete is tapped with a hammer. Delamination commonly begins with the corrosion of reinforcement and subsequent cracking of the concrete and normally occurs in the plane of the reinforcement parallel to the exterior surface of the concrete. It can also result from impact and from crushing that occurs when two concrete components come into contact.

Figure 5: Delamination in culvert slab

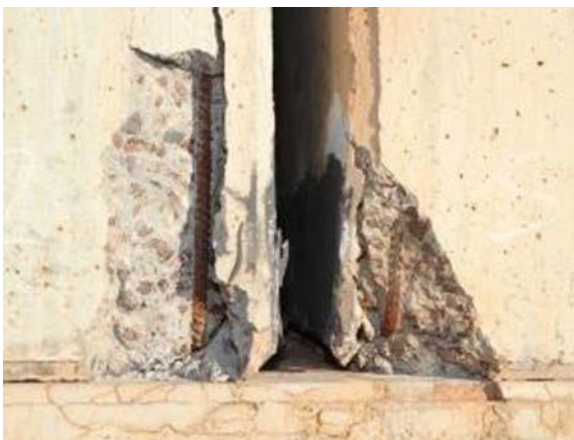
A spall is a fragment, which has been detached from a larger concrete mass. Spalling is a continuation of the delamination process in which the pressure exerted by the corrosion of reinforcement results in complete separation of the delaminated concrete.

Figure 6: Spalling of concrete at ends of deck units

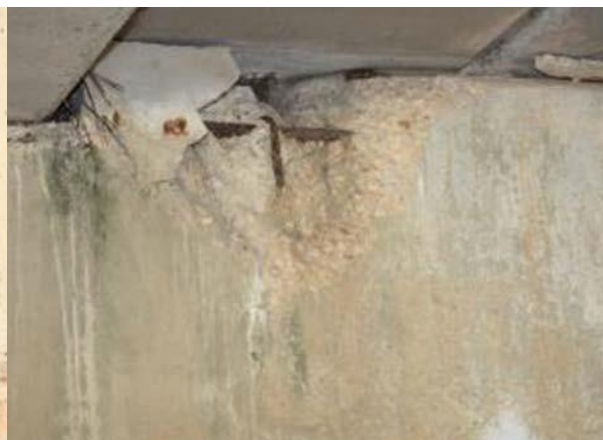
Figure 7: Spalling to front face of headstock

- Failure in the bridge foundations, due to settlement, sliding or rotation, is often manifested as cracking, differential movement or other defect in the substructure. Such movements may be displayed as abnormal clearances between the abutment ballast wall and the end of the deck, or as out-of-range movements at the expansion joints or bearings.
- Settlement of embankments may affect the substructure, appearing as depressions in the road surface adjacent to the structure or as discontinuities in the kerb line.
- Seized or locked bearings can transfer unexpected forces into the bearing shelf resulting in spalling to the front face of the headstock or bearing shelf.

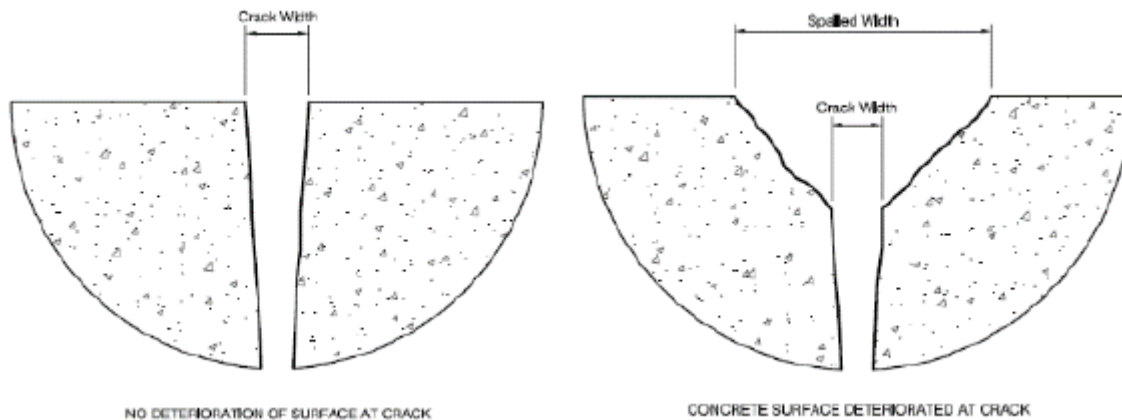
When the concrete surface around a crack has spalled, it is important to ensure that the actual crack width is measured rather than the spalled width as shown:

Figure 9: Accurate measurement of crack width

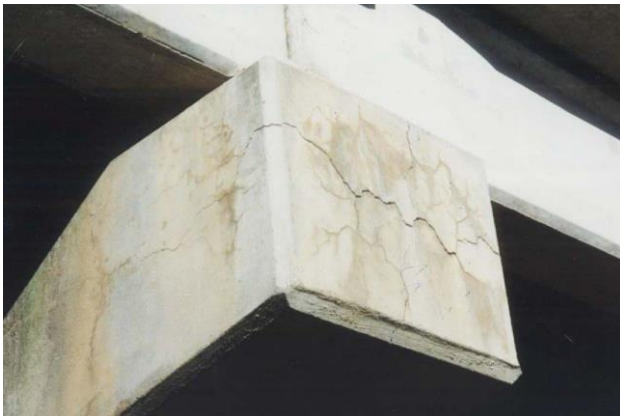
Some aggregates react adversely with the alkalis in cement to produce a highly expansive alkali-silica gel. The expansion of the gel and aggregates under moist conditions leads to cracking and deterioration of the concrete. The cracking occurs through the entire mass of the concrete. AAR is generally slow by nature, and the results may not be apparent for many years. They also require the juxtaposition of three contributing factors: reactive silica in the aggregate, moisture and significant alkalinity.

AAR can be difficult to recognise and identify. AAR cracks can appear similar to other causes of cracking but its closeness can result in pattern type cracking and therefore be more severe for the bridge.

Figure 10: Concrete affected by alkali aggregate reaction (AAR)

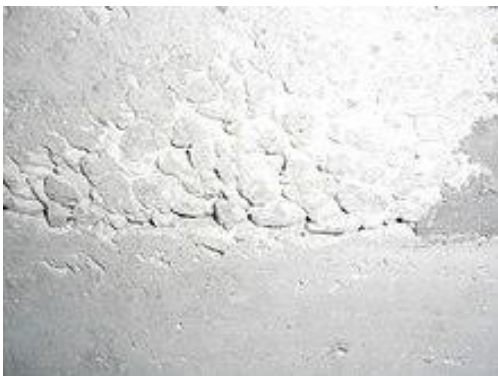
Segregation is the differential concentration of the components in fresh concrete resulting in variable composition. For example, when concrete is allowed to fall from a height of more than 2m, the coarse aggregate may settle to the bottom of the fresh concrete mass leaving an excess of the fine particles at the upper part of the mass.

Other causes of segregation are poor mix design or if closely spaced reinforcing bars prevent the uniform flow of concrete.

Figure 11: Concrete segregation

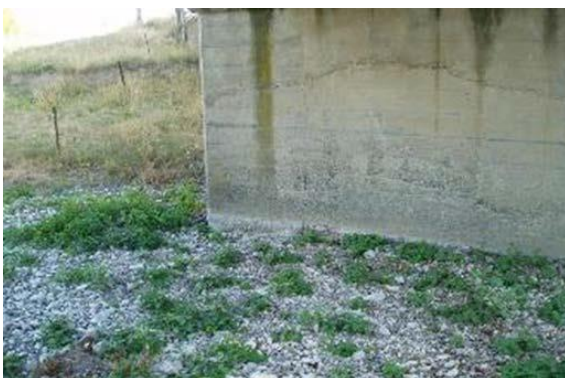
Cold Joints are produced if there is a delay between the placement of successive deliveries of concrete, and if an incomplete bond develops at the joint due to the partial setting of concrete in the first pour.

Figure 12: Cold joints in abutment wall

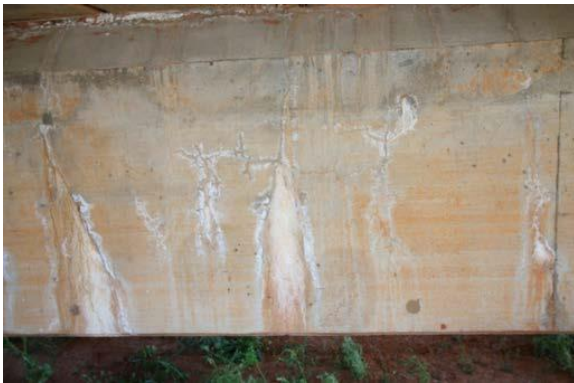
- efflorescence - a deposit of salts, usually white and powdery efflorescence (calcium carbonate)
- exudation - a liquid or gel-like discharge through pores or cracks in the surface
- encrustation - a hard crust or coating formed on the concrete surface at cracks
- stalactite – in extreme cases, a downward pointing formation hanging from the concrete surface, usually shaped like an icicle and made from salts in the concrete.

Figure 13: Efflorescence evident on concrete headstock

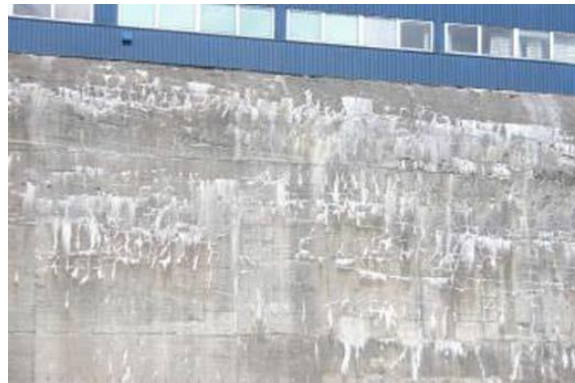
Figure 14: Discharge through cracks in concrete surface

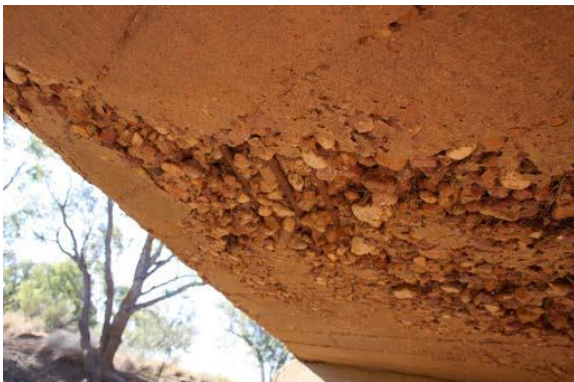
Honeycombing is caused by the improper or incomplete vibration of the concrete which results in voids being left in the concrete where the mortar failed to completely fill the spaces between the coarse aggregate particles.

Figure 15: Concrete honeycombing

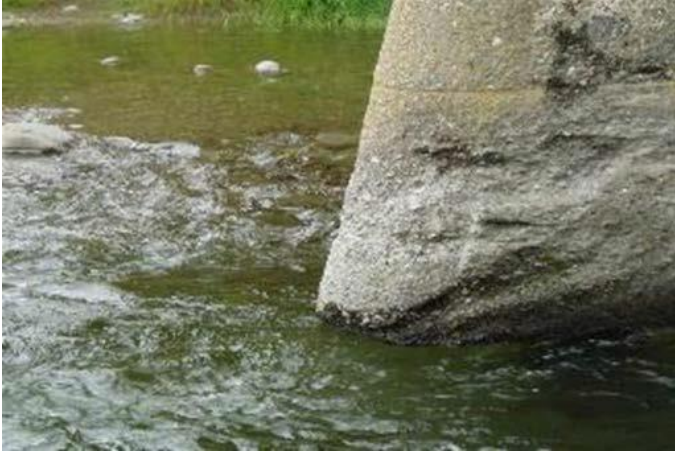
Erosion is caused by the abrasive action of flowing water (or other liquids present), or more particularly, by the action of abrasive materials (e.g. suspended sand and other debris) carried in the water. Erosion due to water wash is generally an indication that the concrete is not durable enough for the environment in which it has been placed. Erosion damage to concrete will significantly reduce the overall durability, as it reduces the effective concrete cover.

Figure 16: Erosion of concrete due to water wash

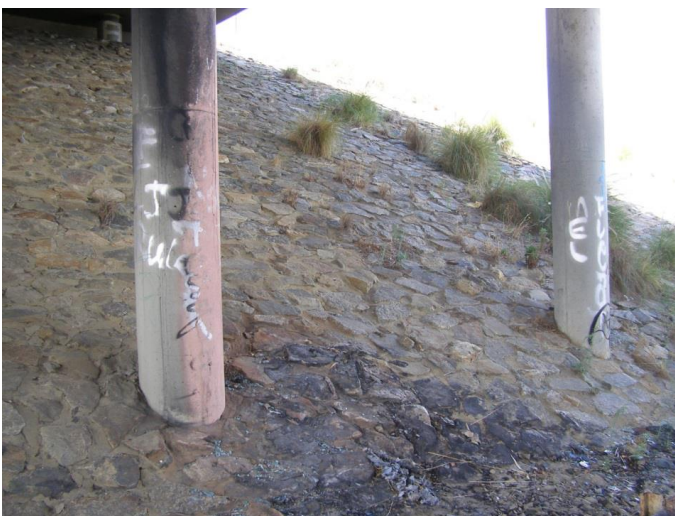
Concrete structures can sustain damage when exposed to fire depending on the duration and intensity. The effects of high temperature fires on concrete structures can include:

- reduction in compressive strength
- reduction in modulus of elasticity
- micro-cracking within concrete matrix
- spalling of concrete
- loss of bond between steel and concrete
- possible loss of residual strength of steel reinforcement and/or loss of tension in prestressing tendons.

Figure 17: Fire damage to concrete column

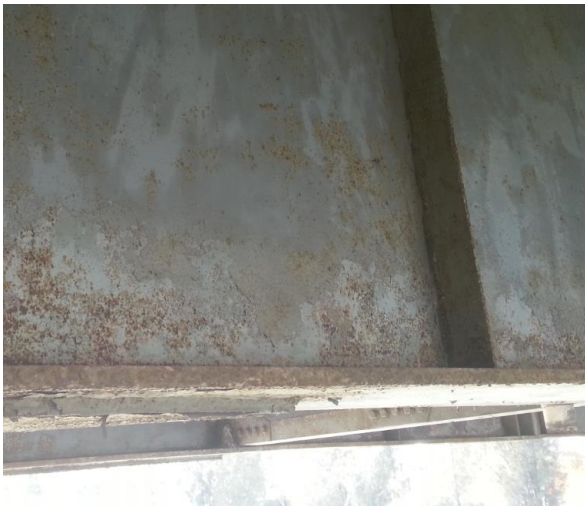
Light corrosion can be identified as small reddish brown spots and occurs on steelwork when the existing protective coating is lost.

Figure 18: Light corrosion on steel work and loss of protective coating

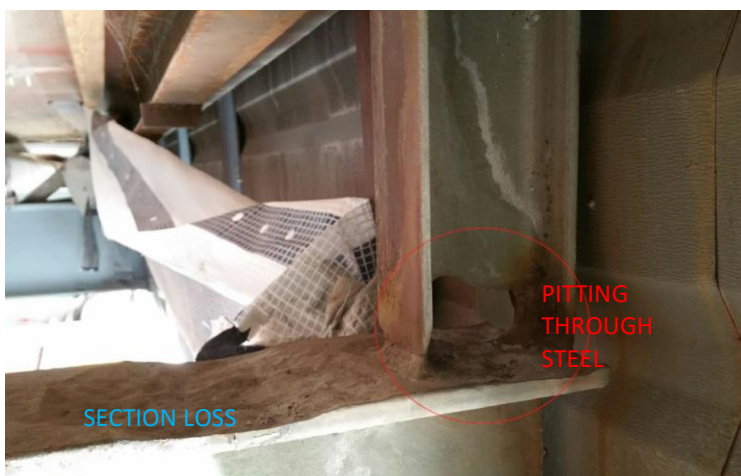
Pitting corrosion can be identified as holes and cavities and is caused by localised corrosion. This generally progresses from light corrosion spots on steelwork or is due to localised water ponding or exposure.

Section loss can be identified as uniform area of steelwork with noticeable cross sectional loss. This may occur when the section of steel work has lost its protective coating exposing the steel surface area to environmental conditions.

Figure 19: Section Loss and Pitting Through Steel

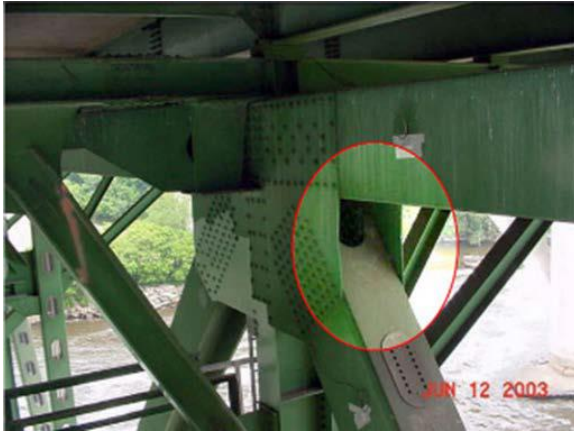
Permanent deformation of steel members can take the form of bending, buckling, twisting or elongation, or any combination of these. Permanent deformations may be caused by overloading, vehicular collision, foundation settlement or inadequate or damaged intermediate lateral supports or bracing.

Figure 20: Buckling of gusset plate

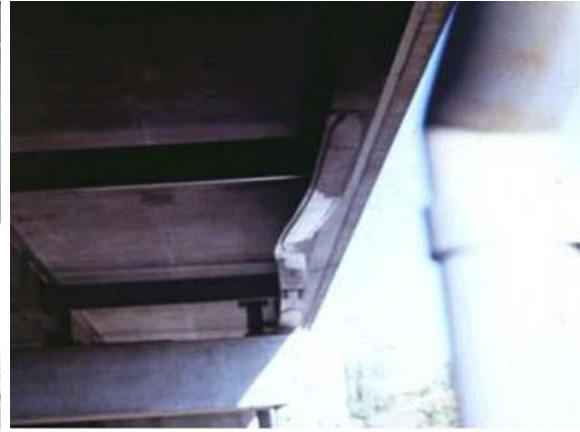
Permanent bending deformation generally occurs in flexural members in the direction of the applied loads. However, vehicular impact may produce permanent bending deformation in any member.

Figure 21: Impact damage to steel beam

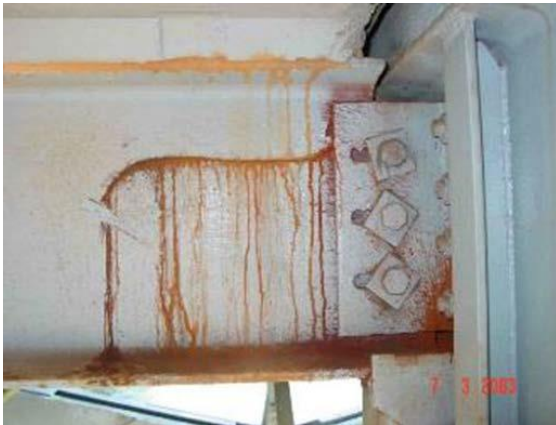
Fatigue failure is the most common cause of cracking and fracture of steelwork structures. Fatigue is the process by which a structural member or element eventually fails after repeated applications of cyclic stress. Failure may occur even though the maximum stress in any one cycle is considerably less than the fracture stress of the material. Characteristically, a fatigue fractured surface displays two distinct zones: a smooth portion indicating stages in the growth of the fatigue crack, and a rough surface, which represents

Figure 22: Fatigue cracking in web

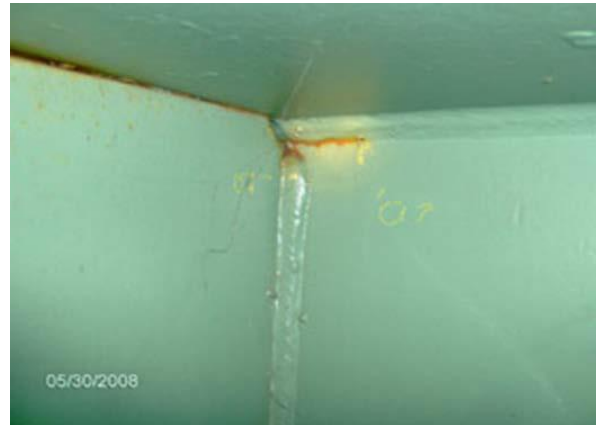
Figure 23: Cracking in welds

Fatigue starts with fabrication flaws or at locations with high surface stress concentrations such as weld toes, irregular cut edges and flame cut edges. It then proceeds through the growth of these flaws until a final failure mode, such as brittle fracture or buckling, occurs. The initial fabrication flaws may be large or small but in many cases are too small to be detected by eye.

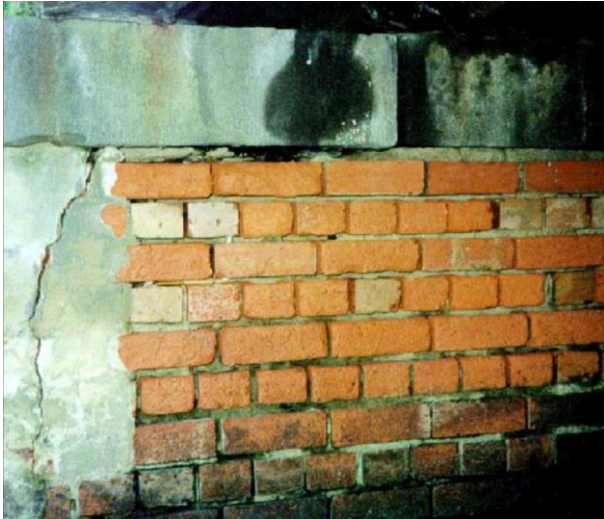
Loss of mortar is the result of the actions of water wash, plant growth or softening by water containing dissolved sulphates or chlorides. Partial disintegration of mortar may lead to loss of stone blocks.

Figure 27: Loss of mortar

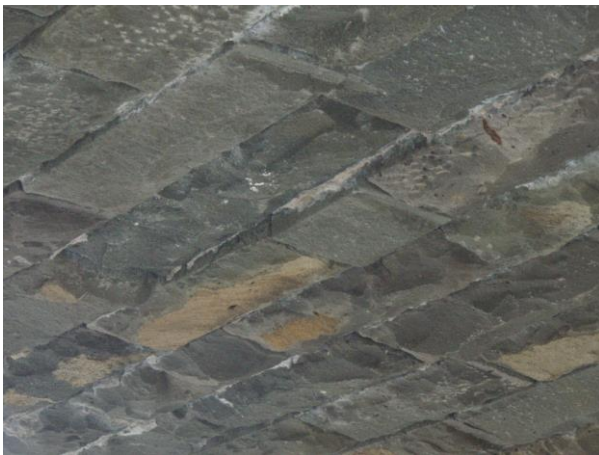
Ground or foundation movement or severe vibration can cause stone blocks to displace and drop relative to other stones in an arch. This can also be exacerbated if the quality of the stones or mortar is poor and failing.

Figure 28: Dropping of arch masonry block

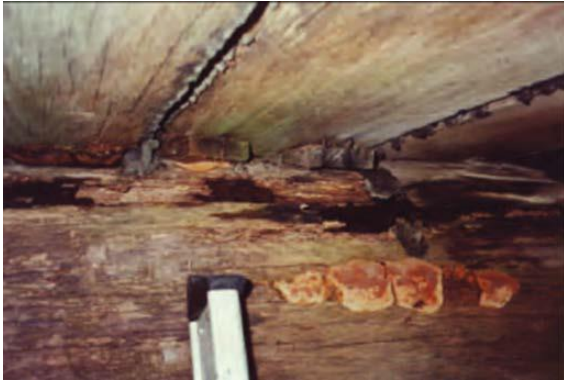
Once established and provided that favourable conditions prevail, the decay fungi continue to grow at an accelerating rate. Depriving the fungi of any one of the required conditions will effectively curtail the spread of decay. Wood that is kept dry or saturated will not rot. Moisture change can affect decay indirectly because drying often leads to surface checks, which may expose untreated parts of timber or create water trapping pockets. Proper preservative treatment effectively provides a toxic barrier to the fungi's food supply, thus preventing decay.

Figure 29: Fungal fruiting body and decay of girder

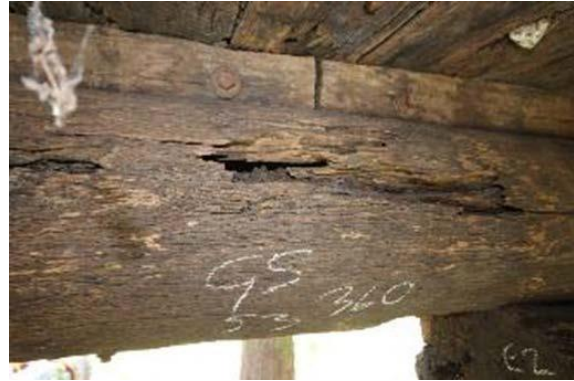
Figure 30: Decay pocket in girder

The most common rotting areas in timber bridges are internally in log girders, corbels, headstocks and piles (piling), and in sawn decking at the exposed ends and interface with kerbs. Decay is often more pronounced at the ends of members.

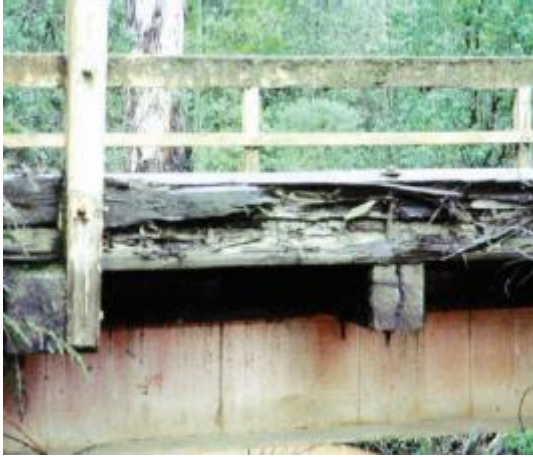
Figure 31: Termite attack

Well-established termite attack usually degrades timber much more quickly than fungi, but it is rare for termite attack to occur in durable hardwoods normally used in bridge

construction without some pre-existing fungal decay. This decay accelerates as the termites extend their galleries through the structure, moving fungal spores and moisture about with their bodies. Hence, although most of the material removed by termites has already lost its structural strength because of decay, the control of termites remains an important consideration.

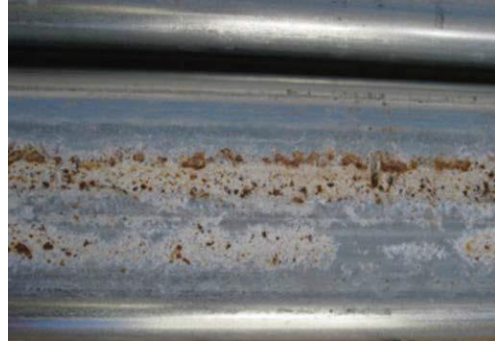
Figure 33: White deposit on zinc metal spray

The cause of any white deposit on the surface of paint over zinc metal spray should be investigated as it may be zinc hydroxide (formed by reaction of zinc with water and air), which is the first sign of the zinc coating breaking down. If left untreated corrosion of the zinc will become extensive.

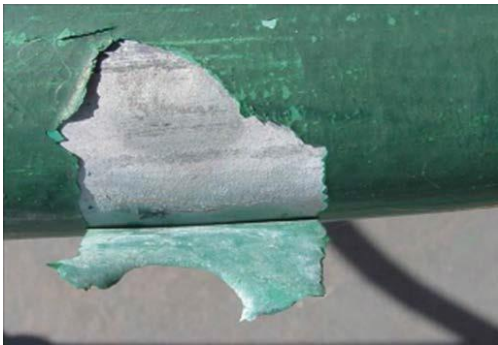
Figure 34: Failure of paint system over galvanising

Breakdown of paint over galvanising is often due to the poor adhesion of a wrongly selected paint system.

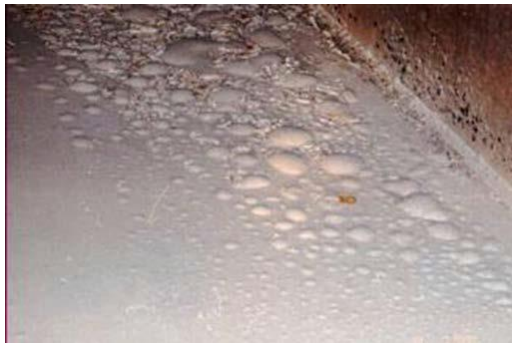
Figure 35: Blistering of paint system

- Blistering - generally caused either by solvents which are trapped within or under the paint film, or, by water which is drawn through the paint film by the osmotic forces exerted by hygroscopic or water soluble salts at the paint/substrate interface. The gas or the liquid then exerts a pressure stronger than the adhesion of the paint.

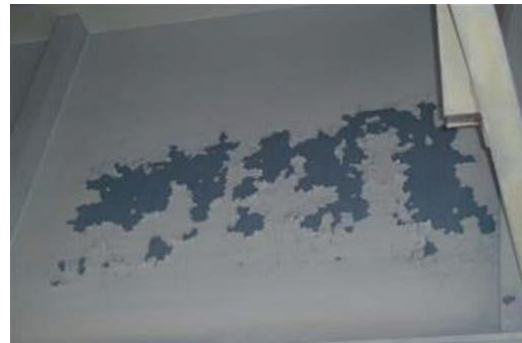
Figure 36: Flaking of paint system

- Flaking - flaking or loss of adhesion is generally visible as paint lifting from the underlying surface in the form of flakes or scales (refer Figure 36). If the adhesive strength of the film is strong then the coating may form large shallow blisters. Causes include:
