Department for Transport,  
Energy and Infrastructure

# **ROAD MANAGEMENT PLAN**

**Golden Grove Road  
North East Road to One Tree Hill Road**

**DECEMBER 2010**

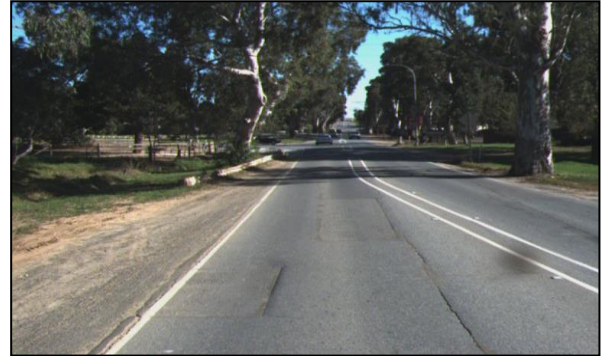
#### One Tree Hill Road to The Grove Way

- Typical 6.2m sealed carriageway
- No kerbing, unsealed shoulders
- No bicycle lanes
- Large trees close to the edge of sealed carriageway
- Some road junctions with various level of junction treatment

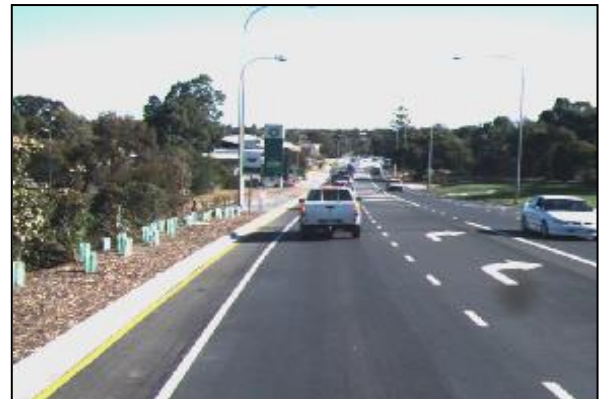
#### The Grove Way to Grenfell Road (east)

- Typical 6.2m sealed carriageway
- No kerbing, unsealed shoulders (apart from recent works around Park Lake Drive)
- No bicycle lanes
- Large trees close to the edge of sealed carriageway
- Some road junctions with various level of junction treatment

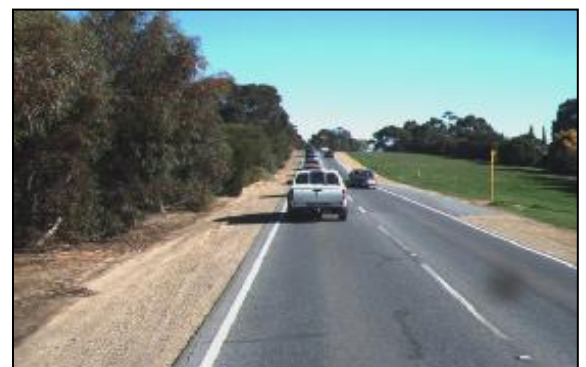
#### Grenfell Road (east) to North East Road

- Covers a distance of 2.6 km
- The road cross-section is 18.8m wide, which involves a divided section with two lanes in each direction, with the road crossing the Dry Creek watercourses

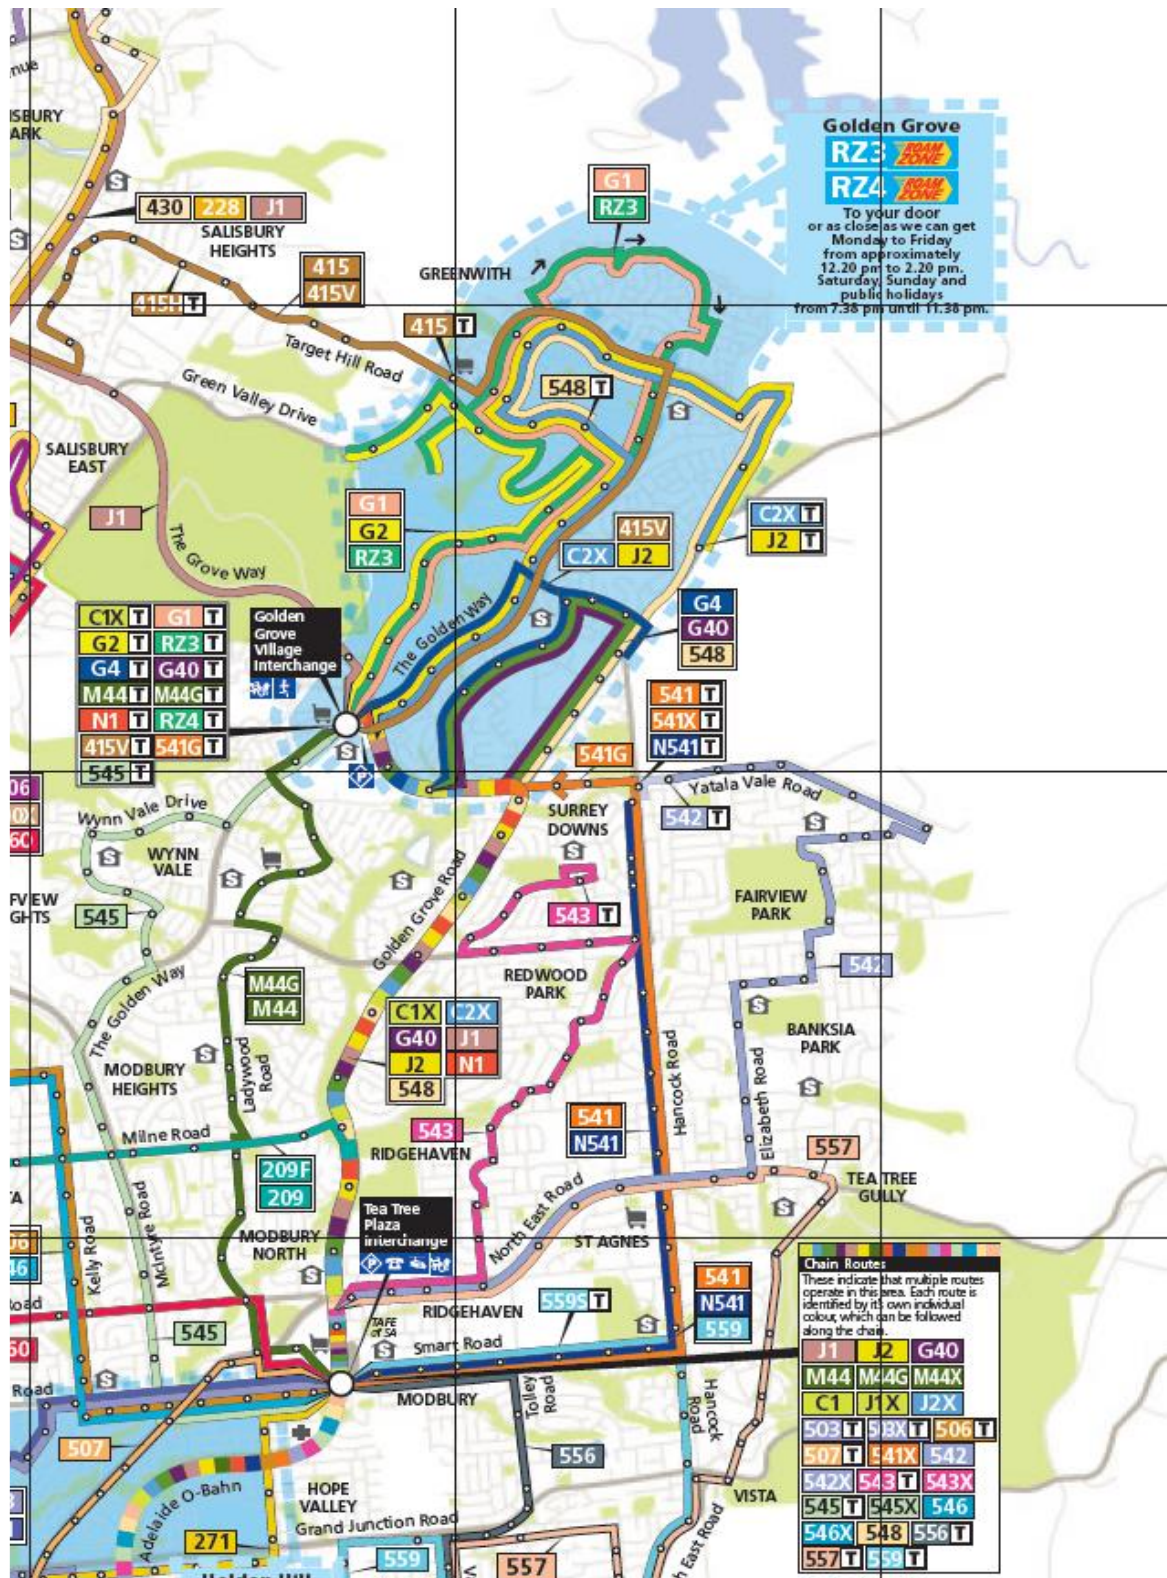
Figure 6.2: Bus routes present on Golden Grove Road - 2010

A number of bus routes use Golden Grove Road. In order to provide an uninterrupted traffic lane, bus stops should be indented.

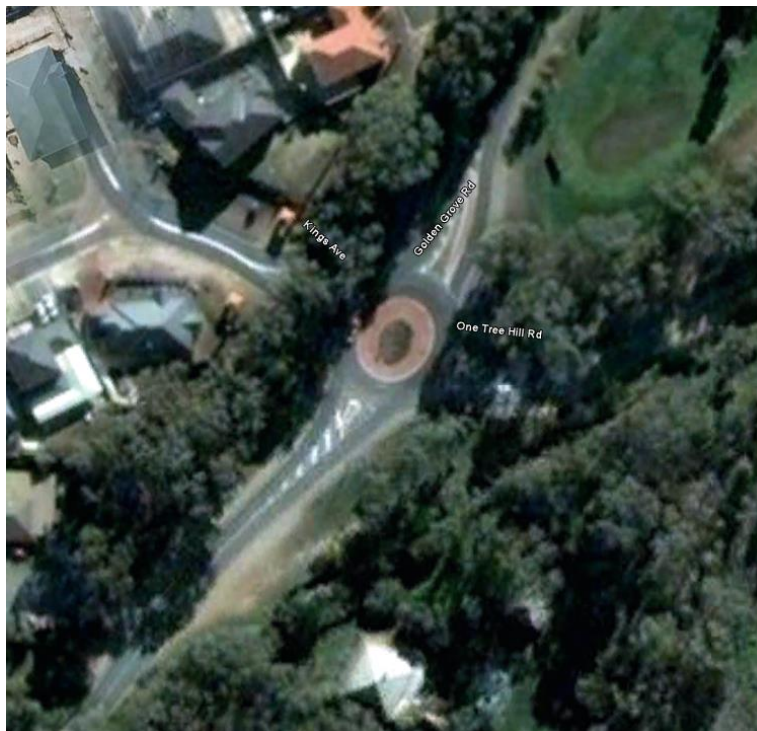
Figure 7.1: Golden Grove Road / One Tree Hill Road Intersection

A site inspection was undertaken which considered the data identified in the crash analysis. The recommended treatments at this location include undertaking an analysis of the existing skid resistance of the current road pavement, especially on the southern approach, and taking appropriate remedial action as required (e.g. asphalt overlay).

To warn motorists to the presence of the roundabout, especially those on the northern approach, consideration should be given to improving the existing signs.

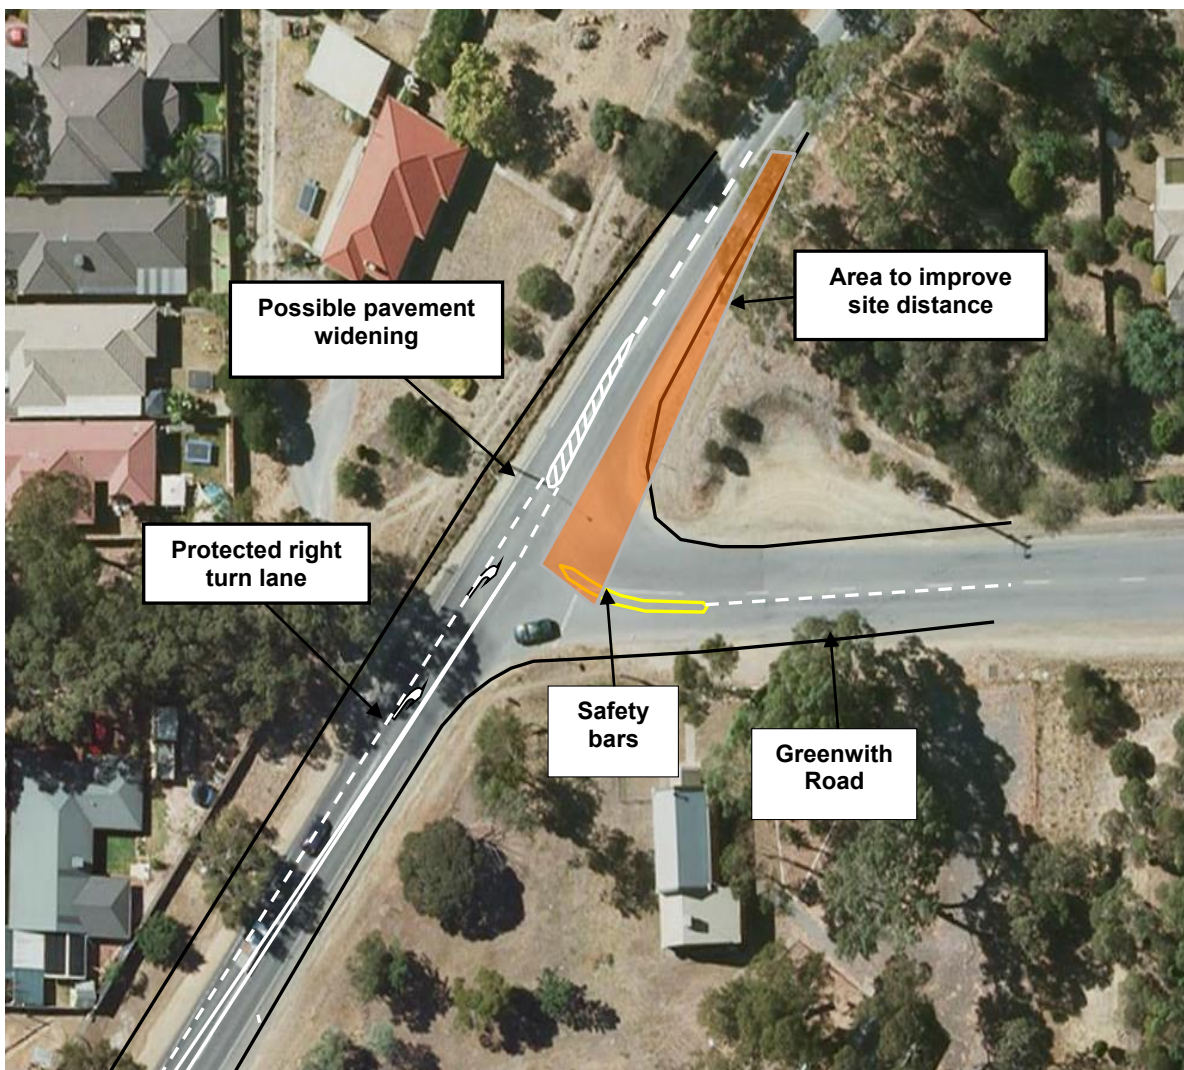
Figure 7.3: Current plans for Golden Grove Road / Greenwith Road Intersection

For continuity in the road layout for drivers, it is considered appropriate to upgrade the junction to include a protected right turn lane as per the recommended treatment in this RMP (refer Figure 5.1). However given the low number of recorded crashes at this junction, such a treatment would be considered a low priority.

In addition to this, the embankment on the north eastern side of the junction could be removed to improve site distance to and from the northern approach.

In the shorter term, consideration will be given to installing improved delineation for the Greenwith Road leg, including separation of the lanes on Greenwith Road with safety bars in the centre of the road and investigate the need for a STOP sign on this leg.

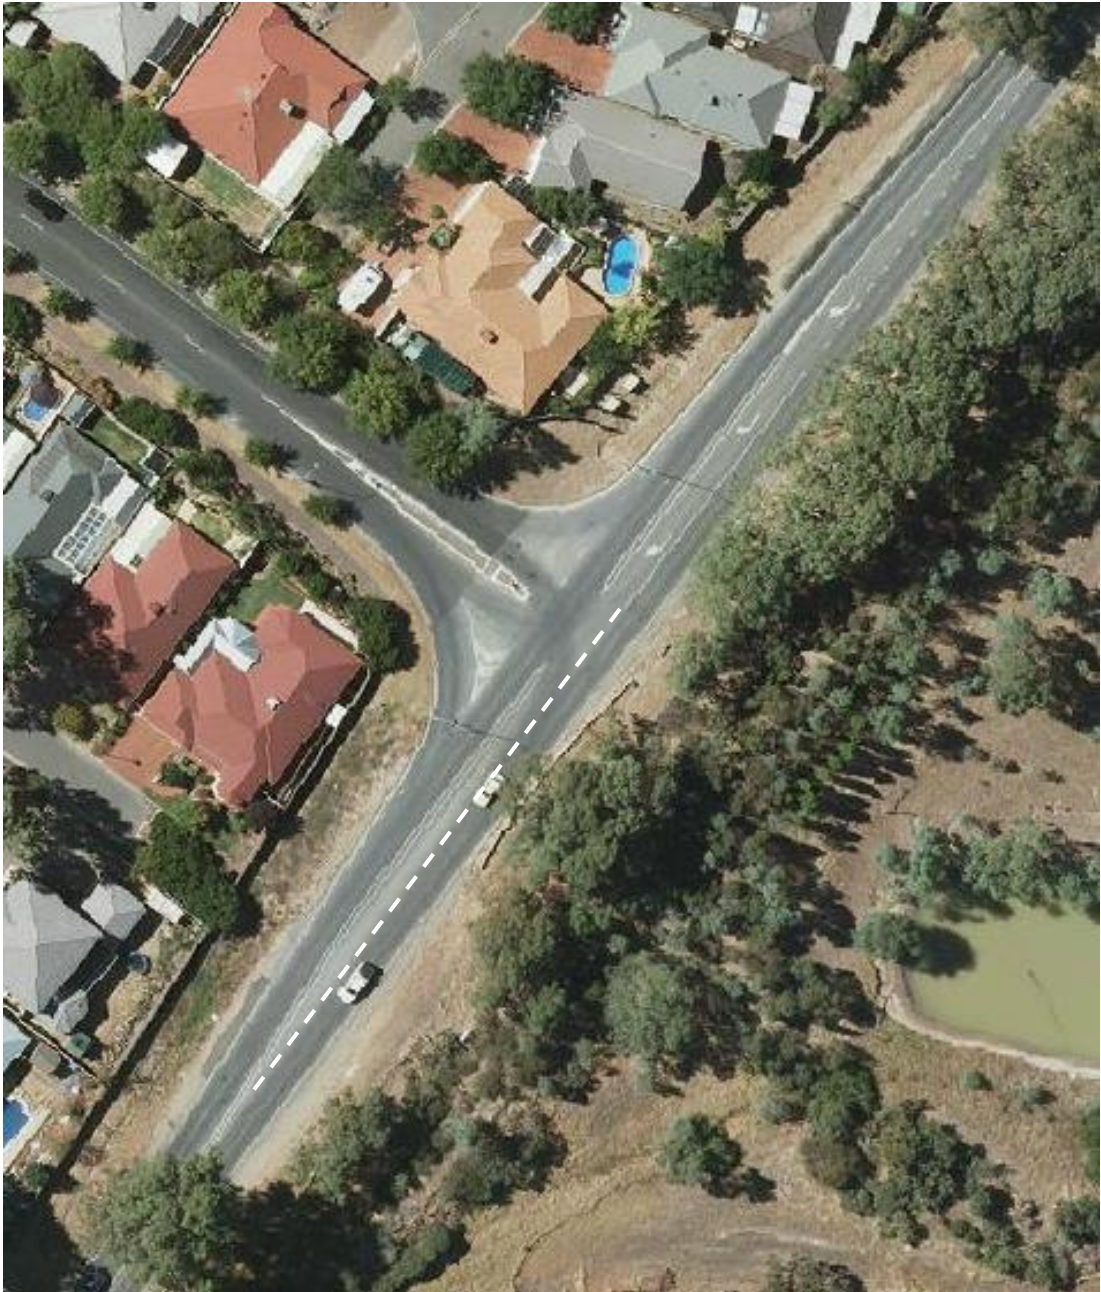
**Figure 7.4: Current plan for John Road junction**

At the time of the site inspection, the linemarking at the junction required maintenance to improve the delineation through this location (refer Figure 7.4). Linemarking maintenance is generally undertaken through a cyclical program, with Golden Grove Road programmed to be revisited every 2 years. The road is scheduled to receive maintenance work in the first half of 2011.

There may be some benefit in converting the current junction treatment (installed in the mid 1990's) to a more conventional arrangement, whereby the existing "acceleration lane" for those vehicles turning right out of John Road is removed, and vehicles are required to store within the central median area (refer Figure 7.5), similar to that recently installed at the Park Lake Drive junction (refer 7.1.10). This may negatively impact on the efficiency of the junction and will need to be further assessed.

Consideration should also be given to improve the road lighting standard through the junction, as it is currently only lit by a single "flag" light. However, given there have been no recorded crashes involving pedestrians at night, this location would be a low priority.

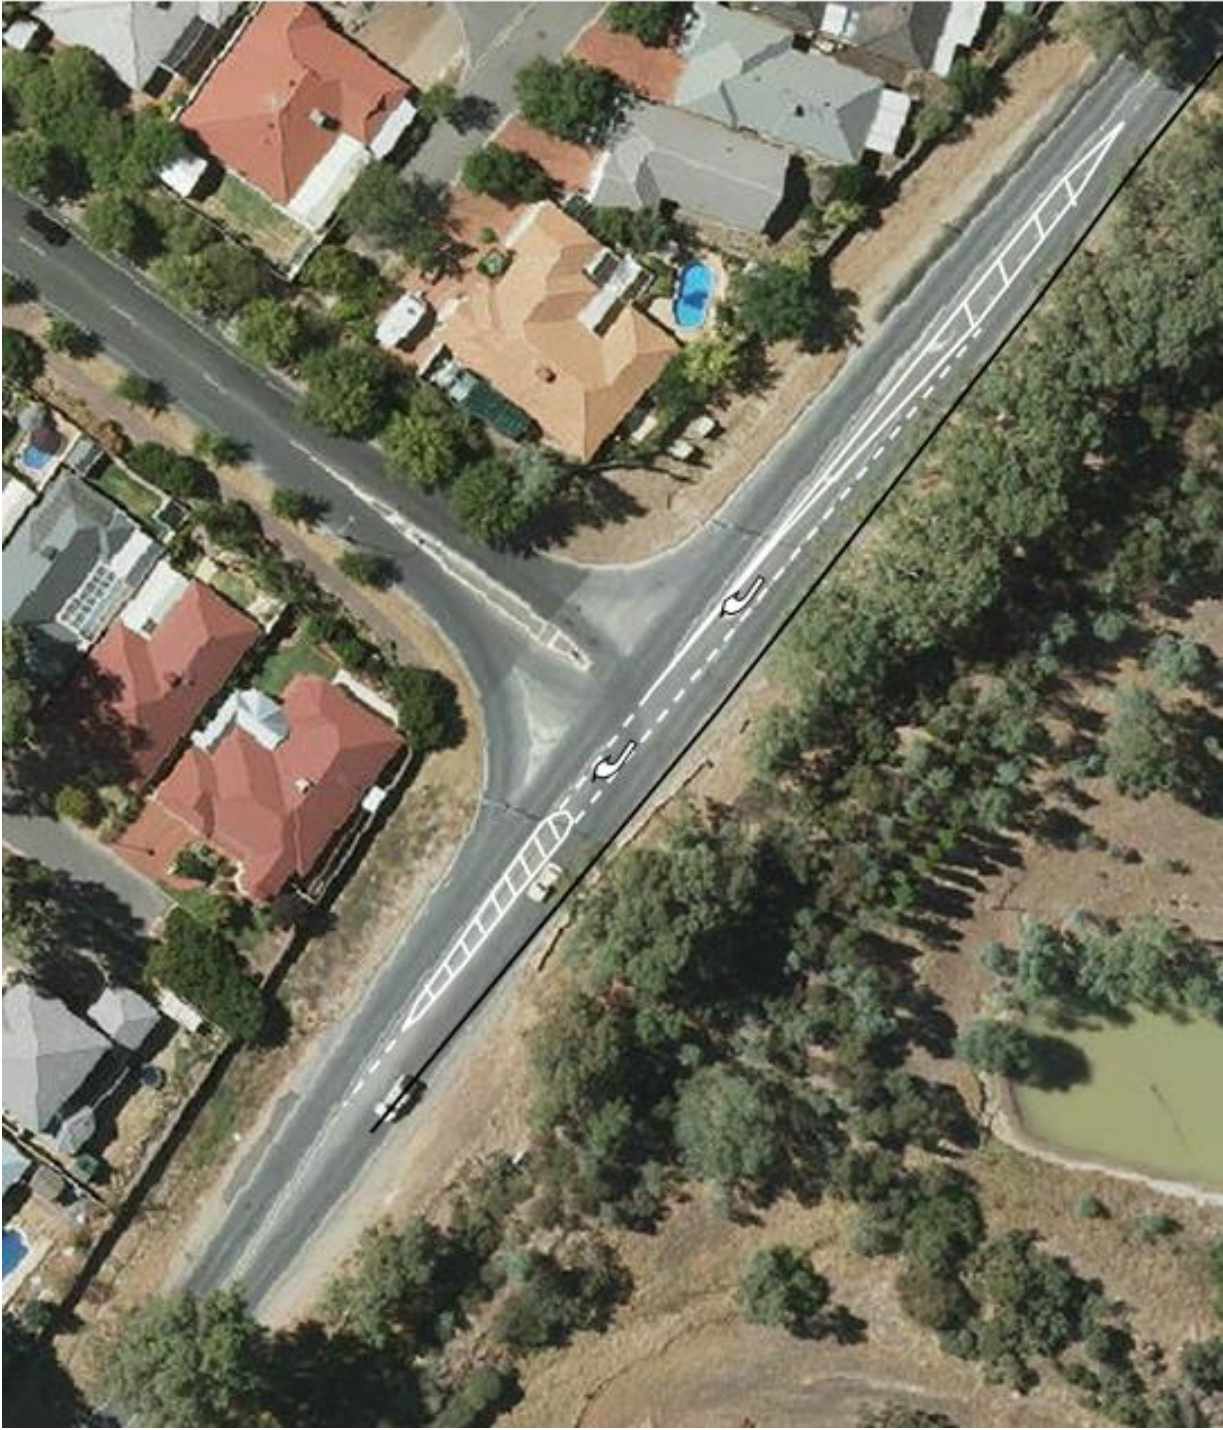
**Figure 7.5: Conventional Channelised Right Turn Lane**

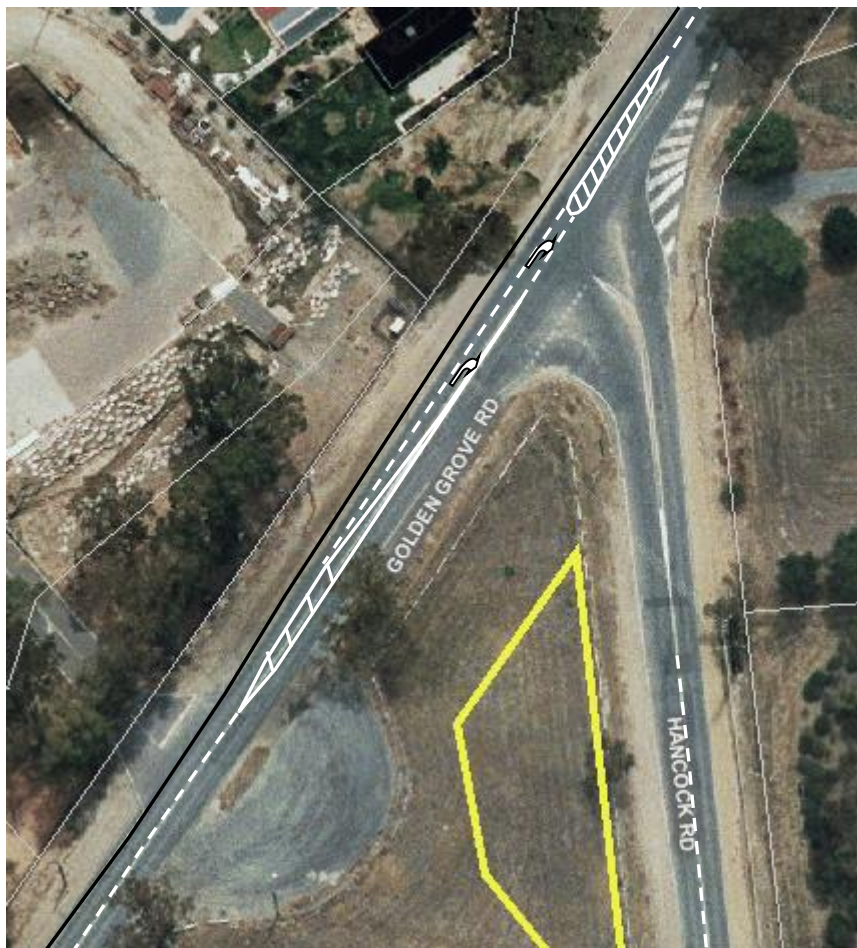
Figure 7.6: Current plan for Golden Grove Rd / Hancock Rd Intersection (channelised right turn lane)

In the medium term, it is considered appropriate to upgrade the junction to include a protected right turn lane as shown in Figure 7.6 as per the recommended treatment in this RMP (refer Figure 5.1). However given the low number of recorded crashes at this junction, such a treatment would be considered a low priority.

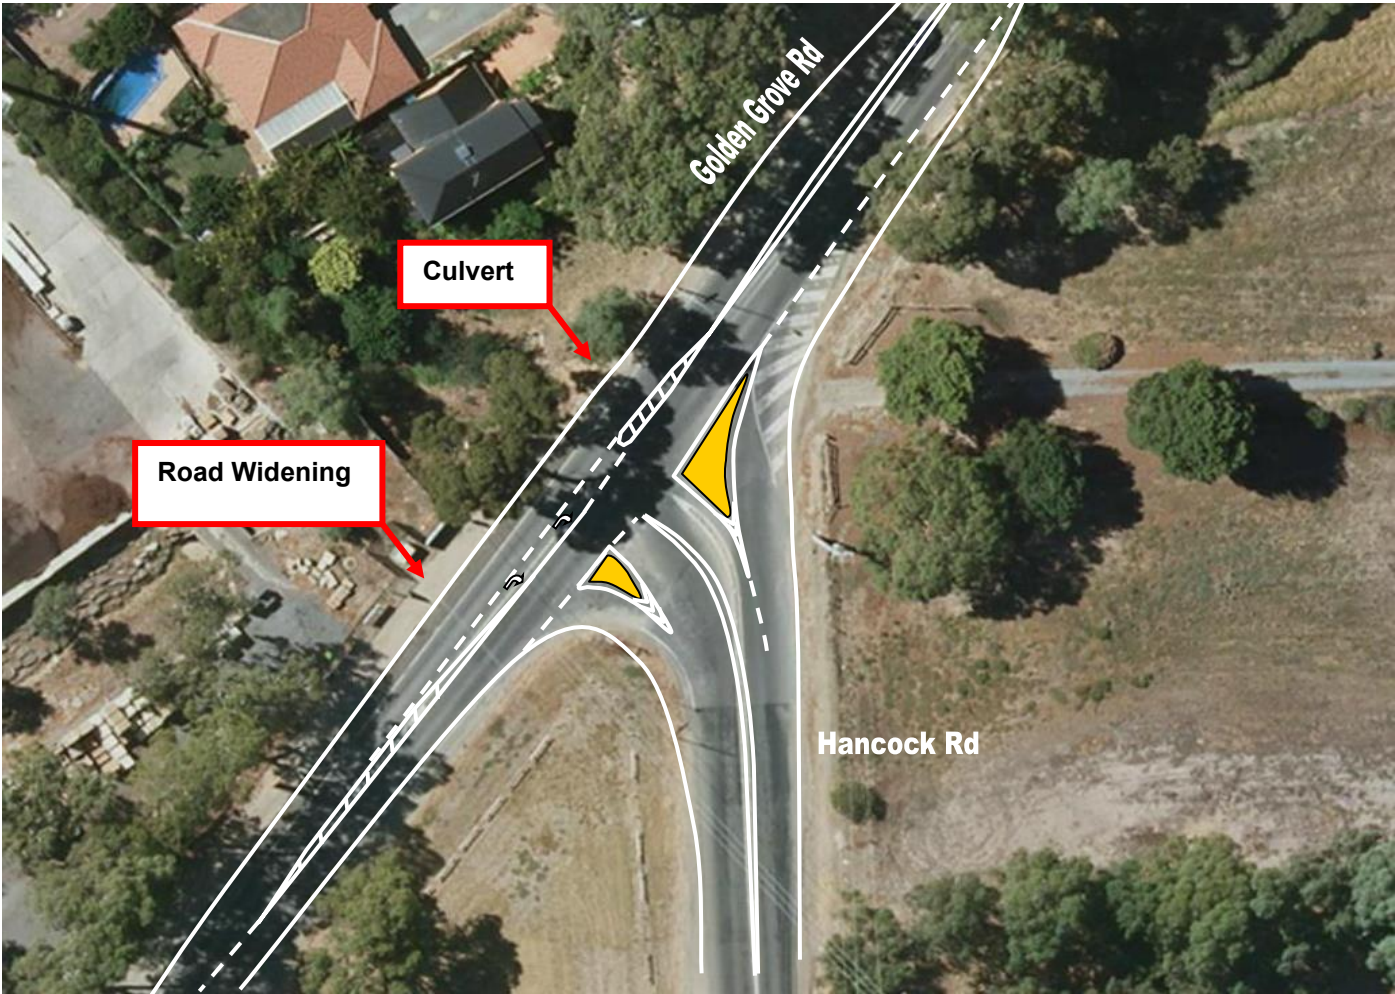
**Figure 7.7: Channelised right turn lane with left turn deceleration lane concept design for Golden Grove Rd / Hancock Rd Intersection**

In addition to this, the provision of a channelised left turn deceleration lane into Hancock Rd should be considered to improve sight lines for vehicles exiting Hancock Rd (refer Figure 7.7).

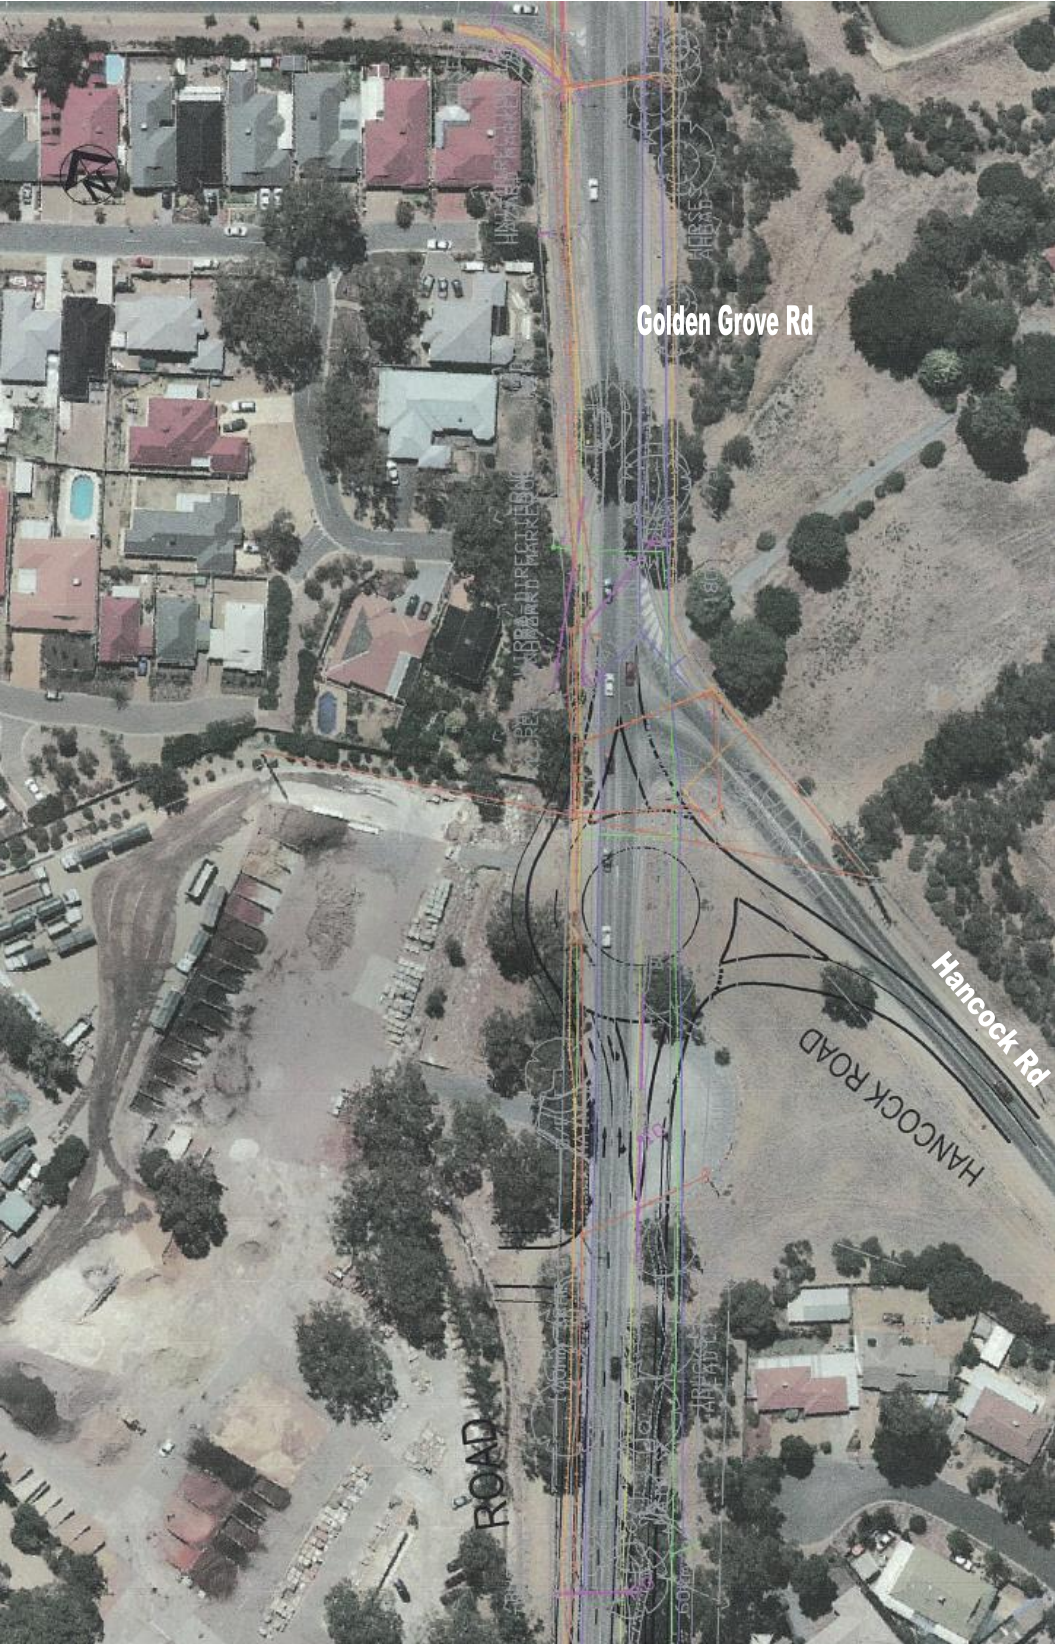
Figure 7.8: Roundabout Concept Design for Golden Grove Rd / Hancock Rd Intersection

A longer term treatment would be the installation of a roundabout at this junction to control traffic movements (refer Figure 7.8).

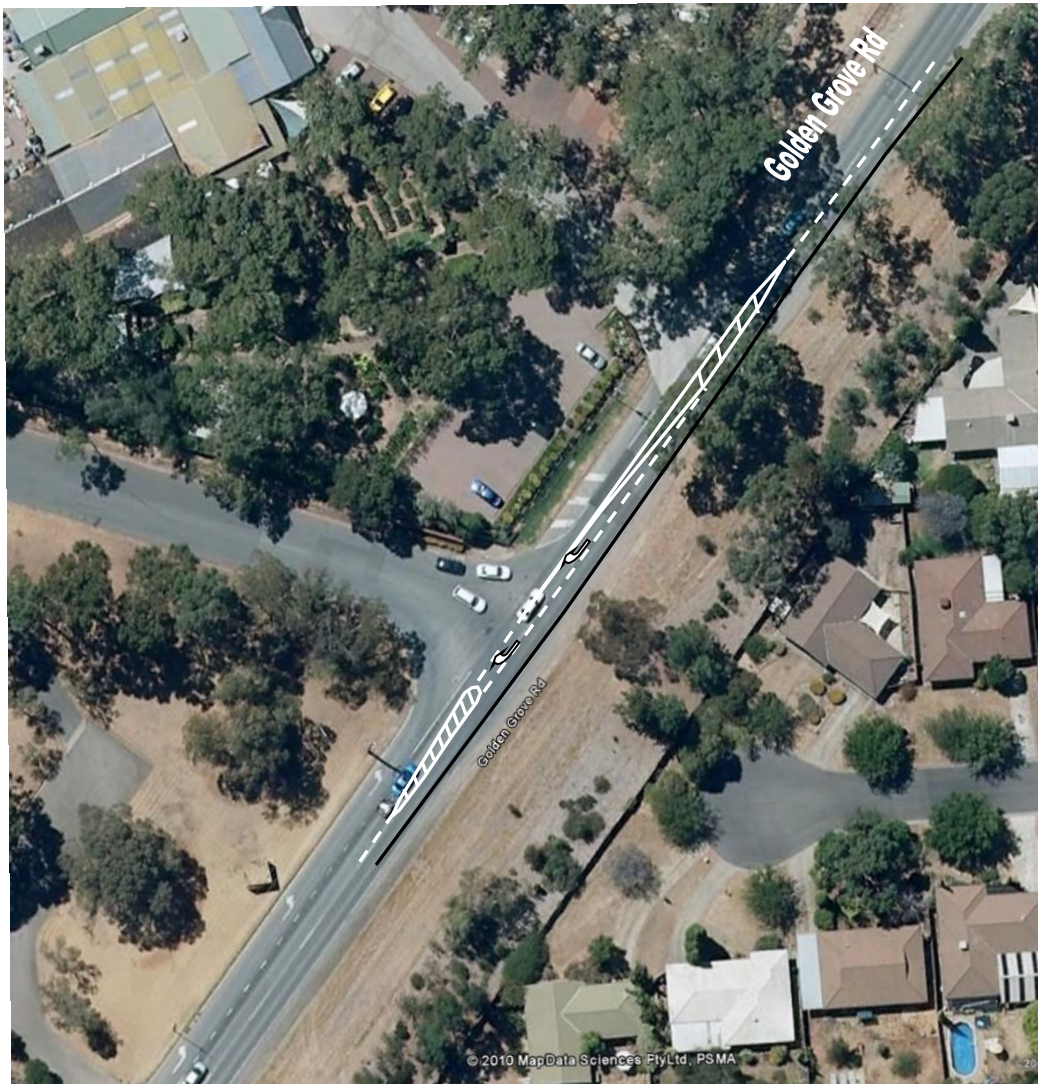
Figure 7.9: Current plan for Golden Grove Rd / Einstein Drive Intersection (channelised right turn lane)

A left turn deceleration lane is provided for vehicles entering Einstein Drive, however there is no provision for right turning vehicles on Golden Grove Road to store safely and enable through vehicles to pass. To create such a facility it is likely to require the removal of at least one large tree from the eastern side of the road. It may also be prudent to extend such a treatment further north to provide a safe access into the Garden Grove business, which has an access to the north of the Einstein Drive junction. This would require the removal of additional trees from the eastern side of Golden Grove Road.

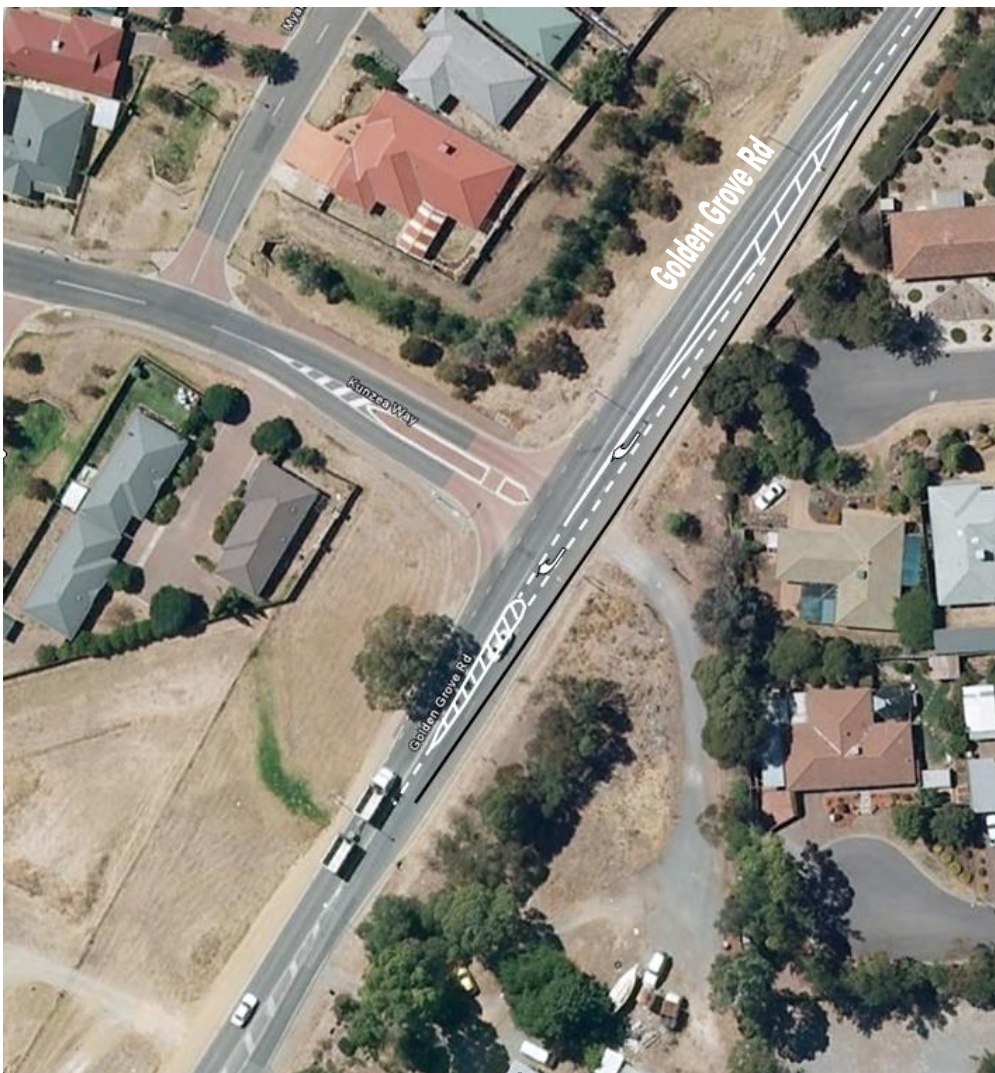
Figure 7.10: Current plan for Golden Grove Rd / Kunzea Way Intersection (channelised right turn lane)

The junction was originally constructed to include an auxiliary right turn lane to enable through vehicles to pass any stationary vehicle on Golden Grove Road waiting to turn right into Kunzea Way.

For continuity in the road layout for drivers, it is considered appropriate to upgrade the junction to include a protected right turn lane as per the recommended treatment in this RMP (refer Figure 5.1). However given the low number of recorded crashes at this junction, such a treatment would be considered a low priority at this time.

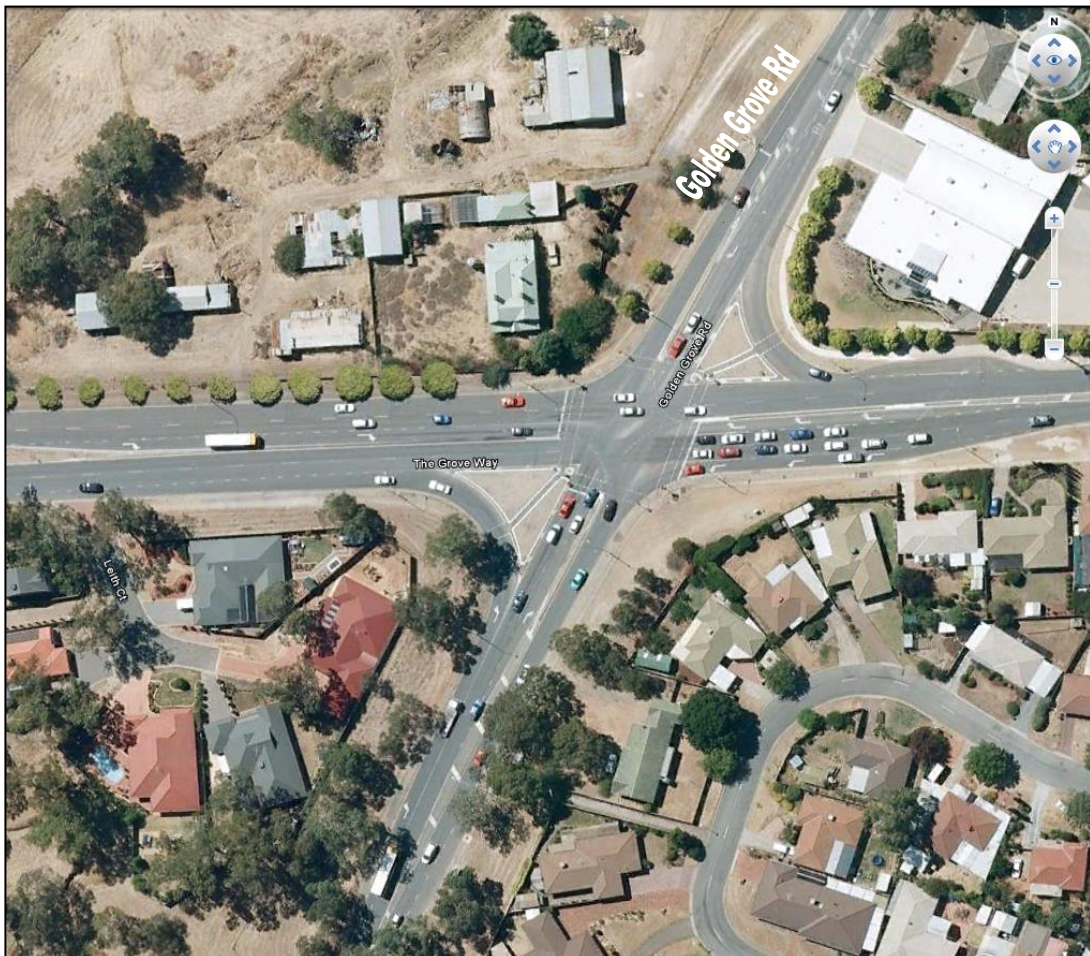
Figure 7.11: Golden Grove Road / The Grove Way / Yatala Vale Road Intersection

Currently, this intersection (refer Figure 7.11) is congested in the peak periods, with particularly high demand for right turn movements from The Grove Way to Golden Grove Road and the corresponding left turn movement. In an effort to manage the efficiency of this site currently the right turn movements from the west are able to perform filter turns, which require motorists to select appropriate gaps in the oncoming traffic stream. Analysis of the crash data suggests that some crashes have been as a result of drivers not being able to do this successfully.

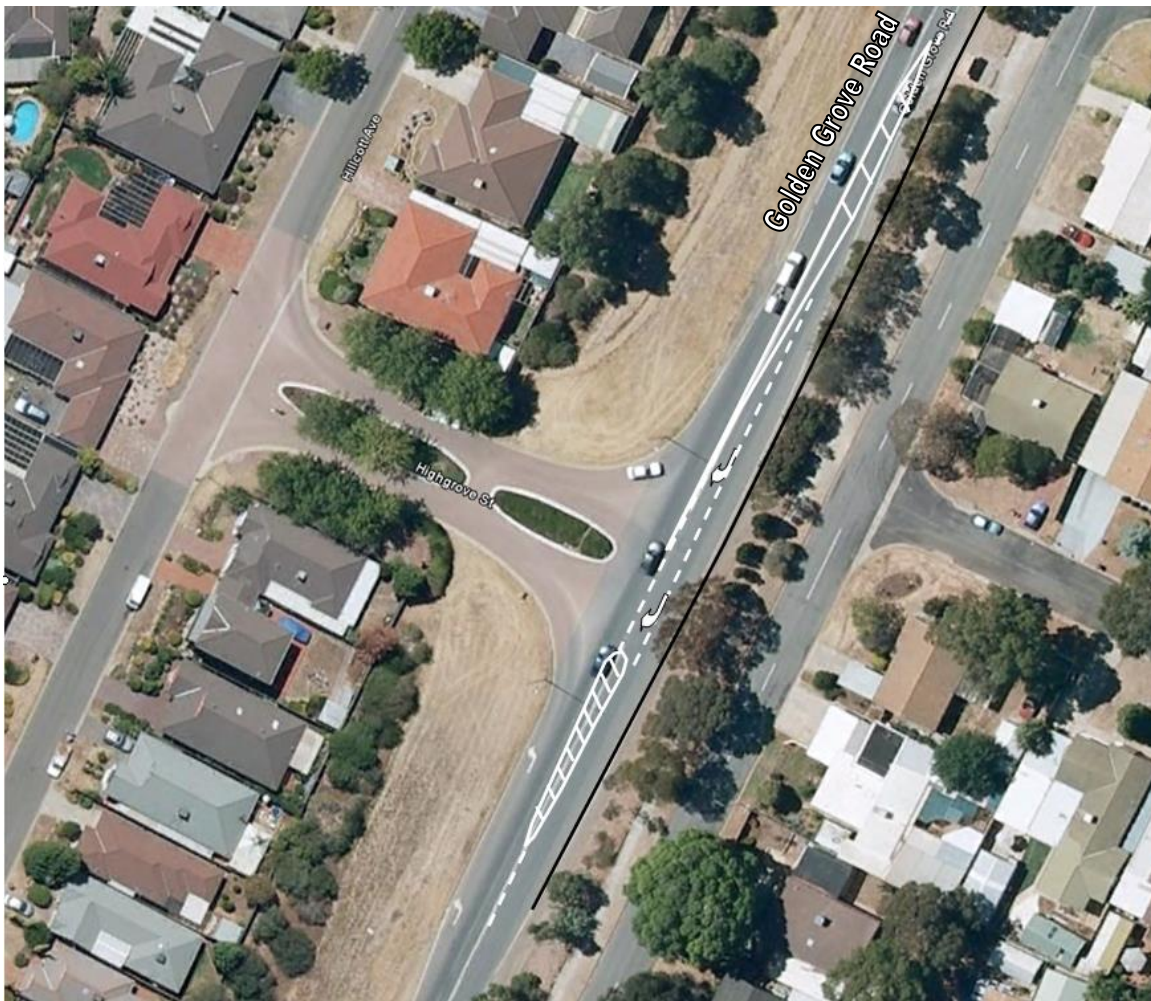
Figure 7.13: Current plan for Golden Grove Rd / Highgrove Street Intersection (channelised right turn lane)

An on site inspection identified some minor issues with the current layout of the junction, predominately related to delineation of the junction

For continuity in the road layout for drivers, it is considered appropriate to upgrade the junction to include a protected right turn lane as per the recommended treatment in this RMP (refer Figure 5.1). However given the low number of recorded crashes at this junction, such a treatment would be considered a low priority at this time.

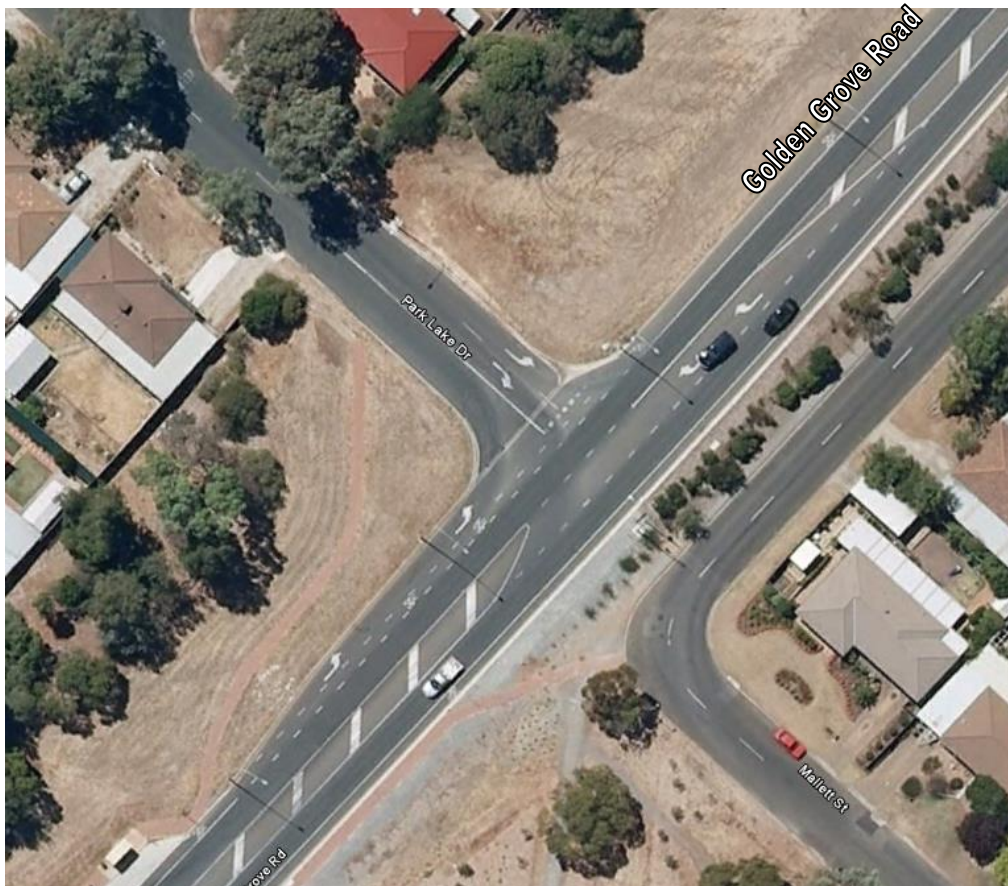
Figure 7.14: Golden Grove Rd / Park Lake Drive Intersection

A standard channelised right turn treatment has already been implemented at this location (refer Figure 7.14), together with a deceleration lane for the left turn into Park Lake Drive. There are also cyclist facilities marked at this intersection. This project was undertaken in 2006.

Given the recent upgrade and the current satisfactory operation of this junction, no further works are recommended at this time.

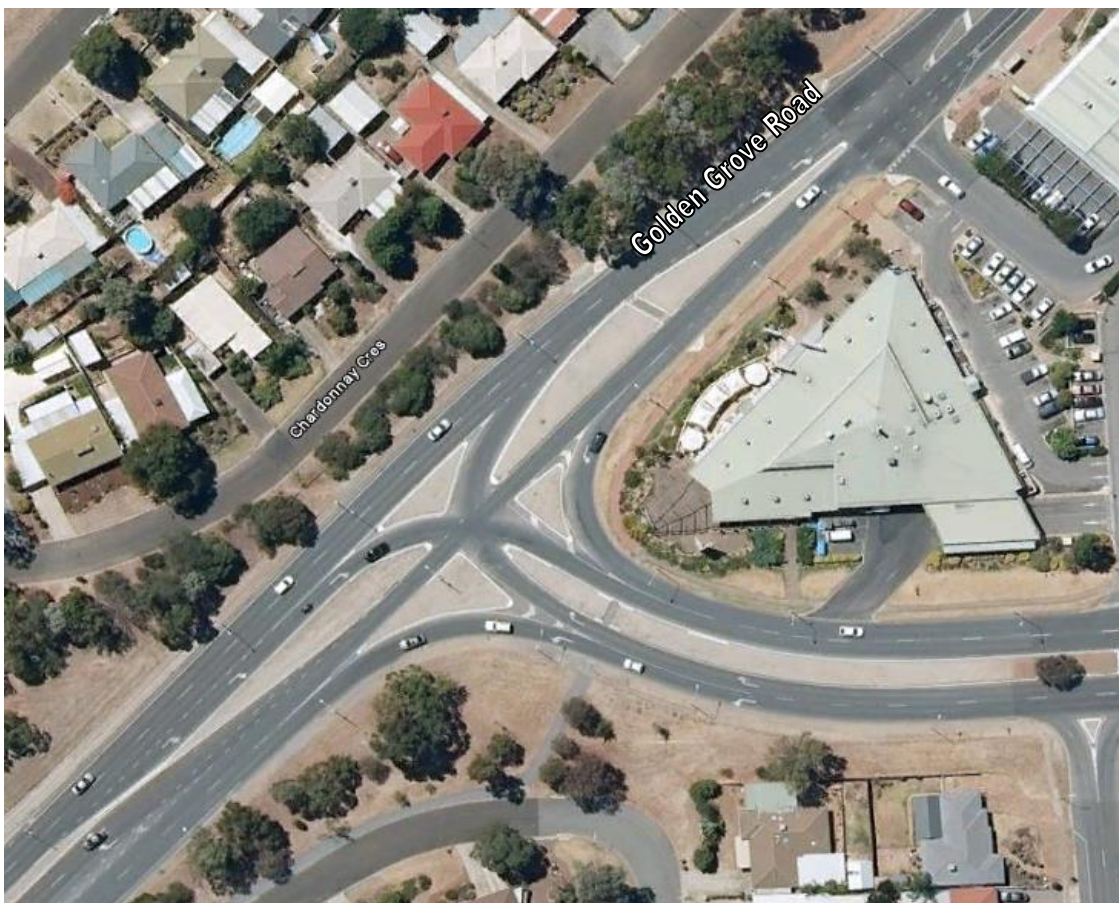
Figure 7.15: Golden Grove Rd / Grenfell Road (east) Intersection

The junction is a “seagull” type junction (refer Figure 7.15), with turning movements being able to be undertaken at relatively high speed due to the generous radius of the curves.

Grenfell Road (east) is located approximately 140m north of the signalised junction of Grenfell Road (west). There is a high demand for left turn out from Grenfell Road (east) to right turn into Grenfell Road (west) and also for the reverse “S” movement. Given the relatively short weave length, it is considered that some of the rear end crashes occurring on the left turn out from Grenfell Road (east) are due to the lead vehicle hesitating in selecting a gap in the oncoming traffic stream to undertake the merge movement to turn right into Grenfell Road (west).

It is recommended that traffic signals are installed on the Grenfell Road (east) junction to be coordinated with the existing signals, with 2 right turn lanes (fully controlled) on the southern and eastern approaches.

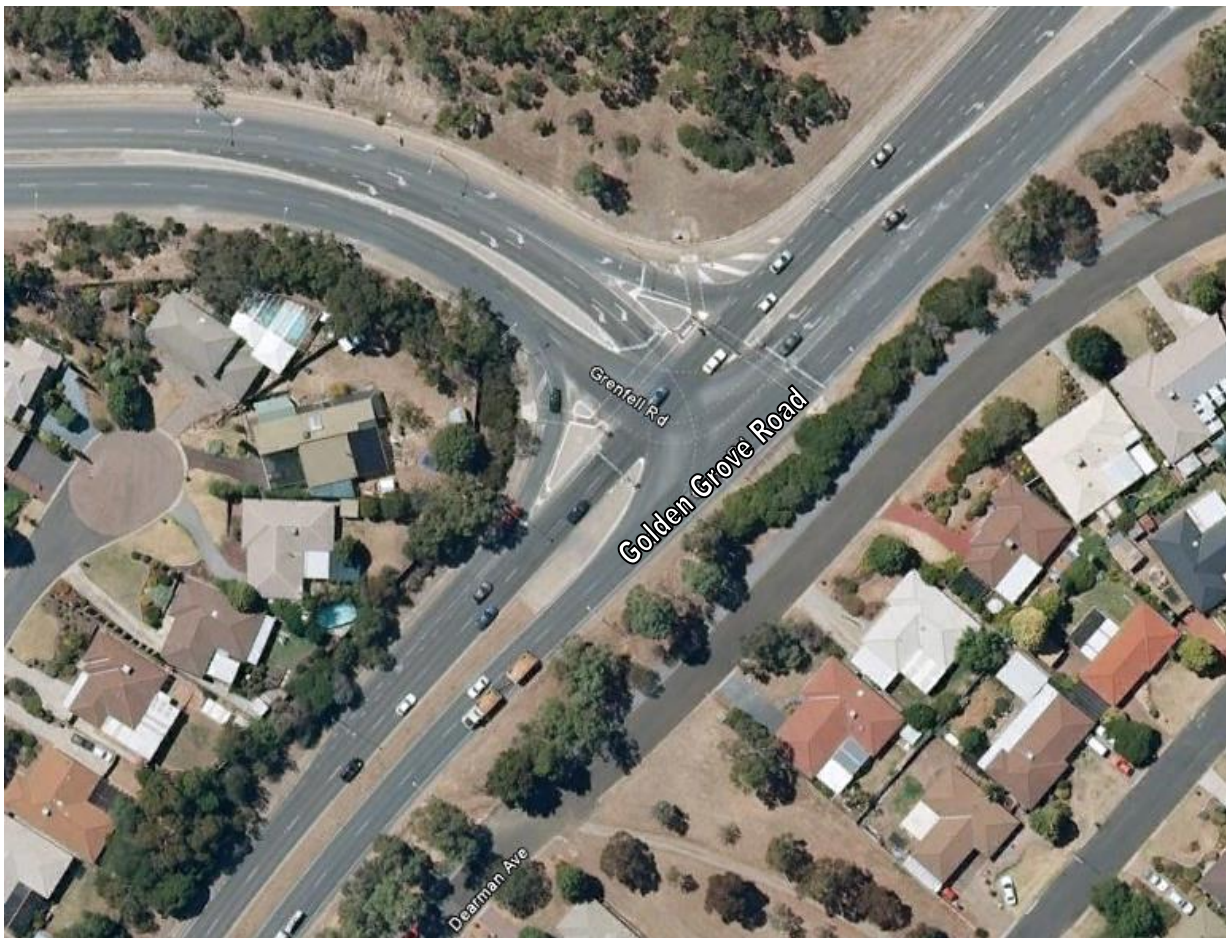
Figure 7.16: Golden Grove Rd / Grenfell Road (west) Intersection

This junction was upgraded with funding received from the Federal Black Spot Program in the 2005/06 financial to install additional right turn lanes on Golden Grove Road and Grenfell Road and then fully controlling these movements (refer Figure 7.16).

The majority of the rear end type crashes have occurred in the high entry angle left turn slip lane on the western approach of the junction.

It is recommended that consideration be given to fully controlling the left turn lane from Grenfell Road (west) at the time when traffic signals are installed at the Grenfell Road (east) junction.

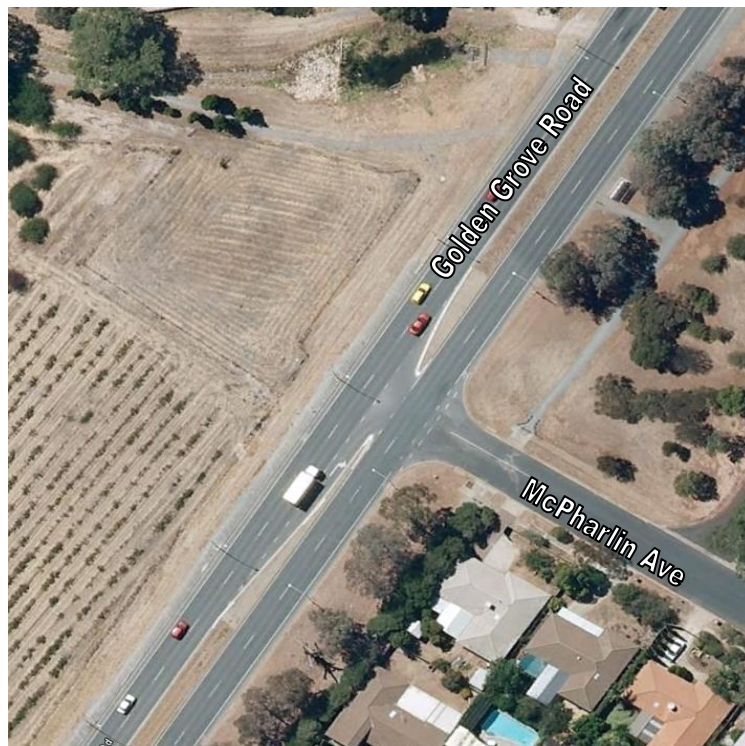
Figure 7.17: Golden Grove Rd / McPharlin Avenue Intersection

No minor treatments are evident to treat the predominant crash type. A more drastic solution may be to permanently ban the right out of McPharlin Avenue, and force any vehicle wishing to head north to use the local road network via McEwin Avenue to Grenfell Road (east) to access Golden Grove Road.
