Department for Transport,  
Energy and Infrastructure

# **ROAD MANAGEMENT PLAN**

**Golden Grove Road  
North East Road to One Tree Hill Road**

**DECEMBER 2010**

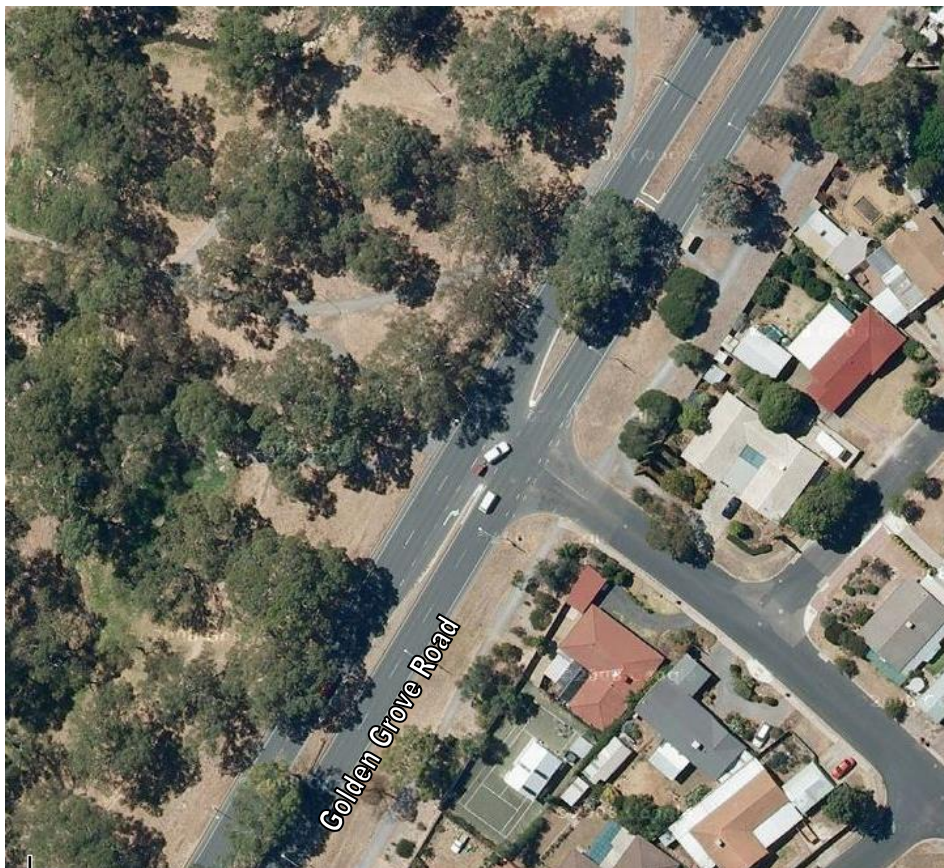
**Figure 7.18: Golden Grove Rd / Maughan Avenue Intersection**

However, all three recorded crashes involved vehicles travelling south on Golden Grove Road, hence the concern with level difference of the southern leg has not been reflected in the crashes occurring at this location.

In relation to the recorded crashes, there are no obvious issues identified in relation to the physical road infrastructure at this location, rather the crashes have resulted from poor driver behaviour. Consideration could be given to installing an advance street name sign to alert drivers unfamiliar to the area with the presence of the side road junction.

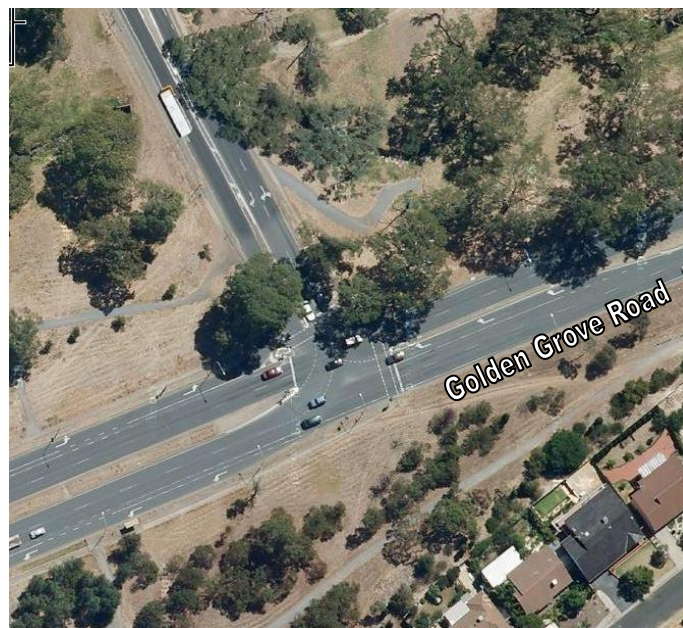
Figure 7.19: Golden Grove Rd / Milne Road (west) Intersection

The predominant crash types are rear end (14), right turn (14) and right angle (10). It should be noted that 9 of the 10 right angle crashes were caused by a vehicle on the southern approach running a red light and colliding with a vehicle taking off to turn right from Milne Rd on a green arrow. The existing “wet film” safety camera is planned to be replaced with a new digital installation in 2011 which may be a more effective deterrent to the current incidence of red light running.

Another option would be to control the right turn outside of the peak hours – this would address 60% of the recorded right turn crashes. The option selected will be determined through further modelling of the operation of the junction, and the ability to add the required right turn storage capacity due to geometric design and environmental constraints at this location.

Given the curvilinear alignment of the northern approach to the intersection and the potential for queues to form back in the peak periods, consideration should be given to provide advance warning to southbound vehicles via an Intelligent Transport System (ITS) solution. The installation of traffic signal mast arms may also provide some benefit to improve the sight distance to traffic signals for approaching vehicles from the north. The mast arm should be located on the SW corner of the junction.

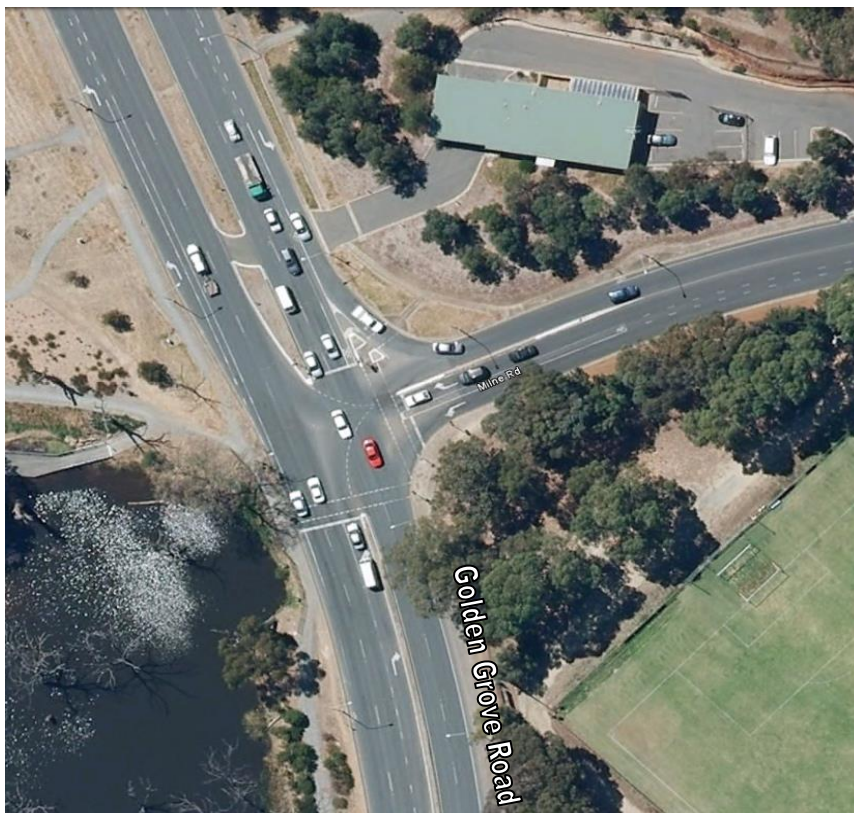
Figure 7.20: Golden Grove Rd / Milne Road (east) Intersection

Given the relatively high incidence of right turn type crashes it is suggested that the right turn movement is fully controlled. This will require further traffic analysis to determine the impact on the intersection efficiency, the capacity required to store the vehicles for the right turn movement and the ability to provide this extra capacity within the existing site constraints.

An alternative may be to partially control the right turns outside of the peak hours, if insufficient right turn storage capacity can be provided on site. This option would treat 60% of the total right turn crashes occurring at this location.

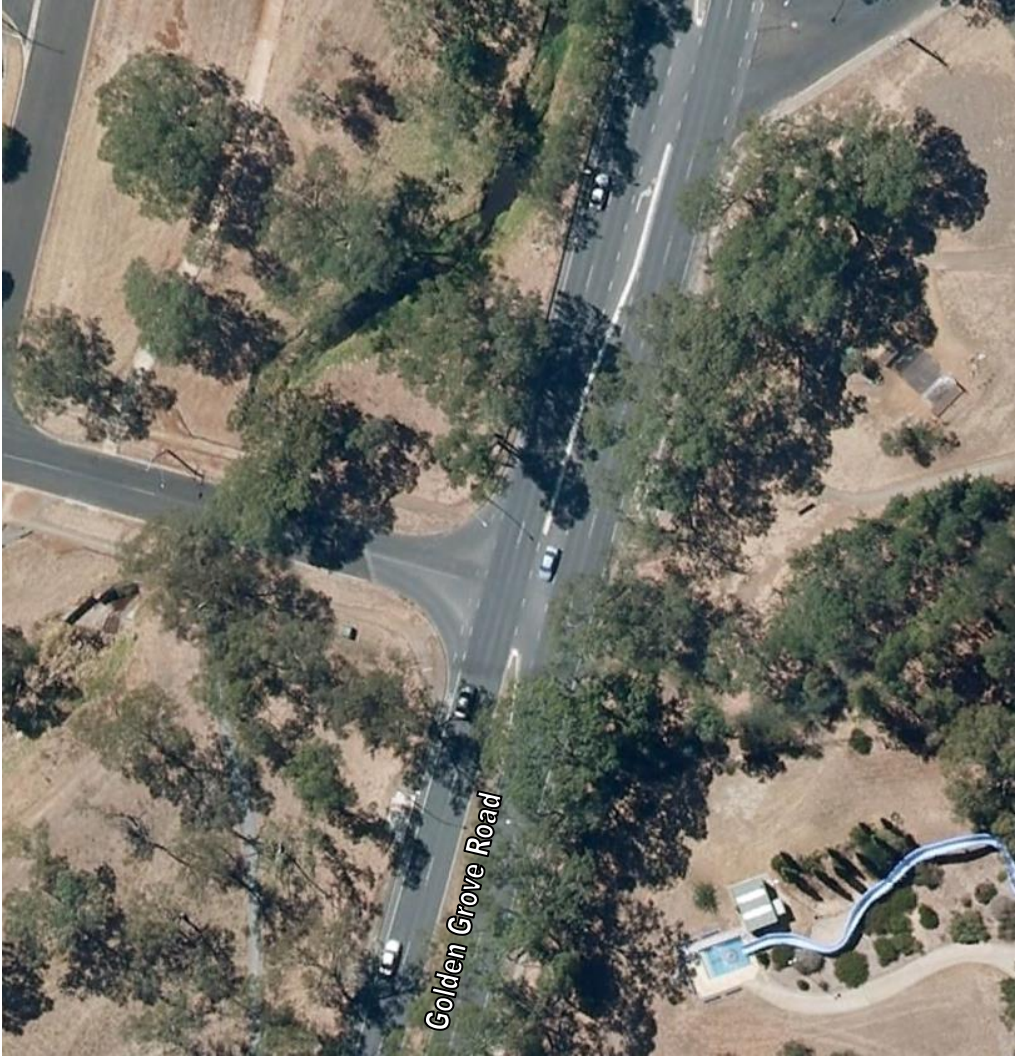
Figure 7.21: Golden Grove Rd / Oratanga Road Intersection

There were 4 crashes at this junction during the period 2005 – 2009, of which only one crash resulted in injury. Based on these statistics, this site would not meet the Black spot criteria.

Given the relatively low crash rate, no specific action is recommended at this location at this time, however on site observations indicate a slight impediment to sight distance due to vegetation both north and south of the junction. Further detailed inspection of the site is required to determine the extent of any tree pruning or removal required to address this issue.

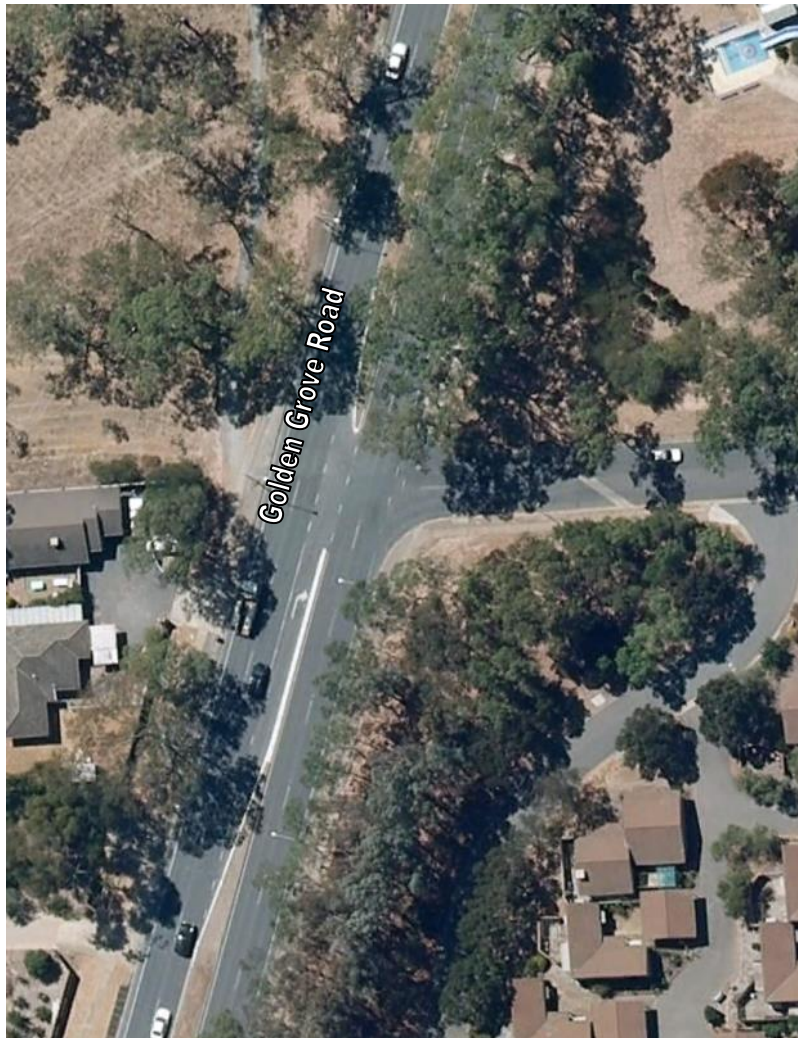
Figure 7.22: Golden Grove Rd / Hazel Grove Intersection

All of the right angle crashes (with 2 resulting in casualties) involved a vehicle heading southbound hitting a vehicle exiting Hazel Grove (2 were turning left onto Golden Grove Road and 2 were turning right onto Golden Grove Road).

No obvious issues were identified in relation to the physical road infrastructure at this location, rather the crashes have resulted from poor driver behaviour. Consideration could be given to installing an advance street name sign to alert drivers unfamiliar to the area with the presence of the side road junction.

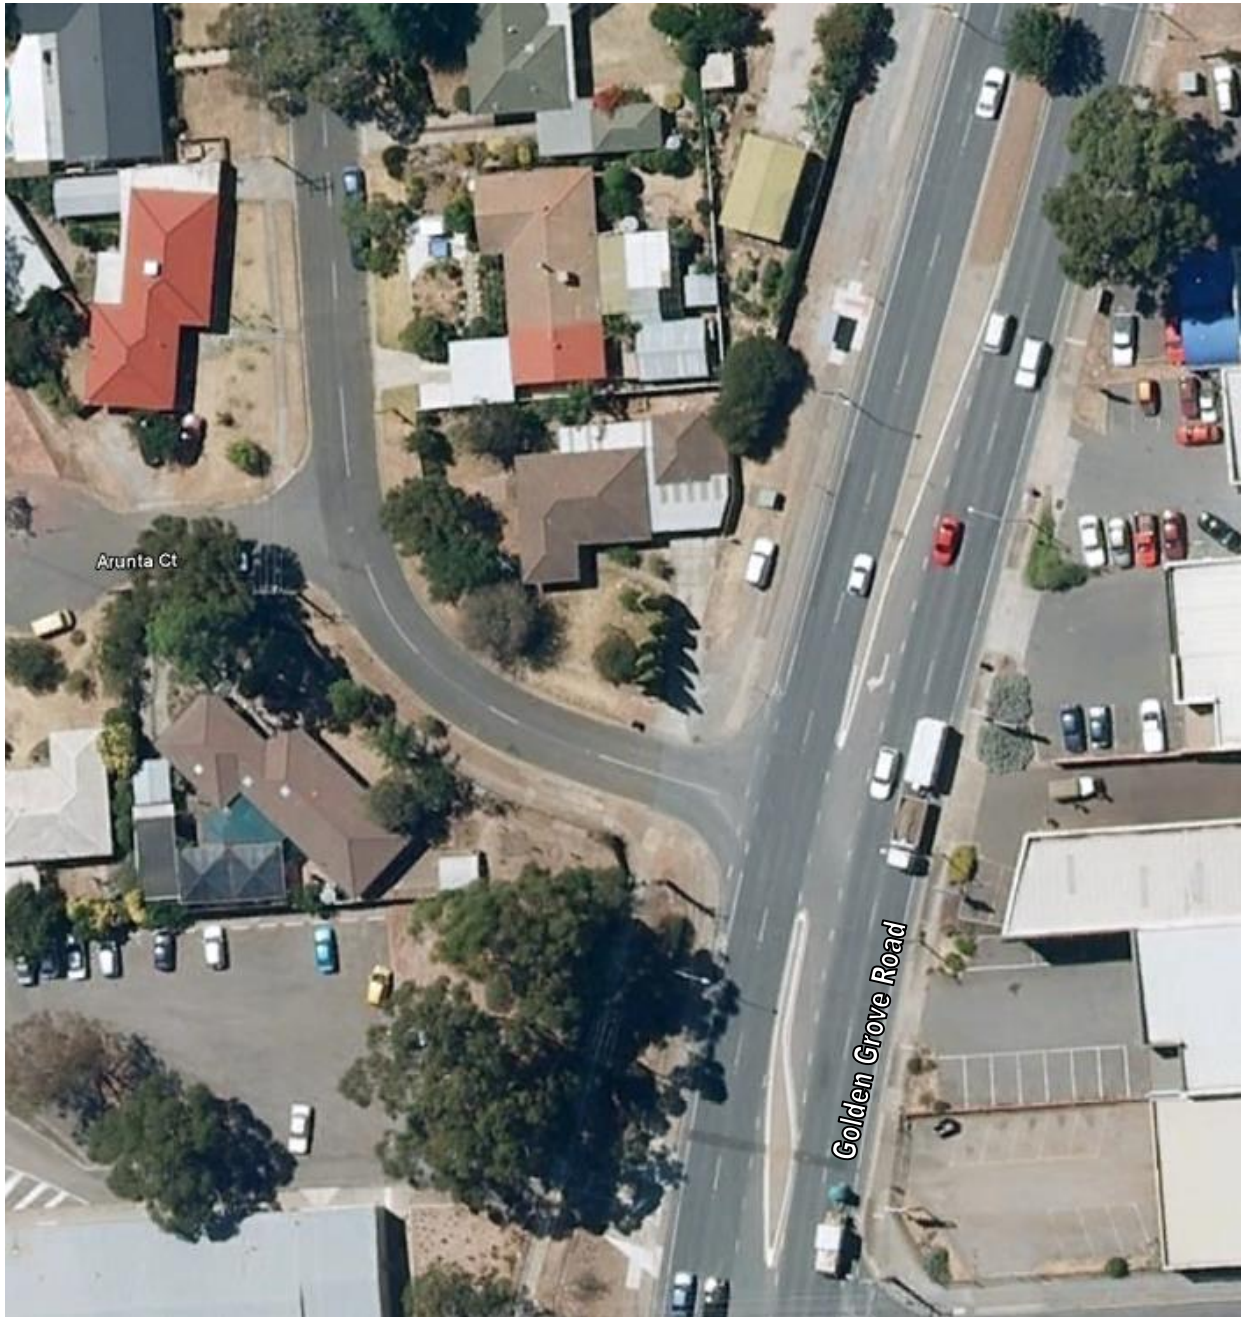
Figure 7.23: Golden Grove Rd / Rawlings Road Intersection

Of the four recorded crashes, there was no consistent crash pattern identified.

Given the above, and the existing standard channelised right turn treatment and right turn storage on Golden Grove Road, no further treatments are considered warranted at this time.

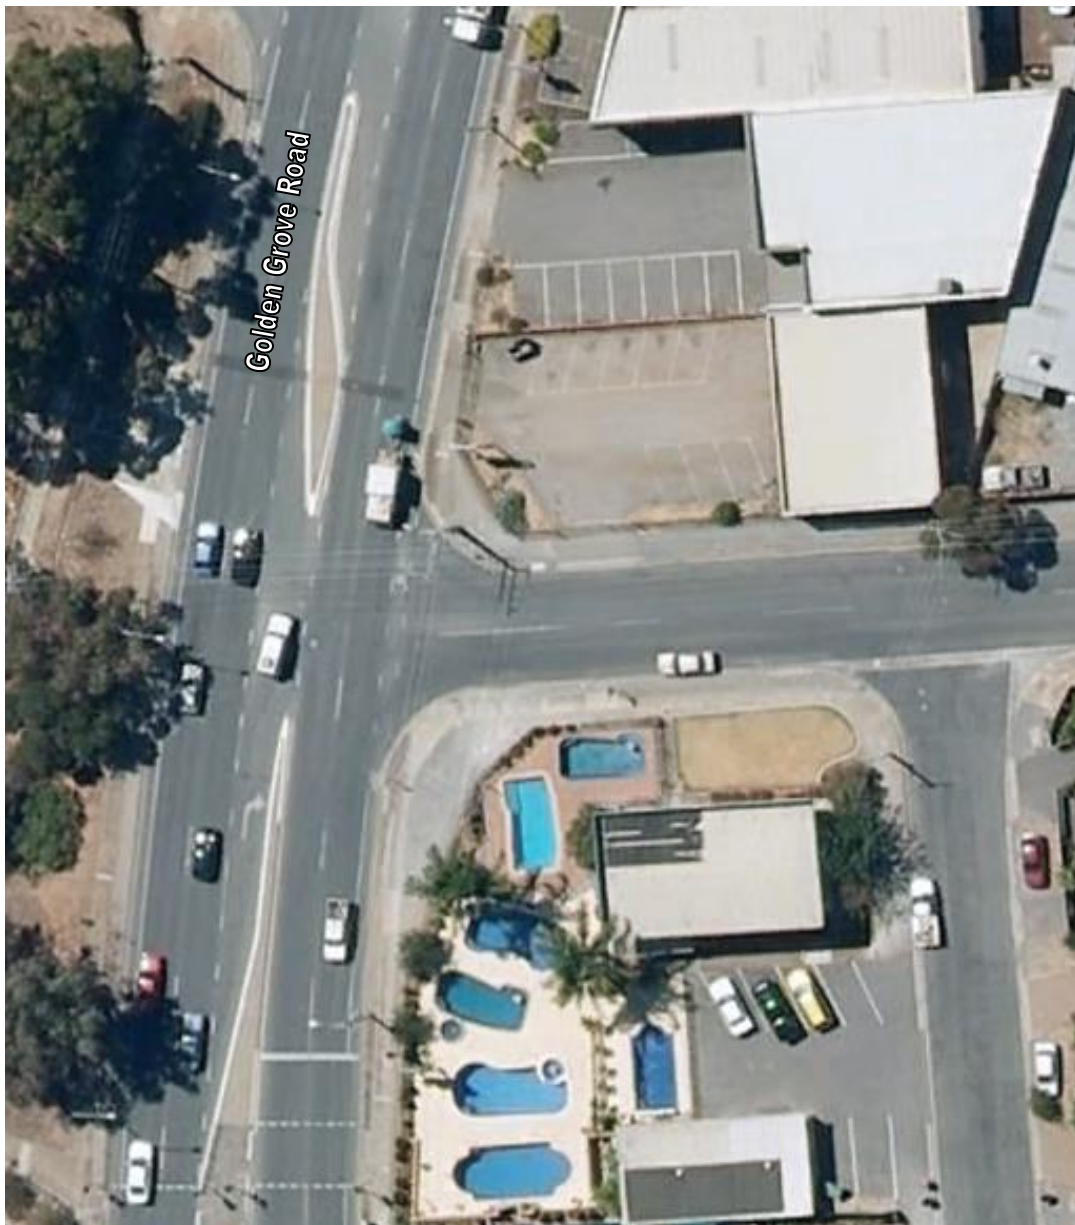
Figure 7.24: Golden Grove Rd / Dewer Avenue Intersection

There were 5 crashes recorded at this junction for the period 2005 – 2009, with 3 of the crashes resulting in injury and as such this location does meet the Black Spot criteria, however there are some 395 other unsignalised locations with a poorer safety record over the same period.

Four of the crashes were right angle type crashes. All of these involved a southbound vehicle. There are no obvious factors contributing to the crashes at this location, and given the low crash rate there are no plans to undertake any works at this location at this time.

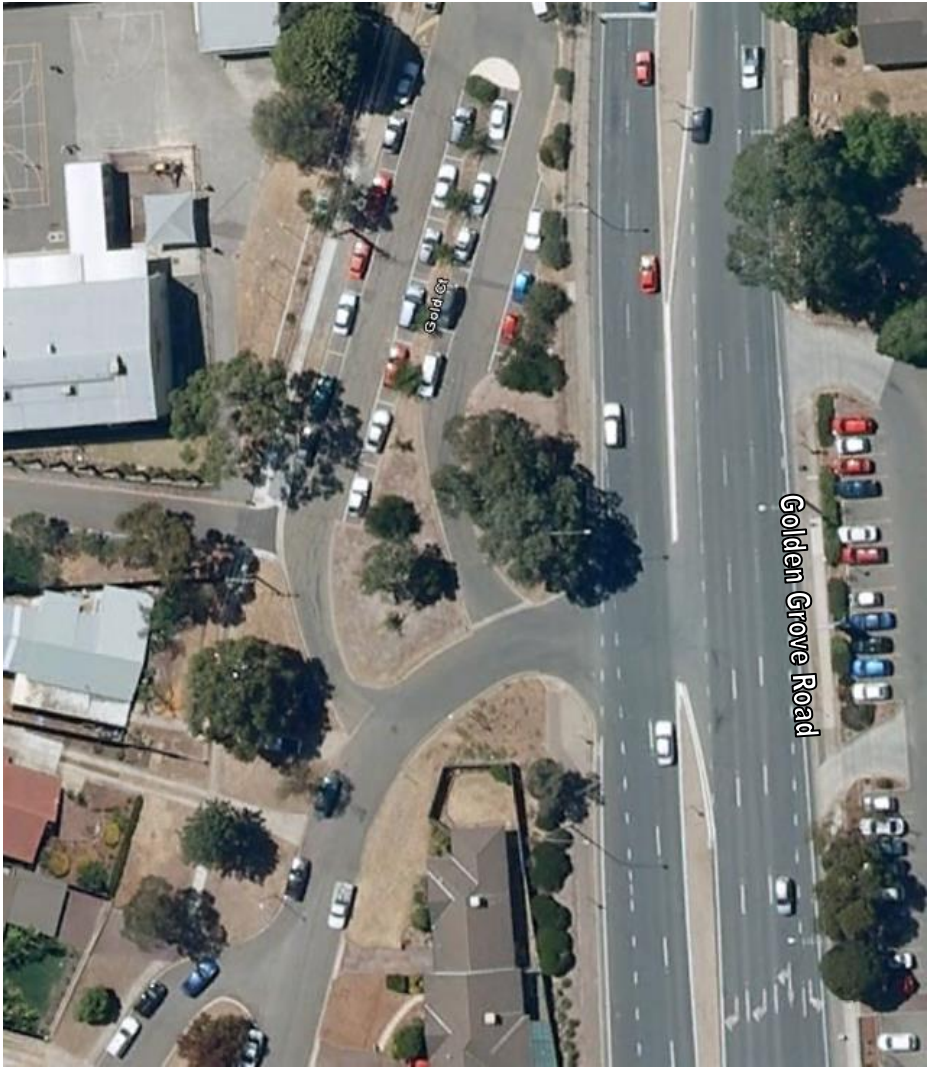
**Figure 7.25: Golden Grove Rd / Gold Court Intersection**

There was only one crash recorded at this junction for the period 2005 – 2009 which involved a rear end type collision in the left turn merge lane from North East Road.

Given the low crash history at this junction, no works are proposed for this site.

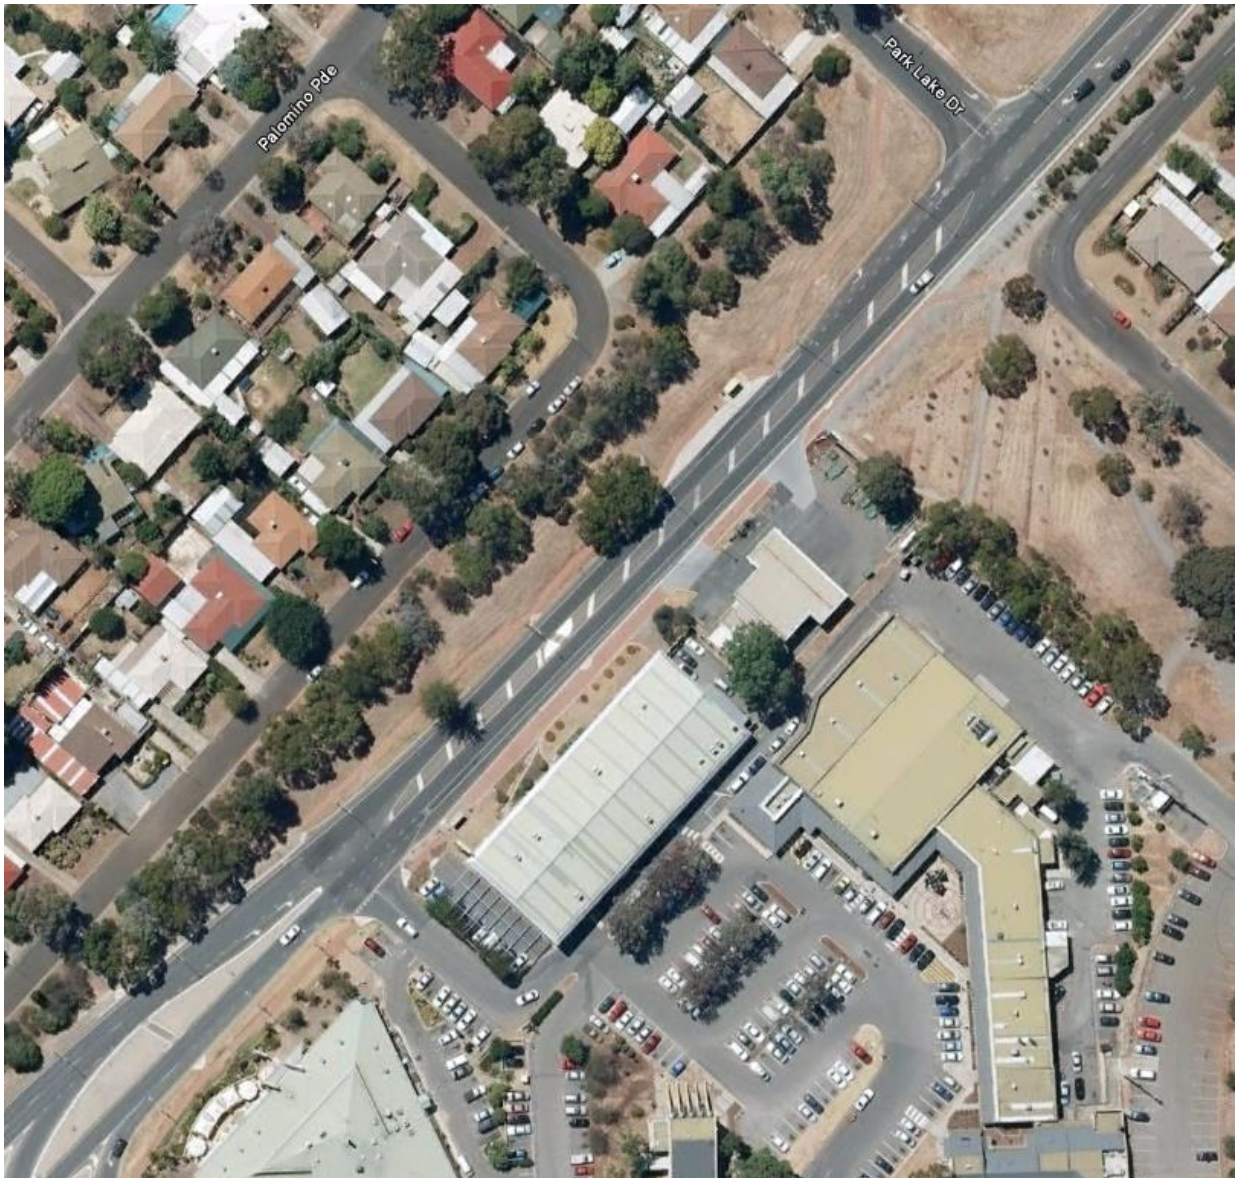
Figure 7.30: Golden Grove Road - Park Lake Drive to Grenfell Road (east)

There were predominantly right angle crashes (7) along this section of road, with all of the 10 crashes involving vehicles entering or exiting commercial or retail properties.

Given the recent implementation of the treatment as shown below, no further works are proposed at this time.

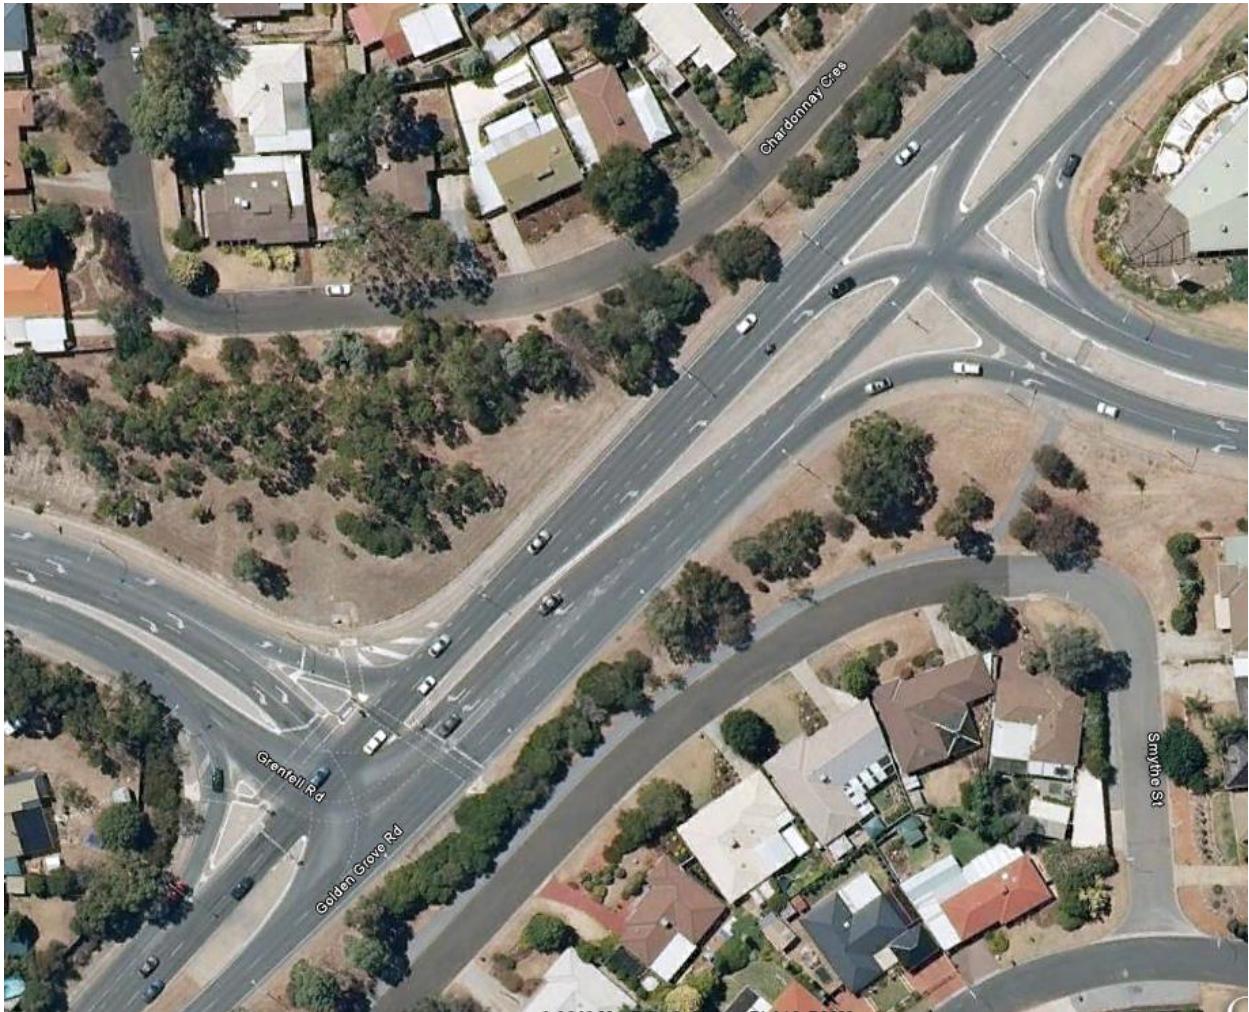
Figure 7.31: Golden Grove Road - Grenfell Road (east) to Grenfell Road (west)

There were only 2 crashes recorded along this short section of road for the period 2005 – 2009.

There are no specific treatments proposed along this section of road at this time, however the proposed installation of traffic signals on Grenfell Road (east) will change the operating conditions on this length of road.

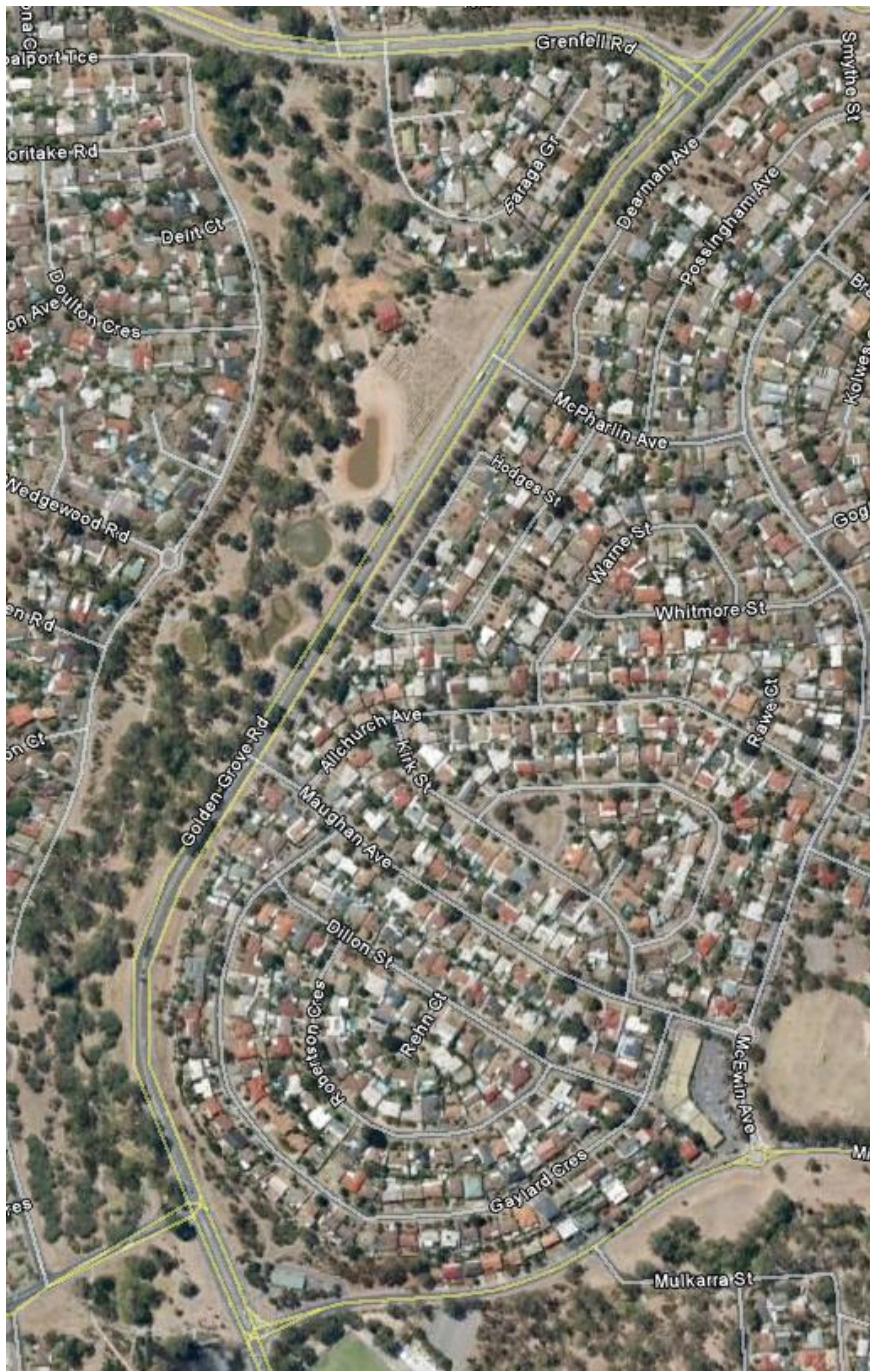
Figure 7.32: Golden Grove Road - Grenfell Road (east) to Grenfell Road (west)

Of these crashes, 2 are related to queuing at the intersection of Golden Grove Road and Milne Road (west) and 1 of the injury crashes was related to queuing at the intersection with Milne Road (east).

There are no specific treatments proposed along this section of road at this time.

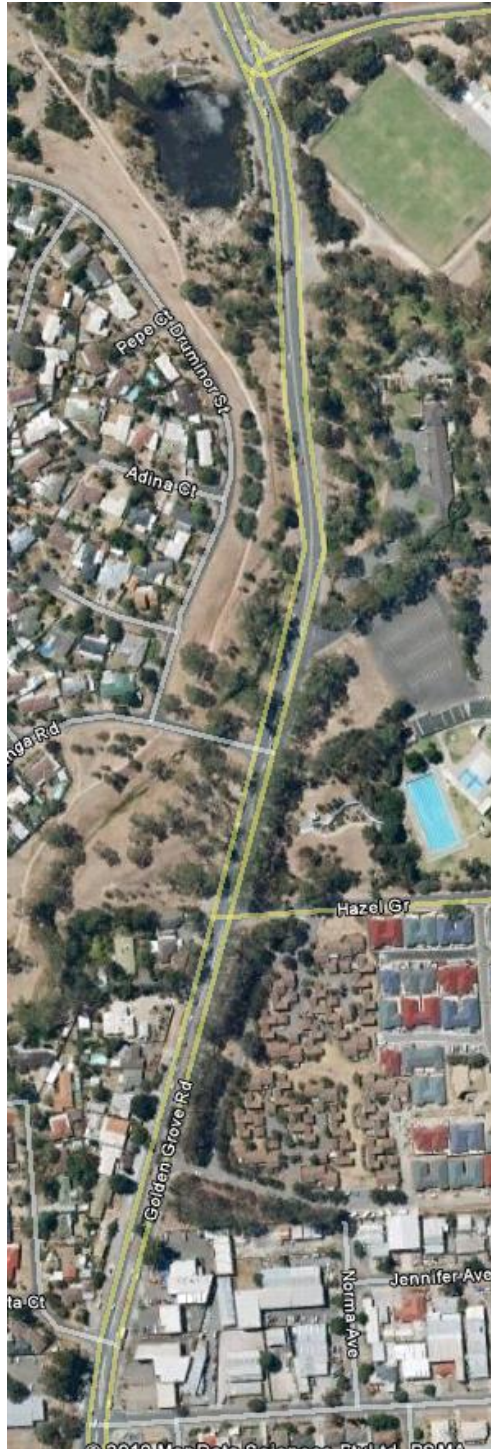
Figure 7.33: Golden Grove Road - Milne Rd (east) to Dewer Avenue

There were 6 crashes recorded along this section of road for the period 2005 – 2009, with only 1 of those resulting in injury.

Most of these crashes are related to vehicles accessing properties adjacent to Golden Grove Road. Given the low crash history, no further treatments are recommended at this time.

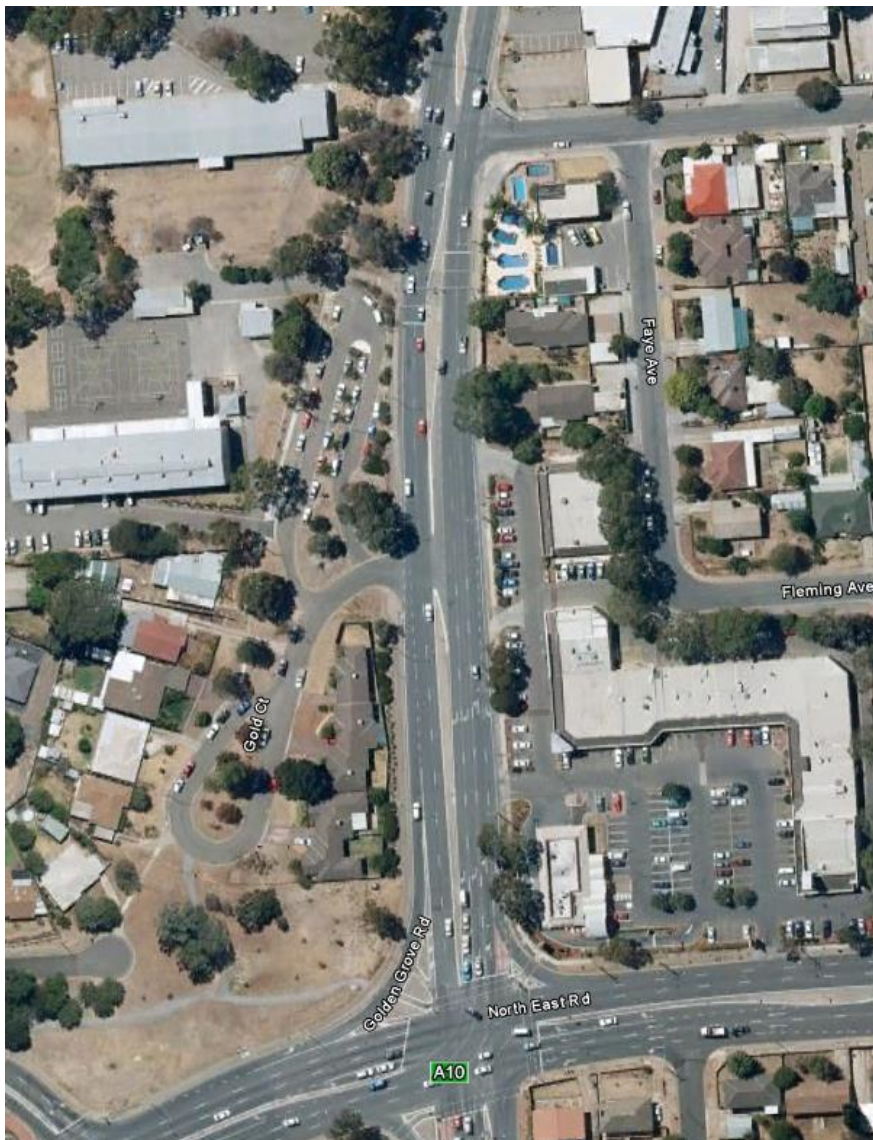
Figure 7.34: Golden Grove Road - Dewer Avenue to North East Road

The majority (8) of the crashes are related to either queuing from North East Road or merging from the left turn slip lane from North East Road. There was only one rear end type crash associated with stopping at the pedestrian crossing. The remainder of the crashes appear to be associated with vehicles entering or exiting commercial properties along this section of road.

Recommendations for the high number of crashes associated with queuing from North East Road have been identified previously in section 7.1.23. No other treatments are considered warranted at this time.
