ROAD MANAGEMENT PLAN

RN05200 – Golden Grove Road

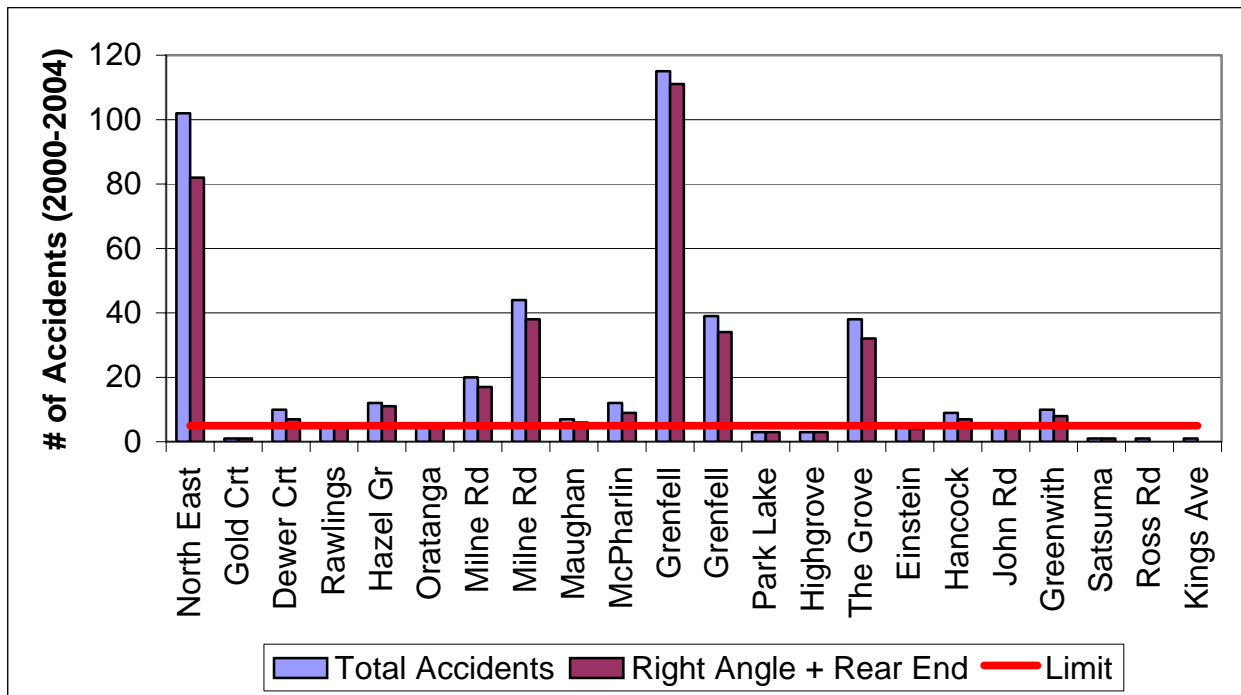
Figure 8 shows the intersections that exceed the limit of 5 crashes as detailed above. It can be seen that intersections that are currently controlled by traffic signals are those with the higher number of crashes.

Figure 8: Crash Data; 2000-2004, Golden Grove Road Intersections

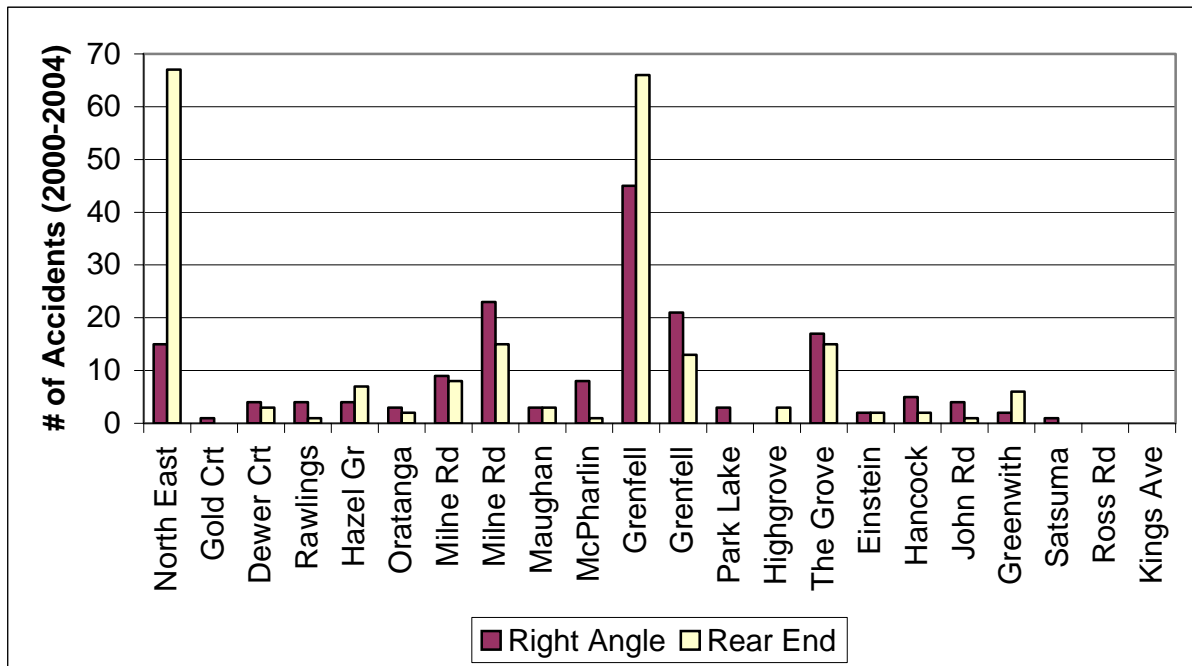
From Figure 8 it can also be seen the majority of these accidents are Right Angle and Rear End type accidents (with the distribution of each of these shown in Figure 9).

Figure 9: Crash Data; 2000-2004, Right Angle and Rear End accidents at Golden Grove Road Intersections

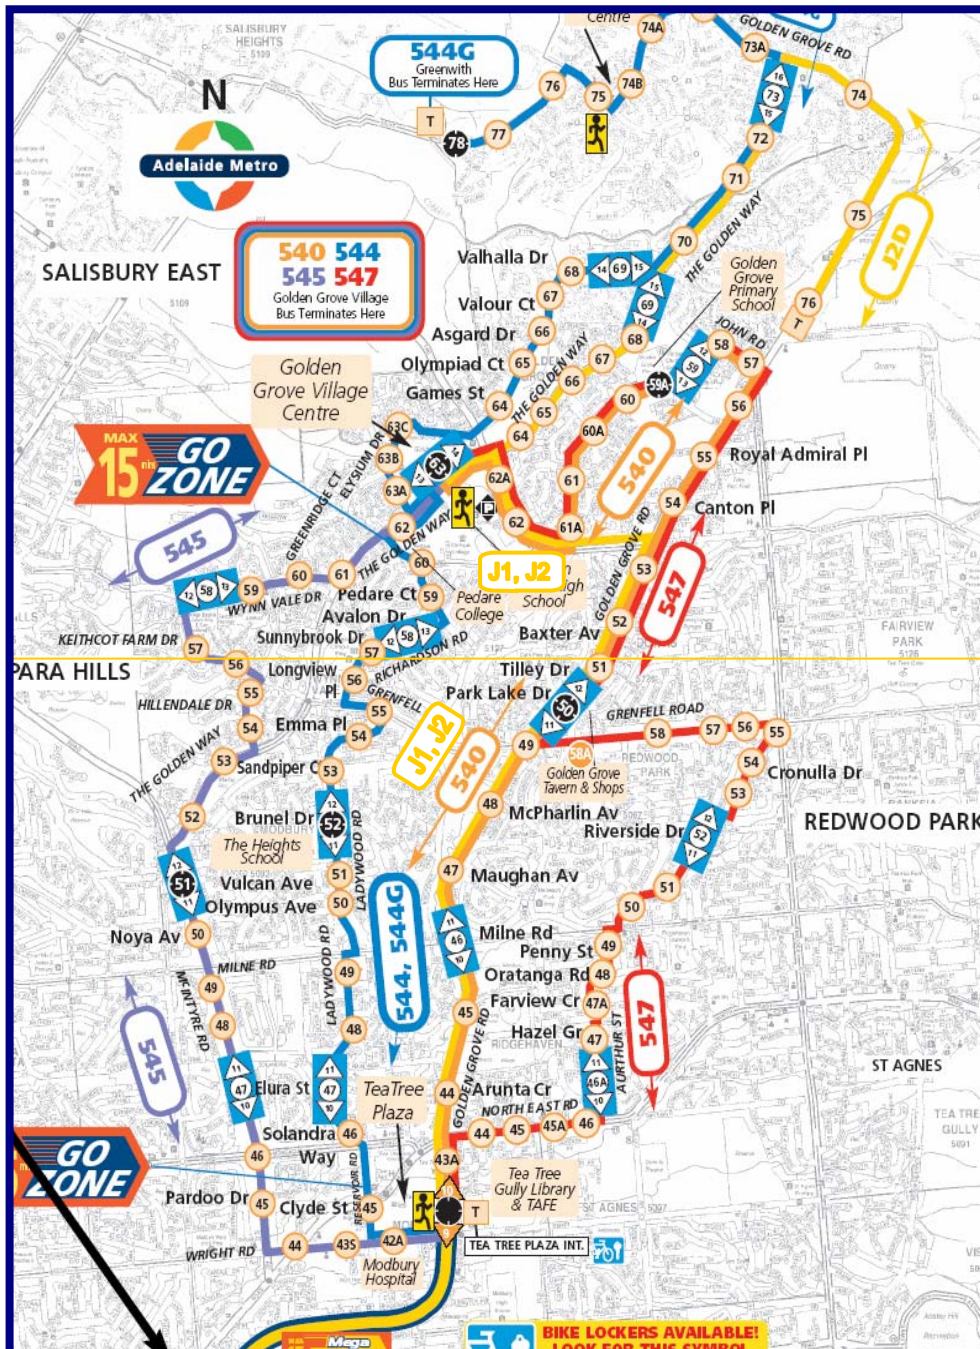
A number of bus routes use Golden Grove Road. In order to provide an uninterrupted traffic lane, bus stops should be indented.

Figure 11: Bus routes present on Golden Grove Road

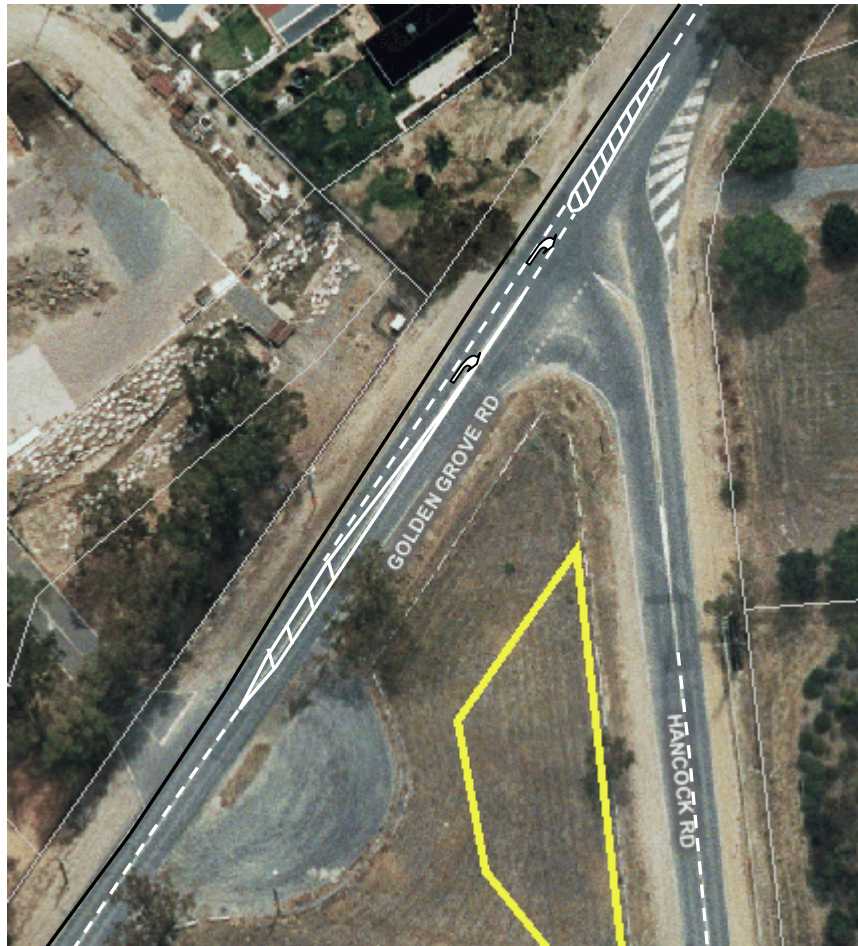
7.1.2 Golden Grove Road – Hancock Road

A moderate number of collisions have occurred at this junction (9 recorded crashes in the period 2000 – 2004).

- Install a protected right turning lane along Golden Grove Road to reduce the rear end and right angle crashes
- Investigate the longer-term traffic management options, including the realignment of the junction or the provision of a roundabout.

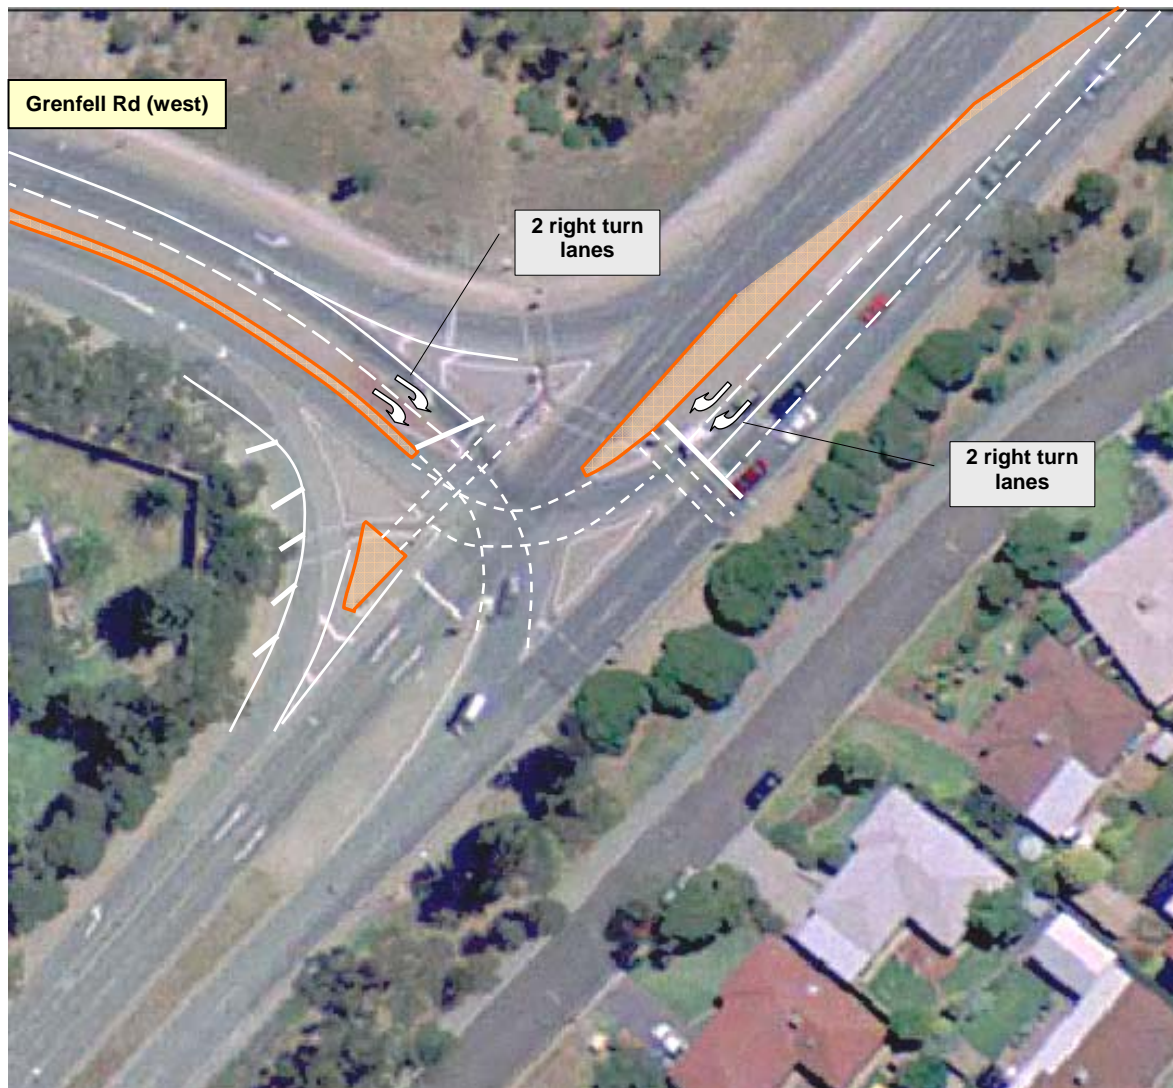
7.1.5 Golden Grove Road – Grenfell Road (west) Intersection

This junction has been investigated to improve its safety record and has subsequently been submitted for Black Spot funding for improvements in the 2005/06 financial year. Analysis of the recorded collision data indicates that the addition of a second right turn lane on Golden Grove Road and the controlling of this right turn movement will reduce the number of collisions occurring at this site. In addition, a second right turn lane on Grenfell Road (west) should also be installed to reduce the traffic delays at the junction.

Refer concept sketch below.

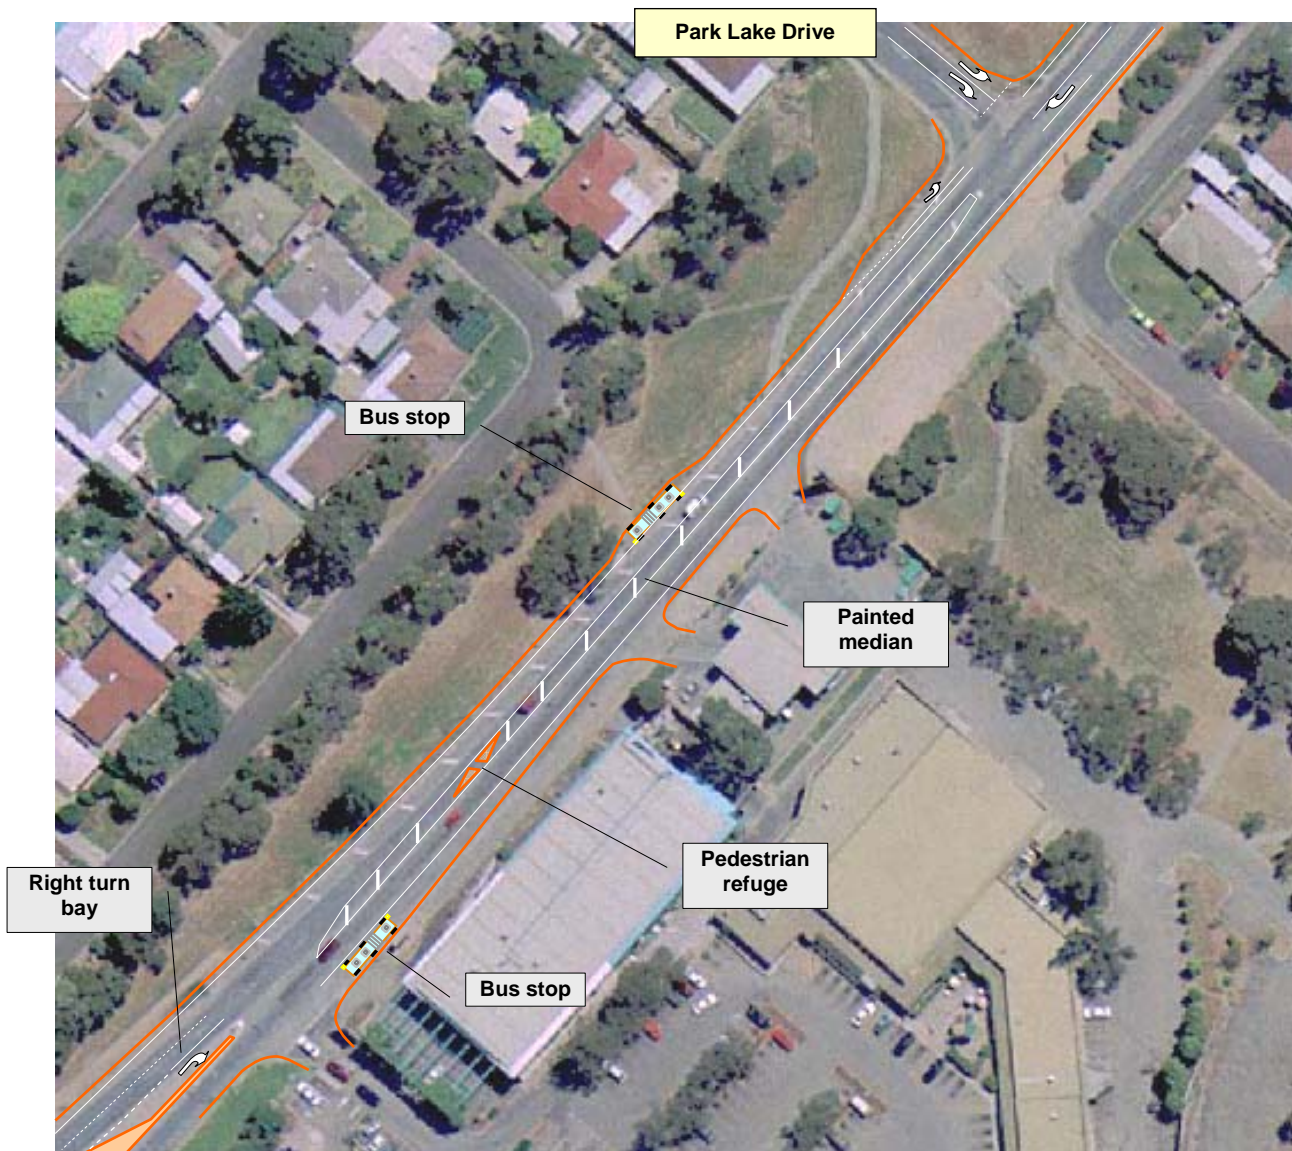
7.1.13 Golden Grove Road: Park Lake Drive – Grenfell Road (east)

- Provide protected turning lanes (painted median) in accordance with preferred scheme
- Install raised pedestrian refuge
- Refer concept sketch below.

ROAD SECTION	TREATMENT	PRIORITY
Golden Grove Road Park Lake Drive to Grenfell Road (east)	In conjunction with Council, install protected turning lanes, install pedestrian refuge, install pedestrian walkthrough, and indent bus bay. Refer Concept Sketch.	High
Golden Grove Road Dewer Avenue to Gold Court	Further detailed analysis of the collision information is required.	
Golden Grove Road Gold Court to North East Road	Further detailed analysis of the collision information is required.	
Golden Grove Road One Tree Hill Road to The Grove Way / Yatala Vale Road	Undertake pavement widening, install painted median where direct access to adjacent properties is required, indent and seal bus bays and install on-road bicycle lanes. Refer Figure 6 and 7.	Medium
Golden Grove Road The Grove Way / Yatala Vale Road to Park Lake Drive	Undertake pavement widening, indent and seal bus bays, and install on-road bicycle lanes. Refer Figure 7.	High
