# Road Structures Inspection Manual

## Part 4C: Condition State Guidelines and Photographs

### Other Structures

Part 4C: Condition State Guidelines and Photographs – Other Structures  
Department of Planning, Transport and Infrastructure, South Australia

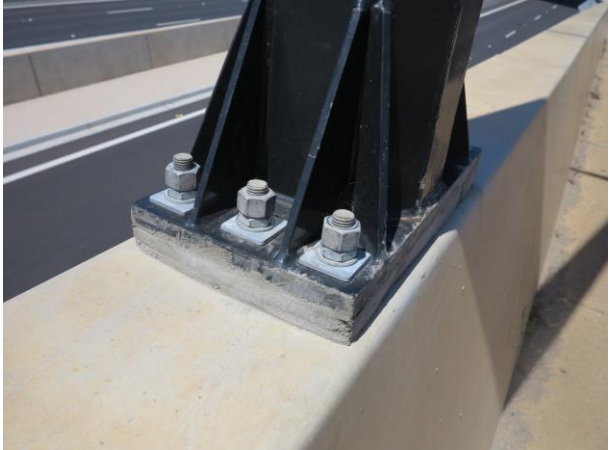
| 70P - Support systems – precast concrete | | Units |
|---|---|---|
| <ul style="list-style-type: none"> <li>The parapet is in good condition with possibly only a few fine cracks away from the hold down bolts and has not been damaged or displaced by vehicle impact.</li> </ul> | <p>Concrete parapet support in good condition</p> | |

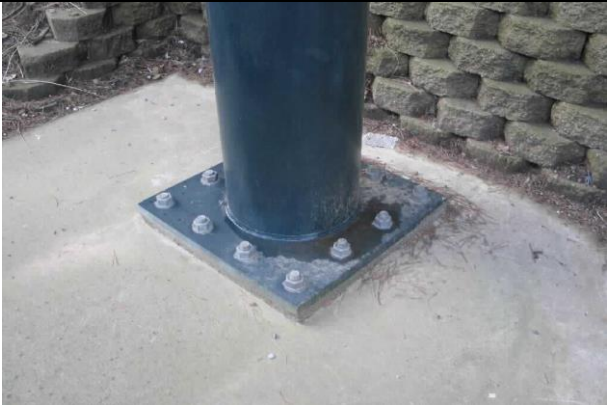
| 70C - Footings – cast in-situ concrete | | Units |
|---|---|---|
| <ul style="list-style-type: none"> <li>The footing / parapet is in good condition with possibly only a few fine cracks away from the hold down bolts.</li> </ul> | <p>Spread footing in good condition</p> | |

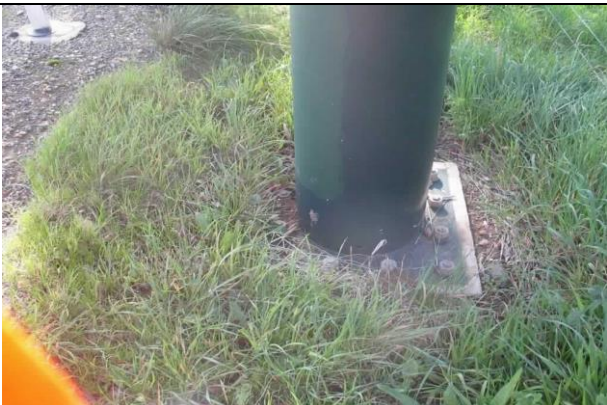
| 70C - Footings – cast in-situ concrete | | Units |
|---|---|---|
| <ul style="list-style-type: none"> <li>The footing / parapet may have some minor spalling due to corrosion of reinforcement close to the surface.</li> <li>There may be some fine cracking around the hold down bolts due to forces transferred through the bolts.</li> <li>Minor soil/vegetation build up around or partially covering footings.</li> </ul> | <p>Footing partially covered by soil and vegetation</p> | |

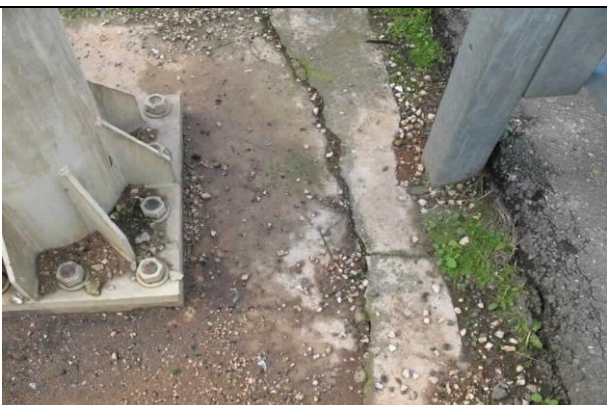
| 70C - Footings – cast in-situ concrete | | Units |
|---|---|---|
| <ul style="list-style-type: none"> <li>The footing / parapet may have some moderate spalling due to corrosion of reinforcement close to the surface.</li> <li>There may be some minor cracking around the hold down bolts due to forces transferred through the bolts.</li> <li>Moderate soil/vegetation build up around and covering footings.</li> </ul> | <p>Transverse fracture in footing concrete</p> | |

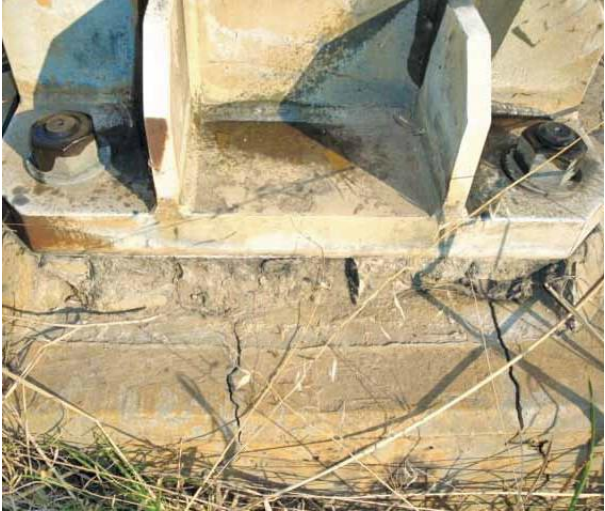
| Condition state 4 -Description | Photo |
|---|---|
| <ul style="list-style-type: none"> <li>• There may be medium cracking or spalling due to corroding reinforcement.</li> <li>• Small delaminations may exist with corroding steel having moderate section loss.</li> <li>• Structural cracking around the hold down bolts is minor but there may also be some minor spalling associated with the bolt forces.</li> <li>• There may be some minor loss of bearing support. There is no scour beneath the spread footing base.</li> </ul> | <p>The concrete footing is severely cracked (VicRoads)</p> |

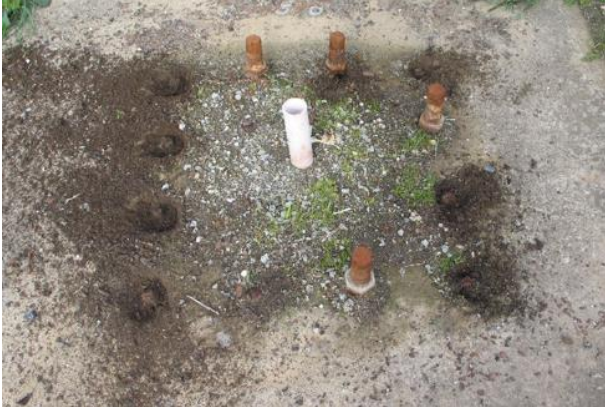
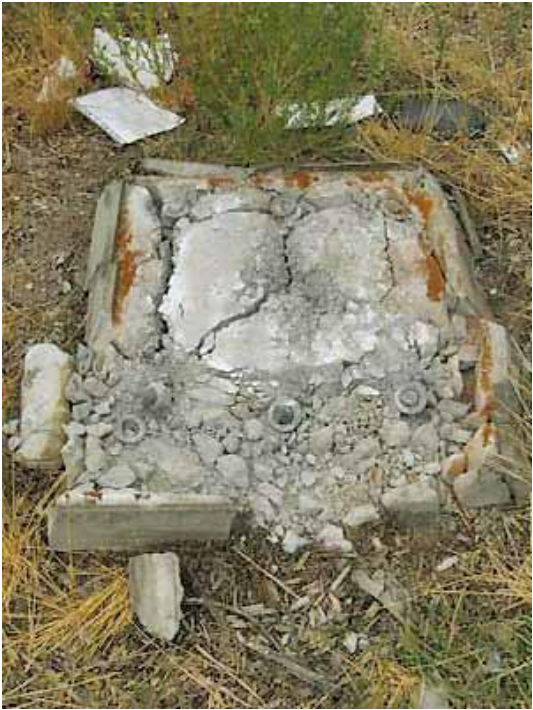
| Condition state 4 -Description | Photo |
|---|---|
| <ul style="list-style-type: none"> <li>• There may be severe cracking or spalling due to corroding reinforcement.</li> <li>• Moderate size delaminations may exist with corroding steel having more severe section loss.</li> <li>• Structural cracking and spalling around the hold down bolts, associated with the transferred bolt forces, is medium.</li> <li>• There may be substantial loss of bearing support. Spread footings may have been undercut by scour action.</li> </ul> | <p>Footing is unsound due to severe anchor rod corrosion</p> <p>The concrete footing is severely cracked and crushed (VicRoads)</p> |

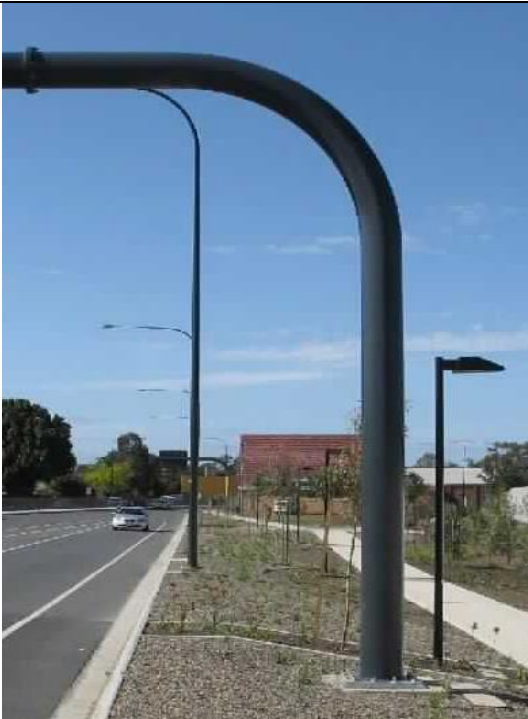
| 71S - Columns – steel | | Units |
|---|---|---|
| <ul style="list-style-type: none"> <li>The paintwork is generally in good condition with only minor chalking, curling or peeling, but no metal exposure.</li> <li>If dual columns, they are adequately braced or stiffened, and all connections are in good condition.</li> </ul> | <p>Column is in good condition</p> | |

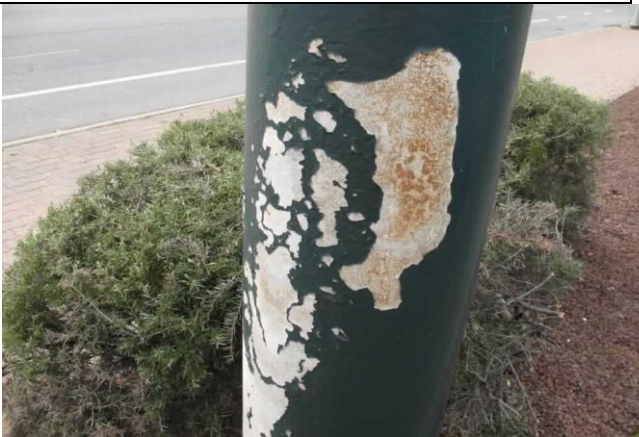
| 71S - Columns – steel | | Units |
|---|---|---|
| <ul style="list-style-type: none"> <li>Painted steelwork may have minor rust spotting to the surface area and the protective coating is losing effectiveness.</li> <li>The columns may not be effectively braced or the connections may be slightly loose or corroded.</li> </ul> | <p>Column has flaking paint and minor corrosion</p> | |

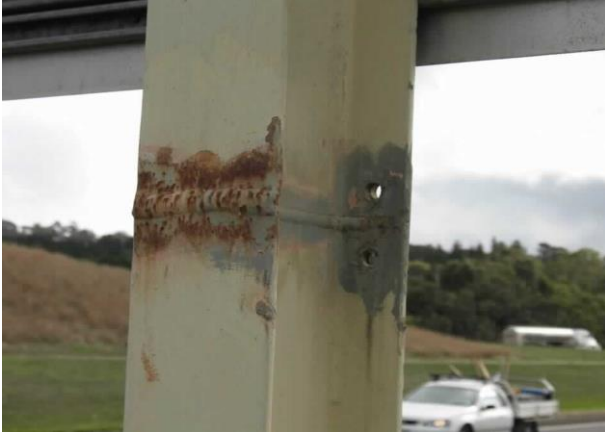
| Condition state 3 -Description | Photo |
|---|---|
| <ul style="list-style-type: none"> <li>Painted steelwork may have moderate rust spotting to the surface area and the protective coating is no longer effective.</li> <li>The columns may not be effectively braced or the connections may be loose or corroded.</li> </ul> | <p>Rust spotting on column (has been previously painted but rusting again)</p> |

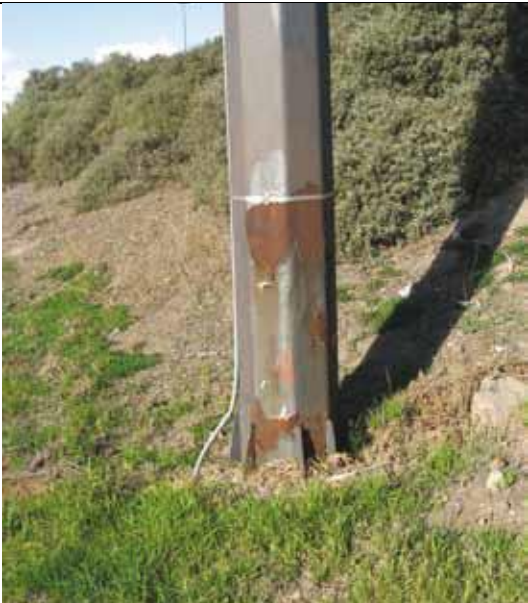
| Condition state 3 -Description | Photo |
|---|---|
| <ul style="list-style-type: none"> <li>Steelwork has medium corrosion and the paint system has failed with significant surface area rusted.</li> <li>Surface pitting may be evident but section loss is minor.</li> <li>Bracing may be ineffective or non-existent and connections may be heavily corroded or loose.</li> <li>Surface damage due to collision impact may be evident but there is no deformation of the section.</li> </ul> | <p>Steel mast has no visible damage but surface corrosion and peeling of coating is evident (VicRoads)</p> |

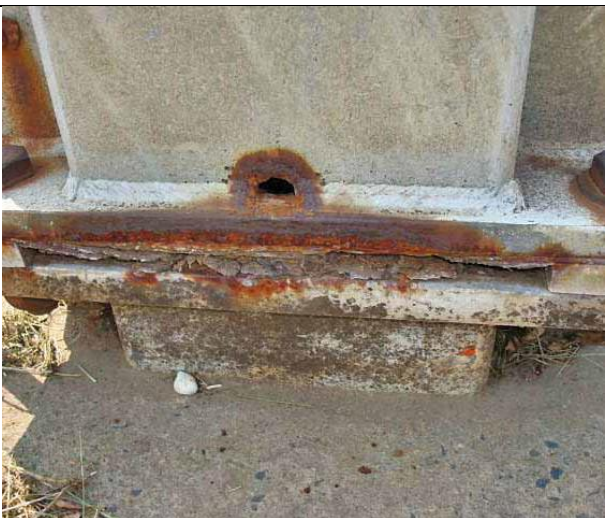
| Condition state 3 -Description | Photo |
|---|---|
| <ul style="list-style-type: none"> <li>Steelwork is severely corroded with up moderate loss of section.</li> <li>The paint system has completely failed requiring cleaning back to bright metal and repainting.</li> <li>Nuts or bolts are severely corroded and possibly no longer functioning to full capacity.</li> <li>Connections may be very loose or bracing may be missing or totally ineffective.</li> <li>There may be visible evidence of cracking in the parent metal or welds.</li> <li>Deformation of section due to collision impact damage is evident.</li> </ul> | <p>Column wall was corroded through (VicRoads)</p> |

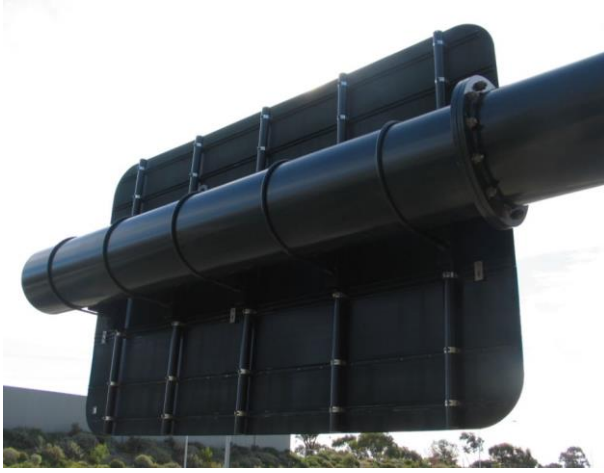
| 72S - Cantilever arms or gantry beams – steel | | Units |
|---|---|---|
| <ul style="list-style-type: none"> <li>The paintwork is generally in good condition with only minor chalking, curling or peeling, but no metal exposure.</li> <li>If dual arms, they are adequately braced or stiffened, and all connections are in good condition.</li> </ul> | <p>Gantry arm is in good condition</p> | |

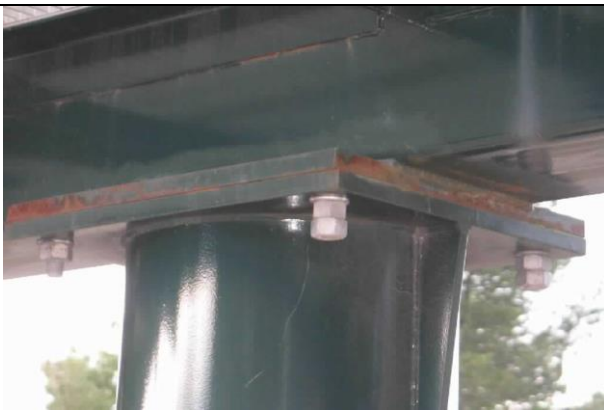
| 72S - Cantilever arms or gantry beams – steel | | Units |
|---|---|---|
| <ul style="list-style-type: none"> <li>Painted steelwork may have minor rust spotting to the surface area and the protective coating is losing effectiveness.</li> <li>The arms may not be effectively braced or the connections may be slightly loose or corroded.</li> <li>Connection bolts may be tight but too short and not fully threaded.</li> </ul> | <p>Connector plates at top of column rusting</p> | |

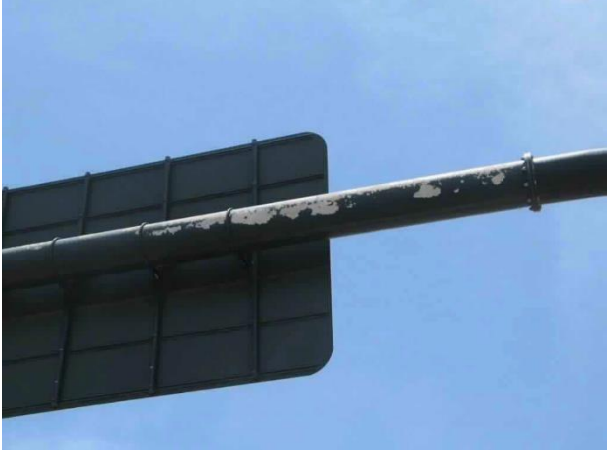
| Condition state 3 -Description | Photo |
|---|---|
| <ul style="list-style-type: none"> <li>Painted steelwork may have moderate rust spotting to the surface area and the protective coating is no longer effective.</li> <li>The arms may not be effectively braced or the connections may be loose or corroded.</li> </ul> | <p data-bbox="791 651 1401 712">Large areas of paint peeling and flaking from horizontal member</p> |

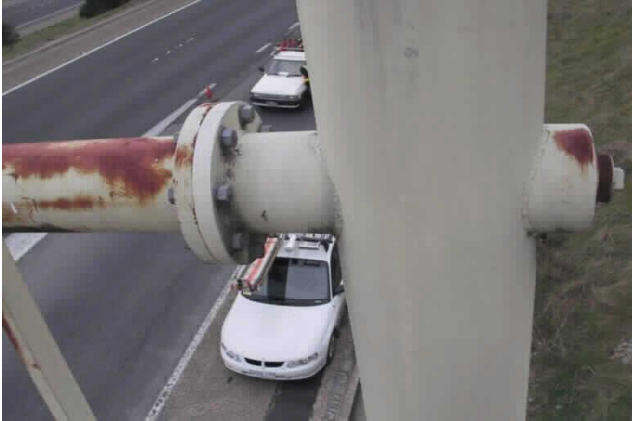
| Condition state 3 -Description | Photo |
|---|---|
| <ul style="list-style-type: none"> <li>Steelwork has medium corrosion and the paint system has failed with significant surface area rusted.</li> <li>Surface pitting may be evident but section loss is only minor.</li> <li>Bracing may be ineffective or non-existent and connections may be heavily corroded, loose or only half threaded.</li> </ul> | <p data-bbox="791 1182 1426 1243">Significant corrosion and minor flaking on horizontal support member</p> |

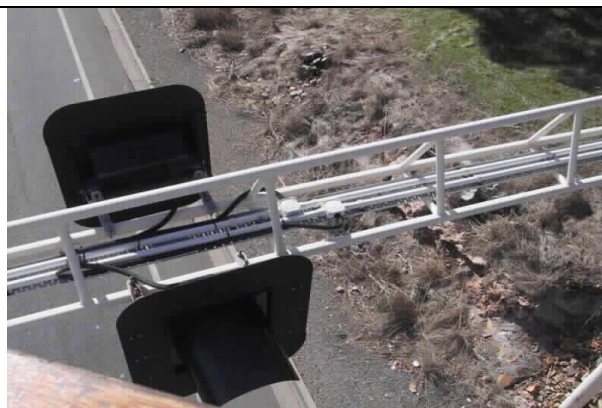
- The paintwork is generally in good condition with only minor chalking, curling or peeling, but no metal exposure.
- The truss should be adequately braced or stiffened, and all connections should be in good condition.

Steel truss in good condition

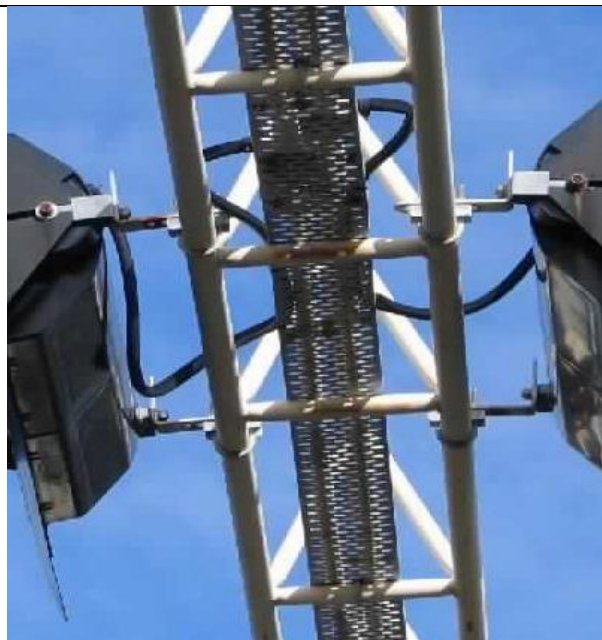
- Painted steelwork may have minor rust spotting to the surface area and the protective coating is losing effectiveness.
- The truss may not be effectively braced or the connections may be slightly loose or corroded.
- Connection bolts may be tight but too short and not fully threaded.

Rust spots on underside of truss members

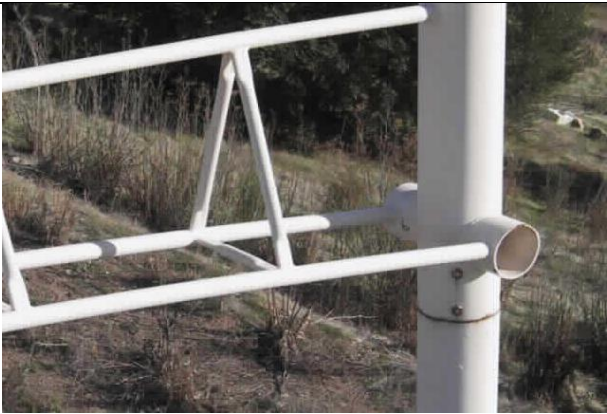
| <b>Condition state 3 -Description</b> <ul style="list-style-type: none"> <li>Painted steelwork may have moderate rust spotting of the surface area and the protective coating is no longer effective.</li> <li>The truss may not be effectively braced or the connections may be loose or corroded.</li> </ul> | <b>Photo</b> <p>Caps from lower chord connection missing and through bolts at top of column corroding</p> |

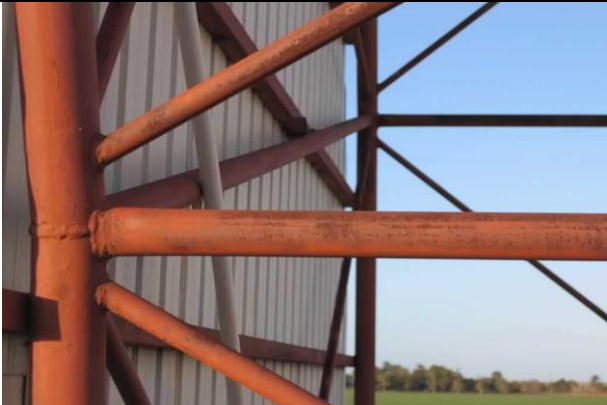
| <b>Condition state 4 -Description</b> <ul style="list-style-type: none"> <li>Steelwork has medium corrosion and the paint system has failed with significant surface area rusted.</li> <li>Surface pitting may be evident but section loss is minor.</li> <li>Bracing may be ineffective or non-existent and connections may be heavily corroded, loose or only half threaded.</li> </ul> | <b>Photo</b> <p>Rusted areas wide spread on truss members</p> |

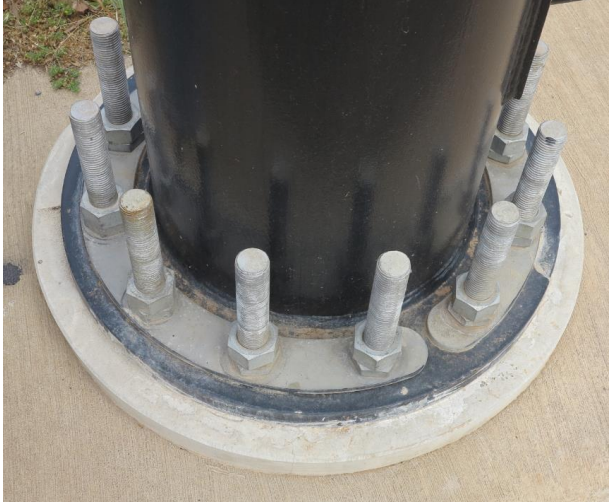
| 74S - Hold down bolts and fittings – steel | | Units |
|---|---|---|
| <ul style="list-style-type: none"> <li>The hold-down bolts and nuts are generally in good condition with no surface rust.</li> <li>All connections are tight and in good condition, with full thread engagement by nuts.</li> <li>Nuts and washers are present on all bolts.</li> </ul> | <p>Hold down bolts and nuts in good condition</p> | |

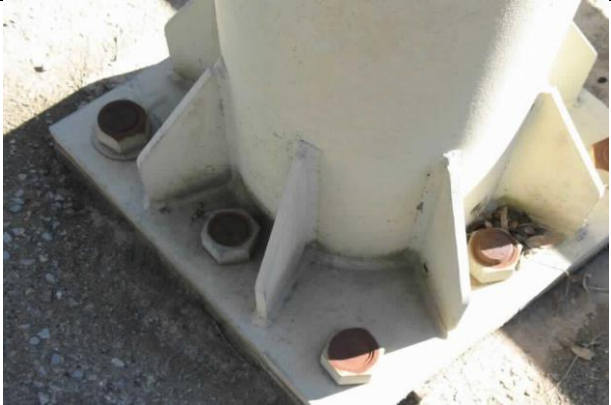
| 74S - Hold down bolts and fittings – steel | | Units |
|---|---|---|
| <ul style="list-style-type: none"> <li>Hold-down bolts and nuts may have minor rust spotting to the surface area. Minor pitting may occur.</li> <li>The connections may be slightly loose.</li> <li>Connection bolts may be tight but too short and not fully threaded. Nuts may be loose, and washers may be absent.</li> </ul> | <p>Top of footing anchor bolts corroding</p> | |

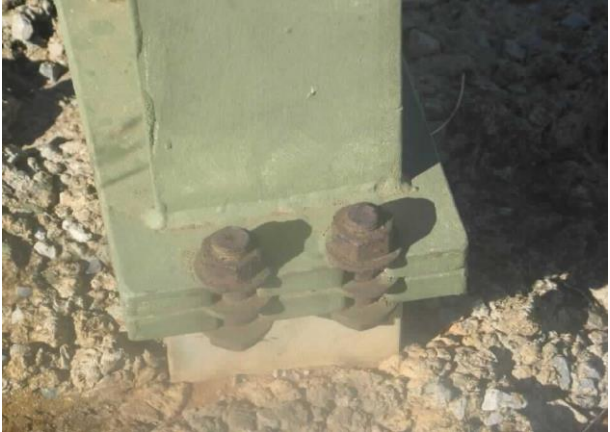
| Condition state 3 -Description | Photo |
|---|---|
| <ul style="list-style-type: none"> <li>• Hold-down bolts and nuts may have moderate rust spotting to the surface area. Moderate pitting may occur.</li> <li>• The connections may be loose.</li> </ul> | <p data-bbox="791 622 1404 656">Corrosion of bolts at base</p> |

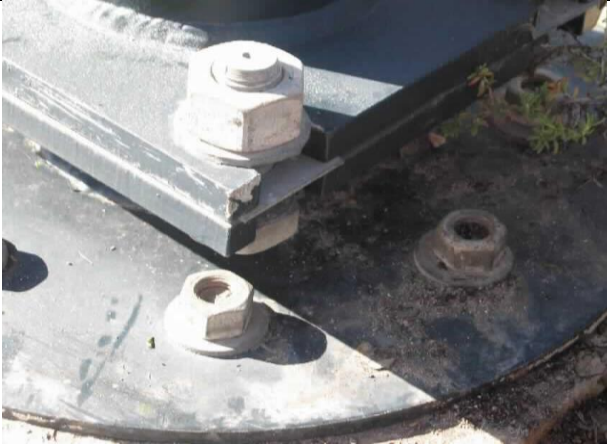
| Condition state 3 -Description | Photo |
|---|---|
| <ul style="list-style-type: none"> <li>• Hold-down bolts and nuts have medium corrosion and the protective coating system has failed with significant surface area rusted.</li> <li>• Surface pitting may be evident but section loss is minor.</li> <li>• The connections may be moderately corroded, loose or only half threaded. One nut may be missing.</li> </ul> | <p data-bbox="791 1131 1404 1193">Nuts on hold down bolts are only engaged over very short thread lengths</p> |

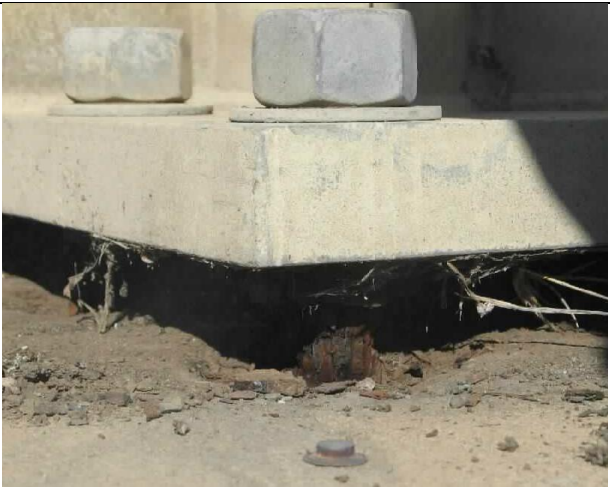
| Condition state 3 -Description | Photo |
|---|---|
| <ul style="list-style-type: none"> <li>• Hold-down bolts and nuts are severely corroded with moderate loss of section.</li> <li>• The paint system has completely failed. Bolts may be fractured and there may be visible evidence of cracking of bolts.</li> <li>• Multiple nuts may be missing or loose.</li> <li>• Fractured or cracked bolts must be recorded and reported immediately.</li> </ul> | <p data-bbox="791 1713 1404 1742">Anchor rods below baseplate severely corroded</p> |

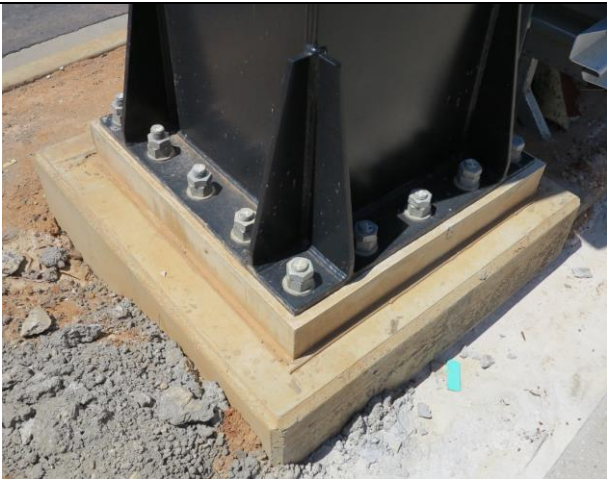
| 75C - Grout or mortar pad beneath baseplate – concrete | | Units |
|---|---|---|
| <ul style="list-style-type: none"> <li>The pad completely fills the area beneath the baseplate, with no shrinkage.</li> <li>The pad is sound with no cracking, spalling or other signs of deterioration.</li> <li>When no pad is present beneath the steel base plate, there is no debris under the base plate.</li> </ul> | <p>Mortar pad in good condition</p> | |

| 75C - Grout or mortar pad beneath baseplate – concrete | | Units |
|---|---|---|
| <p>This component describes any grout or mortar pad beneath the steel baseplate, because it is a critical part of the performance the baseplate and holding down system. A 45° mitre around the baseplate perimeter may be present. In some cases, support blocks are used to provide for initial clamping prior to clamping against hardened grout. Where levelling nuts are provided under the baseplate, the grout or mortar pad may not be present nor required. This detail should be reported for an engineering review.</p> | | Each |

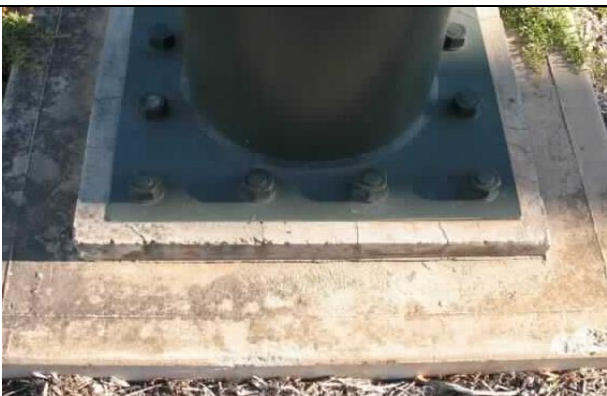
| 75C - Grout or mortar pad beneath baseplate – concrete | | Units |
|---|---|---|
| <ul style="list-style-type: none"> <li>The pad may have fine cracks or small gaps, but is generally sound and fills the area beneath the baseplate.</li> <li>The 45° mitre around the baseplate perimeter may show cracking.</li> <li>When no pad is present, there may be some debris under the base plate.</li> </ul> | <p>Mortar pad has fine cracks</p> | |

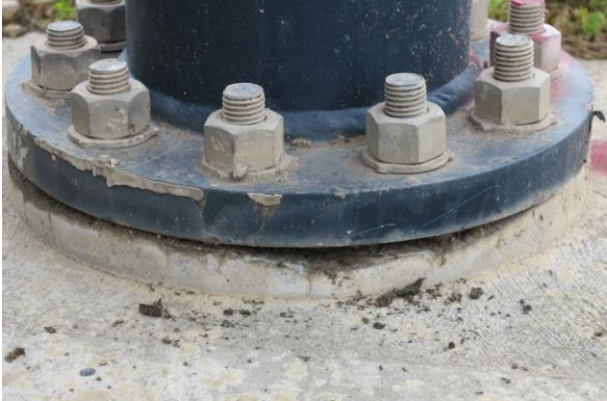
| <p><b>Condition state 3 -Description</b></p> <ul style="list-style-type: none"> <li>• The pad may have moderate cracks or gaps, but is still generally sound and fills the area beneath the baseplate.</li> <li>• The 45° mitre around the baseplate perimeter may show minor cracking.</li> <li>• When no pad is present, there may be debris under the base plate.</li> </ul> | <p><b>Photo</b></p> <p>Gap in grout under base plate</p> |

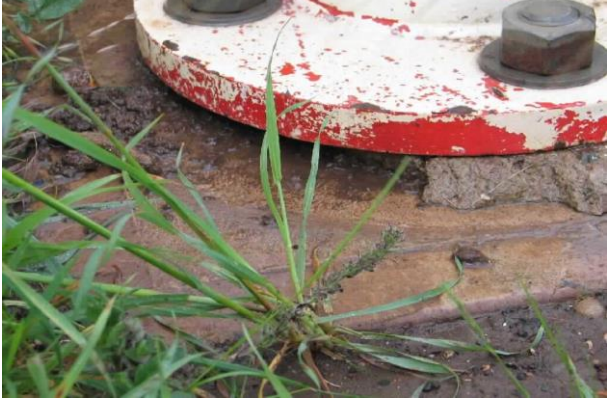
| <p><b>Condition state 4 -Description</b></p> <ul style="list-style-type: none"> <li>• The pad may be severely cracked or contain large gaps where it has spalled or not been installed thoroughly.</li> <li>• The 45° mitre around the baseplate perimeter may be detached for a significant section of perimeter length.</li> <li>• When no pad is present, the base plate may be covered with debris or vegetation.</li> </ul> | <p><b>Photo</b></p> <p>Mortar pad missing a large section of grout</p> |

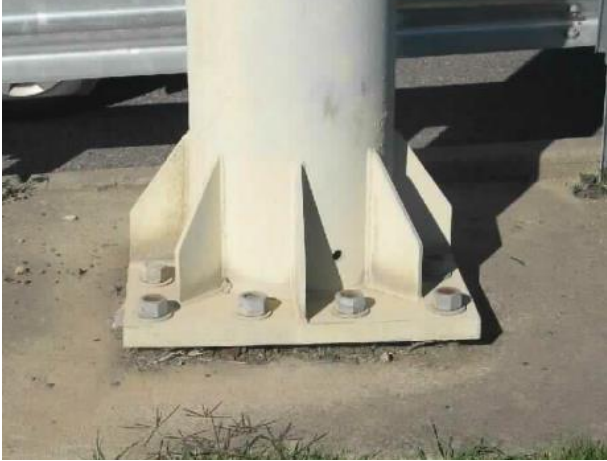
| <p><b>Condition state 5 -Description</b></p> <ul style="list-style-type: none"> <li>• The pad may be completely fractured or not present.</li> </ul> | <p><b>Photo</b></p> <p>No mortar pad under baseplate (not placed at time of construction)</p> |

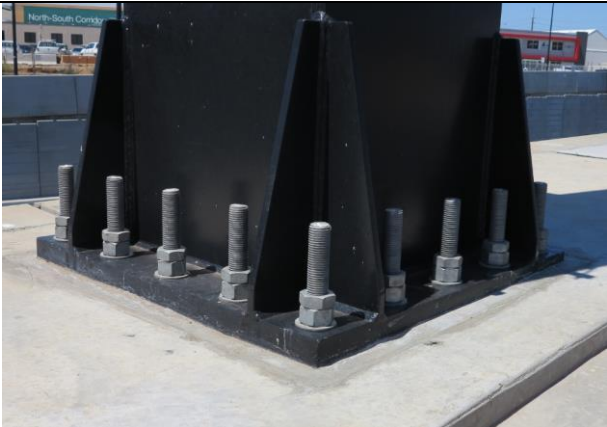
| 75S - Base plates and gussets – steel | | Units |
|---|---|---|
| <ul style="list-style-type: none"> <li>The steelwork and protective coating is generally in good condition with only minor chalking, curling or peeling, but no metal exposure or rusting.</li> <li>All welds have no visible defects.</li> </ul> | <p>Base plate and gusset are in good condition</p> | |

| 75S - Base plates and gussets – steel | | Units |
|---|---|---|
| This component describes base plates, gusset plates and welds at the connection of column to the foundations. Steelwork may be painted or galvanized for protection. Assessment is for steel up to 100 mm above the top of any gussets. | | Each |

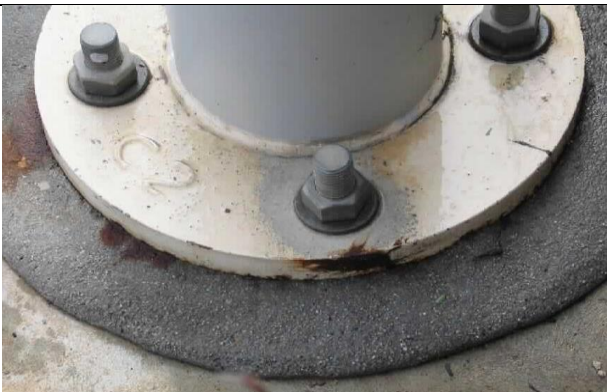
| 75S - Base plates and gussets – steel | | Units |
|---|---|---|
| <ul style="list-style-type: none"> <li>Steelwork may have minor rust spotting to the surface area. Minor pitting may occur.</li> <li>All welds have no visible defects.</li> </ul> | <p>Corrosion starting on base plate</p> | |

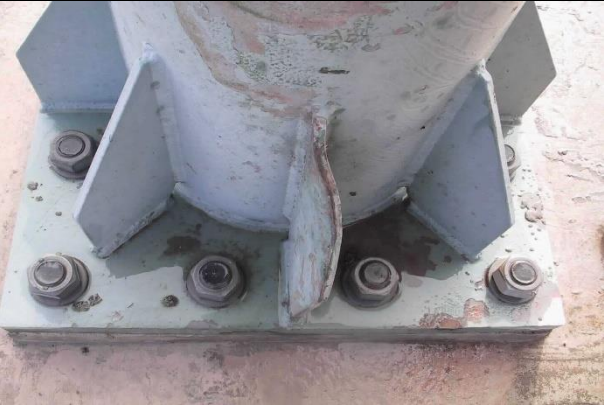
| <p><b>Condition state 3 -Description</b></p> <ul style="list-style-type: none"> <li>Steelwork may have moderate rust spotting of the surface area. Moderate pitting may occur.</li> <li>All welds are sound and have no visible defects.</li> </ul> | <p><b>Photo</b></p> <p>Minor bend on gusset plate</p> |

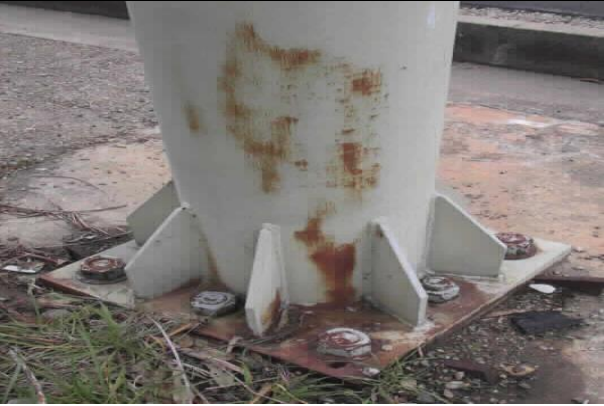
| <p><b>Condition state 4 -Description</b></p> <ul style="list-style-type: none"> <li>Steelwork has medium corrosion and the paint system has failed with significant surface area rusted.</li> <li>Surface pitting may be evident but section loss is minor.</li> <li>Base plates may be buried in soil, debris or vegetation.</li> <li>Paint cracking of paint coatings may occur on weld lines.</li> </ul> | <p><b>Photo</b></p> <p>Base plate is significantly rusted</p> |

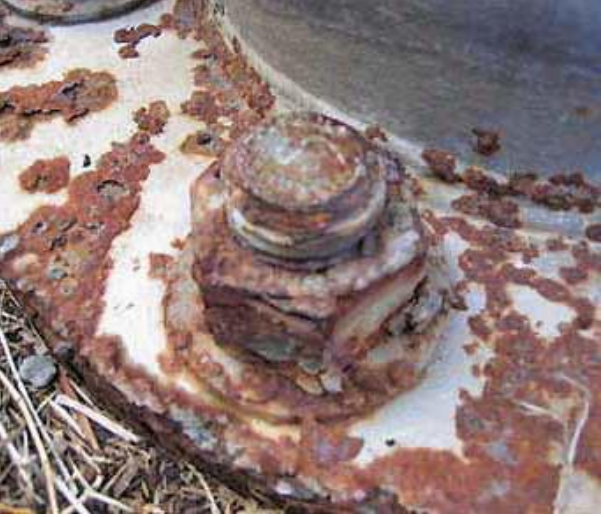
| <p><b>Condition state 5 -Description</b></p> <ul style="list-style-type: none"> <li>Steelwork is severely corroded with moderate loss of section by pitting.</li> <li>Base plates are buried in soil, debris or vegetation.</li> <li>There may be visible evidence of cracking in the parent metal or welds, particularly at top of gussets.</li> <li>This should be recorded and reported immediately.</li> </ul> | <p><b>Photo</b></p> <p>Base plate and gusset is severely corroded and there is a loss of cross section (VicRoads)</p> |

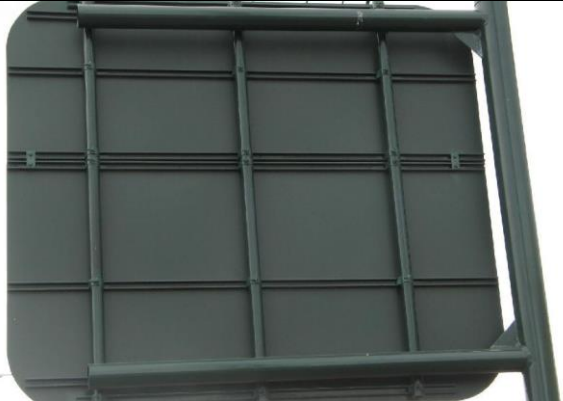
| 76S - Sign face support structure – steel | | Units |
|---|---|---|
| <ul style="list-style-type: none"> <li>The paint or galvanising system is generally sound with only minor chalking, peeling or curling, but with no exposure of metal.</li> <li>All welds, bolts or rivets are in good condition with no movement of plates or sections in the element.</li> <li>There is adequate clearance to the highway.</li> </ul> | <p>All sign face support connections in good condition</p> | |

| 76S - Sign face support structure – steel | | Units |
|---|---|---|
| <p>This item describes the connections of the sign face to the primary structural members and includes all hangers, framing and bracing. Steelwork may be painted or galvanised for protection.</p> <p>Note:</p> <p>Component No. 74S Hold down bolts and 75S Base plates and gussets should be used for the connection of a sign face support structure to a bridge structure.</p> | | Each |

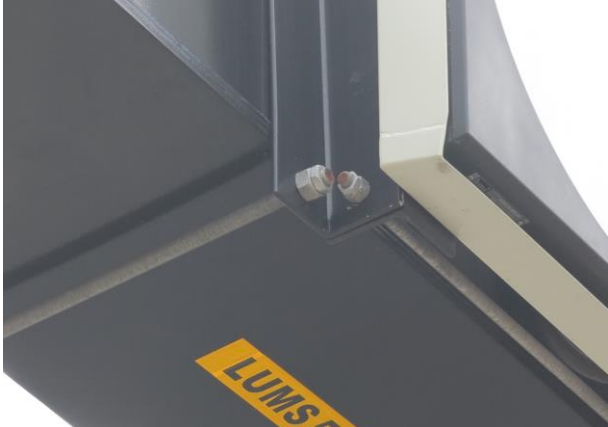
| 76S - Sign face support structure – steel | | Units |
|---|---|---|
| <ul style="list-style-type: none"> <li>Spot rusting of the paint or galvanising system is occurring and the protective coating system is losing effectiveness.</li> <li>Minor rust spotting may have occurred but with no loss of section</li> <li>All member lines are true.</li> <li>All welds, bolts or rivets are in good condition with no movement of plates or sections in the element. Connection bolts may be tight but too short and not fully threaded.</li> </ul> | <p>Minor corrosion to ends of threaded mounting rods</p> | |

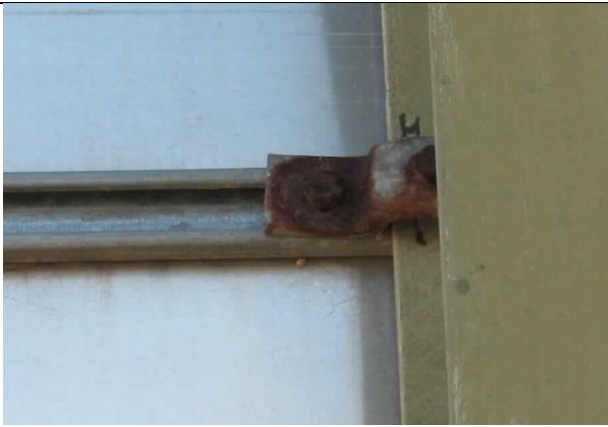
| 76S - Sign face support structure – steel | | Units |
|---|---|---|
| <ul style="list-style-type: none"> <li>Spot rusting of the paint or galvanising system is occurring and the protective coating system is no longer effective.</li> <li>Moderate rust spotting may have occurred but no loss of section has occurred.</li> <li>All welds, bolts or rivets are in fair condition with no movement of plates or sections in the element. Connection bolts should still be tight but may be too short and not fully threaded.</li> <li>There is adequate clearance to the highway.</li> </ul> | <p>Sign clamp corrosion</p> | |

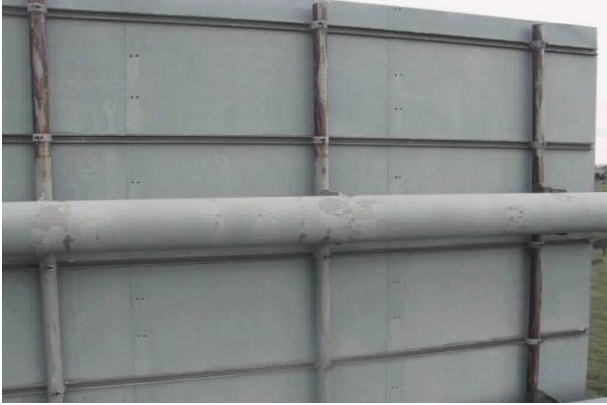
| Condition state 4 -Description | Photo |
|---|---|
| <ul style="list-style-type: none"> <li>Steelwork has moderate corrosion and the protective coating system has completely failed. Surface pitting may be evident but section loss minor.</li> <li>Active corrosion is occurring in isolated areas, but no loss of section is occurring that will affect the strength of the member as a whole.</li> <li>Some nuts and bolts may be corroding but most are still tight and no cracking of welds has occurred.</li> <li>Bracing may not be fully effective and connections may be heavily corroded with isolated loose bolts.</li> <li>There may be minor deviations in the member line and evidence of excessive deflection or movement under dead load or wind loading.</li> <li>Surface damage due to collision impact may be evident but there is no deformation of the section.</li> <li>There may be inadequate clearance to the highway and/or the clearance sign may be missing.</li> <li>Minor surface corrosion is evident around the vent holes.</li> </ul> | <p>Vertical tubes heavily rusted</p> |

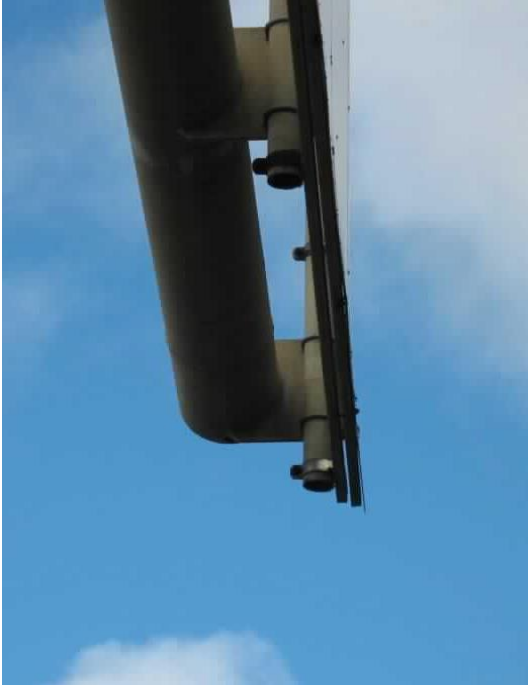
| Condition state 4 -Description | Photo |
|---|---|
| <ul style="list-style-type: none"> <li>Corrosion is well advanced and moderate loss of section has occurred, having a detrimental effect on the strength of the member.</li> <li>Bracing may be ineffective or missing, allowing the support structure or sections thereof to visibly bow under dead loading or deflect noticeably under wind loads.</li> <li>Permanent deflection of members or buckling or distortion of webs, flanges or stiffeners may be evident.</li> <li>Gross deformation of members as a result of impact damage may have occurred.</li> <li>Moderate to heavy surface corrosion is evident around the vent holes.</li> </ul> | <p>Bottom 1/3 edge of sign detached from unistruts (difficult to see but visible movement of sign when trucks pass under)</p> |

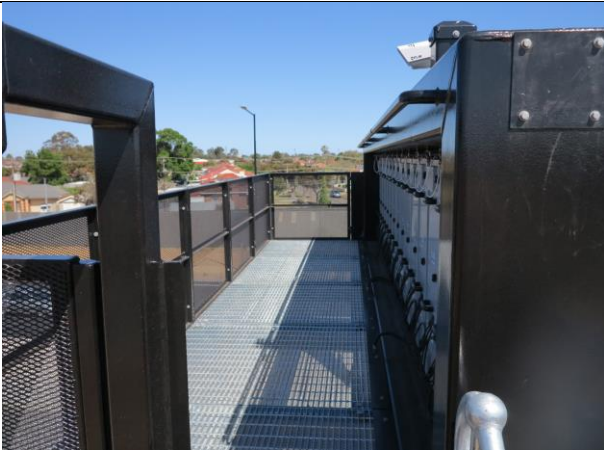
| 77S - Ancillaries (walkways, cable trays, ladders) – steel | | Units |
|---|---|---|
| <ul style="list-style-type: none"> <li>The paintwork is generally in good condition with only minor chalking, curling or peeling, but no metal exposure.</li> <li>All connections are tight and in good condition.</li> <li>Access equipment has been certified and is clearly labelled.</li> <li>There are no tripping hazards, components are fully operational and all locking pins are in place and functional.</li> <li>The equipment is secure and there is no evidence of unauthorised access such as graffiti or other vandalism.</li> </ul> | <p>Walkway and railing in good condition</p> | |

| 77S - Ancillaries (walkways, cable trays, ladders) – steel | | Units |
|---|---|---|
| This item describes the ancillaries provided on the structure for access and security. Steelwork may be painted or galvanized for protection. | | Each |

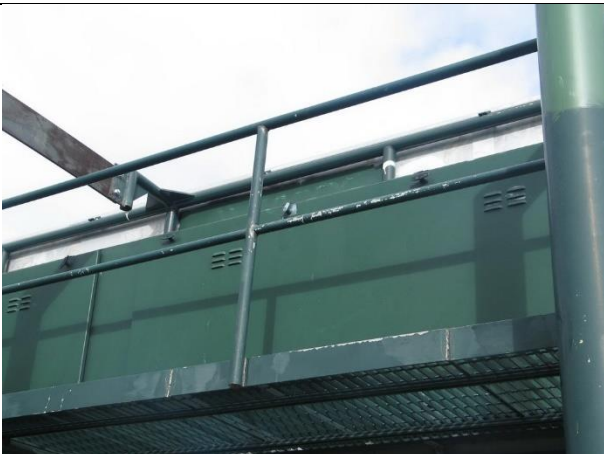
| 77S - Ancillaries (walkways, cable trays, ladders) – steel | | Units |
|---|---|---|
| <ul style="list-style-type: none"> <li>Painted steelwork may have minor rust spotting to the surface area and the protective coating is losing effectiveness.</li> <li>The connections may be slightly loose or beginning to corrode. Connection bolts may be tight but too short and not fully threaded.</li> <li>Access equipment has been certified and is clearly labelled.</li> <li>There are no tripping hazards, components are fully operational and all locking pins are in place and functional.</li> <li>The equipment is secure and there is no evidence of unauthorised access such as graffiti or other vandalism.</li> </ul> | <p>Paint flaking from walkway and railing</p> | |

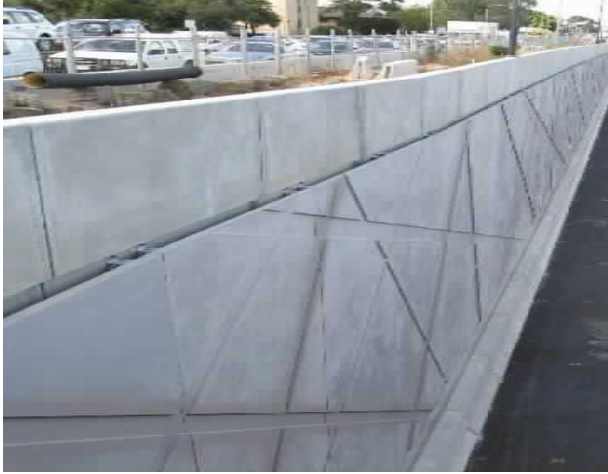
| 80P - Wall facing / panels – precast concrete | | Units |
|---|---|---|
| <ul style="list-style-type: none"> <li>The wall facing system or wall panels have no cracking or spalling.</li> <li>There may be minor dampness or efflorescence powder visible in a few locations.</li> <li>Connections are tight.</li> <li>There is no settlement, sliding, bulging or tilting of wall facing systems or wall panels.</li> </ul> | <p>Precast concrete panels in good condition</p> | |

| 80P - Wall facing / panels – precast concrete | | Units |
|---|---|---|
| <p>This element includes all wall facing systems and wall panels between columns consisting of precast concrete units, including crib headers, stretchers and blocks, keystones and other small interlocking block systems, large hollow and solid interlocking block systems, L and inverted T sections, facing panels and infills. The precast concrete units may be coloured and textured for aesthetic purposes, and may be used as a facade for aesthetic purposes with the true retaining wall hidden behind the facade.</p> <p>For Reinforced Earth walls also refer Component No 8P.</p> | | m <sup>2</sup> of exposed surface area |

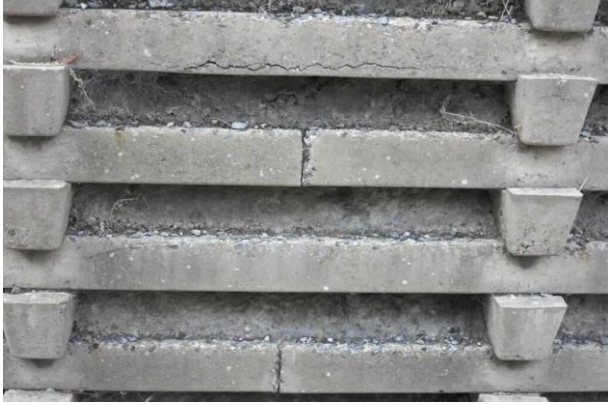
| 80P - Wall facing / panels – precast concrete | | Units |
|---|---|---|
| <ul style="list-style-type: none"> <li>The wall facing system or wall panels have fine cracking or spalling of no consequence.</li> <li>Small sections of wall are showing dampness or efflorescence.</li> <li>Connections are tight wall facing or wall panels are securely held in place.</li> <li>There is no settlement, sliding, bulging or tilting of wall facing system or wall panels.</li> </ul> | <p>Cracked stretcher</p> | |

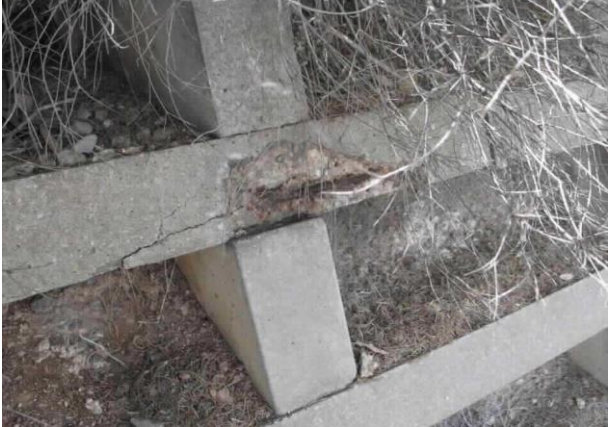
| Condition state 3 -Description | Photo |
|---|---|
| <ul style="list-style-type: none"> <li>• The wall facing system or wall panels have moderate cracking or spalling and may have exposure of reinforcement but no section loss.</li> <li>• Some sections of wall are showing dampness or efflorescence.</li> <li>• Connections are generally tight wall facing or wall panels are reasonably securely held in place.</li> <li>• There may be slight settlement, sliding, bulging or tilting of wall facing system or wall panels.</li> </ul> | <p data-bbox="791 629 1222 651">Moderate spalling to crib wall stretcher</p> |

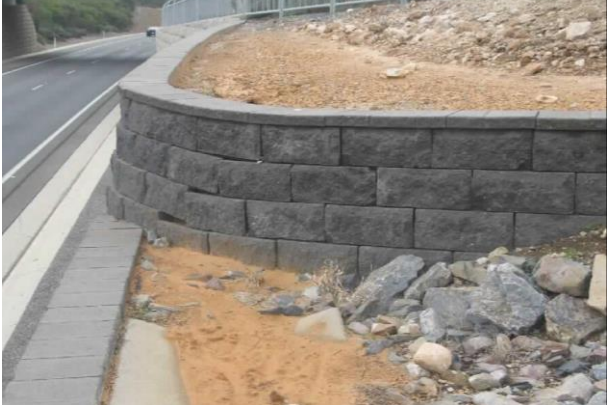
| Condition state 3 -Description | Photo |
|---|---|
| <ul style="list-style-type: none"> <li>• The wall facing system or wall panels have medium cracking and spalling due to corroding reinforcement. Exposed reinforcement may have moderate section loss in isolated areas.</li> <li>• Moderate sections of the wall have dampness or efflorescence.</li> <li>• Connections are loose.</li> <li>• There is minor settlement, sliding, bulging or tilting of wall facing systems or wall panels.</li> </ul> | <p data-bbox="791 1106 1254 1128">Minor settlement evident in keystone wall</p> |

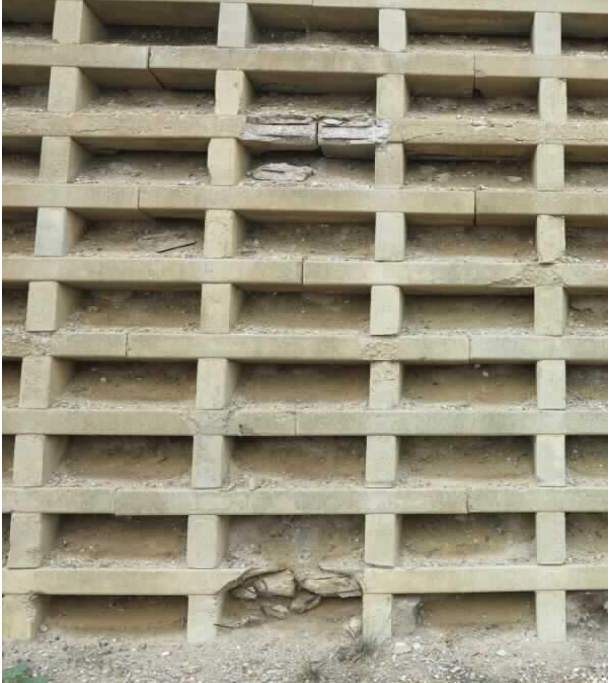
| Condition state 3 -Description | Photo |
|---|---|
| <ul style="list-style-type: none"> <li>• The wall facing system or wall panels have heavy cracking or spalling due to corroding reinforcement affecting both strength and serviceability. Exposed reinforcement may have significant section loss in isolated areas.</li> <li>• Dampness or efflorescence may be quite prevalent.</li> <li>• Connections have failed or are missing.</li> <li>• There is moderate settlement, sliding, bulging or tilting of wall facing systems or wall panels.</li> </ul> | <p data-bbox="791 1861 1326 1917">Heavy spalling to crib header and stretchers with reinforcement exposed and broken</p> |

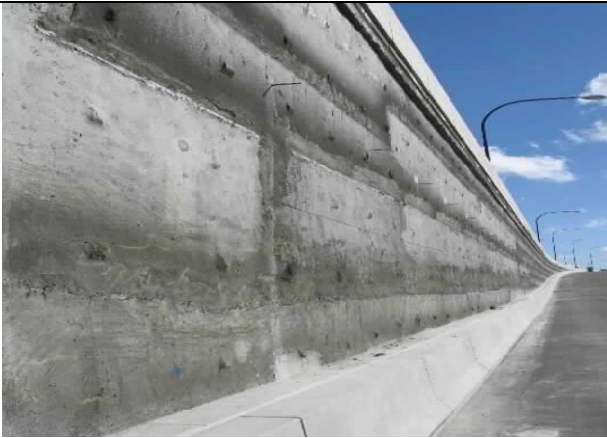
| 80C - Wall facing / panels – cast in-situ concrete | | Units |
|---|---|---|
| <ul style="list-style-type: none"> <li>The wall facing system or wall panels have no cracking or spalling.</li> <li>There may be minor dampness or efflorescence powder visible in a few locations.</li> <li>There is no settlement, sliding, bulging or tilting of wall facing systems or wall panels.</li> </ul> | <p>Shotcrete wall in good condition (prior to placement of precast facing panels)</p> | |

| 80C - Wall facing / panels – cast in-situ concrete | | Units |
|---|---|---|
| This element includes all wall facing systems and wall panels between columns consisting of cast in-situ concrete, including mass concrete, L and inverted T sections, sprayed concrete and infills. The cast in-situ concrete may be coloured and textured for aesthetic purposes. | | m <sup>2</sup> of exposed surface area |

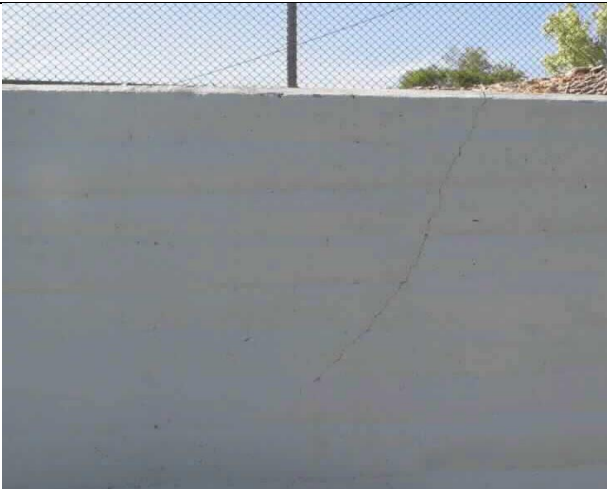
| 80C - Wall facing / panels – cast in-situ concrete | | Units |
|---|---|---|
| <ul style="list-style-type: none"> <li>The wall facing system or wall panels have fine cracking or spalling of no consequence.</li> <li>Minor sections of wall are showing dampness or efflorescence.</li> <li>There is no settlement, sliding, bulging or tilting of wall facing systems or wall panels.</li> </ul> | <p>Concrete wall with fine crack of no consequence</p> | |

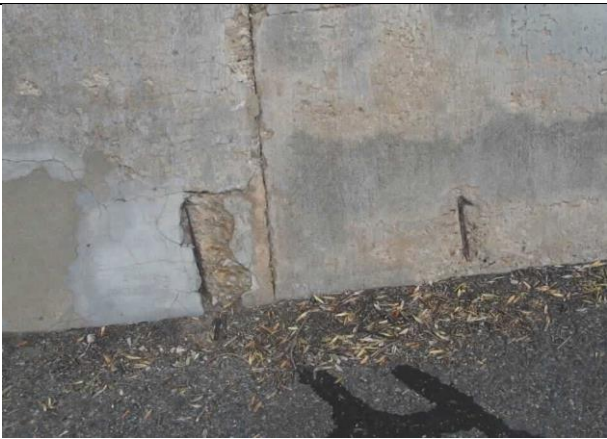
| 80C - Wall facing / panels – cast in-situ concrete | | Units |
|---|---|---|
| <ul style="list-style-type: none"> <li>The wall facing system or wall panels have moderate cracking or spalling and may have exposure of reinforcement but no section loss.</li> <li>Some sections of wall are showing dampness or efflorescence.</li> <li>There is slight settlement, sliding, bulging or tilting of wall facing systems or wall panels.</li> </ul> | <p>Moderate spalling and exposed reinforcement</p> | |

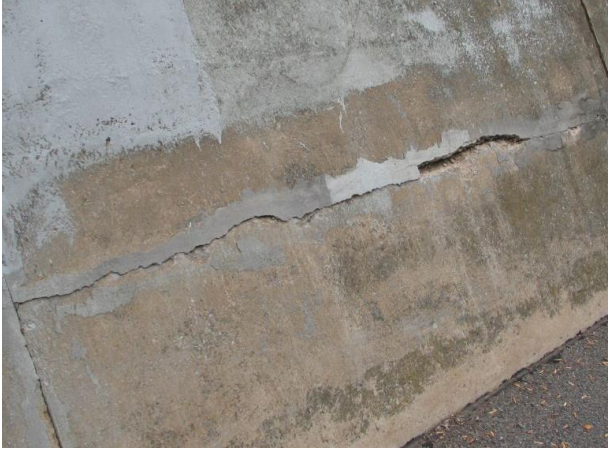
| Condition state 4 -Description | Photo |
|---|---|
| <ul style="list-style-type: none"> <li>• The wall facing system or wall panels have medium cracking and spalling due to corroding reinforcement. Exposed reinforcement may have moderate section loss in isolated areas.</li> <li>• Moderate sections of wall are showing dampness or efflorescence.</li> <li>• There is minor settlement, sliding, bulging or tilting of wall facing systems or wall panels.</li> </ul> | <p data-bbox="791 640 1409 674">Medium cracking and spalling</p> |
