# Road Structures Inspection Manual

## Part 4C: Condition State Guidelines and Photographs

### Other Structures

Part 4C: Condition State Guidelines and Photographs – Other Structures  
Department of Planning, Transport and Infrastructure, South Australia

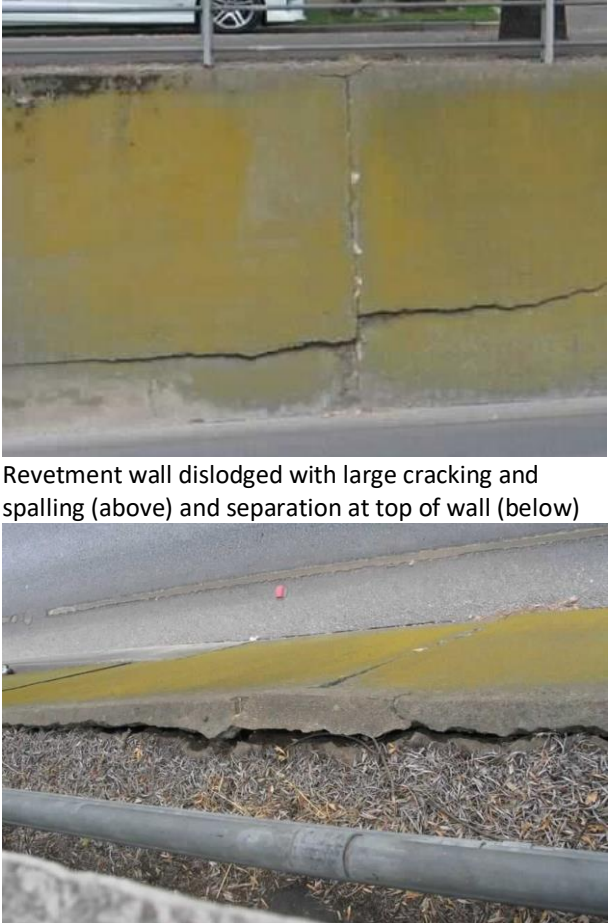
| Condition state 4 -Description | Photo |
|---|---|
| <ul style="list-style-type: none"> <li>• The wall facing system or wall panels have heavy cracking or spalling due to corroding reinforcement affecting both strength and serviceability. Exposed reinforcement may have more severe section loss in isolated areas.</li> <li>• Dampness or efflorescence may be quite prevalent.</li> <li>• There is more moderate settlement, sliding, bulging or tilting of wall facing systems or wall panels.</li> </ul> | <p data-bbox="791 1167 1409 1227">Revetment wall dislodged with large cracking and spalling (above) and separation at top of wall (below)</p> |

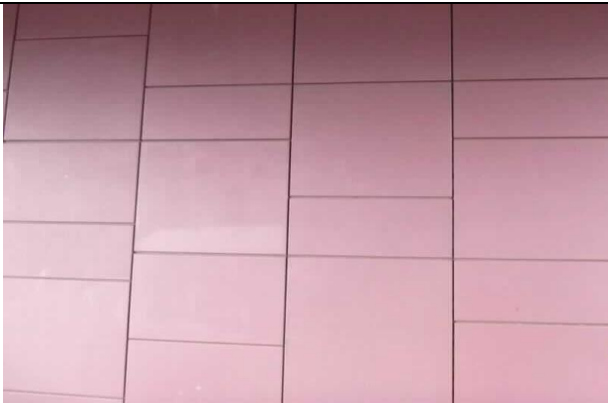
| 80S - Wall facing / panels – steel | | Units |
|---|---|---|
| This element includes all wall facing systems and wall panels between columns manufactured from steel including rolled sections, plates and similar. The steel may be painted, galvanized, PVC coated or uncoated, and may be used as a facade for aesthetic purposes with the true retaining wall hidden behind the facade. | | m <sup>2</sup> of exposed surface area |
| <ul style="list-style-type: none"> <li>No corrosion or deterioration on paint system or galvanising of wall facing system or wall panels.</li> <li>Connections are tight.</li> <li>There is no settlement, sliding, bulging or tilting of wall facing systems or wall panels.</li> </ul> | <p>Steel sheet wall façade in good condition</p> | |

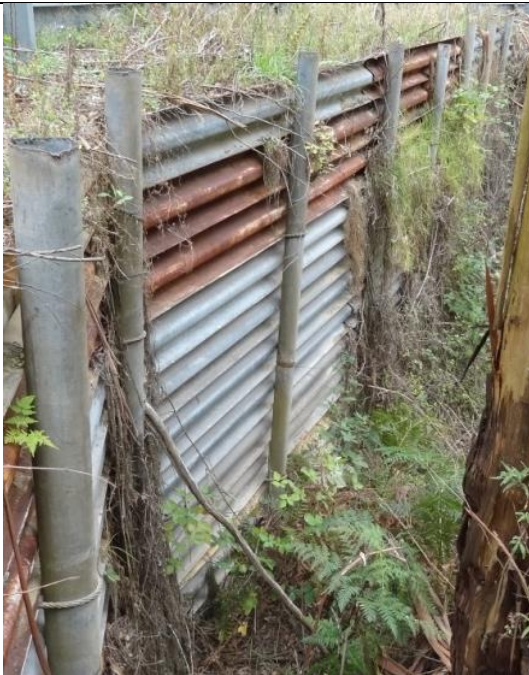
| 80S - Wall facing / panels – steel | | Units |
|---|---|---|
| <ul style="list-style-type: none"> <li>The wall facing system or wall panels have light spot rusting to the surface area and the paint system or galvanising is losing effectiveness.</li> <li>Connections are tight.</li> <li>There is no settlement, sliding, bulging or tilting of wall facing systems or wall panels.</li> </ul> | <p>Rolled sections with spot rusting to up to 5% of the surface area and the galvanising is no longer effective (VicRoads)</p> | |

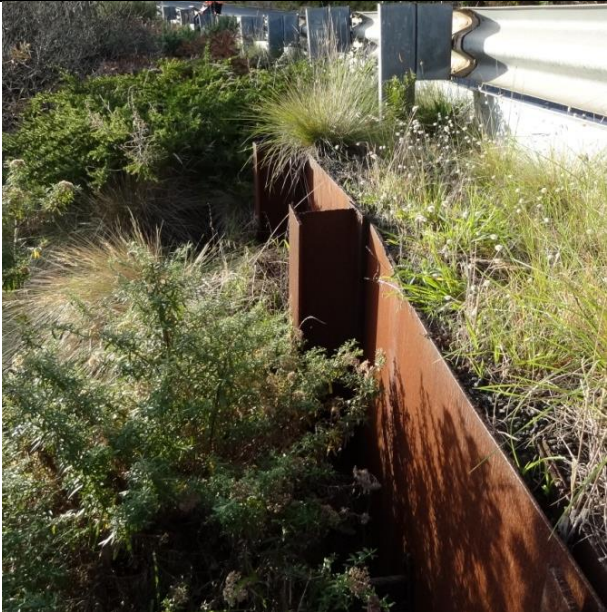
| Condition state 3 -Description | Photo |
|---|---|
| <ul style="list-style-type: none"> <li>• The wall facing system or wall panels has advanced corrosion with loss of section affecting both strength and serviceability.</li> <li>• Connections have failed or are missing.</li> <li>• There is substantial settlement, sliding, bulging or tilting of wall facing systems or wall panels.</li> </ul> | <p data-bbox="791 1518 1401 1615">Plates with advanced corrosion with loss of section affecting strength and substantial bulging between columns (VicRoads)</p> |

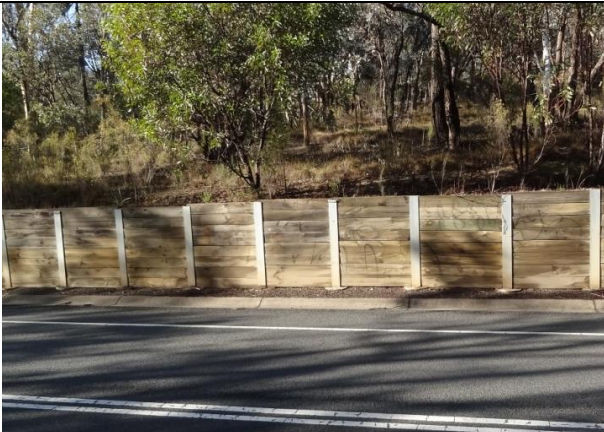
| 80T - Wall facing / panels – timber | | Units |
|---|---|---|
| This element includes all wall facing systems and wall panels between columns manufactured from timber including timber crib headers, stretchers and blocks, sleepers, sawn logs and similar. The timber may be treated or untreated. | | m <sup>2</sup> of exposed surface area |
| <ul style="list-style-type: none"> <li>The wall facing system or wall panels have only minor weathering at the edges or minor damage elsewhere.</li> <li>There is no settlement, sliding, bulging, shrinking or tilting of wall facing systems or wall panels.</li> </ul> | <p>Sleepers with minor weathering at the edges (VicRoads)</p> | |

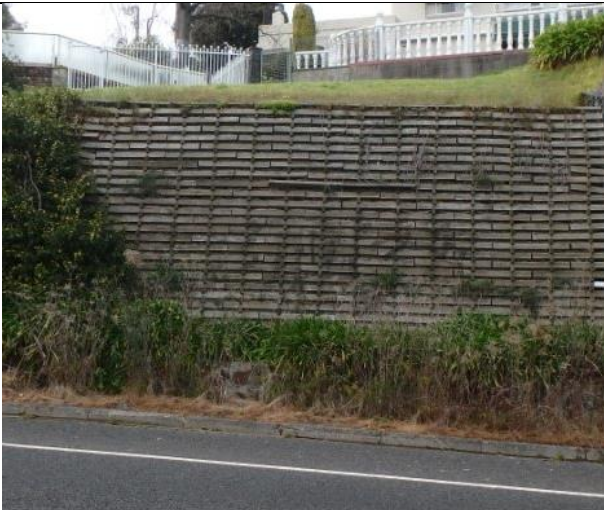
| 80T - Wall facing / panels – timber | | Units |
|---|---|---|
| <ul style="list-style-type: none"> <li>The wall facing system or wall panels have moderate weathering at the edges but away from the connections, or moderate damage elsewhere.</li> <li>There is no settlement, sliding, bulging shrinkage or tilting of wall facing systems or wall panels.</li> <li>Minor sections of wall are showing dampness, mould, moss and fungi growth</li> </ul> | <p>Timber crib headers, stretchers and blocks with moderate weathering at the edges but away from the connections between components (VicRoads)</p> | |

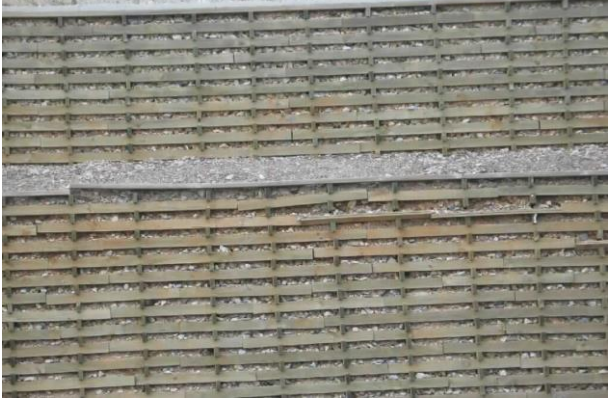
| Condition state 3 -Description | Photo |
|---|---|
| <ul style="list-style-type: none"> <li>• The wall facing system or wall panels have medium weathering at the edges but may also have minor weathering affecting the connections.</li> <li>• There is minor settlement, sliding, bulging shrinkage or tilting of wall facing systems or wall panels.</li> <li>• Moderate sections of wall are showing dampness, mould, moss and fungi growth</li> </ul> | <p data-bbox="791 600 1409 622">Weathered and tilted timber crib headers and stretchers</p> |

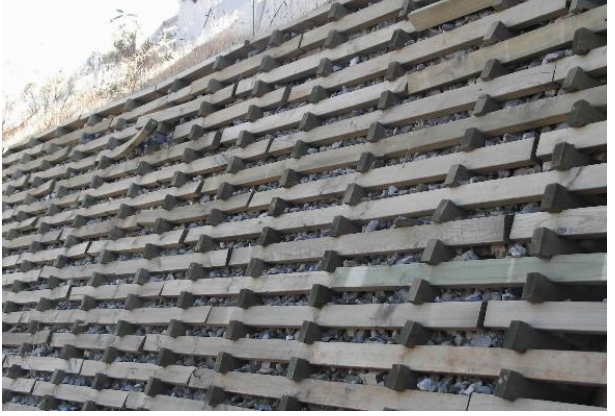
| Condition state 3 -Description | Photo |
|---|---|
| <ul style="list-style-type: none"> <li>• The facing system or wall panels have moderate weathering affecting the connections.</li> <li>• There is moderate settlement, sliding, bulging, shrinkage or tilting of wall facing systems or wall panels.</li> <li>• Significant sections of wall are showing rot, moss and fungi growth</li> </ul> | <p data-bbox="791 1081 1409 1137">Timber crib wall elements bowed and misplaced in several locations</p> |

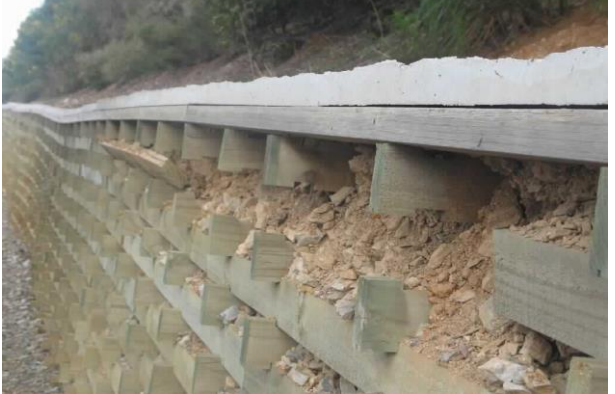
| Condition state 3 -Description | Photo |
|---|---|
| <ul style="list-style-type: none"> <li>• The facing system or wall panels have severe weathering affecting the connections, or have severe damage elsewhere.</li> <li>• There is substantial settlement, sliding, bulging, shrinkage or tilting of wall facing systems or wall panels.</li> <li>• Rot, moss and fungi growth on timber is quite prevalent.</li> </ul> | <p data-bbox="791 1574 1409 1606">Wooden stretchers displaced from timber crib wall</p> |

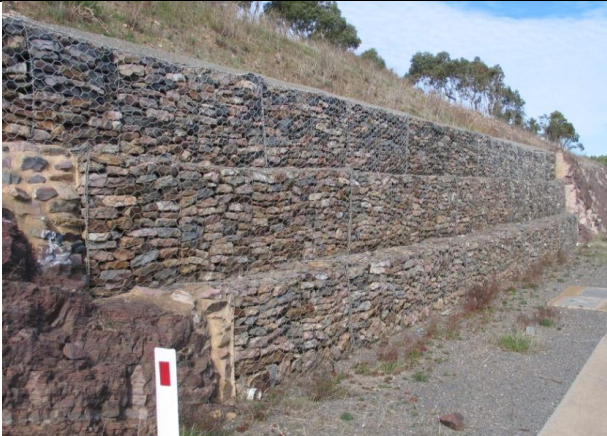
| 800 - Wall facing / panels – other | Units |
|---|---|
| <p>This element includes all wall facing systems and wall panels between columns consisting of granular fill between crib wall headers, gabion fill, masonry (brick or natural stone with mortar) and geotextile (where observable). These may be used as a facade for aesthetic purposes with the true retaining wall hidden behind the facade.</p> <p>It shall include any buttresses and brick columns which protrude out from the face of retaining wall.</p> <p>For Reinforced Earth walls also refer Component No 80.</p> | <p><b>m<sup>2</sup> of exposed surface area</b></p> |
| <ul style="list-style-type: none"> <li>• The crib retaining wall granular fill is not affected by volume loss.</li> <li>• The gabion fill material is not affected by weathering or volume loss.</li> <li>• The masonry is not affected by cracking or loss of mortar, or weathering or loss of brick or natural stone.</li> <li>• The geotextile is not affected by weathering.</li> <li>• There is no settlement, sliding, bulging or tilting of wall facing systems or wall panels.</li> </ul> | <p>Gabion wall in good condition</p> |

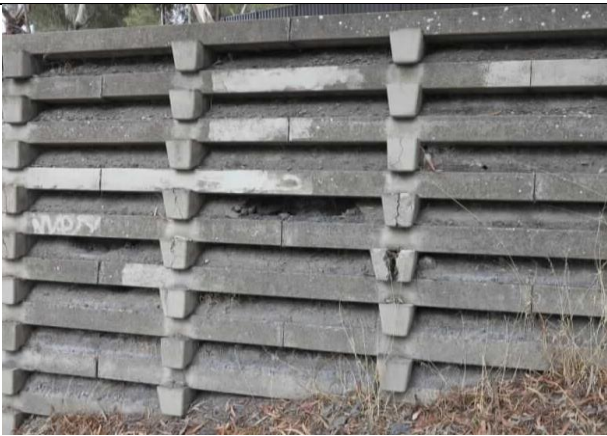
| 800 - Wall facing / panels – other | Units |
|---|---|
| <ul style="list-style-type: none"> <li>• The crib retaining wall granular fill is affected by small volume loss.</li> <li>• The gabion fill material is affected by small volume loss.</li> <li>• The masonry has minor weathering, cracking or loss of mortar or stones.</li> <li>• The geotextile has only minor weathering.</li> <li>• There is no settlement, sliding, bulging or tilting of wall facing systems or wall panels.</li> </ul> | <p>Minor loss of fill in crib wall</p> |

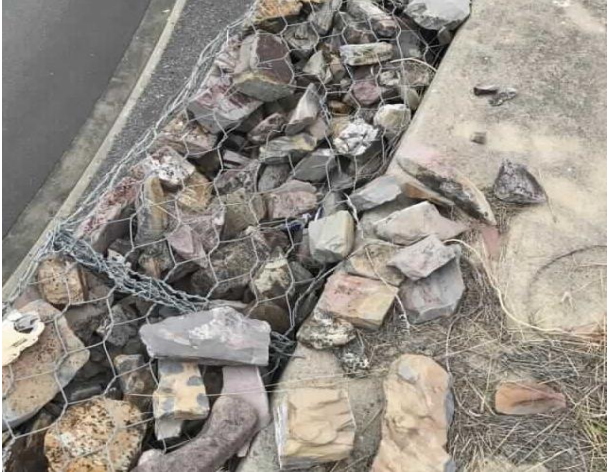
| Condition state 3 -Description | Photo |
|---|---|
| <ul style="list-style-type: none"> <li>• The crib retaining wall granular fill is affected by minor volume loss.</li> <li>• The gabion fill material is affected by minor volume loss.</li> <li>• The masonry has moderate weathering, cracking or loss of mortar or stones.</li> <li>• The geotextile has moderate weathering.</li> <li>• There is minor settlement, sliding, bulging or tilting of wall facing systems or wall panels.</li> </ul> | <p data-bbox="791 667 1134 689">Top of gabion basket torn open</p> |

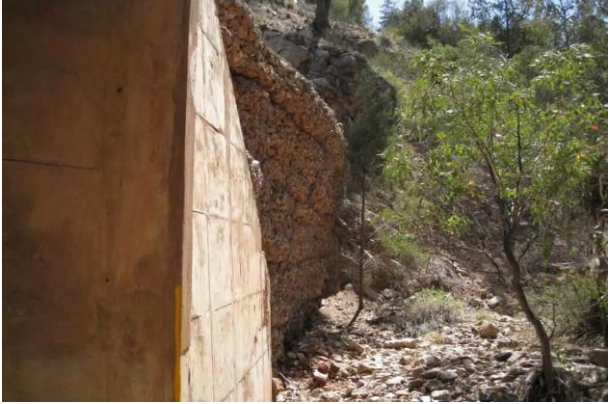
| Condition state 3 -Description | Photo |
|---|---|
| <ul style="list-style-type: none"> <li>• The crib retaining wall granular fill is affected by moderate volume loss.</li> <li>• The gabion fill material is affected by moderate volume loss or moderate weathering.</li> <li>• The masonry has medium weathering, cracking or loss of mortar or stones, or minor loss of bricks.</li> <li>• The geotextile has medium weathering.</li> <li>• There is moderate settlement, sliding, bulging or tilting of wall facing systems or wall panels.</li> </ul> | <p data-bbox="791 1135 1126 1158">Gabion wall deflected outward</p> |

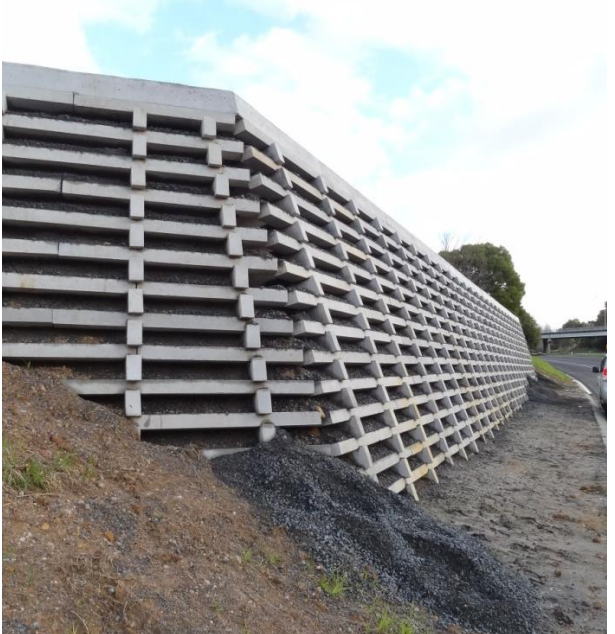
| Condition state 3 -Description | Photo |
|---|---|
| <ul style="list-style-type: none"> <li>• The crib retaining wall granular fill is affected by severe volume loss.</li> <li>• The gabion fill material is affected by severe volume loss or weathering.</li> <li>• The masonry has severe weathering, cracking or loss of mortar. Significant loss of bricks and stones may have occurred which accentuate other damage.</li> <li>• The geotextile has severe weathering.</li> <li>• There is substantial settlement, sliding, bulging or tilting of wall facing systems or wall panels.</li> </ul> | <p data-bbox="791 1836 1390 1888">Crib retaining wall granular fill with severe volume loss (VicRoads)</p> |

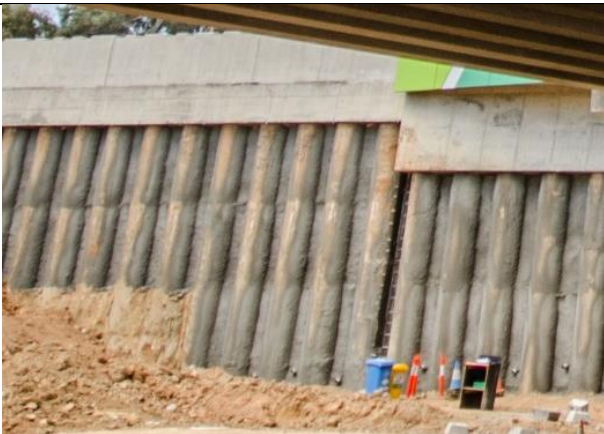
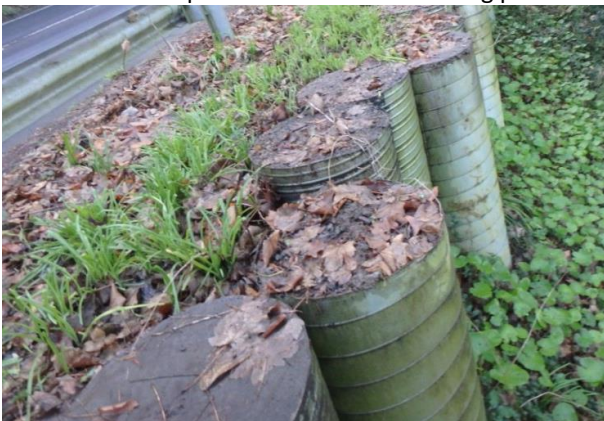
| 81C - Columns – cast in-situ concrete | | Units |
|---|---|---|
| This element includes all bored piles, continuous flight auger (CFA) piles and similar used to form a retaining wall or to support the wall panel system. These piles are installed and then exposed by excavation. | | Each |
| <ul style="list-style-type: none"> <li>The columns have no cracking or spalling.</li> <li>There may be minor dampness or efflorescence powder visible in a few locations.</li> <li>There is no tilting of columns.</li> <li>There is no differential movement between columns, and the wall panels are securely held in place by the columns.</li> </ul> | <p>As-new columns prior to installation of facing panels</p> <p>Columns with no cracking or spalling (VicRoads)</p> | |

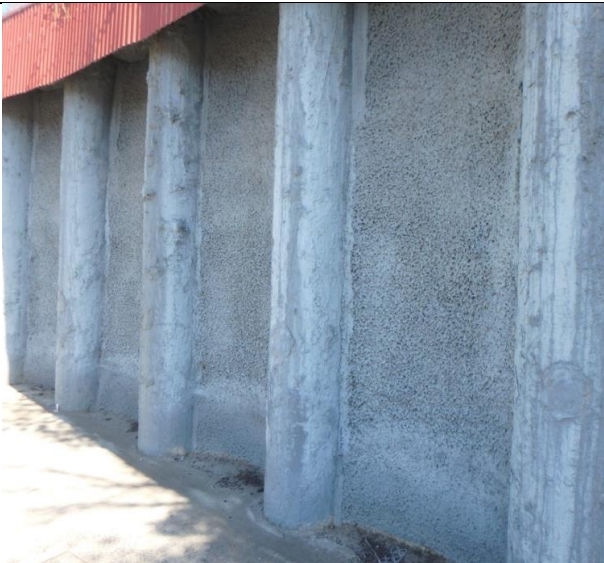
| 81C - Columns – cast in-situ concrete | | Units |
|---|---|---|
| <ul style="list-style-type: none"> <li>The columns have fine cracking or spalling of no consequence.</li> <li>Minor sections of the wall showing dampness or efflorescence.</li> <li>There is no tilting of columns.</li> <li>There is no differential movement between columns, and the wall panels are securely held in place by the columns.</li> </ul> | <p>Columns with fine cracking of no consequence (VicRoads)</p> | |

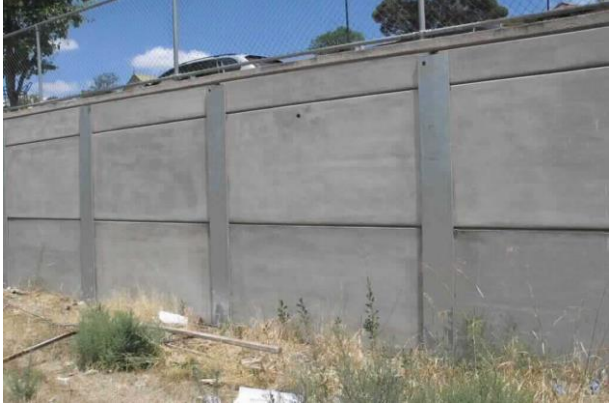
| 81S - Columns – steel | | Units |
|---|---|---|
| This element includes all steel sheet piling and steel columns, driven or bolted in place, to support the wall panel system. The steel may be painted, galvanized or uncoated, and may be used a facade for aesthetic purposes with the true retaining wall hidden behind the facade. | | Each |
| <ul style="list-style-type: none"> <li>The uncoated sheet piles have surface minor surface rust to the entire surface area but no loss of section.</li> <li>The column paint system or galvanising is good condition and not affected by rusting or corrosion.</li> <li>There is no tilting of columns.</li> <li>There is no differential movement between columns, and the wall panels are securely held in place by the columns.</li> </ul> | <p>Columns with galvanising not affected by rusting or corrosion and with no tilting or differential movement</p> | |

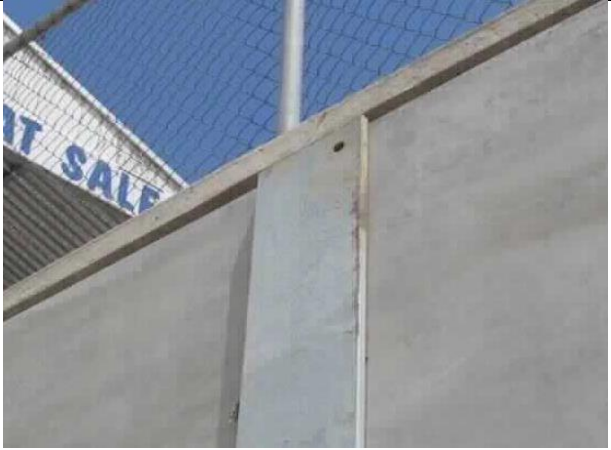
| 81S - Columns – steel | | Units |
|---|---|---|
| <ul style="list-style-type: none"> <li>The uncoated sheet piles have surface rusting to the entire surface area but any corrosion is slight and of no consequence</li> <li>The columns have light spot rusting to the surface area and the paint system or galvanising. Corrosion may be visible on the flanges but is minor and of no consequence.</li> <li>There is no tilting of columns.</li> <li>There is no differential movement between columns, and the wall panels are securely held in place by the columns.</li> </ul> | <p>Steel post with light corrosion starting</p> | |

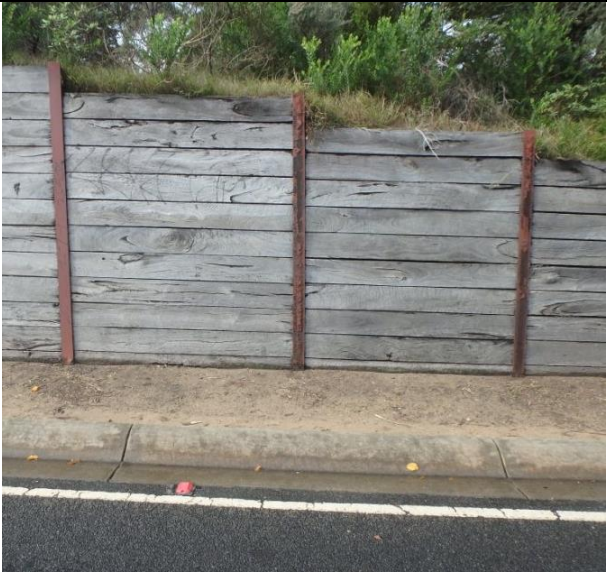
| Condition state 3 -Description | Photo |
|---|---|
| <ul style="list-style-type: none"> <li>• The uncoated sheet piles have surface rusting to the entire surface area but is having minimal effect on strength and serviceability</li> <li>• The column paint system or galvanising has failed with moderate rusting to the surface area. Moderate corrosion may be visible on the flanges but is having minimal effect on strength or serviceability.</li> <li>• There is minor tilting of columns.</li> <li>• There is minor differential movement between columns, and the wall panels are securely held in place by the columns.</li> </ul> | <p>Columns with paint system that has failed with moderate spot rusting to the surface area and moderate corrosion on flanges (VicRoads)</p> |

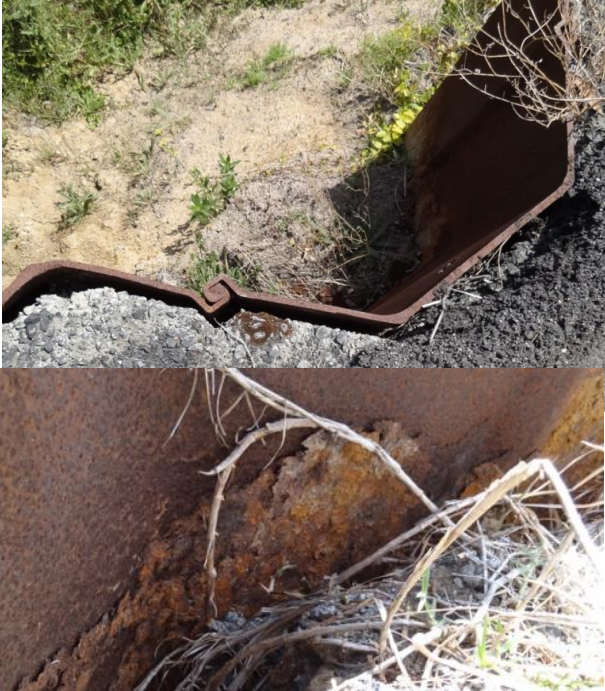
| Condition state 5 -Description | Photo |
|---|---|
| <ul style="list-style-type: none"><li>• The sheet piles have surface rusting to the entire surface area and corrosion is advanced with loss of section affecting both strength and serviceability.</li><li>• The columns have advanced corrosion with loss of section affecting both strength and serviceability.</li><li>• There is substantial tilting of columns.</li><li>• There is substantial differential movement between columns, and the wall panels may not be securely held in place by the columns.</li></ul> | <p data-bbox="791 880 1399 931">Sheet piles with advanced corrosion with loss of section affecting both strength and serviceability (VicRoads)</p> |

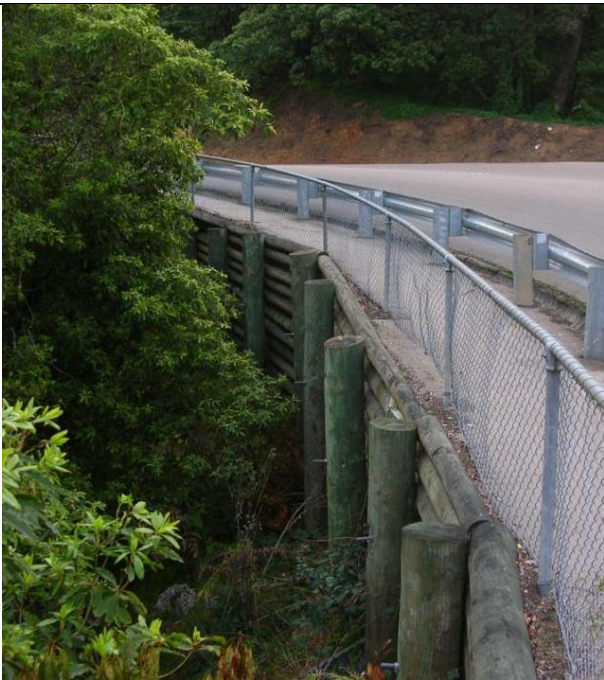
| 81T - Columns – timber | | Units |
|---|---|---|
| <ul style="list-style-type: none"> <li>The columns have only minor splitting with no edge rot or pipe rot.</li> <li>There is no tilting of columns.</li> <li>There is no differential movement between columns, and the wall panels are securely held in place by the columns.</li> </ul> | | |
| | Columns with minor splitting (VicRoads) | |

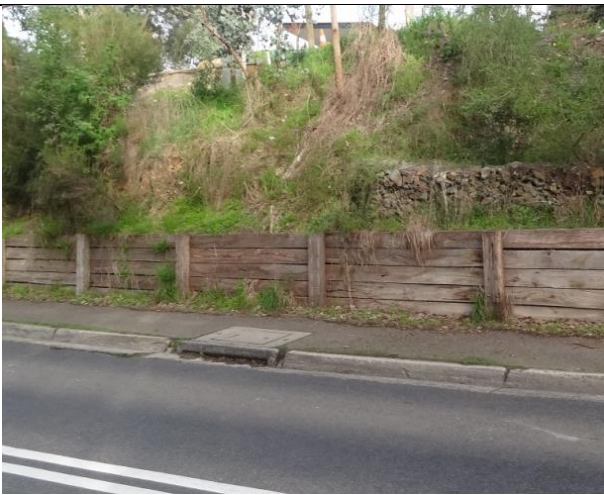
| 81T - Columns – timber | | Units |
|---|---|---|
| <ul style="list-style-type: none"> <li>The columns have minor splitting or edge rot with no pipe rot.</li> <li>There is no tilting of columns.</li> <li>There is no differential movement between columns, and the wall panels are securely held in place by the columns.</li> </ul> | | |
| | Columns with minor splitting and edge rot (VicRoads) | |

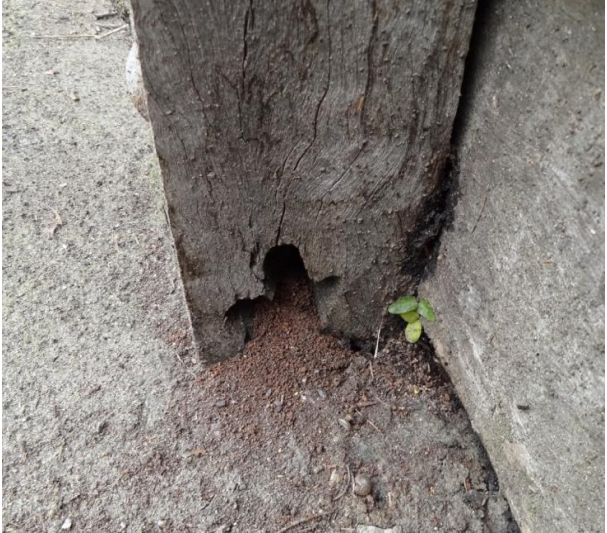
| Condition state 3 -Description | Photo |
|---|---|
| <ul style="list-style-type: none"> <li>• The columns have medium splitting and edge rot and may have moderate pipe rot but any deterioration is having minimal effect on strength or serviceability.</li> <li>• There is minor tilting of columns.</li> <li>• There is minor differential movement between columns, and the wall panels are securely held in place by the columns.</li> </ul> | <p>Column with moderate pipe rot (VicRoads)</p> |

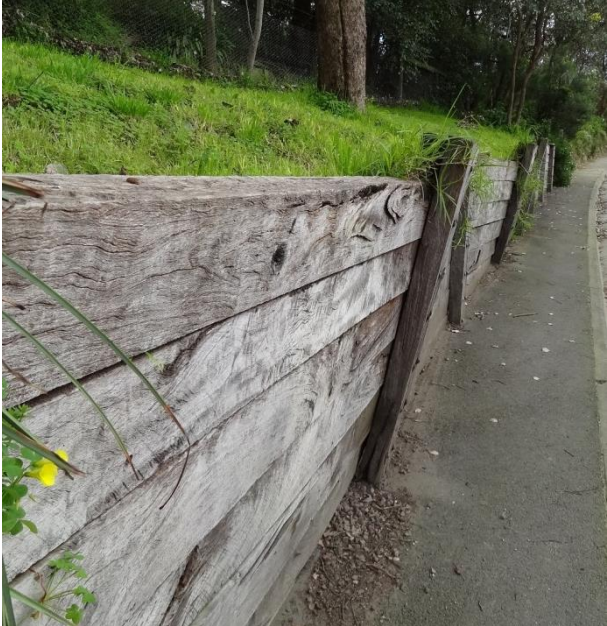
| Condition state 3 -Description | Photo |
|---|---|
| <ul style="list-style-type: none"> <li>• The columns have extensive splitting, edge rot and pipe rot severely affecting both strength and serviceability.</li> <li>• There is substantial tilting of columns.</li> <li>• There is substantial differential movement between columns, and the wall panels may not be securely held in place by the columns.</li> </ul> | <p>Columns with substantial tilting (VicRoads)</p> |

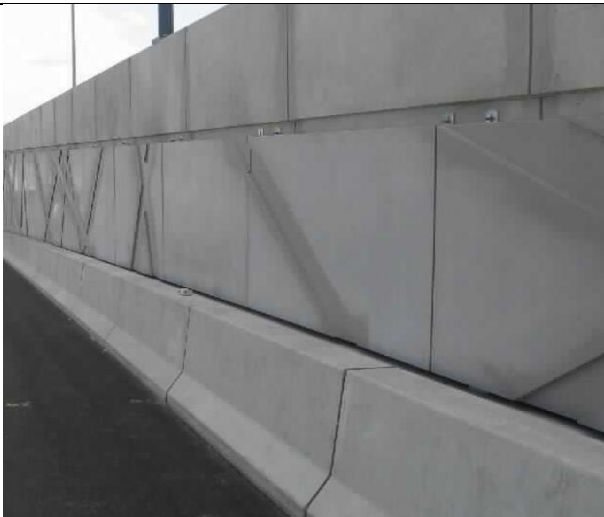
| 82P - Barriers – precast concrete | | Units |
|---|---|---|
| <ul style="list-style-type: none"> <li>The barriers have no cracking or spalling.</li> <li>No accident damage is visible.</li> </ul> | <p>Traffic safety barrier with no deterioration or accident damage</p> | |

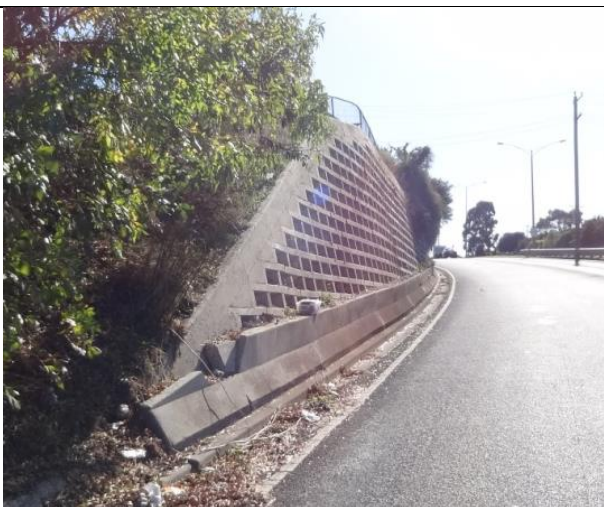
| 82P - Barriers – precast concrete | | Units |
|---|---|---|
| <ul style="list-style-type: none"> <li>The barriers have fine cracking or minor spalling of no consequence.</li> <li>Accident damage is slight and of no consequence.</li> </ul> | <p>Traffic safety barrier with minor accident damage (VicRoads)</p> | |

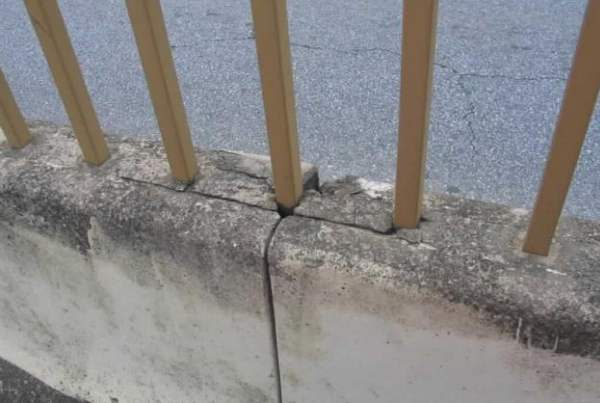
| Condition state 3 -Description | Photo |
|---|---|
| <ul style="list-style-type: none"> <li>The barriers have minor cracking or spalling of little consequence.</li> <li>Accident damage is minor and of little consequence.</li> </ul> | <p>Minor cracking and spalling to traffic safety barrier</p> |

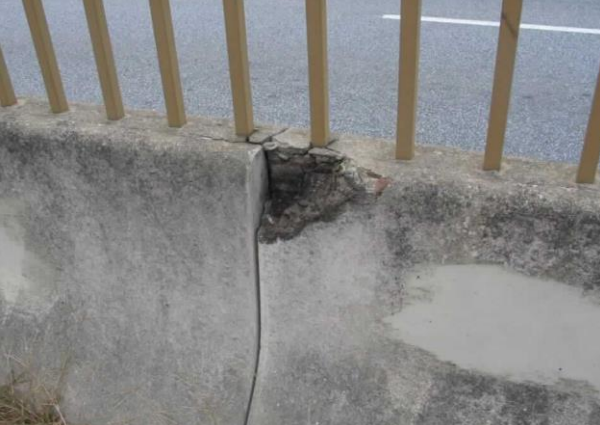
| Condition state 3 -Description | Photo |
|---|---|
| <ul style="list-style-type: none"> <li>The barriers have moderate cracking and spalling due to corroding reinforcement.</li> <li>Accident damage has only a minor effect on strength or serviceability.</li> </ul> | <p>Traffic safety barrier with moderate spall</p> |

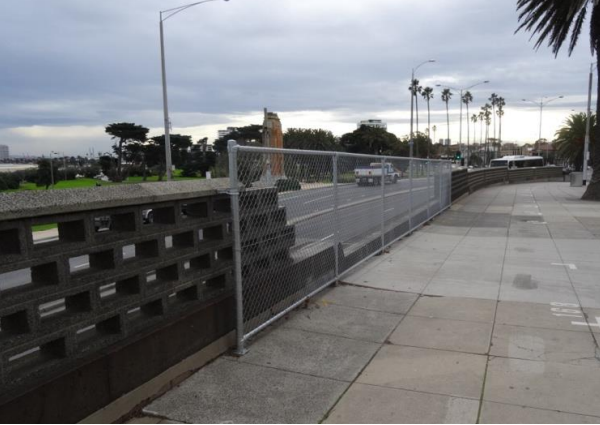
| Condition state 3 -Description | Photo |
|---|---|
| <ul style="list-style-type: none"> <li>The barriers have heavy cracking or spalling due to corroding reinforcement affecting both strength and serviceability.</li> <li>Accident damage has a severe effect on strength and serviceability.</li> <li>Retaining walls within the clear zone but with no traffic safety barrier, or a substandard traffic safety barrier, should be classified in this condition state.</li> <li>Retaining walls within 3 m of a footpath and below footpath level but with no pedestrian barrier should be classified in this condition state.</li> </ul> | <p>Pedestrian barrier at top of wall dismantled due to heavy cracking and spalling affecting both strength and serviceability (VicRoads)</p> |

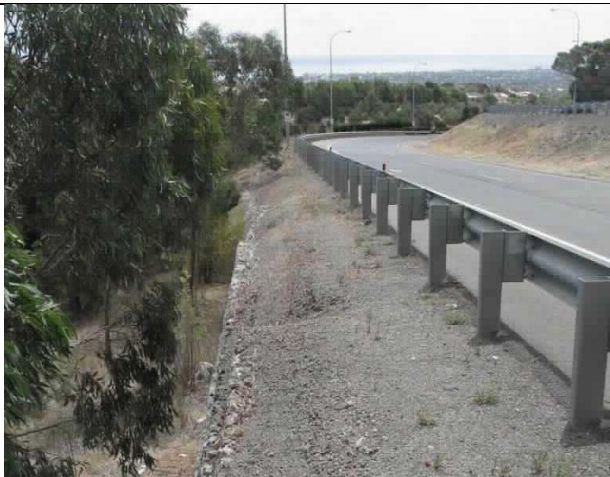
| <b>Condition state 1 -Description</b> <ul style="list-style-type: none"> <li>• The barrier paint system or galvanising is not affected by rusting or corrosion.</li> <li>• Bolting or joint support is tight.</li> <li>• No accident damage is visible.</li> </ul> | <b>Photo</b><br> | W-beam barrier at top of wall in good condition |

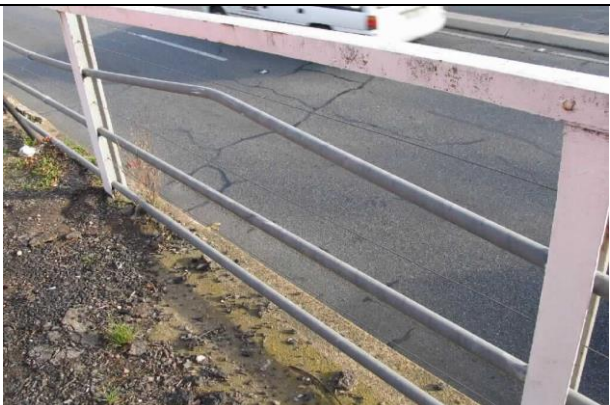
| <b>Condition state 2 -Description</b> <ul style="list-style-type: none"> <li>• The barrier has light spot rusting to the surface area and the paint system or galvanising.</li> <li>• Bolting or joint support is tight.</li> <li>• Accident damage or vandalism is minor and has no impact on performance of barrier.</li> </ul> | <b>Photo</b><br> | Barrier rail bent but no impact on performance |

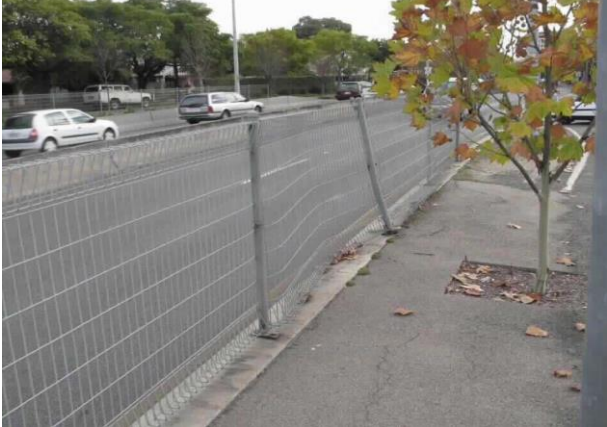
| Condition state 3 -Description | Photo |
|---|---|
| <ul style="list-style-type: none"> <li>• The barrier has minor spot rusting to the surface area and the paint system or galvanising.</li> <li>• Bolting or joint support is generally tight.</li> <li>• Accident damage or vandalism is minor and has little impact on performance of barrier.</li> </ul> | <p>Minor damage to fence with little impact on performance</p> |

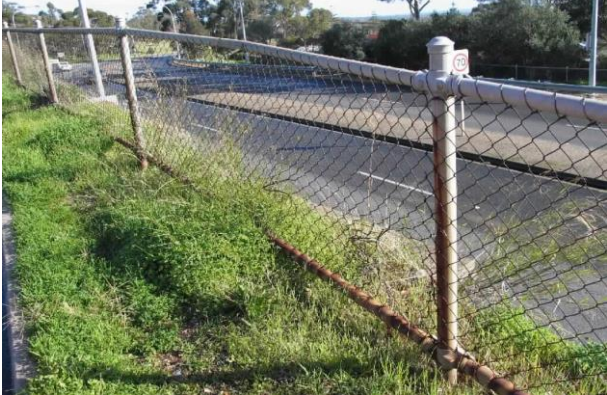
| Condition state 3 -Description | Photo |
|---|---|
| <ul style="list-style-type: none"> <li>• The barrier paint system or galvanising has failed with moderate rusting to the surface area but any minor corrosion is having minimal effect on strength or serviceability.</li> <li>• Bolting or joint support is loose.</li> <li>• Accident damage has only a minor effect on strength or serviceability.</li> </ul> | <p>Pedestrian fence with moderate surface rusting, hole in mesh and bent top rail but with only a minor effect on both strength and serviceability</p> |

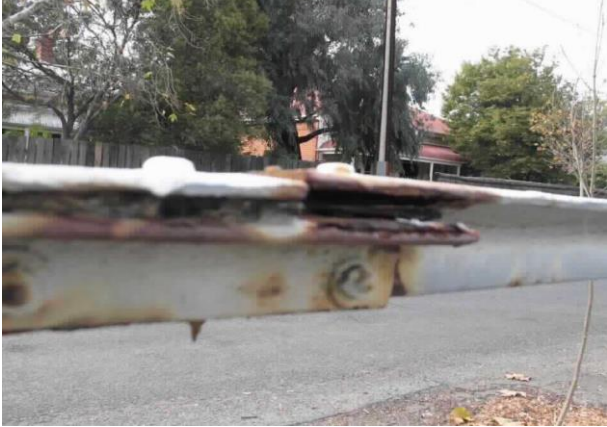
| Condition state 3 -Description | Photo |
|---|---|
| <ul style="list-style-type: none"> <li>• The barrier has advanced corrosion with loss of section affecting both strength and serviceability.</li> <li>• Bolting or joint support has failed or is missing.</li> <li>• Severe accident damage affecting the strength and serviceability.</li> <li>• Retaining walls within the clear zone but with no traffic safety barrier, or a substandard traffic safety barrier, should be classified in this condition state.</li> <li>• Retaining walls within 3 m of a footpath and below footpath level but with no pedestrian barrier should be classified in this condition state.</li> </ul> | <p>Corrosion and bolt sheared at joint of barrier top rail</p> |

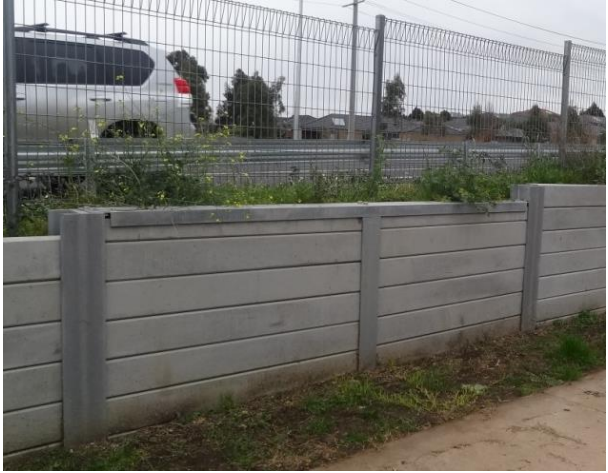
| 83S - Connections and horizontal supports – steel | | Units |
|---|---|---|
| <ul style="list-style-type: none"> <li>The connections and supports paint system or galvanising is not affected by rusting or corrosion.</li> <li>Bolted connections are tight.</li> <li>Welds are sound.</li> </ul> | <p>Stiffeners with galvanising not affected by rusting or corrosion (VicRoads)</p> | |

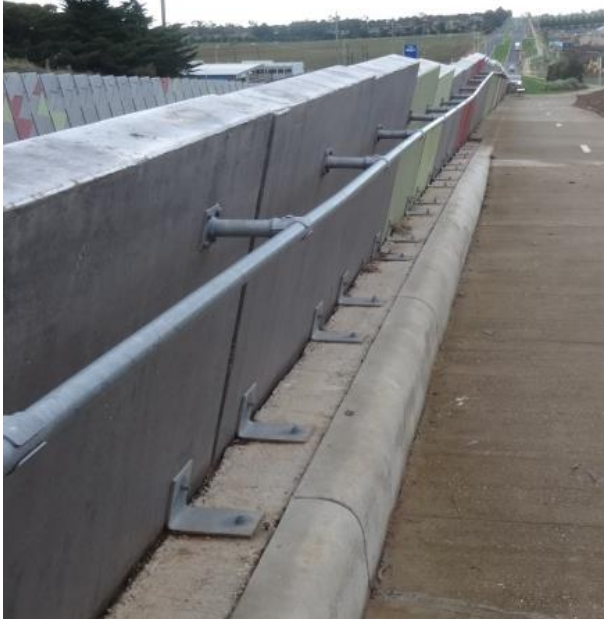
| 83S - Connections and horizontal supports – steel | | Units |
|---|---|---|
| <ul style="list-style-type: none"> <li>The connections and supports have light spot rusting to the surface area.</li> <li>Bolted connections are tight.</li> <li>Welds are sound.</li> </ul> | <p>Hold down bolts and connecting plates with light spot rusting to the surface area and the galvanising is no longer effective (VicRoads)</p> | |

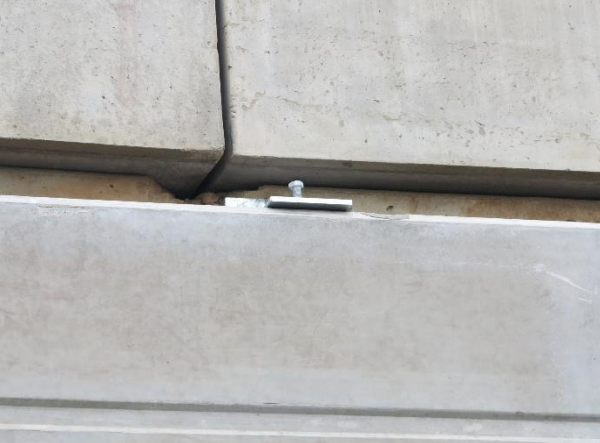
| Condition state 3 -Description | Photo |
|---|---|
| <ul style="list-style-type: none"> <li>• The connections and supports have minor spot rusting to of the surface area.</li> <li>• Bolted connections are generally tight.</li> </ul> | <p data-bbox="794 633 1396 667">Bolt protruding from wall mounting bracket</p> |

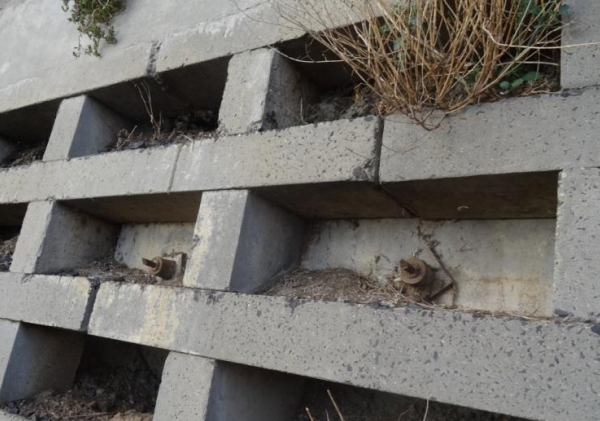
| Condition state 3 -Description | Photo |
|---|---|
| <ul style="list-style-type: none"> <li>• The connections and supports paint system or galvanising have failed with moderate spot rusting to the surface area but any minor corrosion is having minimal effect on strength or serviceability.</li> <li>• Bolted connections are loose.</li> <li>• Welds have cracked with minor loss of effectiveness.</li> </ul> | <p data-bbox="794 1120 1396 1216">Exposed anchor heads with spot rusting to the surface area with minimal effect on strength or serviceability (VicRoads)</p> |

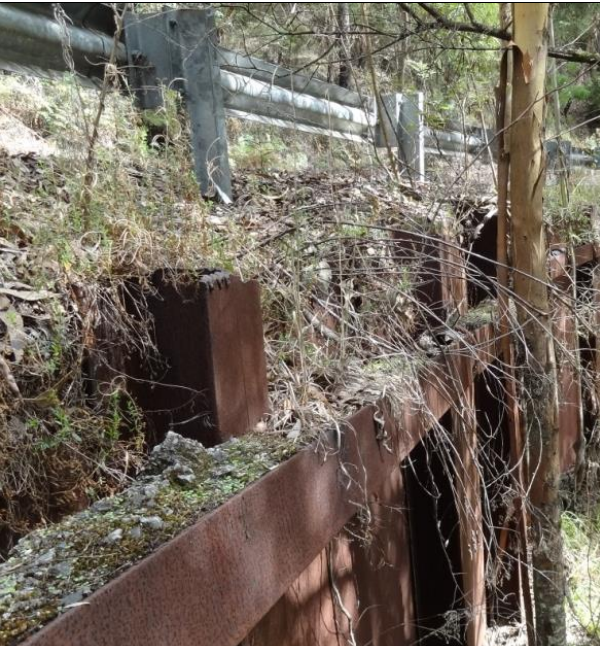
| Condition state 3 -Description | Photo |
|---|---|
| <ul style="list-style-type: none"> <li>• The connections and supports have advanced corrosion with loss of section affecting both strength and serviceability.</li> <li>• Bolted connections have failed or are missing.</li> <li>• Welds have failed.</li> </ul> | <p data-bbox="794 1892 1396 1984">Waler with advanced corrosion with loss of section affecting both strength and serviceability. Welds to columns have failed (VicRoads)</p> |

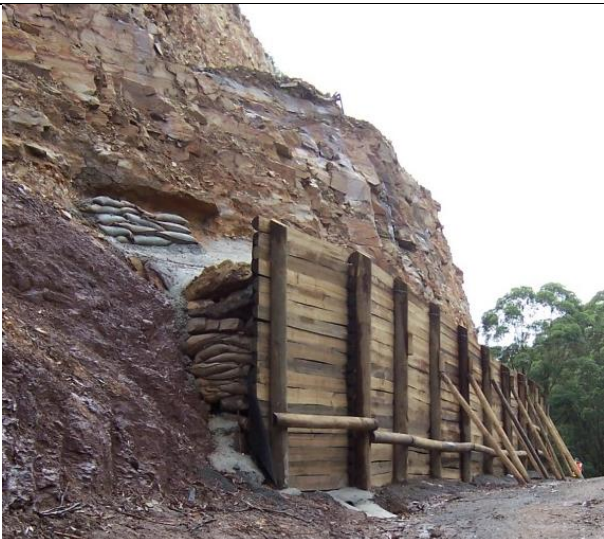
| 83T - Connections and horizontal supports – timber | | Units |
|---|---|---|
| <ul style="list-style-type: none"> <li>The connections and supports have only minor splitting with no edge rot or pipe rot.</li> <li>Bolted connections are tight.</li> </ul> | <p>Walers and struts with no splitting, edge rot or pipe rot (VicRoads)</p> | |

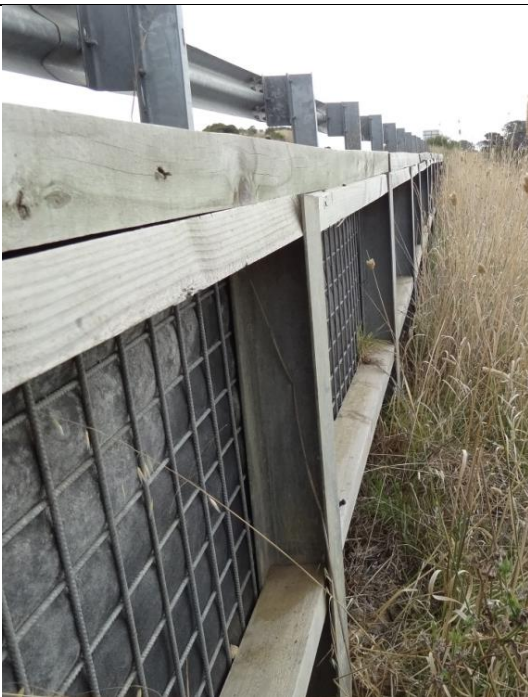
| 83T - Connections and horizontal supports – timber | | Units |
|---|---|---|
| <ul style="list-style-type: none"> <li>The connections and support have minor splitting or edge rot with no pipe rot.</li> <li>Bolted connections are tight.</li> </ul> | <p>Stiffeners with minor splitting (VicRoads)</p> | |

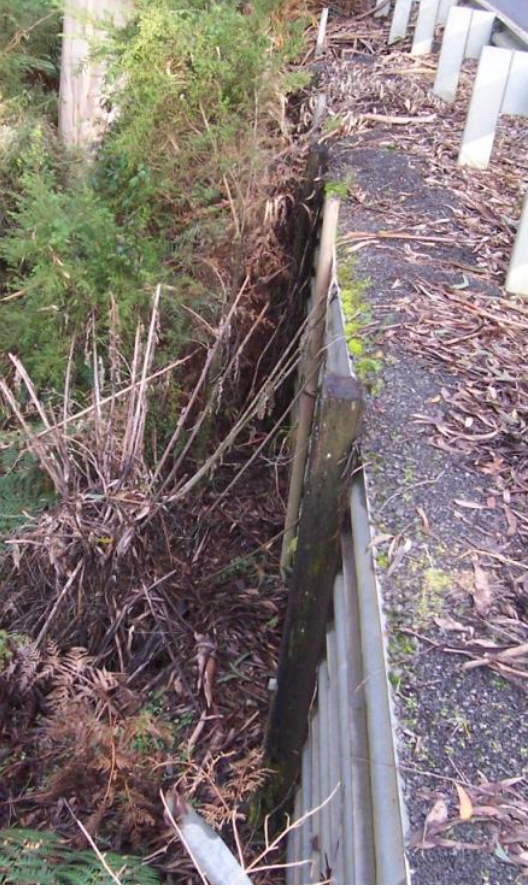
| Condition state 3 -Description | Photo |
|---|---|
| <ul style="list-style-type: none"> <li>The connections and supports have medium splitting and edge rot and may have minor pipe rot but any deterioration is having minimal effect on strength or serviceability.</li> <li>Bolted connections are loose.</li> </ul> | <p>Brace with moderate edge rot and minor pipe rot (VicRoads)</p> |

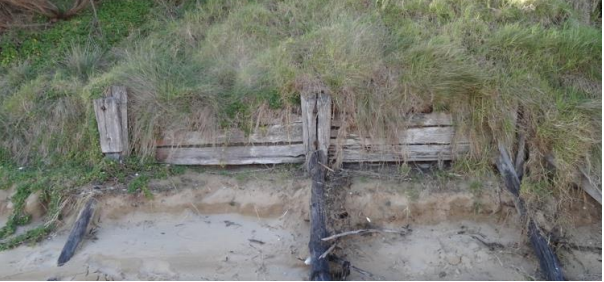
| Condition state 3 -Description | Photo |
|---|---|
| <ul style="list-style-type: none"> <li>The connections and supports have extensive splitting, edge rot and pipe rot severely affecting both strength and serviceability.</li> <li>Bolted connections have failed or are missing.</li> </ul> | <p>Struts with extensive pipe rot. Timber strut block bolted connections have failed (VicRoads)</p> |

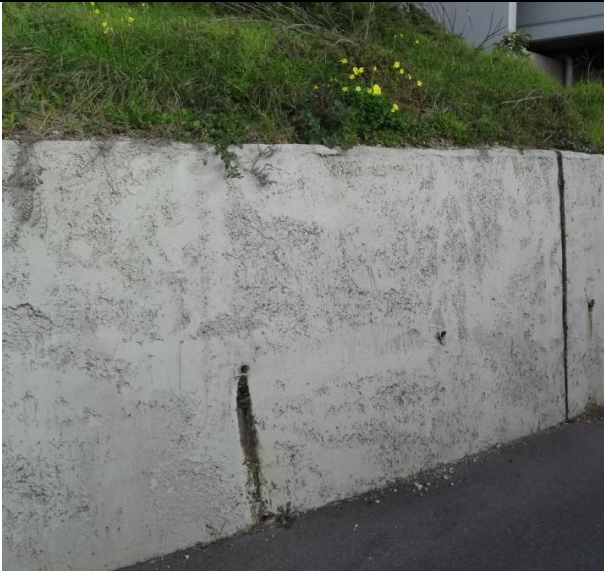
| 840 - Drainage system | | Units |
|---|---|---|
| <ul style="list-style-type: none"> <li>The drainage system is not affected by blockages.</li> <li>The drainage system is not affected by structural failure.</li> <li>The drainage system is not affected by vertical settlement or horizontal displacement.</li> <li>No erosion or scour is evident.</li> </ul> | <p>Weep holes with no blockages, no structural failure, and no erosion evident (VicRoads)</p> | |

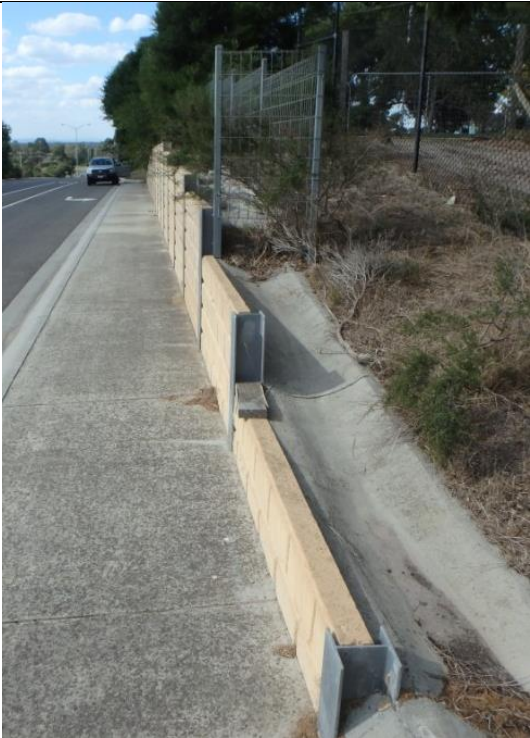
| 840 - Drainage system | | Units |
|---|---|---|
| <ul style="list-style-type: none"> <li>The drainage system has blockages causing small loss of capacity.</li> <li>Concrete components have fine cracking or spalling of no consequence, steel components have light spot rusting to the surface area.</li> <li>Vertical settlement and horizontal displacement of drainage system components is minor and of no consequence.</li> <li>Erosion or scour is minor and of no consequence.</li> </ul> | <p>Drainage channel with only minor blockages (VicRoads)</p> | |

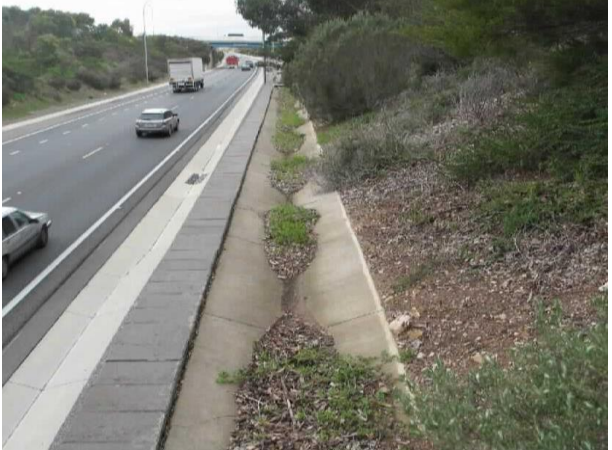
| Condition state 3 -Description | Photo |
|---|---|
| <ul style="list-style-type: none"> <li>• The drainage system has blockages causing minor loss of capacity.</li> <li>• Concrete components have minor cracking or spalling of little consequence, steel components have minor spot rusting to the surface area.</li> <li>• Vertical settlement and horizontal displacement of drainage system components is moderate and of little consequence.</li> <li>• Erosion or scour is moderate and of little consequence.</li> </ul> | <p data-bbox="791 651 1129 678">Drain filled with soil and debris</p> |

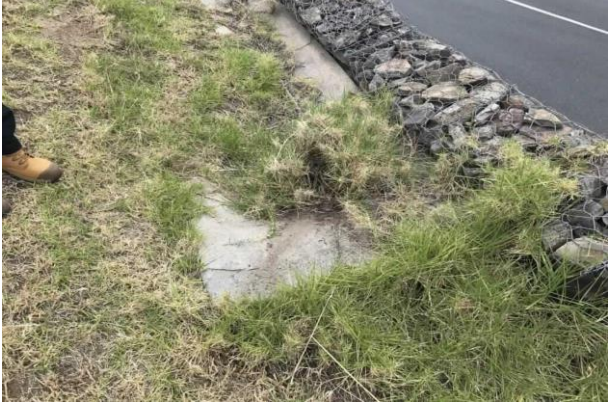
| Condition state 3 -Description | Photo |
|---|---|
| <ul style="list-style-type: none"> <li>• The drainage system has blockages causing moderate loss of capacity.</li> <li>• Concrete components have moderate cracking and spalling due to corroding reinforcement, steel components have moderate rusting to the surface area and moderate corrosion.</li> <li>• Vertical settlement and horizontal displacement of drainage system components is moderate and water is leaking from the drainage system.</li> <li>• Erosion or scour has a moderate effect on strength or serviceability.</li> </ul> | <p data-bbox="791 1122 1342 1180">Drainage channel and sump blocked by vegetation growth causing loss of capacity</p> |
