# Road Structures Inspection Manual

## Part 4C: Condition State Guidelines and Photographs

### Other Structures

Part 4C: Condition State Guidelines and Photographs – Other Structures  
Department of Planning, Transport and Infrastructure, South Australia

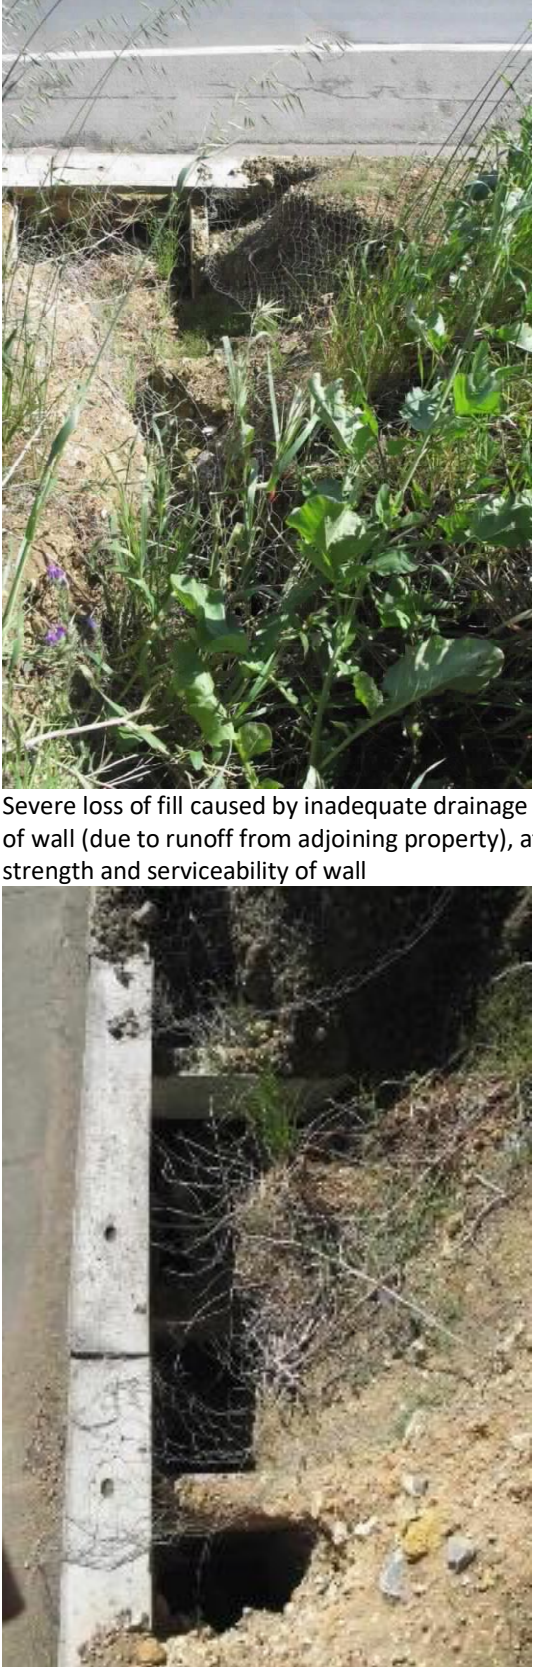
| Condition state 5 -Description | Photo |
|---|---|
| <ul style="list-style-type: none"><li>• The drainage system has severe blockages causing a loss of drainage system effectiveness.</li><li>• Concrete components have heavy cracking or spalling affecting both strength and serviceability, steel components have advanced corrosion with loss of section affecting both strength and serviceability.</li><li>• Vertical settlement and horizontal displacement between drainage system components is severe causing a loss of drainage system effectiveness.</li><li>• Erosion or scour has a severe effect on strength and serviceability.</li></ul> | <p data-bbox="791 987 1414 1077">Severe loss of fill caused by inadequate drainage at top of wall (due to runoff from adjoining property), affecting strength and serviceability of wall</p> |

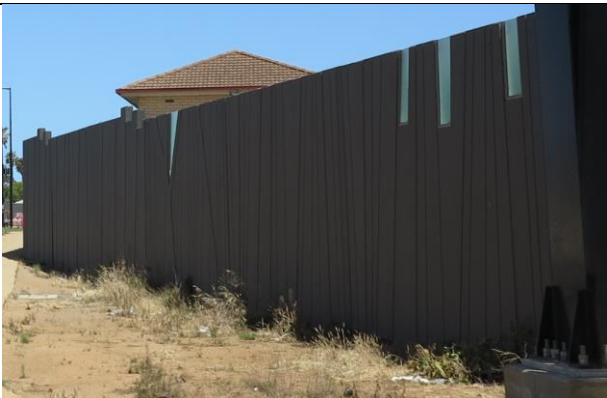
| 90P - Wall facing / panels – precast concrete | | Units |
|---|---|---|
| <ul style="list-style-type: none"> <li>The components are in good condition with no damage visible.</li> <li>There may be minor dampness or efflorescence powder visible in a few locations.</li> <li>No separation or relative movement between units is apparent.</li> </ul> | <p>Precast noise wall panels in good condition.</p> | |

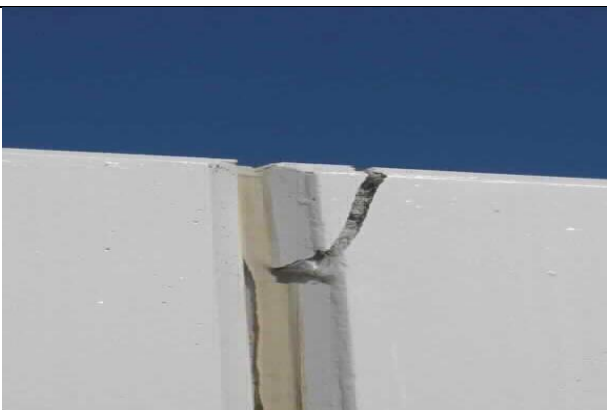
| 90P - Wall facing / panels – precast concrete | | Units |
|---|---|---|
| <ul style="list-style-type: none"> <li>There may be a few small cracks or spalls due to corroding reinforcement.</li> <li>Dampness or efflorescence may be a little more prevalent.</li> <li>There is no separation or relative movement between units.</li> </ul> | <p>Small crack and sealant pulling away at panel joint</p> | |

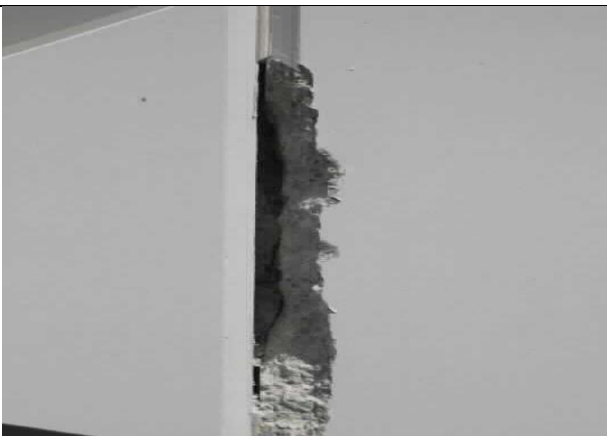
| 90P - Wall facing / panels – precast concrete | | Units |
|---|---|---|
| <ul style="list-style-type: none"> <li>There may be a minor cracks or spalls due to corroding reinforcement.</li> <li>Dampness or efflorescence may be prevalent.</li> <li>There may be small separations or relative movement between units, up to 10 mm.</li> </ul> | <p>Spalling at edge of noise wall panel</p> | |

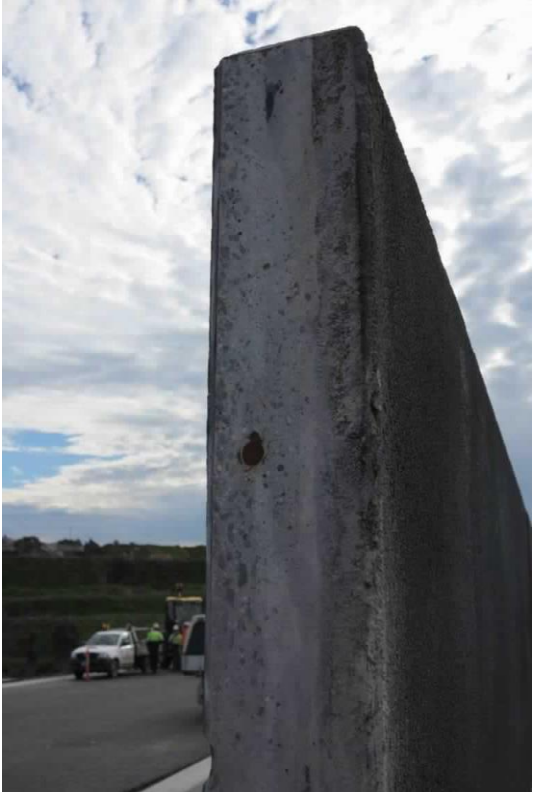
| Condition state 4 -Description | Photo |
|---|---|
| <ul style="list-style-type: none"> <li>• Moderate cracking or spalling may be present due to corroding reinforcement or pressure on the units at the support corners.</li> <li>• Exposed reinforcement may have moderate section loss in isolated areas.</li> <li>• Dampness or efflorescence may be quite prevalent.</li> <li>• There is only minor separation or relative movement between units up to 20 mm.</li> <li>• Connections may be slightly loose or there may be partial separation from the supporting column.</li> </ul> | <p data-bbox="791 981 1326 1014">Corroding reinforcement in end of noise wall panel</p> |

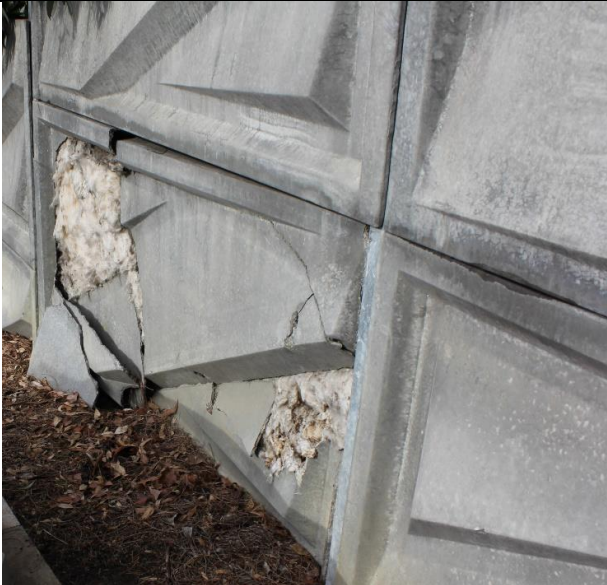
| Condition state 4 -Description | Photo |
|---|---|
| <ul style="list-style-type: none"> <li>• Severe cracking or spalling may be present due to corroding reinforcement or pressure on the units at the support corners.</li> <li>• Exposed reinforcement may have more severe section loss in isolated areas.</li> <li>• Dampness or efflorescence may be quite prevalent.</li> <li>• There is moderate separation or relative movement between units of greater than 20 mm.</li> <li>• Connections may be completely loose with separation from the supporting column.</li> </ul> | <p data-bbox="791 1630 1401 1662">Severe cracking and spalling of precast panel (VicRoads)</p> |

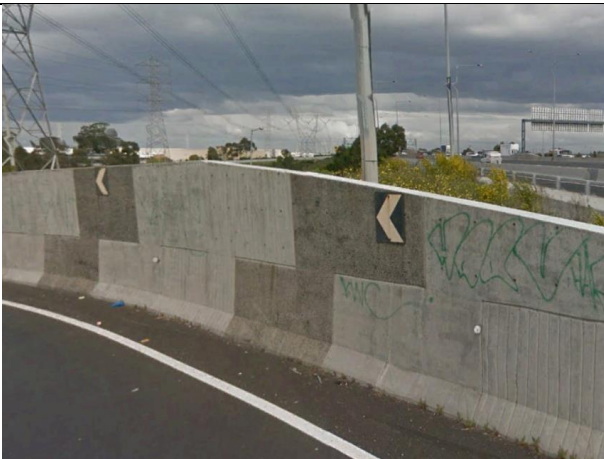
| 90C - Wall facing / panels – cast in-situ concrete | | Units |
|---|---|---|
| <ul style="list-style-type: none"> <li>The components are in good condition with no damage visible.</li> <li>There may be minor dampness or efflorescence powder visible in a few locations.</li> <li>Wall slopes are true to line with no separation of the cast sections.</li> </ul> | <p>Cast-insitu concrete with no visible damage (VicRoads)</p> | |

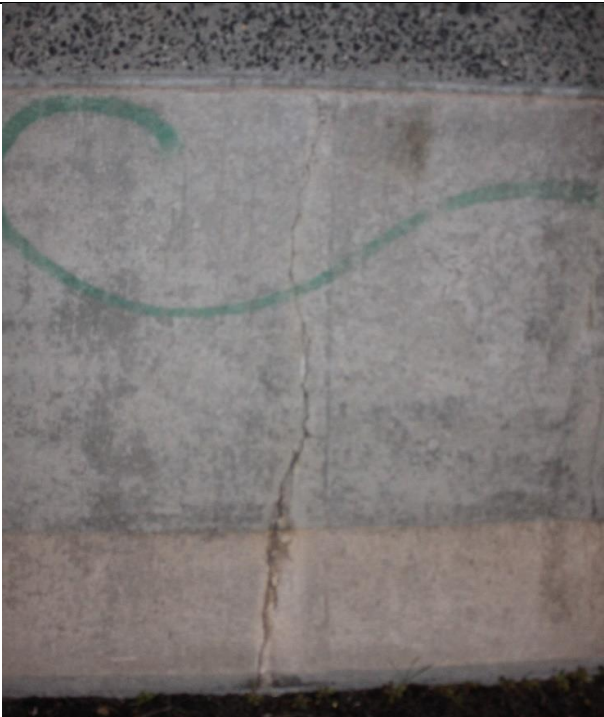
| 90C - Wall facing / panels – cast in-situ concrete | | Units |
|---|---|---|
| <ul style="list-style-type: none"> <li>There may be a few minor cracks or spalls due to corroding reinforcement.</li> <li>Dampness or efflorescence may be a little more prevalent.</li> <li>There is no separation or relative movement between cast sections.</li> </ul> | <p>Minor crack in noise wall with no movement observed (VicRoads)</p> | |

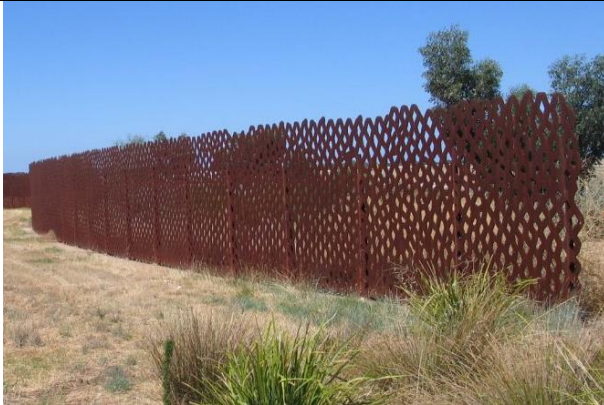
| 90S - Wall facing / panels – steel | | Units |
|---|---|---|
| <ul style="list-style-type: none"> <li>The paint system is generally sound with only minor chalking, peeling or curling, but with no exposure of metal.</li> <li>All welds, bolts or rivets are in good condition with no movement of plates or sections in the component.</li> </ul> | <p>Weathering steel visual screen wall in good condition (Note, rusted appearance due to alloy additions forming an impervious oxide layer to provide corrosion resistance to the steel plate)</p> | |

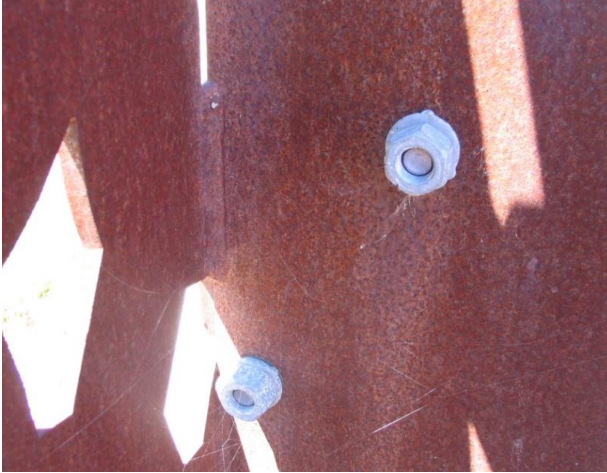
| Condition state 4 -Description | Photo |
|---|---|
| <ul style="list-style-type: none"> <li>• Some surface pitting may be present with active corrosion occurring in isolated areas but no loss of section area has occurred which would affect the strength of the member.</li> <li>• The paint system has broken down with moderate rust spotting and surface pitting.</li> <li>• Nuts and bolts may be corroded but are still tight and no cracking of welds has occurred.</li> <li>• Riveted plates may have minor movements of 2 to 5 mm but rivets are generally sound.</li> </ul> | <p>Nuts on fixing bolts only engaged on very short thread lengths</p> |

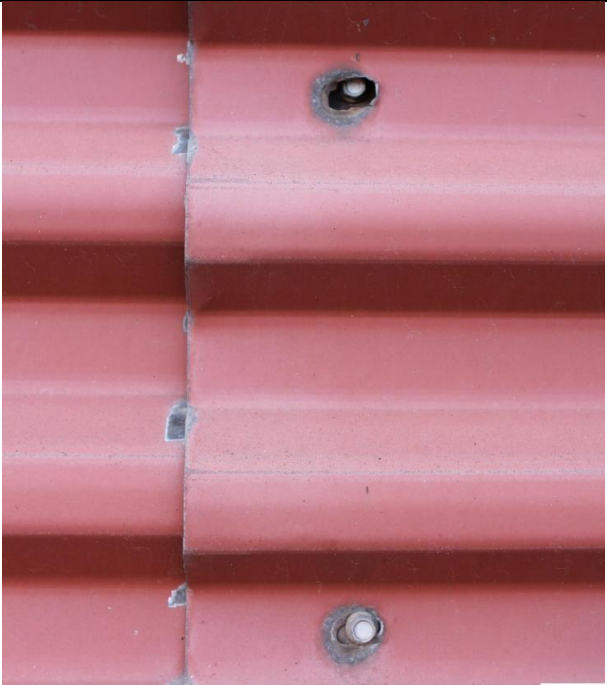
| Condition state 4 -Description | Photo |
|---|---|
| <ul style="list-style-type: none"> <li>• Corrosion is well advanced and loss of section has occurred having a detrimental effect on the strength of the member, i.e. a flange may be badly corroded over a sizeable length.</li> <li>• There may be some cracking of the welds between the plates.</li> <li>• Rivets or bolts may be severely corroded and no longer carrying full load or functioning as intended.</li> <li>• Rivets may be broken or missing allowing excessive movement of plates.</li> <li>• The paint system has completely broken down.</li> </ul> | <p>Surface pitting and section loss around connections has resulted in loss of support for corrugated steel (VicRoads)</p> |

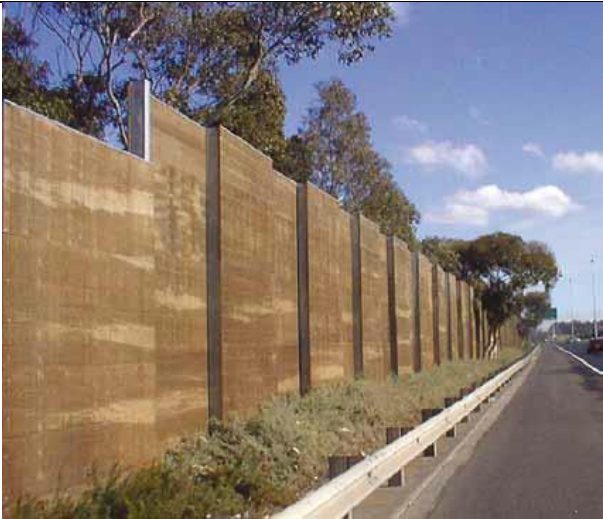
| 90T - Wall facing / panels – timber | | Units |
|---|---|---|
| <ul style="list-style-type: none"> <li>The timber panels are in good condition with no or only minor weathering at the edges or minor damage elsewhere.</li> <li>Connections to the columns are tight and adequate to transfer all loads due to wind.</li> </ul> | <p>Timber panels in good condition (VicRoads)</p> | |

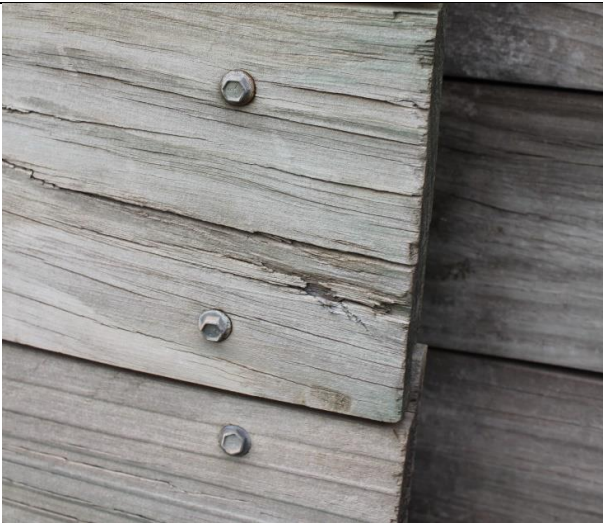
| 90T - Wall facing / panels – timber | | Units |
|---|---|---|
| <ul style="list-style-type: none"> <li>The walls are in good condition with only minor weathering at the edges but away from the connections, or minor damage elsewhere.</li> <li>Slight settlement or slope changes may be present.</li> <li>Connections may be slightly loose but having little or no effect on the panel support.</li> </ul> | <p>Weathering of timber panels at the edges and connections slightly loose (VicRoads)</p> | |

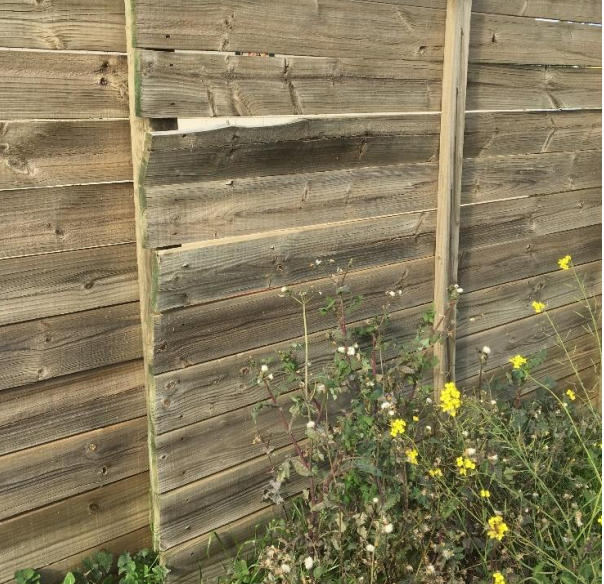
| Condition state 3 -Description | Photo |
|---|---|
| <ul style="list-style-type: none"> <li>• The walls are generally in fair condition with moderate settlement or slope changes present.</li> <li>• The timber panels may have moderate weathering affecting the connections, or have moderate damage elsewhere.</li> <li>• Connections may be loose allowing movement of the panels away from the supports.</li> </ul> | <p>Minor weathering of timber at edges. Connections are loose allowing panels to move (VicRoads)</p> |

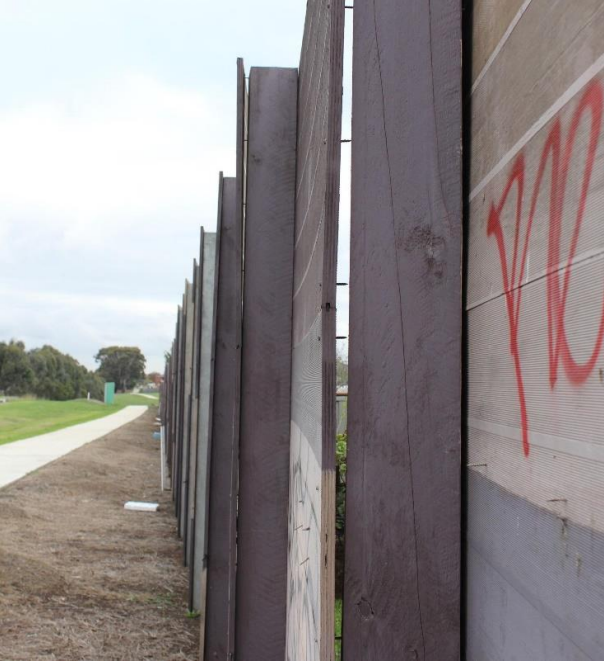
| Condition state 3 -Description | Photo |
|---|---|
| <ul style="list-style-type: none"> <li>• The walls are in poor condition with extensive settlement or slope changes present.</li> <li>• The timber panels may have extensive weathering at the edges affecting the connections, or have significant damage elsewhere.</li> <li>• Connections may be lost or completely loose allowing excessive movement of the panels away from the supports or the panels to be free at one end.</li> </ul> | <p>Connections are completely lost allowing excessive movement of panel (VicRoads)</p> |

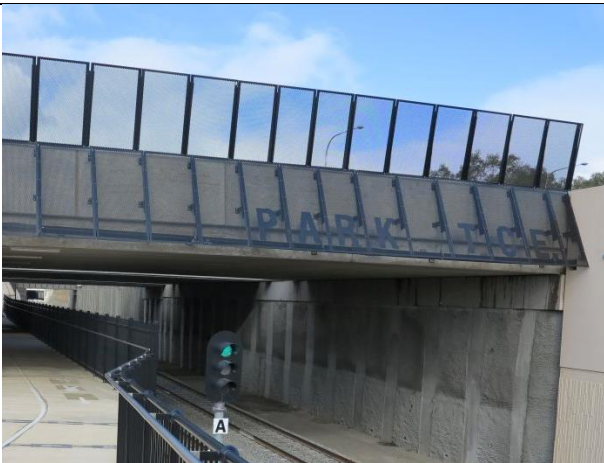
| 900 - Wall facing / panels – other | | Units |
|---|---|---|
| <ul style="list-style-type: none"> <li>The walls are in good condition with no cracking, no loss of mortar, bricks or stones, and has maintained its slope and level.</li> <li>The Perspex, fibre glass or light pressed metal section screens are in good condition and well held in place.</li> </ul> | <p>Light pressed metal visual screen wall in good condition</p> | |

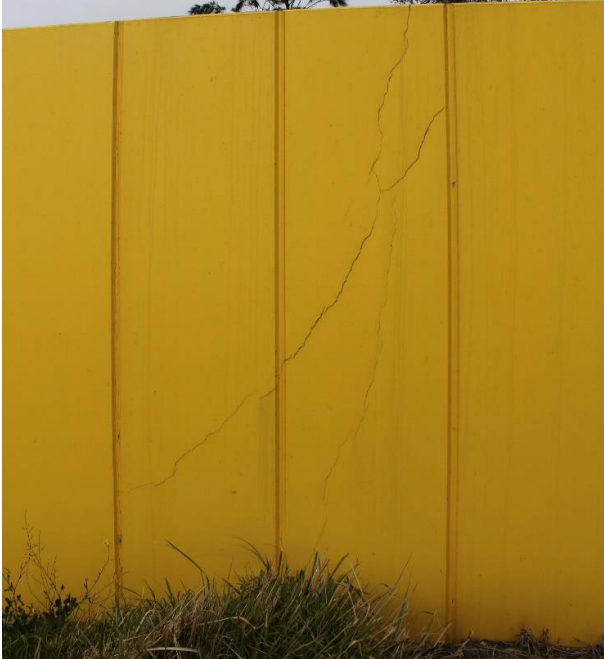
| Condition state 3 -Description | Photo |
|---|---|
| <ul style="list-style-type: none"> <li>• The walls are generally in fair condition with moderate cracking or loss of mortar. Medium settlement or slope changes may be present.</li> <li>• Minor loss of bricks or stones may have occurred which are of little consequence.</li> <li>• The Perspex, fibre glass or light pressed metal panels may have lost flexible filler at the connections, or the connections may be loose.</li> <li>• The Perspex may have minor splits of no great concern. The panels may be bent or buckled but not serious enough to require replacement.</li> <li>• Panels may have moved or suffered moderate accident damage and may be only have partial supported at one of the ends.</li> </ul> | <p data-bbox="791 1581 1289 1606">Moderate cracking in acrylic panel (VicRoads)</p> |

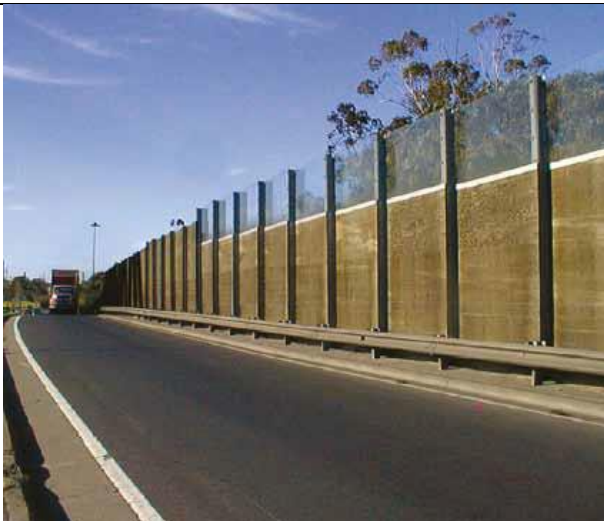
| 91S - Column supports – steel | | Units |
|---|---|---|
| <ul style="list-style-type: none"> <li>The steel columns are in good condition with no loss of paintwork or corrosion evident.</li> <li>There is no change in the slope of the columns due to differential movement, and the wall panels are securely held in place.</li> </ul> | <p>Steel columns in good condition (VicRoads)</p> | |

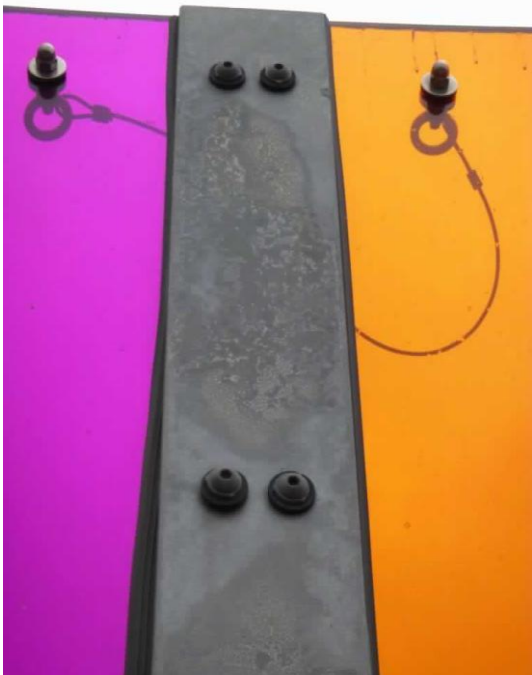
| 91S - Column supports – steel | | Units |
|---|---|---|
| <ul style="list-style-type: none"> <li>The steel columns are in good condition with only minor loss of paintwork and light rust spotting of the surface area.</li> <li>Minor corrosion may be visible on the flanges.</li> <li>There is no change in the slope of the columns due to differential movement, and the wall panels are securely held in place.</li> </ul> | <p>Galvanised coating on visual screen support post deteriorating</p> | |

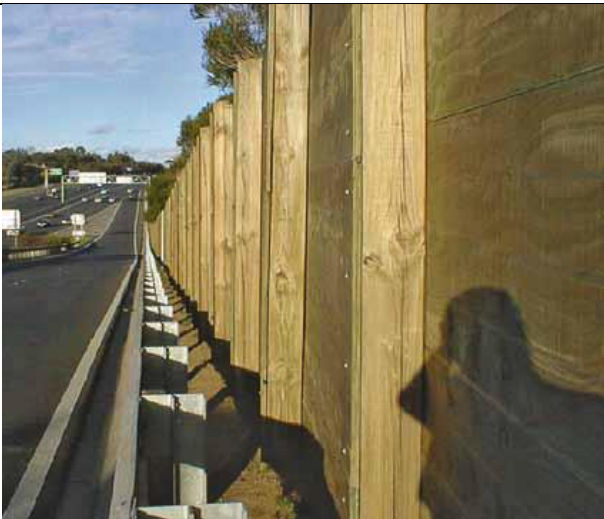
| 91T - Column supports – timber | | Units |
|---|---|---|
| <ul style="list-style-type: none"> <li>The columns are in good condition with no splitting or edge rot.</li> <li>There is no change in the slope of the columns due to differential movement, and the wall panels are securely held in place.</li> </ul> | <p>Columns in good condition (VicRoads)</p> | |

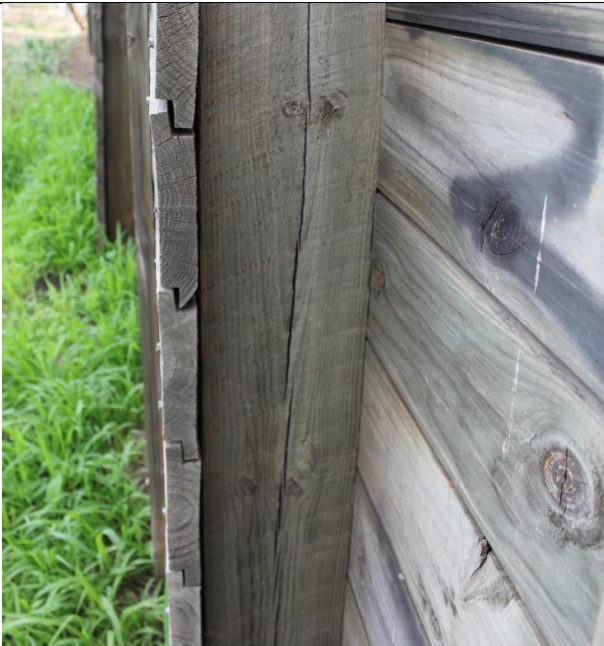
| 91T - Column supports – timber | | Units |
|---|---|---|
| <ul style="list-style-type: none"> <li>The columns are in good condition with only minor splitting or edge rot, but the columns are sound with no pipe rot.</li> <li>There is no change in the slope of the columns due to differential movement, and the wall panels are securely held in place.</li> </ul> | <p>Timber column has minor splitting (VicRoads)</p> | |

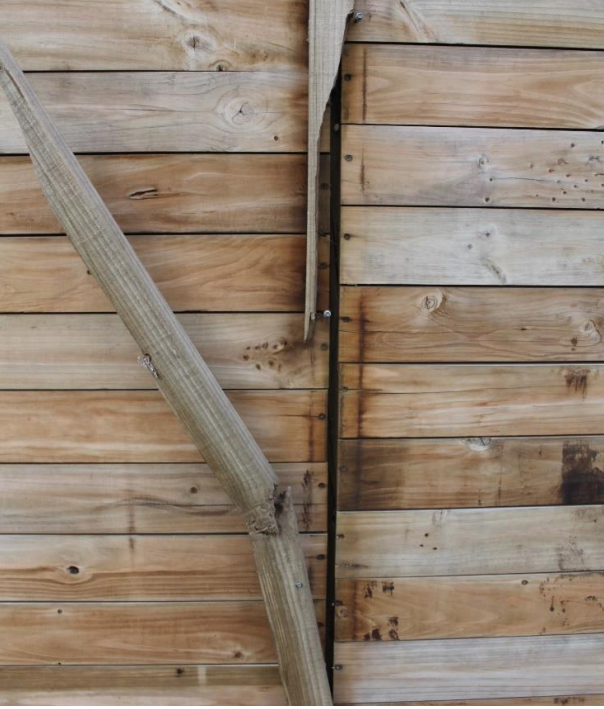
| Condition state 3 -Description | Photo |
|---|---|
| <ul style="list-style-type: none"> <li>The columns are in poor condition with extensive splitting, pipe rot and edge rot significantly affecting the strength of the member.</li> <li>There may be substantial changes in the slope of the columns due to differential movement, and the wall panels may be slipping out from the columns.</li> </ul> | <p data-bbox="794 1615 1401 1673">Timber column has split and no longer provides any structural support to noise attenuation wall (VicRoads)</p> |

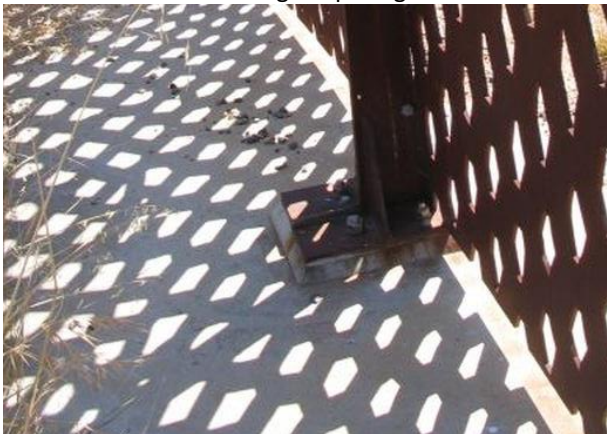
| 92C - Foundation –concrete (precast or cast in-situ) | Units |
|---|---|
| <ul style="list-style-type: none"> <li>• The foundations or barrier walls are in good condition with no cracking or spalling.</li> <li>• There are no indications of settlement of the foundations.</li> </ul> | <p>The precast barrier walls (behind the screen) are in good condition with no cracking or spalling</p> <p>Cast in-situ foundation in good condition</p> |

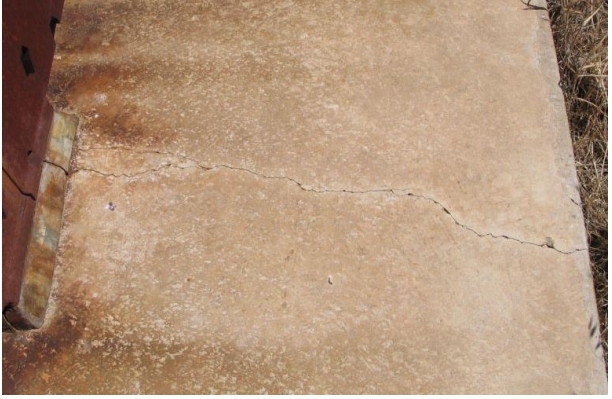
| <b>Condition state 2 -Description</b> <ul style="list-style-type: none"> <li>• The foundations or barrier walls are in good condition with only minor cracking or spalling of no consequence.</li> <li>• There are no indications of settlement of the foundations.</li> </ul> | <b>Photo</b><br><br>Minor cracking in concrete foundation |

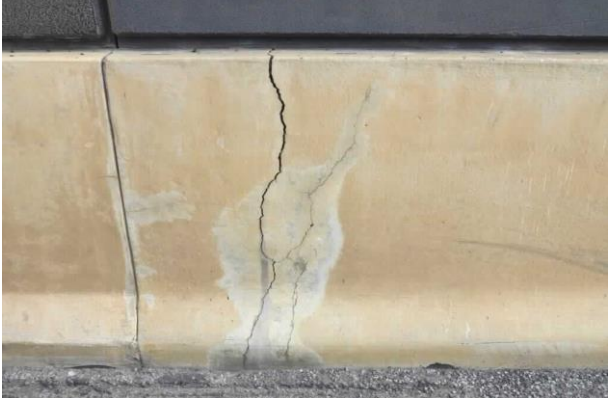
| <b>Condition state 3 -Description</b> <ul style="list-style-type: none"> <li>• The foundations or barrier walls are in good condition with moderate cracking or spalling of little consequence.</li> <li>• There may be indications of slight settlement of the foundations.</li> </ul> | <b>Photo</b><br><br>Moderate cracking in barrier supporting noise wall |

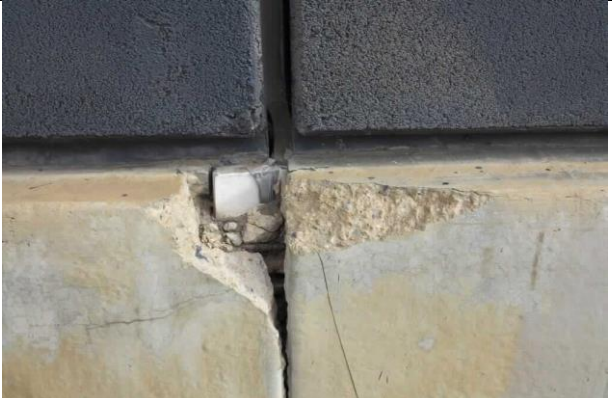
| <b>Condition state 4 -Description</b> <ul style="list-style-type: none"> <li>• The foundations or barrier walls are generally in fair condition with medium cracking and spalling due to corroding reinforcement.</li> <li>• Exposed reinforcement may have moderate section loss in isolated areas.</li> <li>• There may be signs of minor settlement of the foundations.</li> </ul> | <b>Photo</b><br><br>Large spall in barrier supporting noise wall |

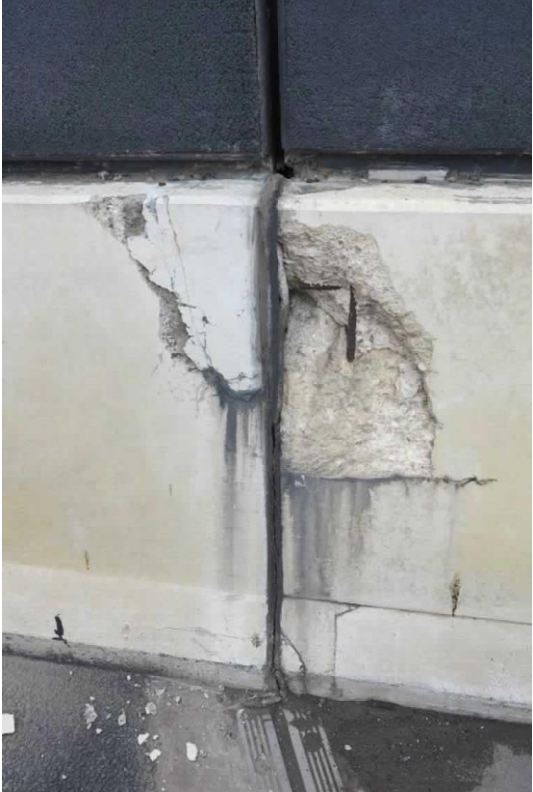
| Condition state 5 -Description | Photo |
|---|---|
| <ul style="list-style-type: none"><li>• The foundations or barrier walls are in poor condition with severe cracking or spalling present due to corroding reinforcement.</li><li>• Exposed reinforcement may have significant section loss in isolated areas.</li><li>• There may be significant settlement of the foundations.</li></ul> | <p data-bbox="791 987 1374 1034">Severe cracking and spalling and failed sealant on concrete barrier supporting precast noise wall panels</p> |

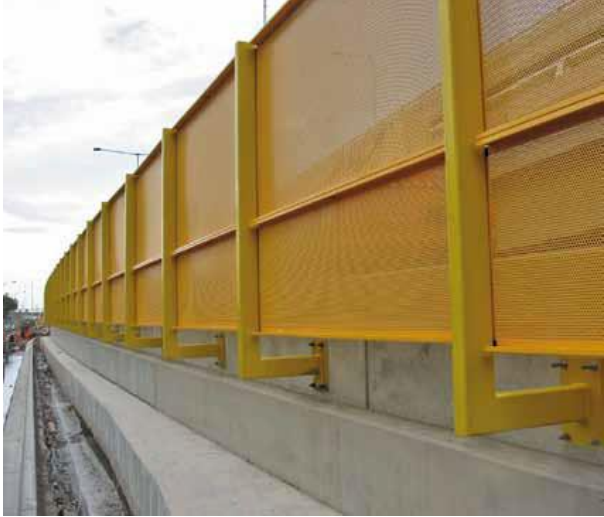
| 93S - Hold-down bolts, base plates and fittings – steel | |
|---|---|
| <ul style="list-style-type: none"> <li>The paintwork is in good condition with no metal exposure.</li> <li>All connections are tight and in good condition.</li> </ul> | <p>Steel base plates, nuts and bolts connections in sound condition (VicRoads)</p> |

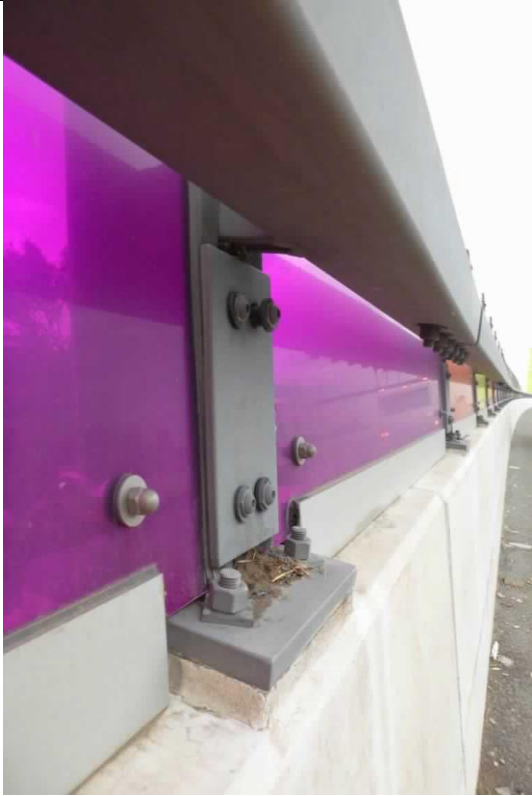
| 93S - Hold-down bolts, base plates and fittings – steel | |
|---|---|
| <ul style="list-style-type: none"> <li>Painted steelwork may have light rust spotting to the surface area and the protective coating is losing effectiveness.</li> <li>The connections may be slightly loose or beginning to corrode.</li> </ul> | <p>Loose bolt on visual screen connection</p> |

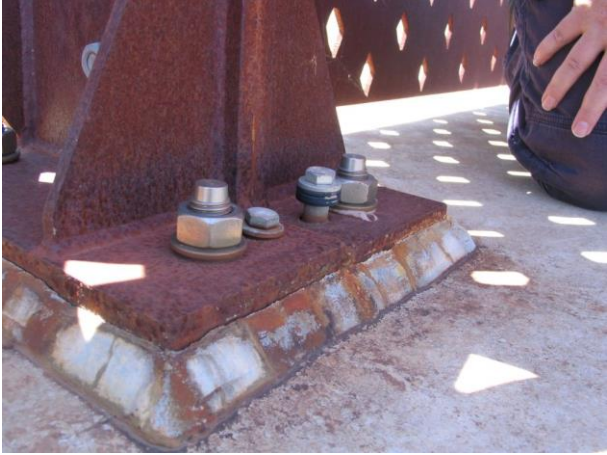
| <b>Condition state 3 -Description</b> <ul style="list-style-type: none"> <li>Painted steelwork may have minor rust spotting to the surface area and the protective coating is no longer effective.</li> <li>The connections may be loose or have minor corrosion.</li> </ul> | <b>Photo</b><br><br>Loose hold down bolt in visual screen wall base plate |

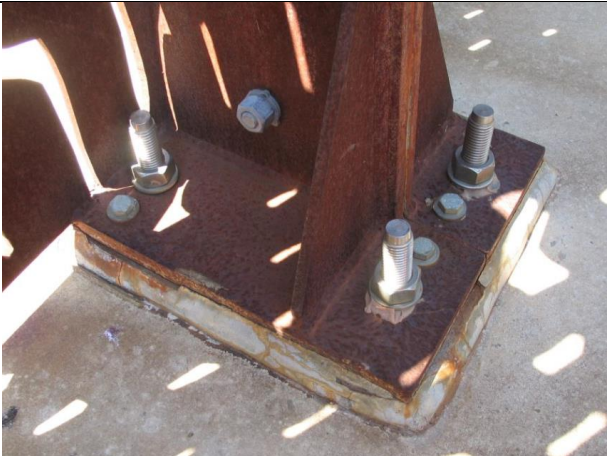
| <b>Condition state 4 -Description</b> <ul style="list-style-type: none"> <li>Steelwork has moderate corrosion and the paintwork has failed with moderate surface area rusted.</li> <li>Some surface pitting may be evident but section loss is minimal.</li> <li>Connections may be moderately corroded or loose.</li> </ul> | <b>Photo</b><br><br>Baseplate bent at corner over missing edge of mortar pad |

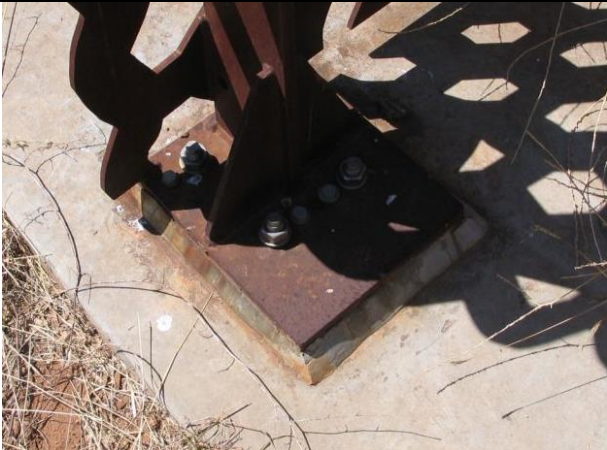
| 94C - Grout or mortar pad beneath baseplate – concrete | | Units |
|---|---|---|
| <ul style="list-style-type: none"> <li>The mortar pad completely fills the area beneath the baseplate, is sound with no drummy sound, cracking, spalling or other signs of deterioration.</li> </ul> | <p>Mortar pad in good condition, although some staining from the baseplate</p> | |

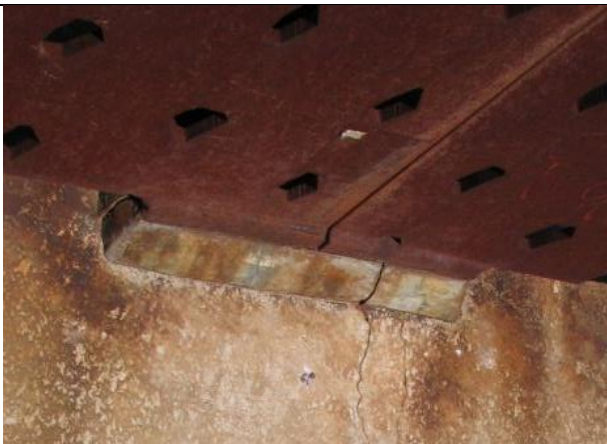
| 94C - Grout or mortar pad beneath baseplate – concrete | | Units |
|---|---|---|
| <ul style="list-style-type: none"> <li>The mortar pad may have fine cracks or small gaps, but is generally sound and fills the area beneath the baseplate.</li> </ul> | <p>Minor crack in mortar pad beneath baseplate</p> | |

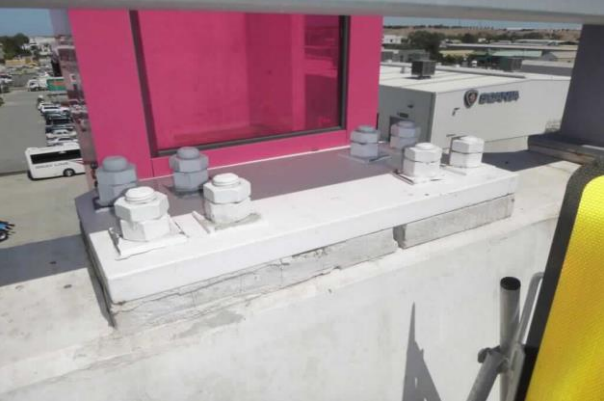
| <b>Condition state 3 -Description</b> <ul style="list-style-type: none"> <li>The pad may have moderate cracks or gaps, but is still generally sound and fills the area beneath the baseplate.</li> </ul> | <b>Photo</b> <p>Moderate crack in urban art mortar pad but still sound</p> |

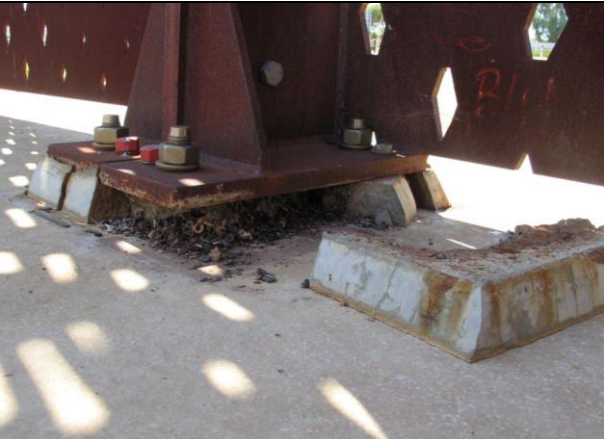
| <b>Condition state 4 -Description</b> <ul style="list-style-type: none"> <li>The mortar pad may be severely cracked or only contain large gaps, where it has spalled or not been installed thoroughly.</li> </ul> | <b>Photo</b> <p>Severe cracking and spalling with a large section of mortar pad missing</p> |

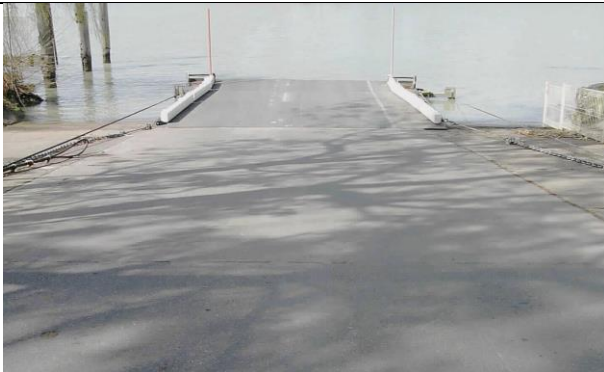
| <ul style="list-style-type: none"> <li>The transition between the road and ramp slab is smooth with no level difference, rutting, bumps, depressions cracking or potholes.</li> <li>Ramp slabs are in good condition with only minor cracking and have not settled.</li> </ul> | | Ramp slab in good condition |

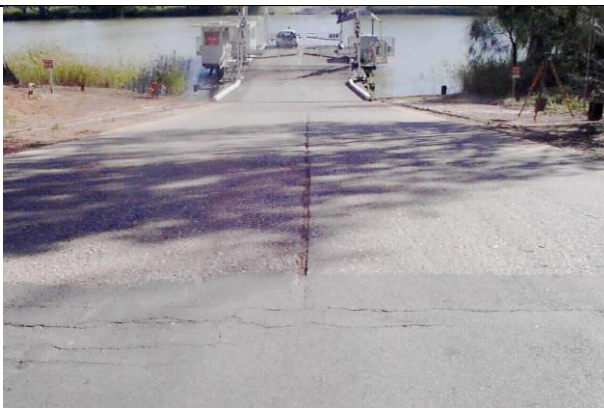
| <ul style="list-style-type: none"> <li>The approaches to the ramps may have settled slightly but the transition is generally smooth with minor rutting, bumps, depressions, potholes or some minor cracking.</li> <li>Ramp slabs are in good condition with only minor rutting, cracking and spalling.</li> <li>The slab may have settled slightly but level differences between slab sections are minor.</li> </ul> | | Minor differential settlement at top of ramp |

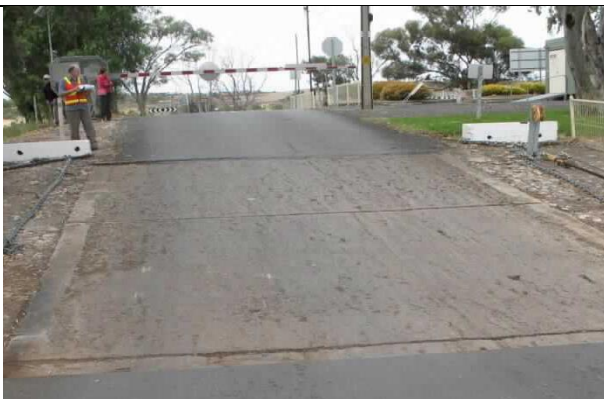
| <ul style="list-style-type: none"> <li>The approaches to the ramps may have settled further with a moderate level difference within 1m of the ramp slab.</li> <li>Ramp slabs are in fair condition with moderate rutting, cracking and spalling. Any exposed reinforcement may be lightly corroded but there is no section loss.</li> <li>The slab may have settled further with moderate level differences between slab sections.</li> </ul> | | Slab has significant surface erosion and loss of concrete fines but no sign of distress or reinforcement corrosion |

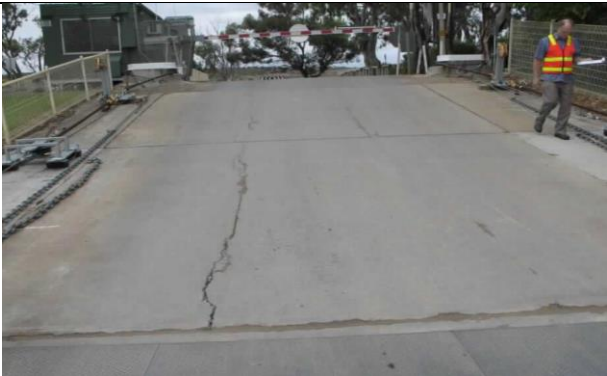
| <p><b>Condition state 4 -Description</b></p> <ul style="list-style-type: none"> <li>• Settlement of approaches to the ramps has advanced further with a significant level difference within 1m of the ramp slab.</li> <li>• Ramp slabs are in poor condition with medium rutting, cracking and spalling. Exposed reinforcement may be corroded and showing some minor section loss.</li> <li>• The slab may have settled further with significant level differences between slab sections.</li> </ul> | <p><b>Photo</b></p> <p>Slab has large longitudinal and transverse cracks</p> |

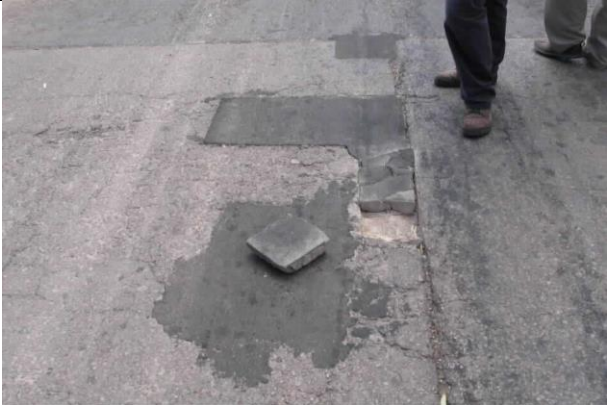
| <p><b>Condition state 5 -Description</b></p> <ul style="list-style-type: none"> <li>• Settlement of approaches to the ramps is pronounced with a substantial level difference within 1m of the ramp slab.</li> <li>• Ramp slabs are in very poor condition with severe cracking and spalling and exposed reinforcement is corroded and may be showing moderate section loss.</li> <li>• The slab may have settled dramatically with substantial level differences between slab sections.</li> </ul> | <p><b>Photo</b></p> <p>Substantial cracking with areas of concrete surface broken out</p> |

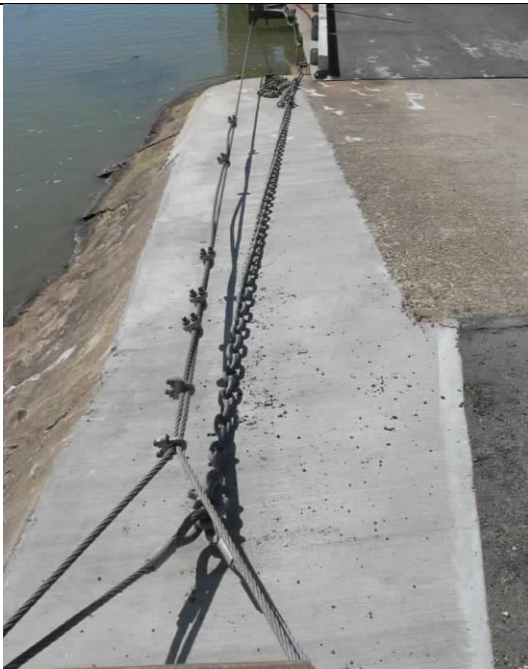
| 101C - Ramp shoulder – concrete | | Units |
|---|---|---|
| <ul style="list-style-type: none"> <li>Ramp shoulders are in good condition with only minor cracking and have not settled.</li> </ul> | <p>Shoulder in good condition (stone pitching with concrete overlay)</p> | |

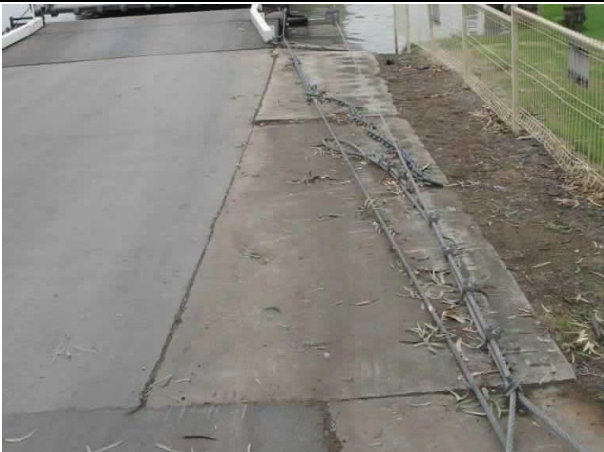
| 101C - Ramp shoulder – concrete | | Units |
|---|---|---|
| <ul style="list-style-type: none"> <li>Ramp shoulders are in good condition with only minor cracking and spalling.</li> <li>The shoulder may have settled slightly but level differences between the shoulder sections or the ramp slab are minor.</li> </ul> | <p>Shoulder with minor settlement between concrete sections</p> | |

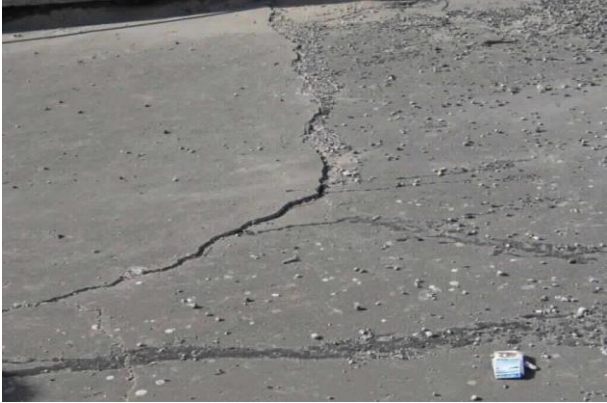
| <p><b>Condition state 3 -Description</b></p> <ul style="list-style-type: none"> <li>• Ramp shoulders are in fair condition with moderate cracking and spalling. Any exposed reinforcement may be lightly corroded but there is no section loss.</li> <li>• The shoulder may have settled further with moderate level differences between the shoulder sections or the ramp slab.</li> </ul> | <p><b>Photo</b></p> <p>Moderate cracking and settlement</p> |

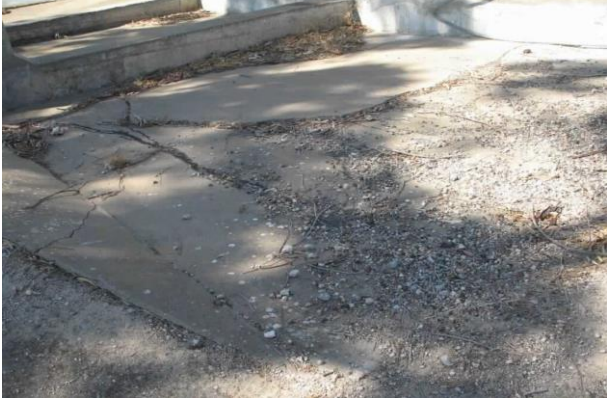
| <p><b>Condition state 4 -Description</b></p> <ul style="list-style-type: none"> <li>• Ramp shoulders are in poor condition with medium cracking and spalling. Exposed reinforcement may be corroded and showing some minor section loss.</li> <li>• The shoulder may have settled further with significant level differences between the shoulder sections or the ramp slab.</li> </ul> | <p><b>Photo</b></p> <p>Large cracks and spalling with exposed reinforcement in some areas</p> |

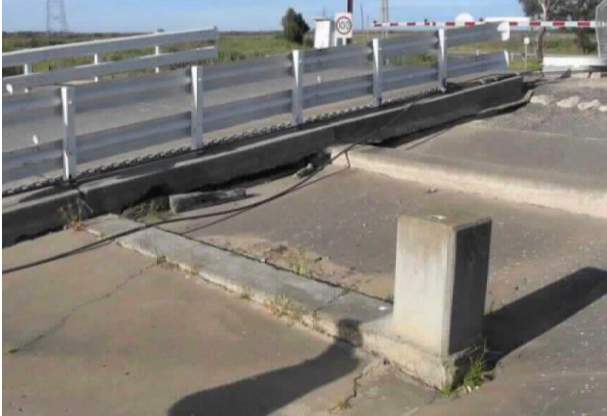
| <p><b>Condition state 5 -Description</b></p> <ul style="list-style-type: none"> <li>• Ramp shoulders are in very poor condition with severe cracking and spalling and exposed reinforcement is corroded and may be showing heavy section loss.</li> <li>• The shoulder may have settled dramatically with substantial level differences between the shoulder sections or the ramp slab.</li> </ul> | <p><b>Photo</b></p> <p>Concrete slab panels between the spear arms have settled substantially, causing the ramp slab edge to spall off exposing reinforcement which is corroding</p> |

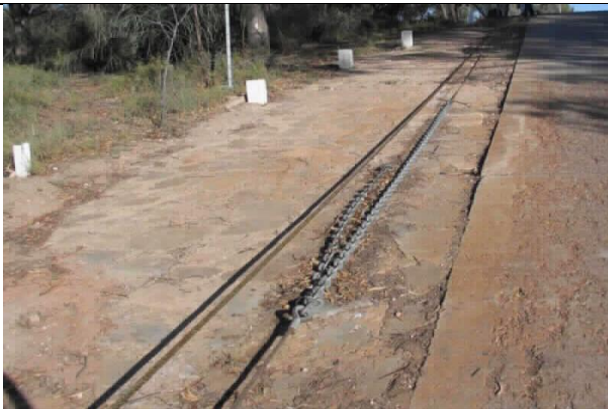
| 1010 - Ramp shoulder – other | | Units |
|---|---|---|
| <ul style="list-style-type: none"> <li>The shoulders are generally in good condition with only minor fine cracks in the mortar between stones, with no loss of mortar between the stones.</li> </ul> | <p>Stone pitching in generally good condition</p> | |

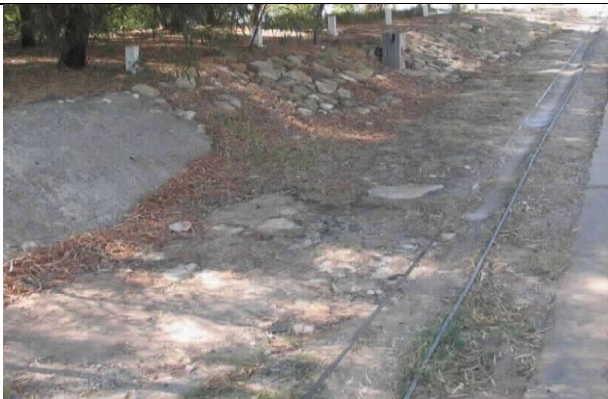
| 1010 - Ramp shoulder – other | | Units |
|---|---|---|
| <ul style="list-style-type: none"> <li>The shoulder may have a number of fine cracks in the mortar but no cracking of the stones. There may be minor loss of mortar of no concern.</li> <li>The shoulder may have settled slightly but level differences between the shoulder sections or the ramp slab are minor.</li> </ul> | <p>Shoulder in sound condition with some cracks in the mortar</p> | |

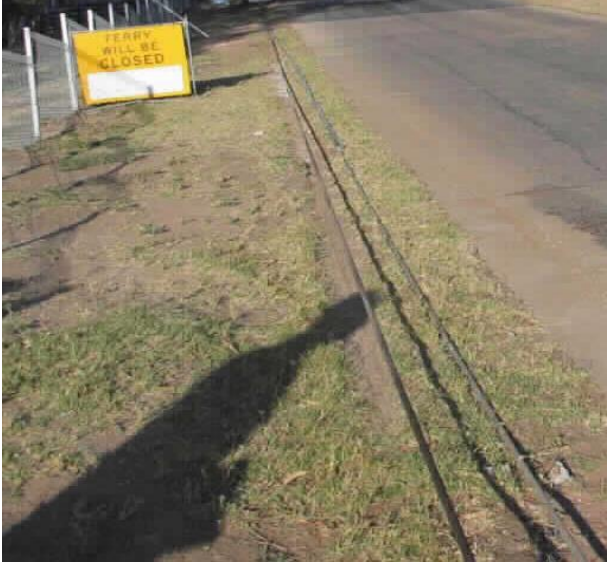
| Condition state 3 -Description | Photo |
|---|---|
| <ul style="list-style-type: none"> <li>• The shoulder may have a number of minor cracks in the mortar and fine cracking of the stones. There may be minor loss of mortar of no concern.</li> <li>• The shoulder may have settled further with moderate level differences between the shoulder sections or the ramp slab.</li> <li>• The shoulder may not be visible, beneath a layer of soil or vegetation.</li> </ul> | <p data-bbox="791 763 1409 786">Shoulder not exposed due to layer of soil and vegetation</p> |

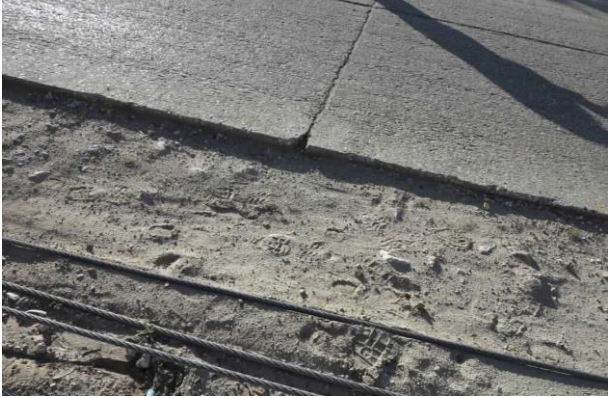
| Condition state 3 -Description | Photo |
|---|---|
| <ul style="list-style-type: none"> <li>• Moderate cracking of the mortar or moderate mortar loss.</li> <li>• Loss of stone material may be occurring in some places.</li> <li>• The shoulder may have settled further with significant level differences between the shoulder sections or the ramp slab.</li> </ul> | <p data-bbox="791 1234 1409 1323">Stone pitching shoulder covered by layer of topsoil, with significant level difference to ramp slab (note spall at joint in edge of ramp)</p> |

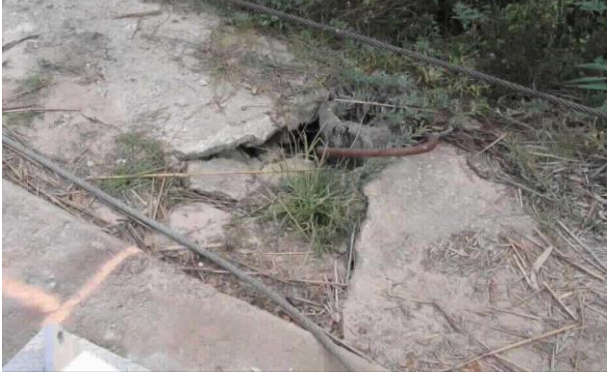
| Condition state 3 -Description | Photo |
|---|---|
| <ul style="list-style-type: none"> <li>• Severe cracking of the mortar or heavy loss of mortar may be occurring in the shoulder.</li> <li>• There may be heavy loss of stone material from the shoulder.</li> <li>• The shoulder may have settled dramatically with substantial level differences between the shoulder sections or the ramp slab.</li> </ul> | <p data-bbox="791 1749 1409 1767">Large area of pitching has broken out</p> |

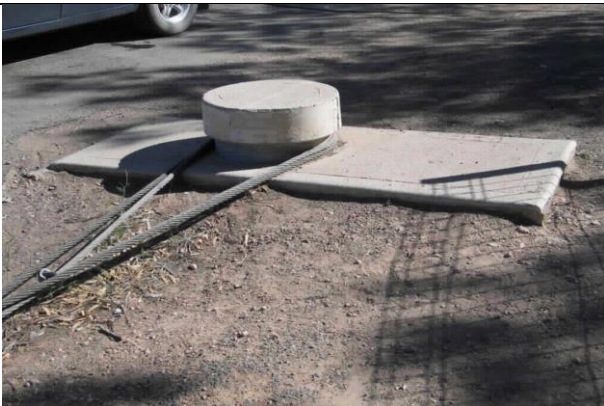
| 102C - Deadmen – concrete | | Units |
|---|---|---|
| <ul style="list-style-type: none"> <li>The deadman is in good condition with only minor cracking due to shrinkage or corroding reinforcement.</li> <li>There is no cracking due to differential settlement of footings or scouring under spread footings.</li> <li>The steel paint system is in good condition with only minor chalking, peeling or curling, but with no exposure of the metal.</li> </ul> | <p>Concrete deadman in good condition</p> | |
