# Road Structures Inspection Manual

## Part 4C: Condition State Guidelines and Photographs

### Other Structures

Part 4C: Condition State Guidelines and Photographs – Other Structures  
Department of Planning, Transport and Infrastructure, South Australia

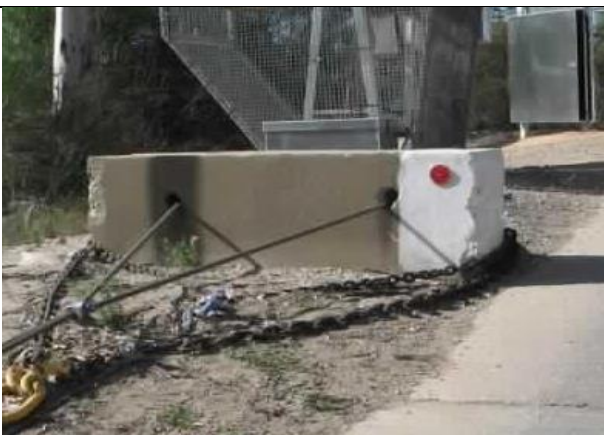
| 102C - Deadmen – concrete | | Units |
|---|---|---|
| <ul style="list-style-type: none"> <li>There is minor cracking or spalling due to corroding reinforcement or differential settlement of footings.</li> <li>There is no scour beneath the spread footing base.</li> <li>Light spot rusting of the paint system is occurring to the surface area of the steel collar or brackets.</li> </ul> | <p>Concrete deadman with cable through holes, minor spalling at both edges due to cable wear</p> | |

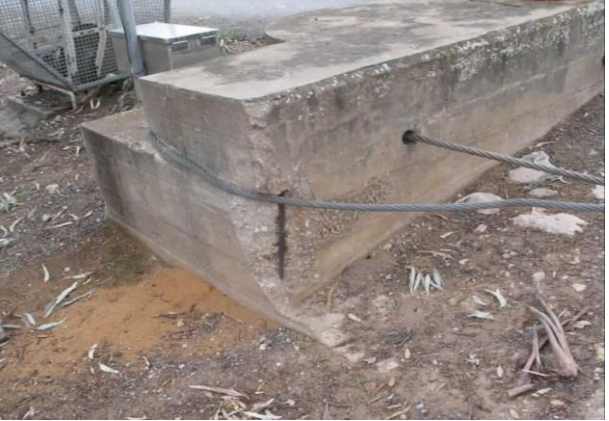
| Condition state 3 -Description | Photo |
|---|---|
| <ul style="list-style-type: none"> <li>• Moderate cracking or spalling due to differential settlement may have occurred.</li> <li>• Moderate to severe cracking or spalling due to corroding reinforcement or ASR may be evident. There is minor loss of reinforcement section.</li> <li>• Minor surface rusting to the steel collar or brackets and minor corrosion and pitting in areas but no loss of section area has occurred</li> </ul> | <p>Moderate spalling to corner of deadman, with corroded reinforcement visible</p> |

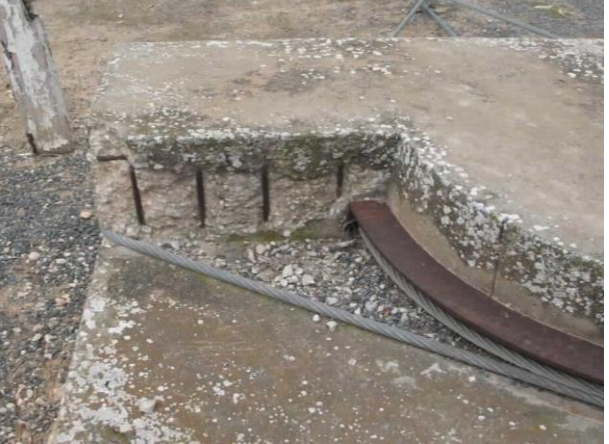
| Condition state 3 -Description | Photo |
|---|---|
| <ul style="list-style-type: none"> <li>• Medium cracking or spalling due to differential settlement may have occurred.</li> <li>• Medium to severe cracking or spalling due to corroding reinforcement or ASR may be evident. There is moderate loss of reinforcement section.</li> <li>• There is no scour beneath the spread footing base.</li> <li>• Moderate surface rusting to the steel collar or brackets and moderate corrosion and pitting in areas but no loss of section area has occurred.</li> </ul> | <p>Significant spalling of deadman with corroded reinforcement exposed. Moderate surface rusting to steel cable guide</p> |

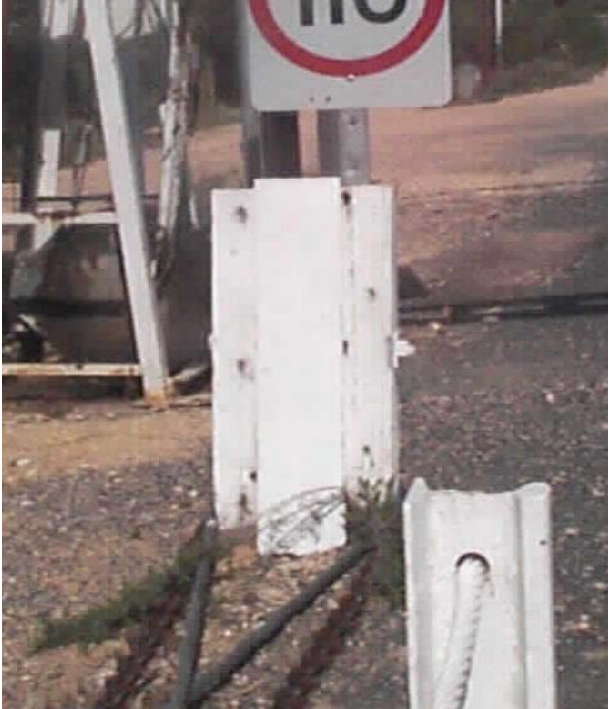
| <b>102S - Deadmen – steel</b><br><br>This component defines steel members that are used to anchor the ferry cables. It includes any packing (including timber) between flanges. | Units<br><br><b>Each</b> |
|---|---|
| <ul style="list-style-type: none"> <li>• The deadman is in good condition with no deterioration of any welds or bolts.</li> <li>• The paint system is in good condition with only minor chalking, peeling or curling, but with no exposure of the metal.</li> <li>• Packing is in good condition and connection to the steel deadman are good.</li> </ul> | <p>Steel RSJ deadman with timber packing, in good condition</p> |

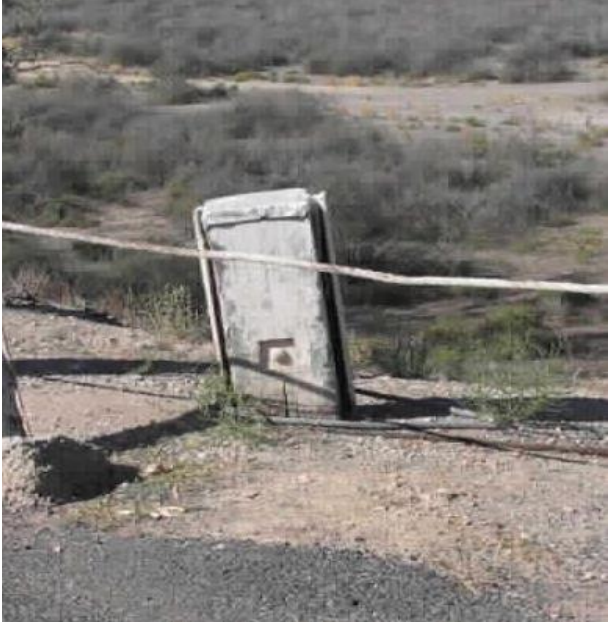
| <b>102S - Deadmen – steel</b><br><br>This component defines steel members that are used to anchor the ferry cables. It includes any packing (including timber) between flanges. | Units<br><br><b>Each</b> |
|---|---|
| <ul style="list-style-type: none"> <li>• Light spot rusting of the paint system is occurring to the surface area.</li> <li>• No corrosion has occurred as yet.</li> <li>• No cracking of welds has occurred, but there may be some minor rusting of nuts or bolts.</li> <li>• Packing is generally in good condition but may have minor deterioration. Connection to the steel is still good.</li> </ul> | <p>Steel RSJ deadman generally in good condition however timber packing with minor deterioration to timber and paint system</p> |

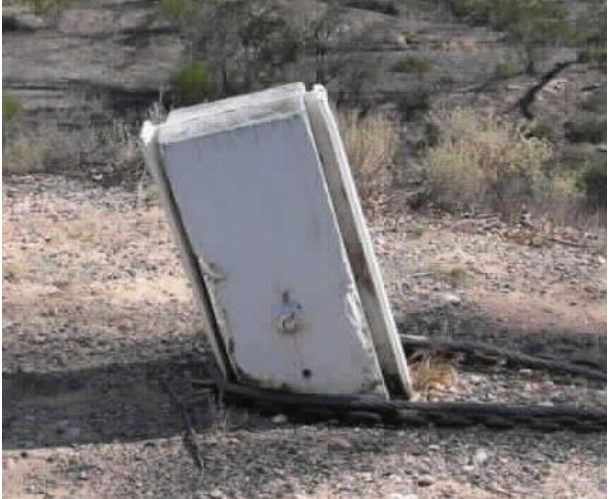
| Condition state 3 -Description | Photo |
|---|---|
| <ul style="list-style-type: none"> <li>• The paint system has broken down with minor surface rusting to the area and minor corrosion and pitting in areas but no loss of section area has occurred which would affect the strength of the deadman.</li> <li>• No cracking of welds has occurred, but there may be some moderate rusting of nuts or bolts.</li> <li>• Packing is in fair condition but may have moderate deterioration. Connections to the steel may be slightly loose.</li> </ul> | <p data-bbox="791 689 1409 752">Steel RSJ with some surface rusting and minor corrosion at base, timber packing with minor deterioration</p> |

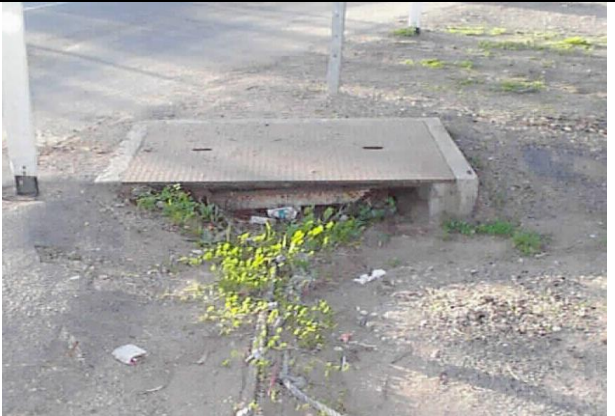
| Condition state 3 -Description | Photo |
|---|---|
| <ul style="list-style-type: none"> <li>• The paint system has broken down with moderate surface rusting to the area and moderate corrosion and pitting in areas but no loss of section area has occurred which would affect the strength of the deadman.</li> <li>• Nuts and bolts may be corroded with moderate loss of tension in the bolt.</li> <li>• Welds may be cracked with minor loss of effectiveness.</li> <li>• Packing could have major splitting and/or large areas of rot. Connections may be loose and not engaged with the steel deadman.</li> </ul> | <p data-bbox="791 1200 1409 1294">Steel RSJ pile with steel saddle for cable, obscured by gully cover. Visible area displays moderate rusting and corrosion</p> |

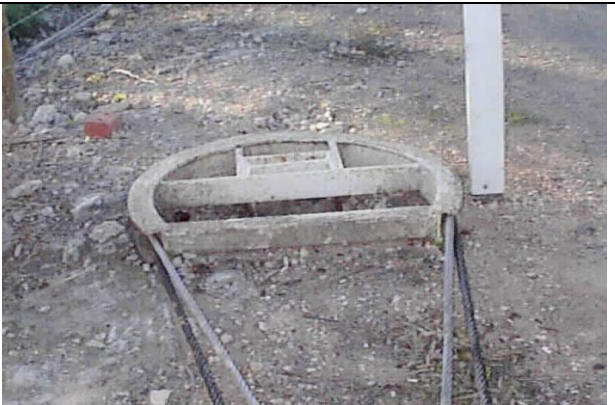
| Condition state 3 -Description | Photo |
|---|---|
| <ul style="list-style-type: none"> <li>• Corrosion is well advanced having a detrimental effect on the strength of the deadman. Full support for the ferry cable is not provided, with deadman movement occurring with ferry movements.</li> <li>• The paint system has completely broken down with corrosion and pitting in areas.</li> <li>• Packing is missing or has significant deterioration and requires treatment or replacement in the short term. Connections to the steel deadman may be completely lost.</li> </ul> | <p data-bbox="791 1731 1409 1832">Steel RSJ pile with steel saddle for cable. Very poor condition – exhibits significant movement with ferry movements</p> |

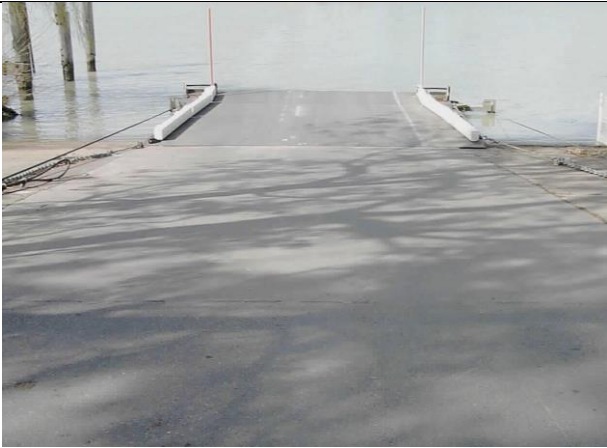
| 1030 - Ramp joints – other | | Units |
|---|---|---|
| <ul style="list-style-type: none"> <li>There may be fine cracking of the traffic surface at the top joint.</li> <li>Slab joints are in good condition with no cracking or spalling at the joint edges.</li> </ul> | <p>Top joint with only fine cracks</p> | |

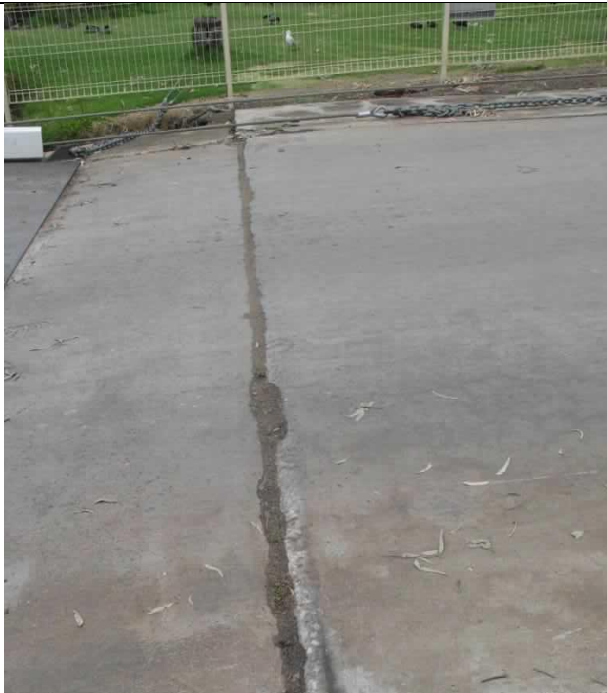
| 1030 - Ramp joints – other | | Units |
|---|---|---|
| <ul style="list-style-type: none"> <li>There is minor cracking or spalling of the concrete slab or the approach traffic surface at the joint edges.</li> </ul> | <p>Slab joint with minor spalling at edges</p> | |

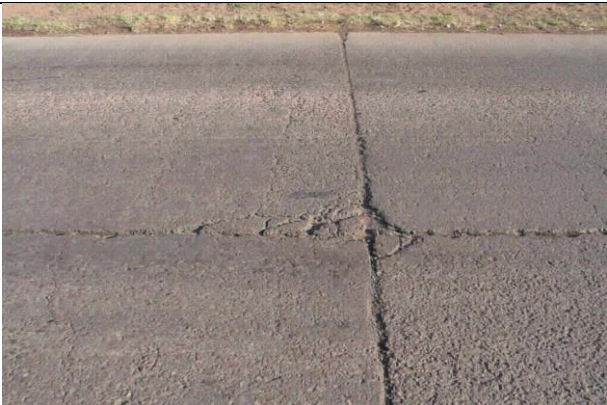
| Condition state 3 -Description | Photo |
|---|---|
| <ul style="list-style-type: none"> <li>There is moderate cracking or spalling of the concrete slab or the approach traffic surface at the joint edges.</li> </ul> | <p>Moderate cracking and spalling at slab joint</p> |

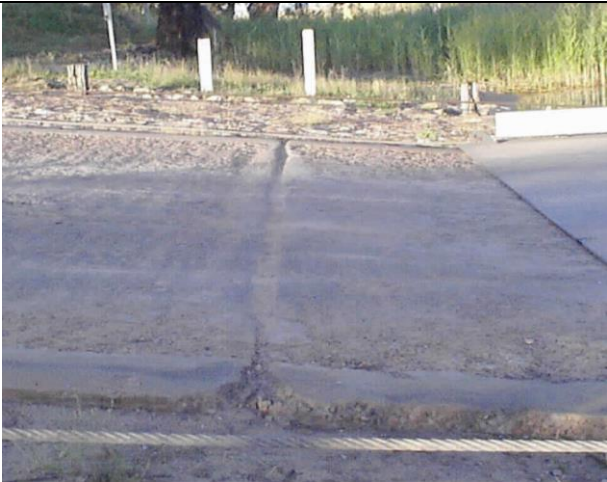
| Condition state 3 -Description | Photo |
|---|---|
| <ul style="list-style-type: none"> <li>There is significant cracking or spalling of the concrete slab or the approach traffic surface at the joint edges.</li> </ul> | <p>Slab joint in poor condition. Significant cracking and spalling has seen joint open up and fill with material</p> |

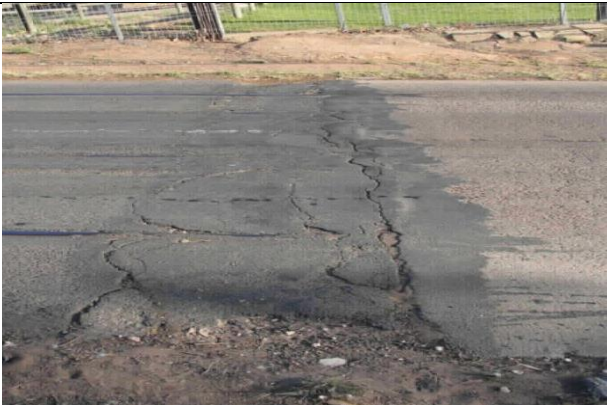
| Condition state 3 -Description | Photo |
|---|---|
| <ul style="list-style-type: none"> <li>Substantial cracking or spalling of the concrete slab or the approach traffic surface at the joint edges.</li> </ul> | <p>Top joint with substantial cracking and deterioration of the AC approach surface</p> |

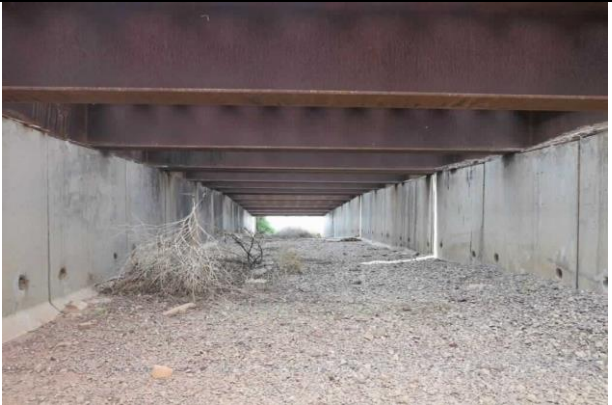
| <ul style="list-style-type: none"> <li>The walls are in good condition with only minor cracking due to corroding reinforcement.</li> <li>No subsidence of the road surface behind the abutment.</li> <li>Cast-in plate paintwork is generally sound with only minor chalking, peeling or curling, but no exposure of the metal.</li> </ul> | | |
| Abutment walls in good condition | | |

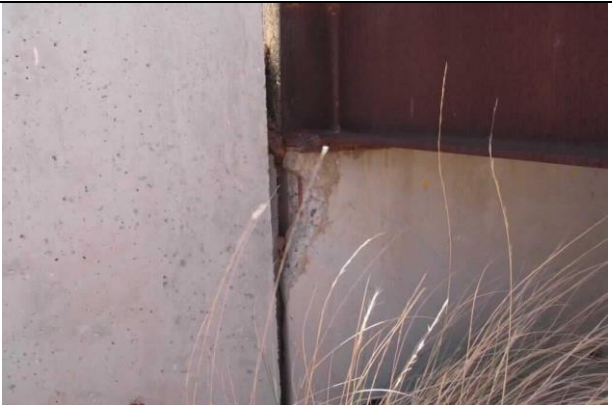
| <ul style="list-style-type: none"> <li>The wall may have minor cracking and spalling due to corroding reinforcement, earth pressure, beam friction on differential movements.</li> <li>Minor subsidence of the road surface may be evident behind the abutment.</li> <li>Light spot rusting of the cast-in plate paint system is occurring and the system starting to lose effectiveness. No corrosion has occurred as yet</li> </ul> | | |
| Minor spall on abutment wall | | |

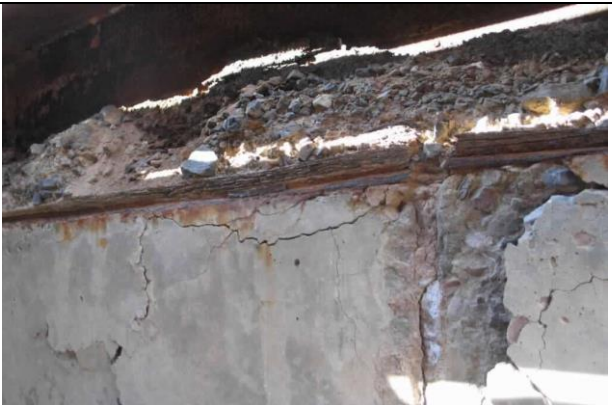
| <ul style="list-style-type: none"> <li>Moderate cracking and spalling may be visible due to earth pressure, beam friction, edge bearing or differential movements.</li> <li>Reinforcement may be corroded, with minor loss of section and associated moderate to severe cracking, spalling and delamination of concrete.</li> <li>The road surface behind the abutment has moderate subsidence.</li> <li>Spot rusting of the cast-in plate paint system is increasing and the system is no longer effective. Light corrosion has occurred.</li> </ul> | | |
| Moderate spalling and corrosion of cast-in plate | | |

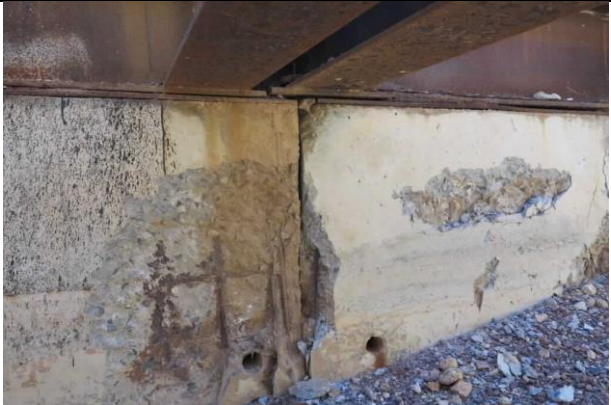
| Condition state 4 -Description | Photo |
|---|---|
| <ul style="list-style-type: none"> <li>• More advanced cracking and spalling may be visible due to earth pressure, beam friction, edge bearing or differential movements.</li> <li>• Corrosion of the reinforcement is advanced, with moderate loss of section and associated moderate to severe cracking, spalling and delamination of concrete.</li> <li>• The road surface behind the abutment has subsided noticeably.</li> <li>• The cast-in plate paint system has broken down with corrosion and pitting in areas.</li> </ul> | <p>Significant spalling at abutment wall with corroded reinforcement visible</p> |

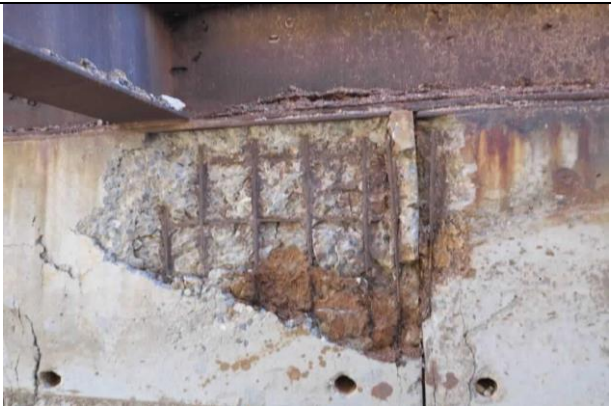
| Condition state 4 -Description | Photo |
|---|---|
| <ul style="list-style-type: none"> <li>• Severe cracking and spalling due to structural mechanisms is evident in abutment walls.</li> <li>• Corrosion of the reinforcement is well advanced with more severe section loss.</li> <li>• There may be significant movement of the abutment wall. There may be severe subsidence of the road surface behind the abutment.</li> <li>• Corrosion of the cast-in plate is well advanced, having a definite detrimental effect on the strength of the element. The paint system has completely broken down.</li> </ul> | <p>Severe spalling with large area of corroding reinforcement; cast-in plate is also heavily corroded</p> |

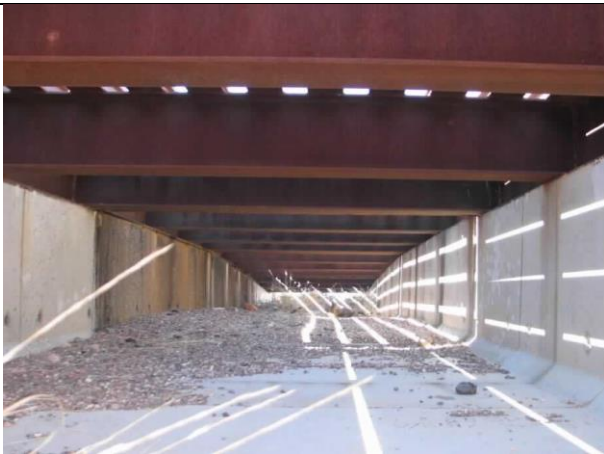
| 112C - Grid base slab – concrete | | Units |
|---|---|---|
| <ul style="list-style-type: none"> <li>The slab shows little or no deterioration with only a few fine superficial cracks of no importance.</li> <li>Minor cracking due to corroding reinforcement may be present.</li> <li>The slab is clear with no or little gravel, soil or vegetation build up present.</li> </ul> | <p>Base slab in good condition</p> | |

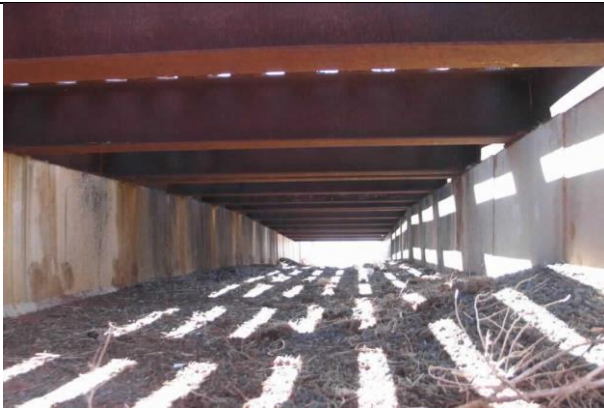
| 112C - Grid base slab – concrete | | Units |
|---|---|---|
| <ul style="list-style-type: none"> <li>Minor cracking and spalling may be present with small areas of corroding reinforcement visible.</li> <li>Dampness patches and efflorescence powder may be visible with evidence of minor ponding.</li> <li>Shrinkage cracking is fine and dry.</li> <li>Minor soil, gravel or vegetation build up is present on the slab, but having no effect on the components.</li> </ul> | <p>Base slab in good condition with minor gravel build up of little consequence</p> | |

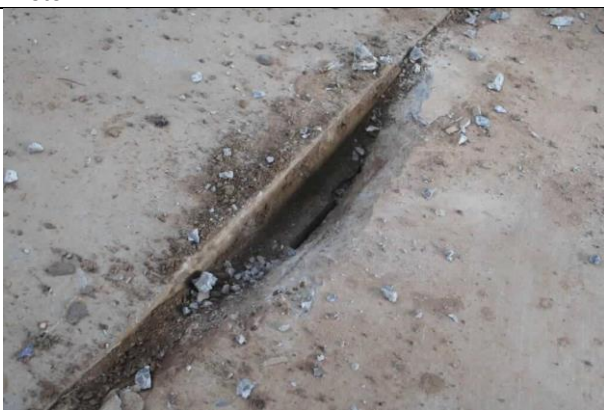
| 112C - Grid base slab – concrete | | Units |
|---|---|---|
| <ul style="list-style-type: none"> <li>Moderate cracking and spalling may be present with minor loss of section due to corroding reinforcement.</li> <li>Dampness patches and efflorescence powder may be more prominent.</li> <li>Water may be ponding on the slab.</li> <li>Shrinkage cracking is fine and dry.</li> <li>Moderate soil or gravel build up is present on the slab, but only having minor effect on the components.</li> </ul> | <p>Moderate spalling in base slab</p> | |

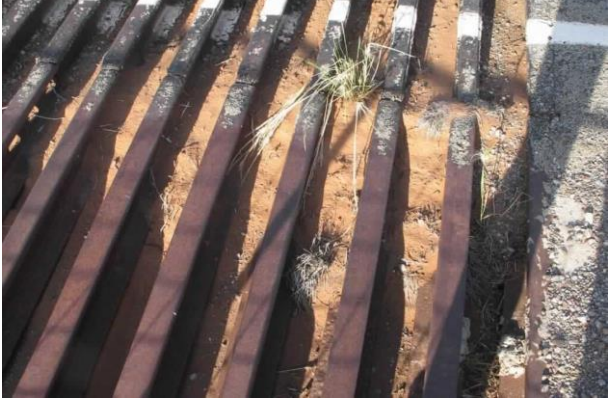
| Condition state 4 -Description | Photo |
|---|---|
| <ul style="list-style-type: none"> <li>• There may be moderate to severe cracking and spalling with moderate loss of section due to corroding reinforcement.</li> <li>• The slab has extensive crazed cracking.</li> <li>• Significant accumulation of soil, gravel or vegetation build up is present and partially filling the grid and threatening corrosion of the components.</li> </ul> | <p data-bbox="791 600 1409 622">Grid almost full of soil</p> |

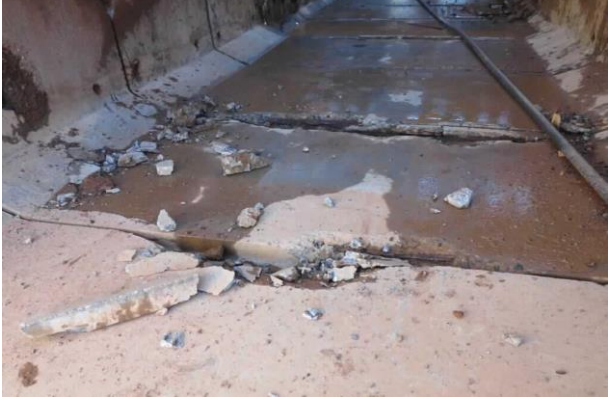
| Condition state 4 -Description | Photo |
|---|---|
| <ul style="list-style-type: none"> <li>• There may be severe cracking/spalling or advanced corrosion of reinforcement over large areas with more severe loss of section of reinforcement.</li> <li>• Excessive accumulation of soil, gravel or vegetation build up is present and filling the grid, causing corrosion of the components.</li> </ul> | <p data-bbox="791 1064 1409 1086">Severe cracking and spalling on base slab</p> |

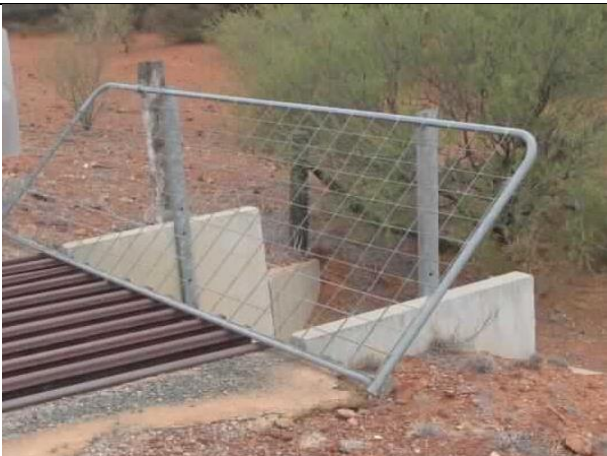
| 113C - Wingwall – concrete | | Units |
|---|---|---|
| <ul style="list-style-type: none"> <li>The wall is in good condition with no cracking, spalling, rotation, movement or moment cracking.</li> <li>Independent wingwalls are hard up against the abutment walls.</li> </ul> | | |
| Wingwalls in good condition | | |

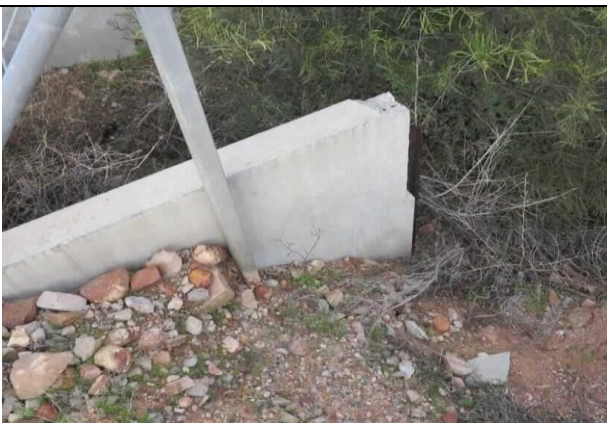
| 113C - Wingwall – concrete | | Units |
|---|---|---|
| <ul style="list-style-type: none"> <li>There may be some minor cracking or spalling due to corroding reinforcement or earth pressures.</li> <li>Any joint with the abutment may be cracked as a result of differential movement.</li> <li>Independent walls may be rotating or show small forward movements but there is no loss of embankment material.</li> </ul> | | |
| Minor spall | | |

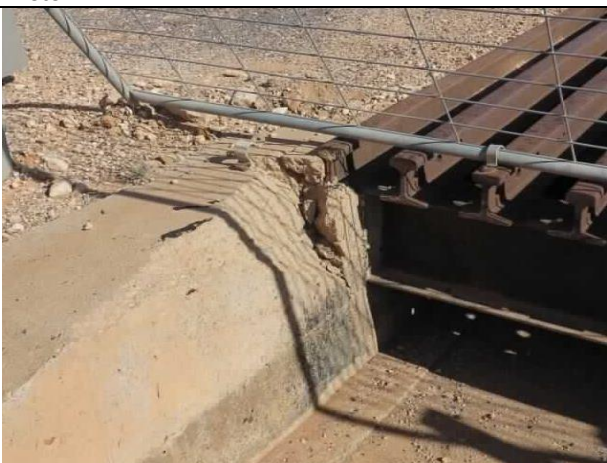
| 113C - Wingwall – concrete | | Units |
|---|---|---|
| <ul style="list-style-type: none"> <li>There may be moderate cracking or spalling due to corroding reinforcement or earth pressures. There may be minor loss of section of reinforcement due to corrosion.</li> <li>Any joints with the abutment may have minor cracking and minor spalling of the adjoining edges may be evident.</li> <li>Independent wingwalls may show minor rotations or movements.</li> <li>There is some loss of fill but little effect on serviceability as a result of differential movements.</li> </ul> | | |
| Moderate spalling | | |

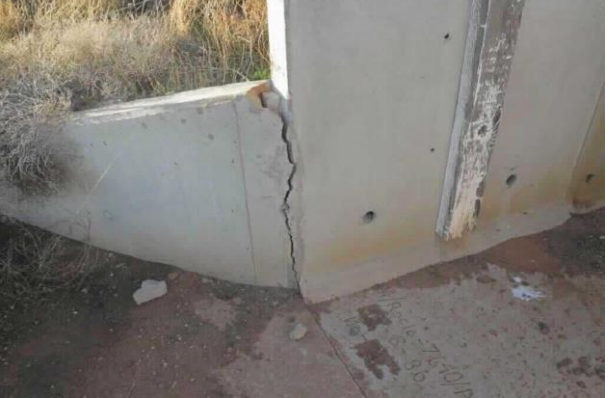
| Condition state 4 -Description | Photo |
|---|---|
| <ul style="list-style-type: none"> <li>• There may be medium cracking or spalling due to corroding reinforcement, ASR or earth pressures. There may be moderate loss of section of reinforcement due to corrosion.</li> <li>• Any joints with the abutment may be cracked and spalling of the adjoining edges may be evident.</li> <li>• Independent wingwalls may show moderate rotations or movements.</li> <li>• There is moderate loss of fill with minor effect on serviceability as a result of differential movements.</li> </ul> | <p data-bbox="794 600 1149 627">Large crack and spall at wingwall</p> |

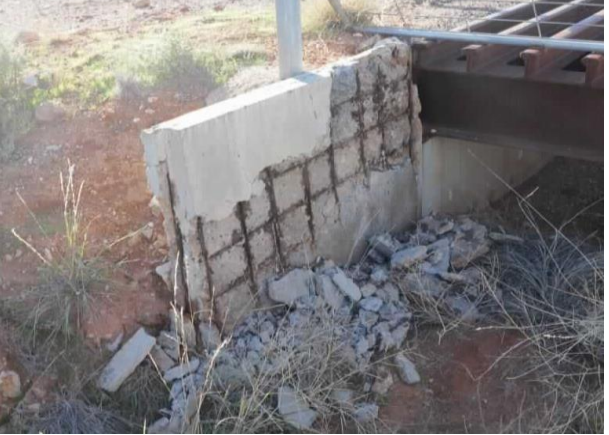
| Condition state 4 -Description | Photo |
|---|---|
| <ul style="list-style-type: none"> <li>• There may be heavy cracking or spalling due to corroding reinforcement or earth pressures. There may be more severe loss of section of reinforcement due to corrosion (and the resultant cracking and spalling this may cause). This may include any joint with the abutment that is cracked and badly spalled as a result of differential movements.</li> <li>• The water bar may be torn and fill escaping through the gap.</li> <li>• Independent wingwalls may show large rotations or movements due to earth pressure causing excessive loss of fill material from behind.</li> </ul> | <p data-bbox="794 1144 1085 1171">Heavy spalling on wingwall</p> |

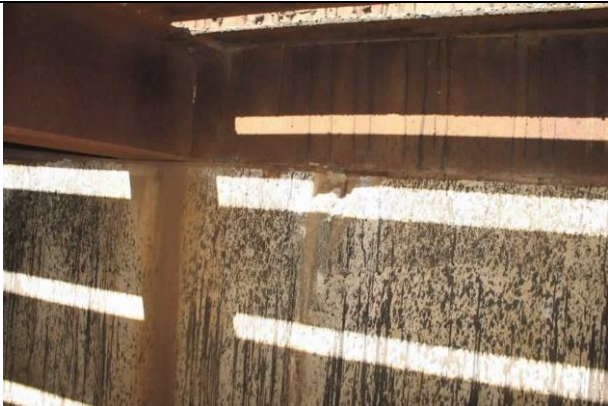
| 114S - Grid baffle plates – steel | | Units |
|---|---|---|
| <ul style="list-style-type: none"> <li>Rusting of the paint or galvanising system to the surface area is occurring and the paint system is losing effectiveness.</li> <li>No corrosion of the section has occurred.</li> <li>No cracking of welds has occurred, but there may be some minor rusting of nuts or bolts.</li> </ul> | <p>Baffle plate with some rusting but no corrosion</p> | |

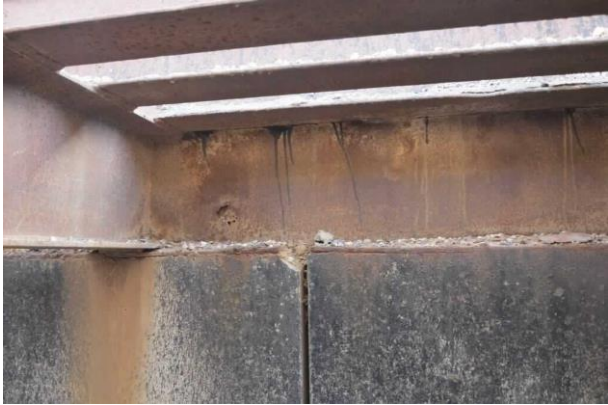
| 114S - Grid baffle plates – steel | | Units |
|---|---|---|
| <ul style="list-style-type: none"> <li>Rusting of the paint system to the surface area is occurring and the paint system is no longer effective.</li> <li>Some surface pitting may be present.</li> <li>No cracking of welds has occurred, but there may be some moderate rusting of nuts or bolts.</li> <li>Minor corrosion has occurred in isolated areas and minor loss of section area may have occurred which would affect the strength of the member.</li> </ul> | <p>Baffle plate with minor corrosion</p> | |

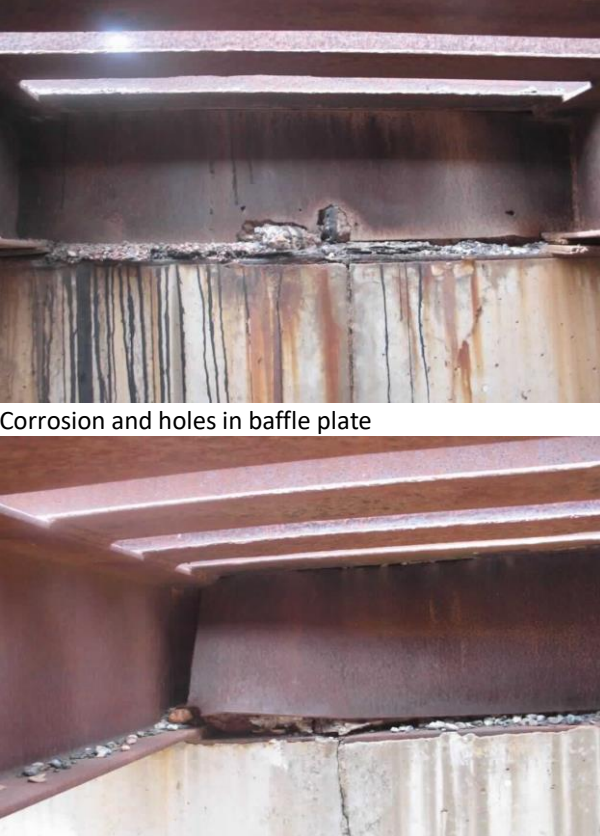
| Condition state 4 -Description | Photo |
|---|---|
| <ul style="list-style-type: none"> <li>• The paint or galvanising system has completely broken down with surface pitting in locations.</li> <li>• Welds may be cracked with minor loss of effectiveness. Nuts and bolts may be corroded with minor loss of tension in bolt.</li> <li>• Active corrosion may be occurring in isolated areas and moderate loss of section area has occurred affecting the strength of the member.</li> <li>• Baffle plate is deformed with loss of fill from behind.</li> </ul> | <p data-bbox="794 600 1166 629">Corrosion and holes in baffle plate</p> <p data-bbox="794 1032 975 1061">Bent baffle plate</p> |

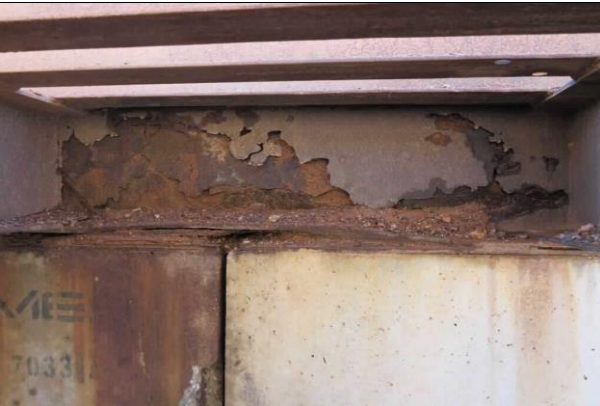
| Condition state 4 -Description | Photo |
|---|---|
| <ul style="list-style-type: none"> <li>• Corrosion is well advanced and significant loss of section has occurred having a detrimental effect on the strength of the member.</li> <li>• Welds may be broken. Bolts or rivets may be missing. Splice joint bolts may be loose (can be loosened by a spanner).</li> </ul> | <p data-bbox="794 1503 1315 1532">Severe baffle plate corrosion and loss of section</p> |

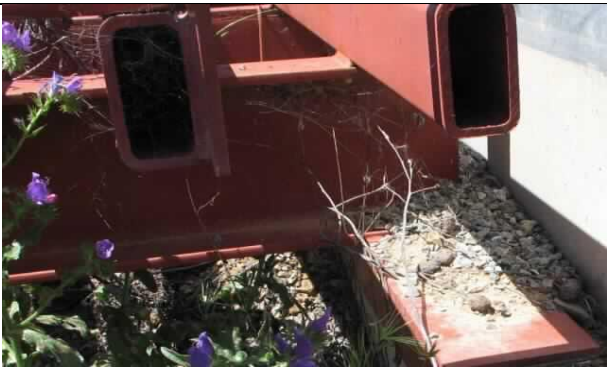
| 115S - Grid girders – steel | | Units |
|---|---|---|
| <ul style="list-style-type: none"> <li>The paint system is generally sound with only minor chalking, peeling or curling, but with no exposure of metal.</li> <li>All welds, bolts and rivets are in good condition.</li> </ul> | <p>Girder in good condition</p> | |

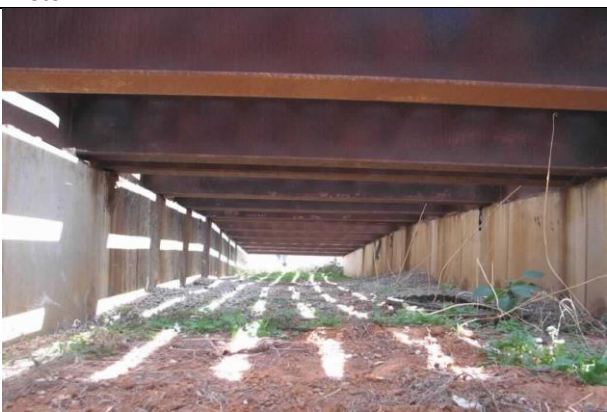
| 115S - Grid girders – steel | | Units |
|---|---|---|
| <ul style="list-style-type: none"> <li>Rusting of the paint or galvanising system to the surface area is occurring and the paint system is losing effectiveness.</li> <li>No corrosion of the section has occurred.</li> <li>No cracking of welds has occurred, but there may be some minor rusting of nuts or bolts.</li> </ul> | <p>Girders in good general condition, with some surface rusting</p> | |

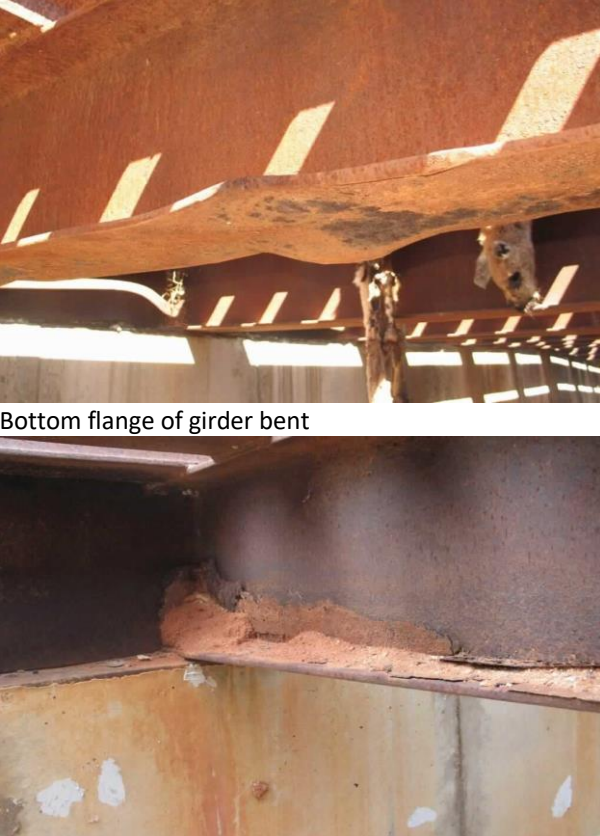
| Condition state 3 -Description | Photo |
|---|---|
| <ul style="list-style-type: none"> <li>• Rusting of the paint system to the surface area is occurring and the paint system is no longer effective.</li> <li>• Some surface pitting may be present.</li> <li>• No cracking of welds has occurred, but there may be some moderate rusting of nuts or bolts.</li> <li>• Minor corrosion has occurred in isolated areas but no loss of section area has occurred which would affect the strength of the member.</li> </ul> | <p data-bbox="794 600 1104 627">Bottom flange of girder bent</p> <p data-bbox="794 1034 970 1059">Girder corrosion</p> |

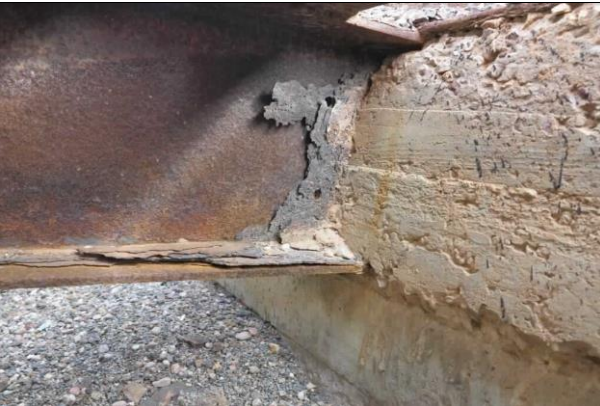
| Condition state 3 -Description | Photo |
|---|---|
| <ul style="list-style-type: none"> <li>• The paint or galvanising system has completely broken down with surface pitting in locations.</li> <li>• Welds may be cracked with minor loss of effectiveness. Nuts and bolts may be corroded with minor loss of tension in bolt.</li> <li>• Active corrosion may be occurring in isolated areas but no loss of section area has occurred which would affect the strength of the member.</li> </ul> | <p data-bbox="794 1505 1066 1529">Heavy corrosion of girder</p> |

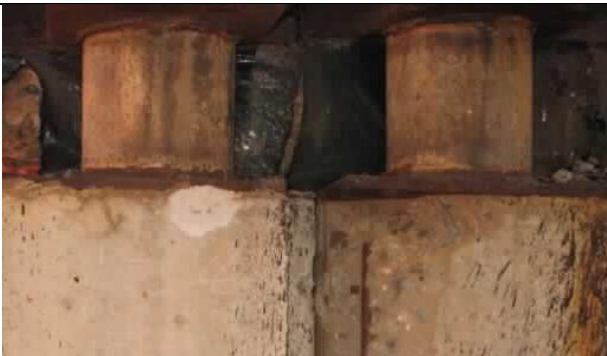
| 116S - Grid packers – steel | | Units |
|---|---|---|
| <ul style="list-style-type: none"> <li>The paint system is generally sound with only minor chalking, peeling or curling, but with no exposure of metal.</li> <li>All welds, bolts and rivets are in good condition.</li> </ul> | <p>Packers in good condition (abutment spall assessed under Component 110C)</p> | |

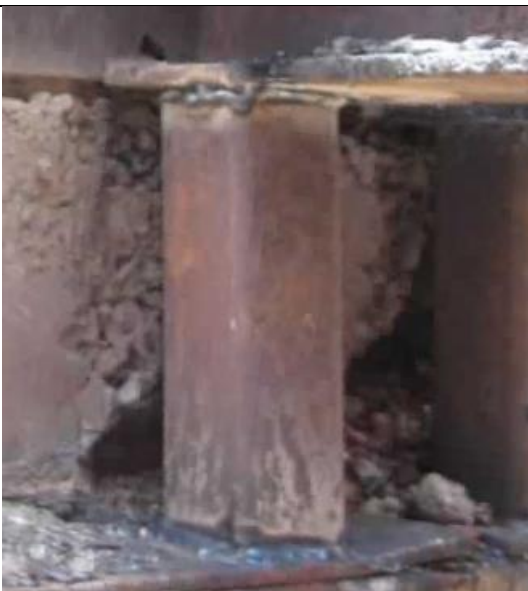
| 116S - Grid packers – steel | | Units |
|---|---|---|
| <ul style="list-style-type: none"> <li>Rusting of the paint or galvanising system to the surface area is occurring and the paint system is losing effectiveness.</li> <li>No corrosion of the section has occurred.</li> <li>No cracking of welds has occurred, but there may be some minor rusting of nuts or bolts.</li> </ul> | <p>Packer with surface rusting but no corrosion, and welds in good condition</p> | |

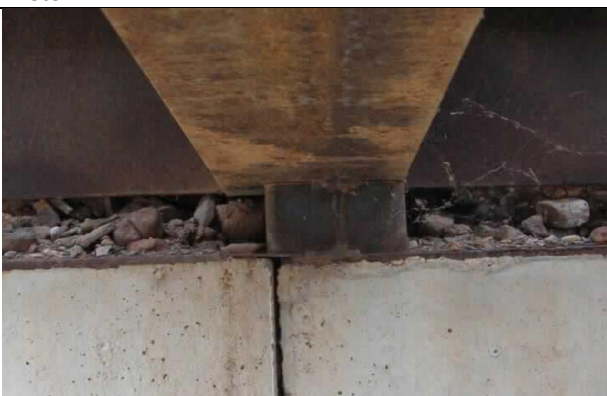
| 116S - Grid packers – steel | | Units |
|---|---|---|
| <ul style="list-style-type: none"> <li>Rusting of the paint system to the surface area is occurring and the paint system is no longer effective.</li> <li>Some surface pitting may be present.</li> <li>No cracking of welds has occurred, but there may be some moderate rusting of nuts or bolts.</li> <li>Minor corrosion has occurred in isolated areas but no loss of section area has occurred which would affect the strength of the member.</li> </ul> | <p>Packer not centred</p> | |

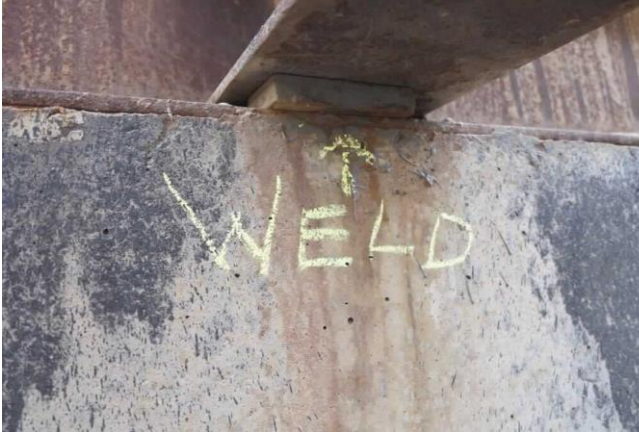
| Condition state 4 -Description | Photo |
|---|---|
| <ul style="list-style-type: none"> <li>• The paint or galvanising system has completely broken down with surface pitting in locations.</li> <li>• Welds may be cracked with minor loss of effectiveness. Nuts and bolts may be corroded with minor loss of tension in bolt.</li> <li>• Packer may be dislodged.</li> <li>• Active corrosion may be occurring in isolated areas but no loss of section area has occurred which would affect the strength of the member.</li> </ul> | <p data-bbox="791 622 1433 656">Loose packer, weld broken</p> |

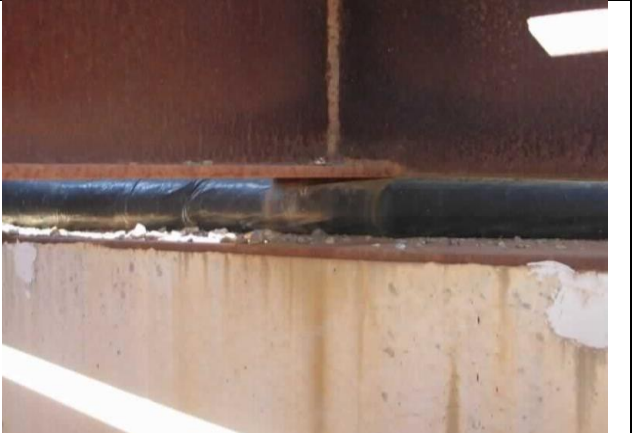
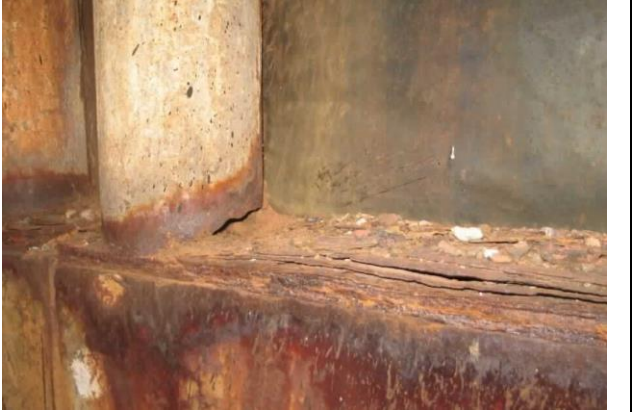
| Condition state 4 -Description | Photo |
|---|---|
| <ul style="list-style-type: none"> <li>• Corrosion is well advanced and loss of section has occurred having a detrimental effect on the strength of the member, i.e. a flange may be badly corroded over a sizeable length.</li> <li>• Packer may be missing.</li> <li>• Welds may be broken. Bolts or rivets may be missing. Splice joint bolts may be loose (can be loosened by a spanner).</li> </ul> | <p data-bbox="791 1120 1433 1153">Packer missing under girder</p> <p data-bbox="791 1563 1433 1624">Packer badly corroded with loss of section affecting strength</p> |

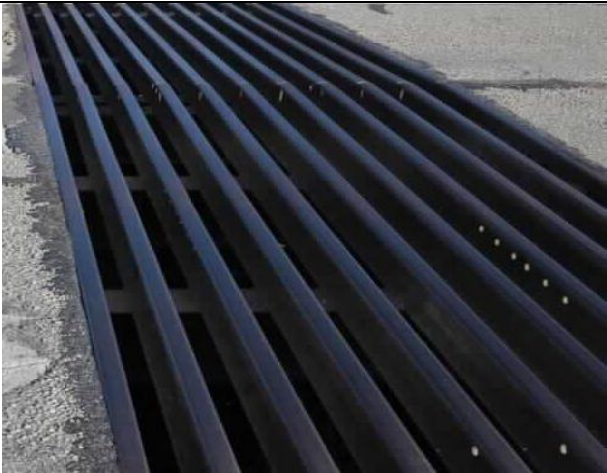
| <b>Condition state 1 -Description</b> <ul style="list-style-type: none"> <li>• The paint system is generally sound with only minor chalking, peeling or curling, but with no exposure of metal.</li> <li>• All welds, bolts and rivets are in good condition.</li> </ul> | <b>Photo</b> <p>Grid railing in good condition</p> | |

| <b>1170 - Grid rails – steel</b> <p>This component describes the steel railing that forms the trafficable surface of the grid and includes all welds to the grid girders, plates welded to the rails to maintain even heights and any steel plates placed over railing joins or gaps.</p> <p>Comment should also be made regarding the vertical alignment of the railings – but being aware this could indicate the failure of other grid components (such as grid packers, girders, abutments or pier walls) and therefore an appropriate condition rating should be applied for that component.</p> | | Units<br><br><b>Linear metres</b> |

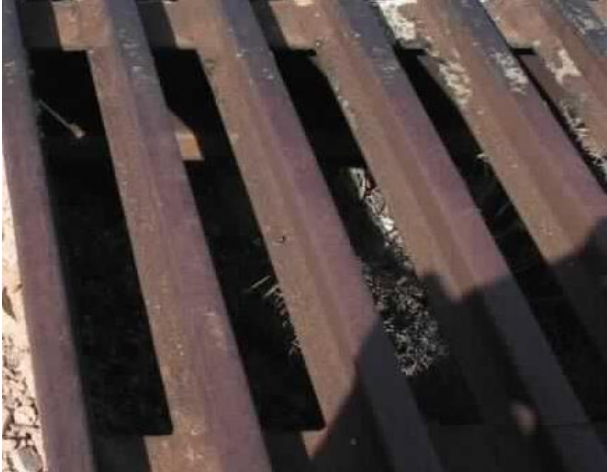
| <b>Condition state 2 -Description</b> <ul style="list-style-type: none"> <li>• Rusting of the paint or galvanising system to the surface area is occurring and the paint system is losing effectiveness.</li> <li>• No corrosion of the section has occurred.</li> <li>• No cracking of welds has occurred, but there may be some minor rusting of nuts or bolts.</li> </ul> | <b>Photo</b> <p>Surface rusting but no corrosion, welds still fine</p> | |

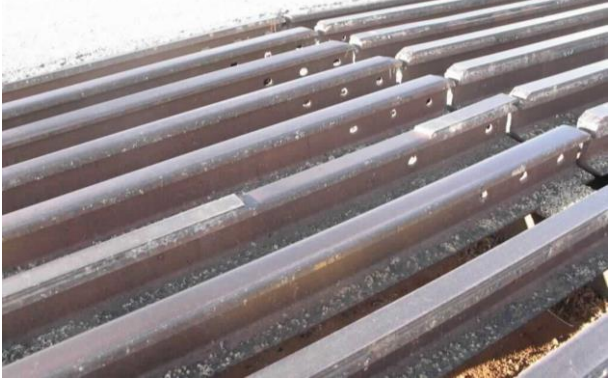
| Condition state 3 -Description | Photo |
|---|---|
| <ul style="list-style-type: none"> <li>• Rusting of the paint system to the surface area is occurring and the paint system is no longer effective.</li> <li>• Some surface pitting may be present.</li> <li>• No cracking of welds has occurred, but there may be some moderate rusting of nuts or bolts.</li> <li>• Minor corrosion has occurred in isolated areas but no loss of section area has occurred which would affect the strength of the member.</li> </ul> | <p data-bbox="791 577 1409 600">Section of plate welded to top of rails has broken away</p> |

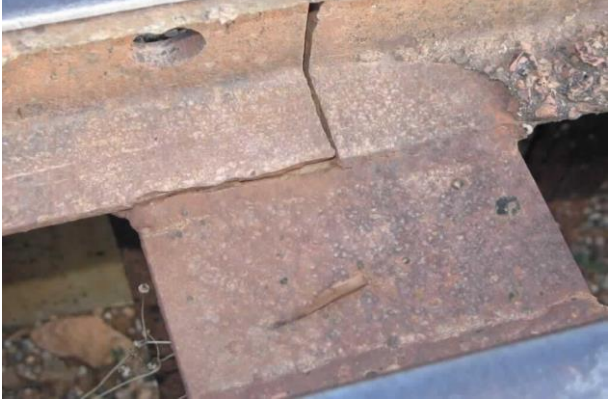
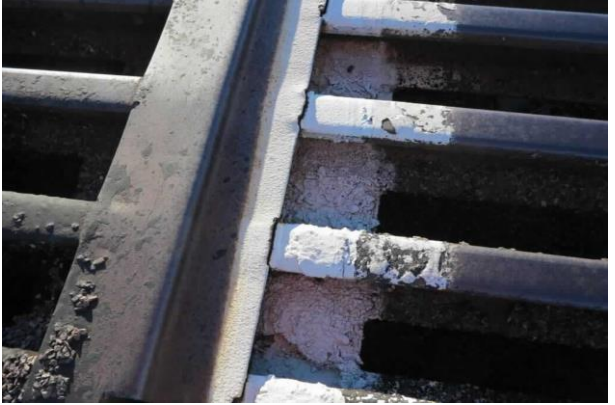
| Condition state 3 -Description | Photo |
|---|---|
| <ul style="list-style-type: none"> <li>• The paint or galvanising system has completely broken down with surface pitting in locations.</li> <li>• Welds may be cracked with minor loss of effectiveness. Nuts and bolts may be corroded with minor loss of tension in bolt.</li> <li>• Active corrosion may be occurring in isolated areas but no loss of section area has occurred which would affect the strength of the member.</li> </ul> | <p data-bbox="791 1048 1409 1070">Rail to girder weld cracked</p> <p data-bbox="791 1480 1409 1541">Broken welds on plate used to cover grid rail height difference</p> |

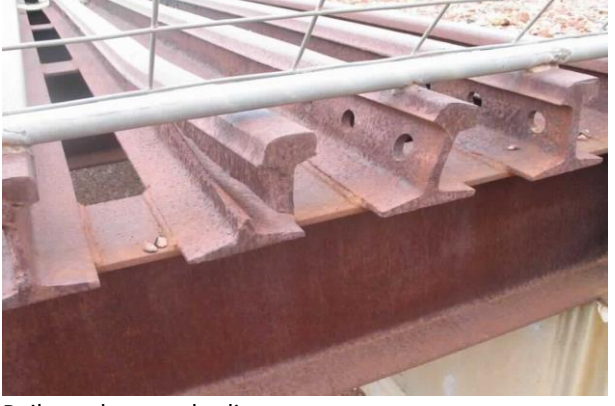
| Condition state 3 -Description | Photo |
|---|---|
| <ul style="list-style-type: none"> <li>• Corrosion is well advanced and loss of section has occurred having a detrimental effect on the strength of the member, i.e. a flange may be badly corroded over a sizeable length.</li> <li>• Rails may be deformed.</li> <li>• Welds may be broken. Bolts or rivets may be missing. Splice joint bolts may be loose (can be loosened by a spanner).</li> </ul> | <p data-bbox="791 1989 1409 2007">Rails are bent and split</p> |

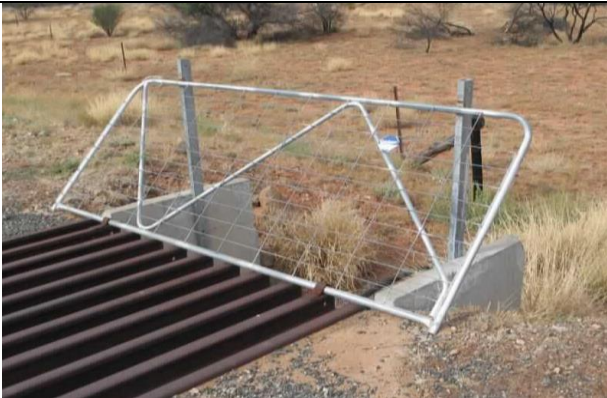
| 1180 - Fence – other | | Units |
|---|---|---|
| <ul style="list-style-type: none"> <li>The paint or galvanising is generally in good condition with no rusting or corrosion.</li> <li>The timber shows only minor deterioration and all the bolting is tight.</li> <li>No accident damage is visible.</li> </ul> | <p>Fence in good condition</p> | |

| 1180 - Fence – other | | Units |
|---|---|---|
| <p>This component is the fence or gate structure located at the ends of the cattle grid, adjoining on to the neighbouring boundary fence. These are usually constructed of steel mesh with either a metal or timber frame. Includes the posts used to support the fence.</p> | | Each |

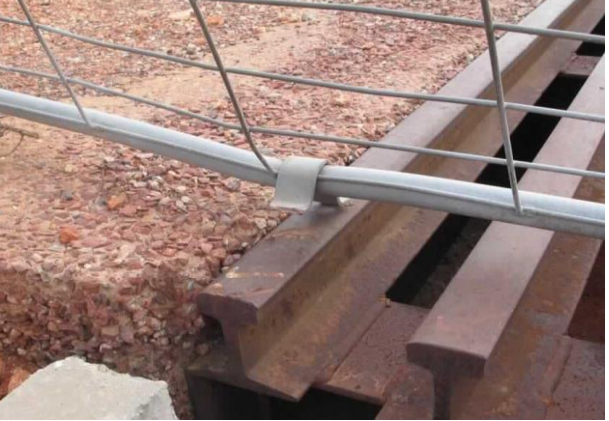
| Condition state 3 -Description | Photo |
|---|---|
| <ul style="list-style-type: none"> <li>• Minor rusting has formed to the surface area and the paint system is no longer effective.</li> <li>• Moderate decay, splitting cracking or crushing may be present affecting the strength and serviceability of the fence to a minor extent.</li> <li>• Connections may be starting to loosen in a number of areas.</li> <li>• Accident damage has only a minor effect on strength or serviceability of the fence.</li> </ul> | <p data-bbox="794 618 1082 645">Fence anchor weld broken</p> |

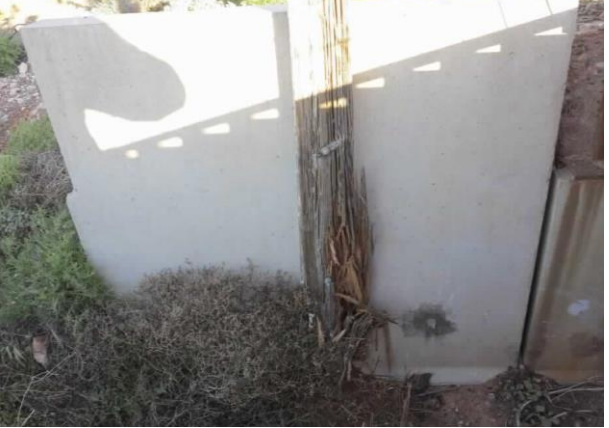
| Condition state 3 -Description | Photo |
|---|---|
| <ul style="list-style-type: none"> <li>• The paint system may have broken down and there is surface pitting in a number of locations on the fence but there is minimal effect on strength or serviceability</li> <li>• Significant decay, splitting cracking or crushing may be present affecting the strength and serviceability of the fence to a moderate extent.</li> <li>• Connections may be loose in a number of areas.</li> <li>• Accident damage has a moderate effect on strength or serviceability of the fence.</li> </ul> | <p data-bbox="794 1120 1166 1146">Fence post attacked by white ants</p> |

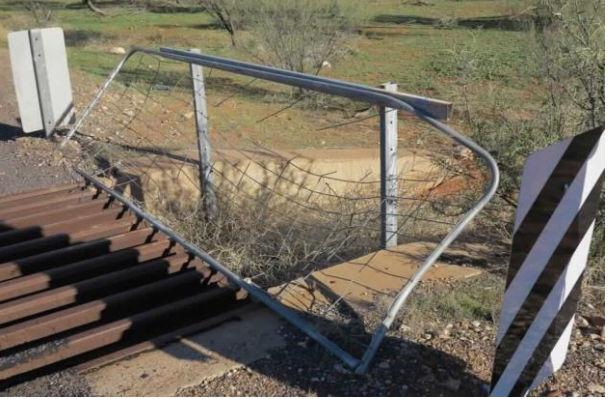
| Condition state 3 -Description | Photo |
|---|---|
| <ul style="list-style-type: none"> <li>• Corrosion is advanced with loss of section affecting both strength and serviceability.</li> <li>• Severe decay splitting cracking or crushing may be present affecting the strength and serviceability of the fence.</li> <li>• Connections may be quite loose.</li> <li>• Accident damage is severe.</li> <li>• Fence has collapsed or is missing.</li> </ul> | <p data-bbox="794 1626 1027 1653">Badly damaged fence</p> |
