# Road Structures Inspection Manual

## Part 4C: Condition State Guidelines and Photographs

### Other Structures

Part 4C: Condition State Guidelines and Photographs – Other Structures  
Department of Planning, Transport and Infrastructure, South Australia

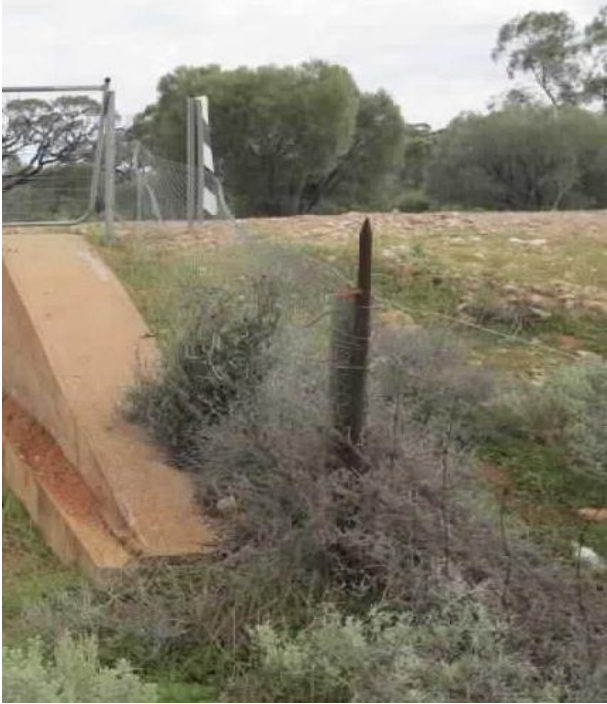
| 1190 - Boundary fence connection – other | | Units |
|---|---|---|
| <ul style="list-style-type: none"> <li>Connection is in good condition and forms an effective barrier.</li> </ul> | <p>Connection is in good condition</p> | |

| 1190 - Boundary fence connection – other | | Units |
|---|---|---|
| This is the connection between the cattle grid fence and the adjoining boundary fence, which with the cattle grid forms the barrier to prevent livestock movement between adjoining properties. | | Each |

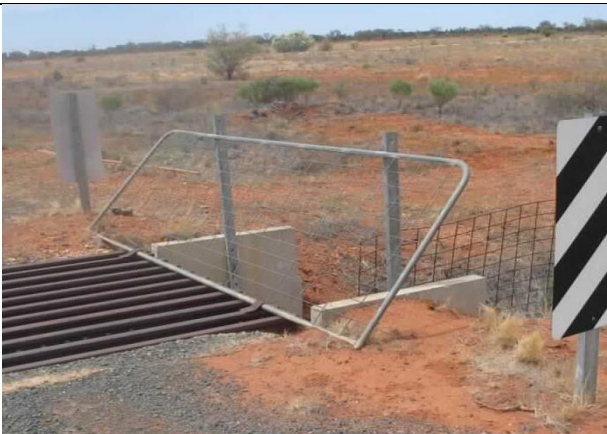
| 1190 - Boundary fence connection – other | | Units |
|---|---|---|
| <ul style="list-style-type: none"> <li>Connection is generally in good condition and forms an effective barrier although minor deterioration is present.</li> </ul> | <p>Connection with the boundary fence in sound condition, and forming an effective barrier</p> | |

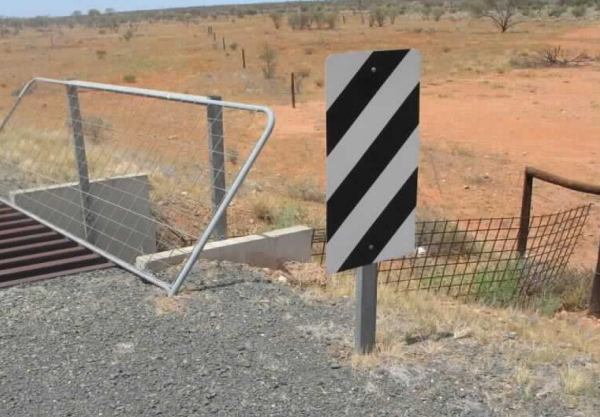
| Condition state 3 -Description | Photo |
|---|---|
| <ul style="list-style-type: none"> <li>Connections may be starting to loosen in a number of areas and the effectiveness of the barrier is being affected.</li> </ul> | <p>Mesh panel is not properly secured and on a lean</p> |

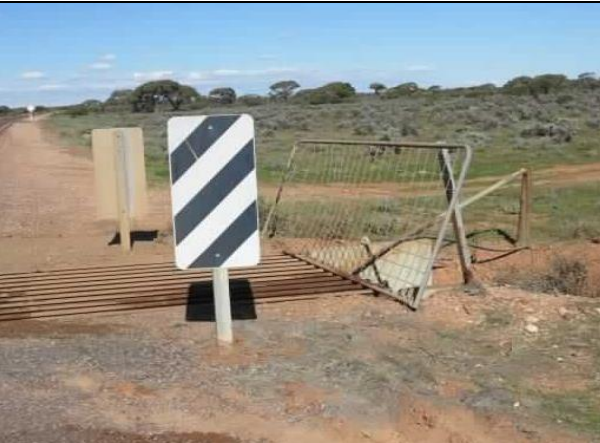
| Condition state 3 -Description | Photo |
|---|---|
| <ul style="list-style-type: none"> <li>Connections may be loose in a number of areas and the barrier has lost effectiveness.</li> </ul> | <p>Connection to boundary fence has partially collapsed</p> |

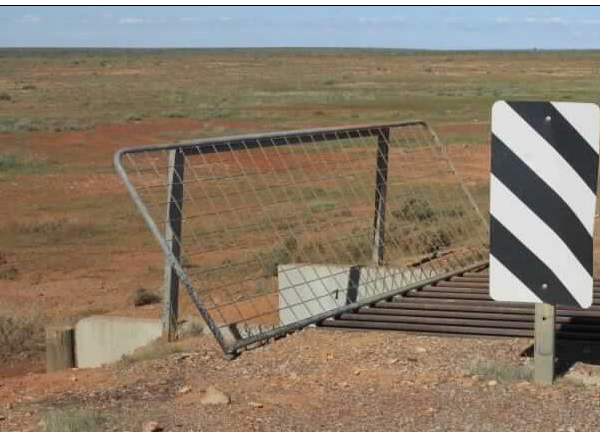
| Condition state 3 -Description | Photo |
|---|---|
| <ul style="list-style-type: none"> <li>Connection may be quite loose or non-existent (may be a result of collapsed or missing boundary fence) and there is no effective barrier.</li> </ul> | <p>No connection (no boundary fence present)</p> |

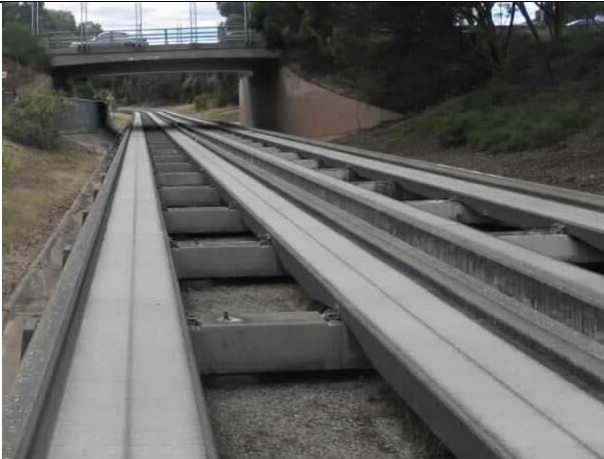
| <ul style="list-style-type: none"> <li>The units are in good condition with only minor faint cracking or minor edge chipping of the units.</li> <li>Entry/exit ramp is in good condition with only minor cracking and has not settled.</li> </ul> | <p>Track in good condition</p> | |

| <p>This component is the precast busway track including the kerb which is precast integral to the track.</p> <p>Also included are the cast in-situ concrete entry and exit ramps to and from the busway track.</p> | | m <sup>2</sup> of exposed surface area |

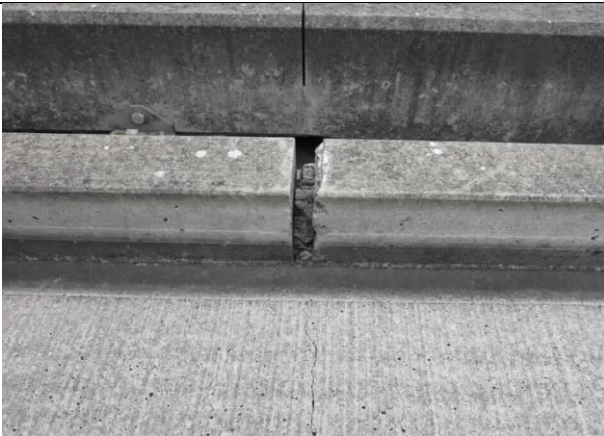
| <ul style="list-style-type: none"> <li>Minor cracks or spalls may be present with only minor reinforcement corrosion.</li> <li>Edge spalling of the units may have exposed some reinforcement.</li> <li>Entry/exit ramp may have settled slightly but level differences between ramp sections are minor.</li> </ul> | <p>Kerb spall at saw cut</p> | |

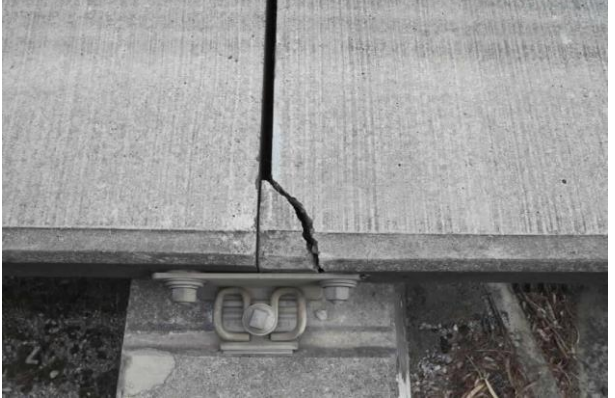
| Condition state 3 -Description | Photo |
|---|---|
| <ul style="list-style-type: none"> <li>• Moderate cracking and spalling may be present with minor loss of section of the reinforcement.</li> <li>• Entry/exit ramp may have settled further with moderate level differences between slab sections.</li> <li>• Vegetation growth adjacent or within the track, but only minimal effect on the busway. Removal should be considered.</li> </ul> | |
| | Track spall at joint |

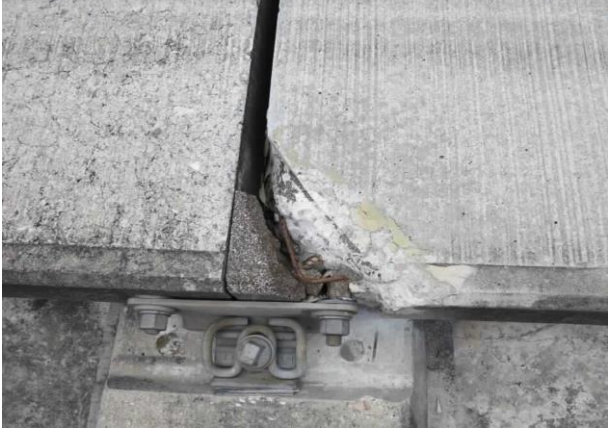
| Condition state 3 -Description | Photo |
|---|---|
| | Track spall at joint with failed Silspec repair |

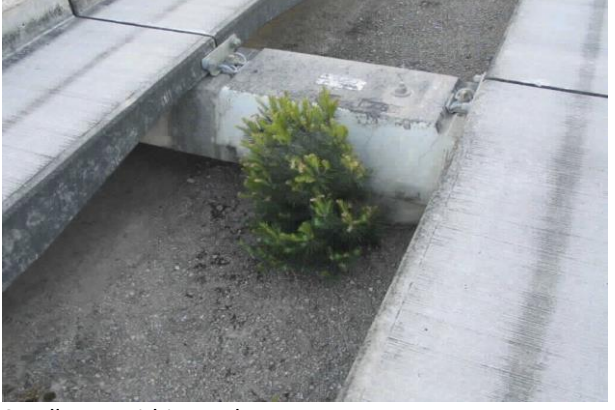
| Condition state 3 -Description | Photo |
|---|---|
| | Small tree within track |

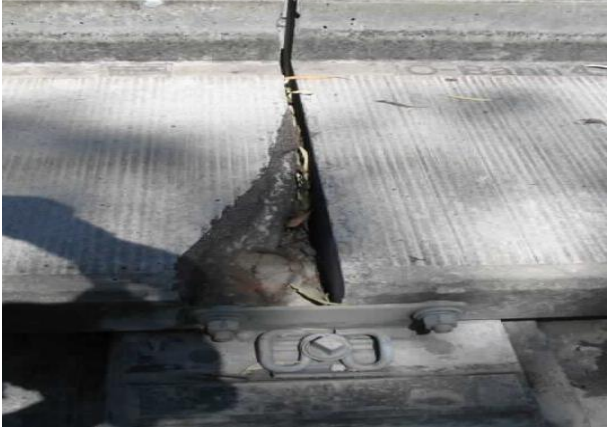
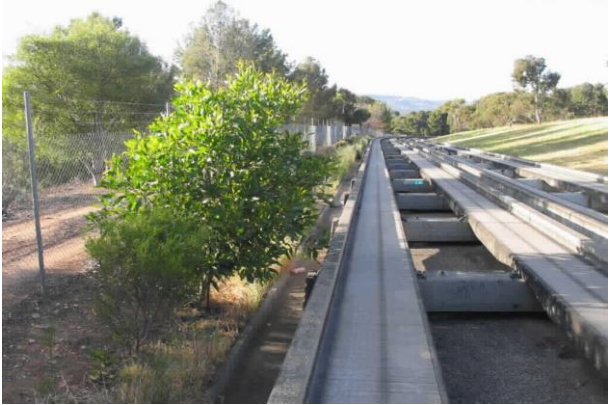
| Condition state 4 -Description | Photo |
|---|---|
| <ul style="list-style-type: none"> <li>• Medium cracking and spalling may be present with moderate loss of section of the reinforcement.</li> <li>• Entry/exit ramp may have settled further with significant level differences between slab sections.</li> <li>• Vegetation growth adjacent or within the track is affecting the busway, and should be removed.</li> </ul> | <p>Spall over connection</p> <p>Large tree adjacent track</p> |

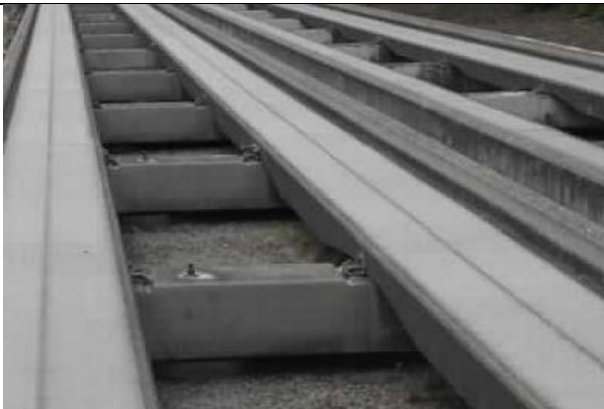
| 131P - Busway sleepers – precast concrete | |
|---|---|
| <ul style="list-style-type: none"> <li>The sleepers are in good condition with only very minor cracking due to corroding reinforcement, shrinkage, lack of curing.</li> <li>The clamp brackets and hold-down bolts and nuts are generally in good condition with no surface rust.</li> <li>All connections are tight and in good condition, with full thread engagement by nuts. Nuts and washers are present on all bolts.</li> </ul> | <p>Sleepers in good condition</p> |

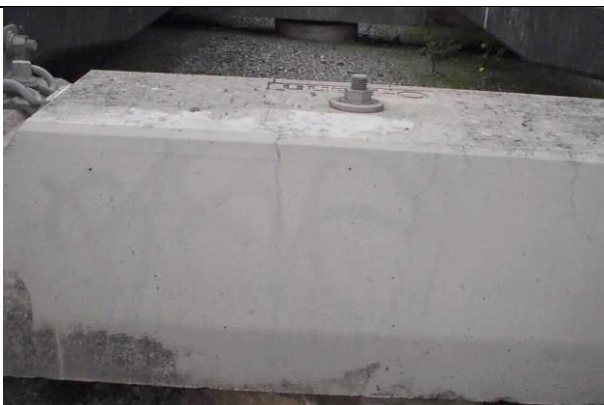
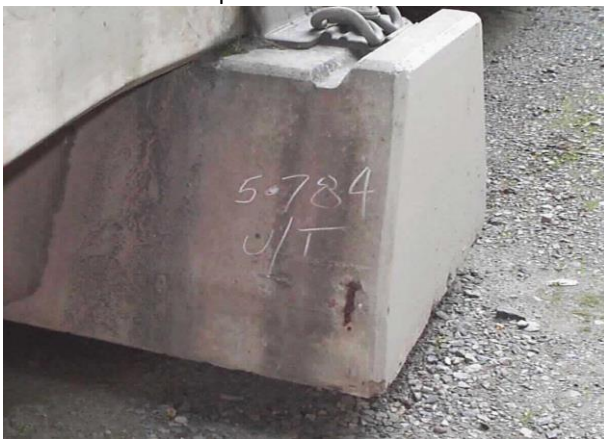
| 131P - Busway sleepers – precast concrete | |
|---|---|
| <ul style="list-style-type: none"> <li>The sleepers may have a few minor fine cracks or minor spalls due to corroding reinforcement.</li> <li>The clamp brackets and hold-down bolts and nuts may have minor rust spotting to the surface area. Minor pitting may occur. Small amounts of debris may be present.</li> <li>The connections may be slightly loose. Connection bolts may be tight but too short and not fully threaded. Nuts may be loose, and washers may be absent.</li> </ul> | <p>Minor cracks in sleeper</p> <p>Minor spall in sleeper</p> |

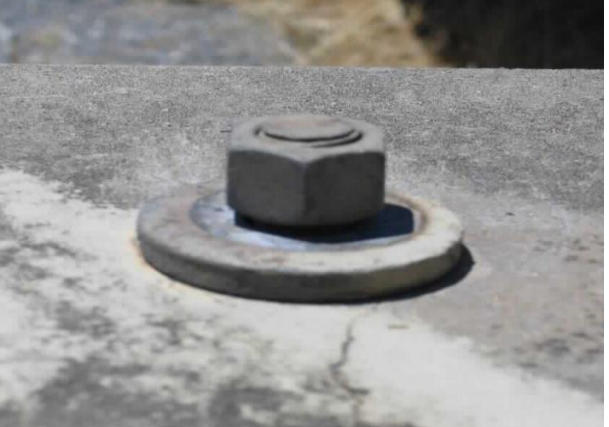
| Condition state 3 -Description | Photo |
|---|---|
| <ul style="list-style-type: none"> <li>• Moderate cracking or spalling may exist and there may be some light rust staining in the cracks.</li> <li>• Exposed reinforcement may have minor section loss in isolated areas.</li> <li>• The clamp brackets and hold-down bolts and nuts may have moderate rust spotting to the surface area. Moderate pitting may occur. A moderate amount of debris may be present.</li> <li>• The connections may be loose.</li> </ul> | |
| | Loose sleeper bolt |

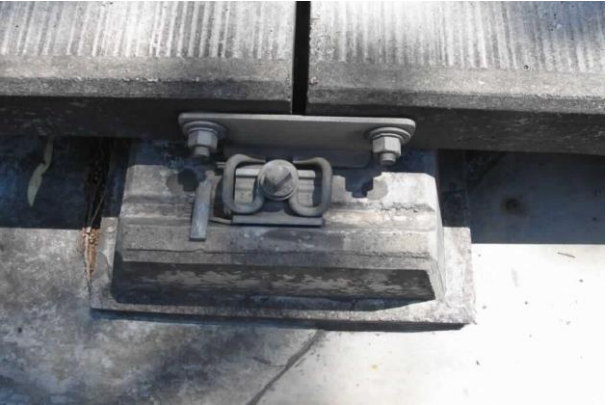
| Condition state 3 -Description | Photo |
|---|---|
| | Packing shim dislodged |

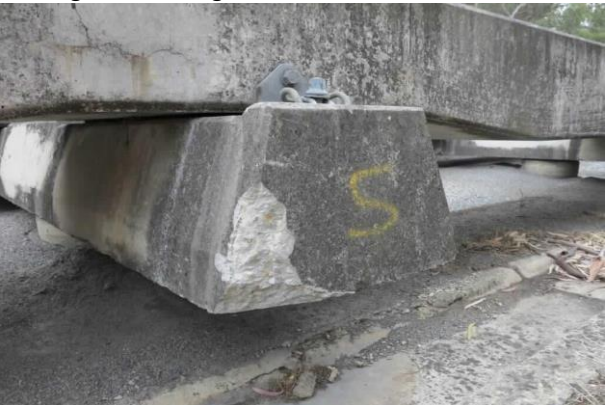
| Condition state 3 -Description | Photo |
|---|---|
| | Spall to end of sleeper |

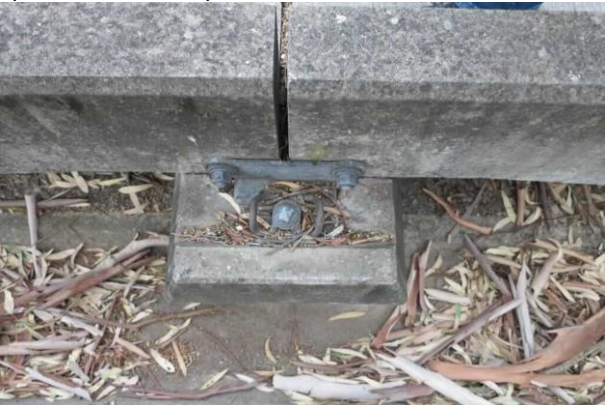
| Condition state 3 -Description | Photo |
|---|---|
| | Debris around clamp brackets |

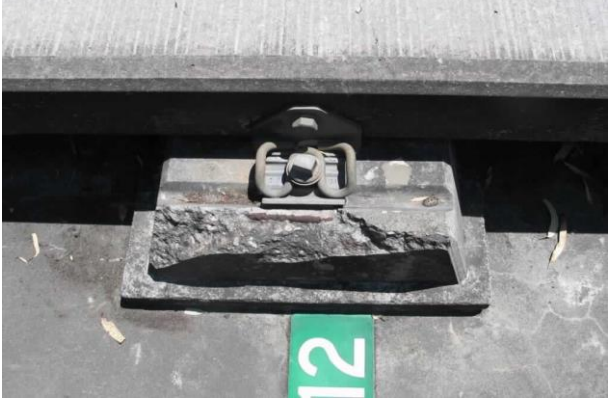
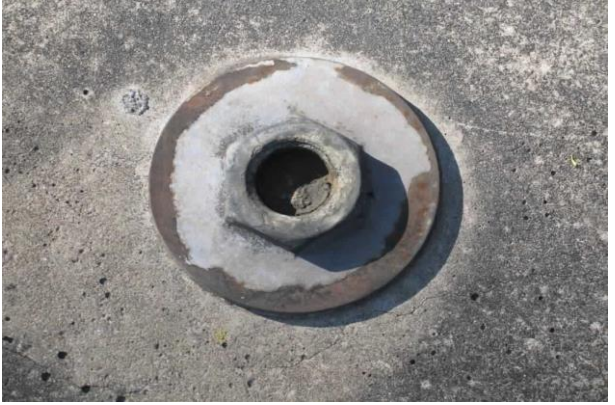
| Condition state 4 -Description | Photo |
|---|---|
| <ul style="list-style-type: none"> <li>• Medium cracking or spalling may exist and there may be some rust staining in the cracks.</li> <li>• Exposed reinforcement may have moderate section loss in isolated areas.</li> <li>• The clamp brackets and hold-down bolts and nuts have medium corrosion with significant surface area rusted.</li> <li>• Surface pitting may be evident but section loss is minor.</li> <li>• The connections may be moderately corroded, loose or only half threaded. One nut may be missing.</li> </ul> | <p>Spalled end of sleeper</p> <p>Minimal thread of sleeper bolt</p> |

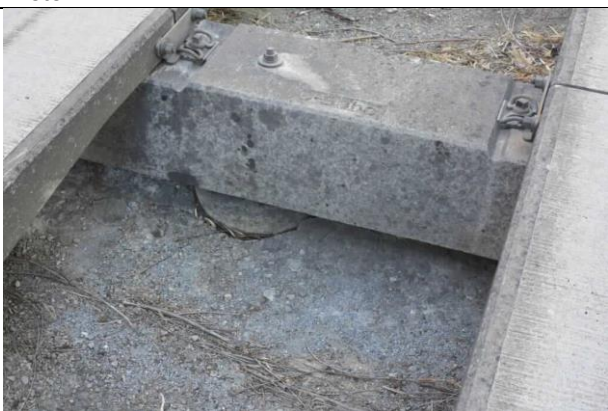
| 132C - Busway piles – cast in-situ concrete | | Units |
|---|---|---|
| <ul style="list-style-type: none"> <li>The piles have fine cracking or spalling due to corroding reinforcement.</li> <li>Minor scour has only a slight effect on pile support.</li> </ul> | | |
| | Minor scour around pile | |

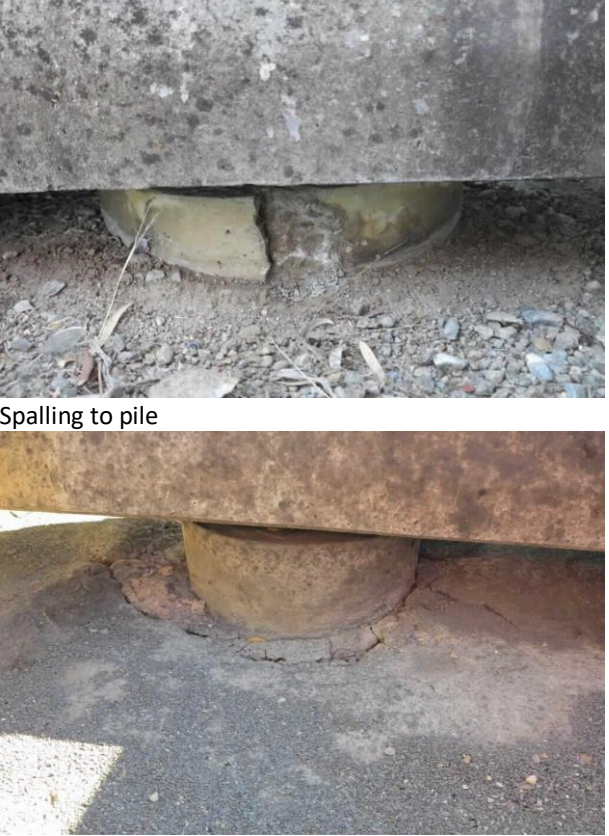
| Condition state 3 -Description | Photo |
|---|---|
| <ul style="list-style-type: none"> <li>The piles have minor cracking or spalling due to corroding reinforcement with minor loss of section in the steel bars.</li> <li>Moderate level of scour and may be starting to have a minor effect on the level of pile support.</li> </ul> | <p>Spalling to pile</p> <p>Moderate scour around pile</p> |

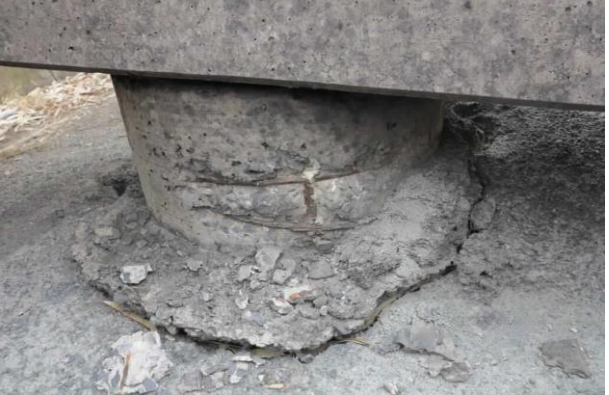
| Condition state 3 -Description | Photo |
|---|---|
| <ul style="list-style-type: none"> <li>The piles have moderate cracking or spalling due to corroding reinforcement with moderate loss of section in the steel bars.</li> <li>Scour is advanced and is affecting the level of pile support. Remedial action should be considered.</li> </ul> | <p>Moderate spalling to pile</p> |

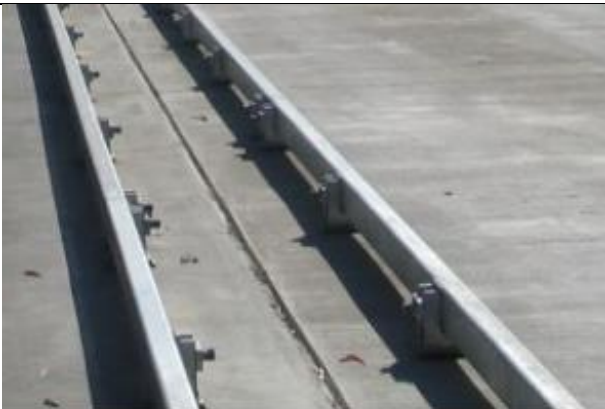
| 133S - Busway guide rails – steel | | Units |
|---|---|---|
| <ul style="list-style-type: none"> <li>The guide rails are in good condition with minimal corrosion or loss of coating and no visible cracks.</li> <li>Connections are tight and in good condition.</li> </ul> | <p>Guide rail in good condition</p> | |

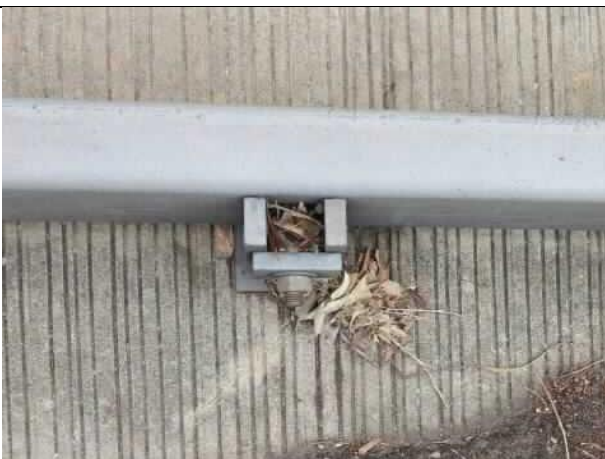
| 133S - Busway guide rails – steel | | Units |
|---|---|---|
| <ul style="list-style-type: none"> <li>The guide rails may have some minor surface corrosion. There are no visible cracks.</li> <li>Connections may be slightly loose or beginning to corrode.</li> </ul> | <p>Debris in guide rail fixings</p> | |

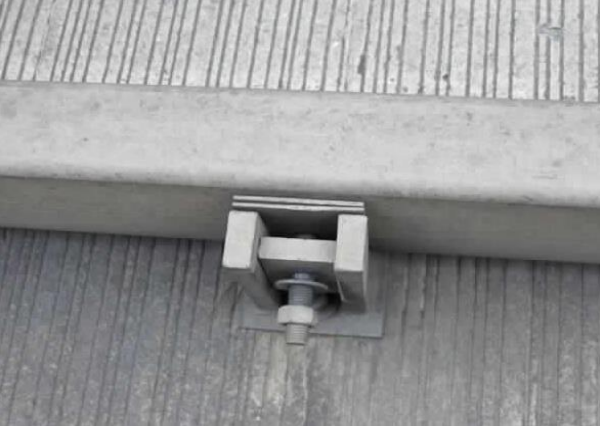
| Condition state 3 -Description | Photo |
|---|---|
| <ul style="list-style-type: none"> <li>• The guide rails may have some moderate surface corrosion. There are no visible cracks.</li> <li>• The connections may be loose or have minor corrosion.</li> </ul> | <p data-bbox="794 622 943 645">Fixing rotated</p> |

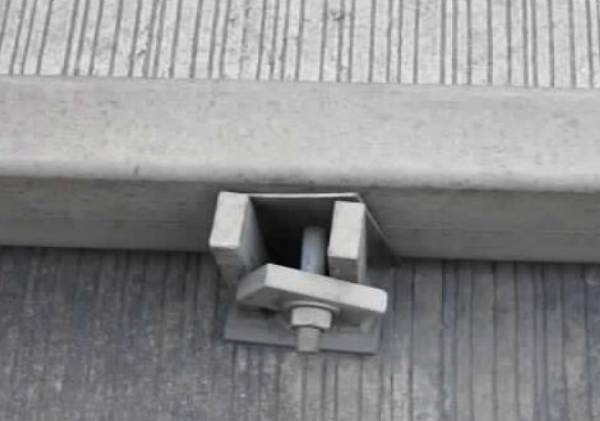
| Condition state 3 -Description | Photo |
|---|---|
| <ul style="list-style-type: none"> <li>• The surface coating system may have broken down and some active corrosion may be present with significant rust spotting to the guide rails and surface pitting. There are no visible cracks.</li> <li>• Connections may be moderately corroded or loose.</li> </ul> | <p data-bbox="794 1115 1198 1137">Fixing for guide rail rotated and loose</p> |

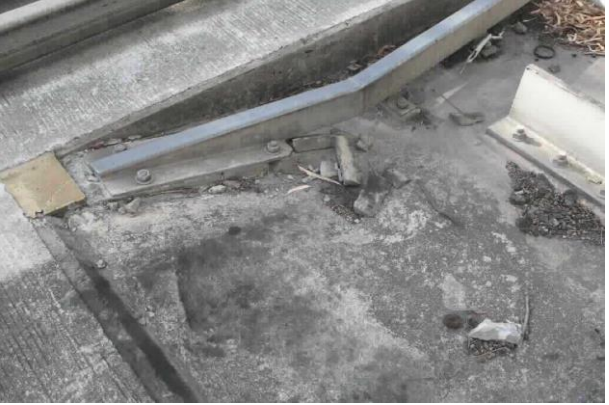
| Condition state 3 -Description | Photo |
|---|---|
| <ul style="list-style-type: none"> <li>• The steel may have some moderate surface corrosion. There are no visible cracks.</li> <li>• The connections may be loose or have minor corrosion.</li> <li>• The mortar pad may have moderate cracks or spalls, but is still generally sound and fills the area beneath the sump buster.</li> <li>• Accumulated debris is present and is building up around the sump buster or guide rails, and should be removed.</li> </ul> | <p data-bbox="794 595 1406 629">Spalled mortar pad under sump buster</p> |

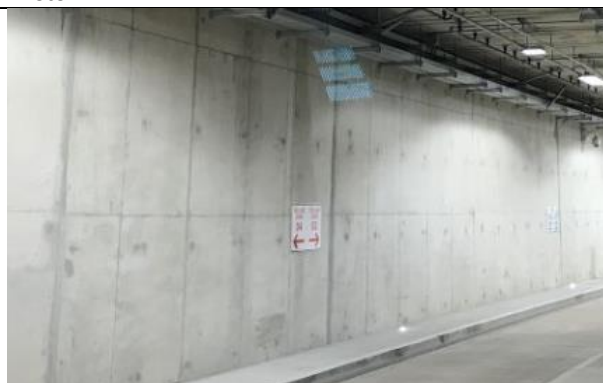
- The tunnel walls are in good condition with only minor shrinkage cracking. Precast units are in good condition with only minor fine cracking of no consequence.
- The wall should be reasonable dry.

Concrete wall lining in good condition

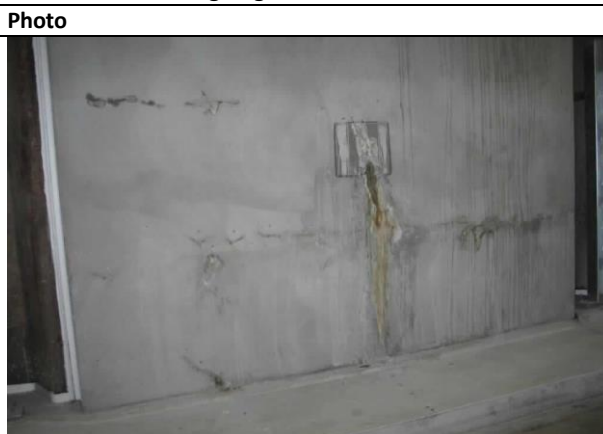
- The tunnel wall may have minor cracking and spalling due to shrinkage or corroding reinforcement.
- Minor water seepage is evident along with some efflorescence.

Cracking and water seepage in tunnel wall

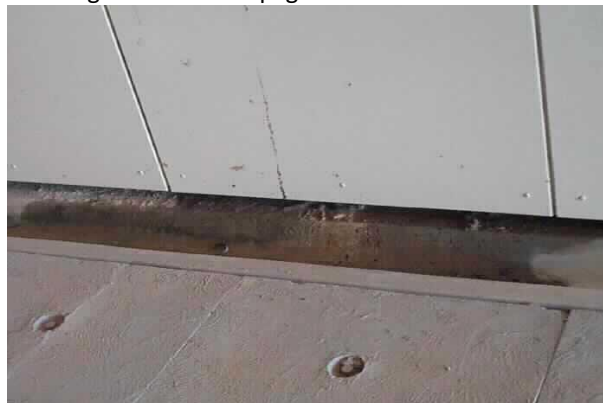
Water in side spoon drain, likely from leaking shrinkage cracks in wall

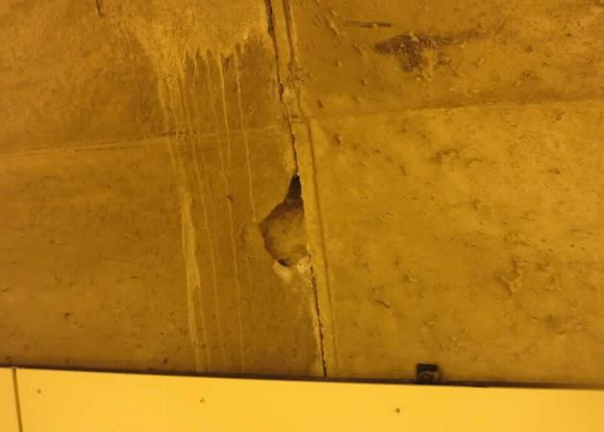
| Condition state 3 -Description | Photo |
|---|---|
| <ul style="list-style-type: none"> <li>• Minor cracking or spalling may be visible due to corroding reinforcement or earth pressure.</li> <li>• Moderate water seepage and efflorescence is evident.</li> </ul> | <p data-bbox="794 622 1401 651">Void in wall above lining</p> |

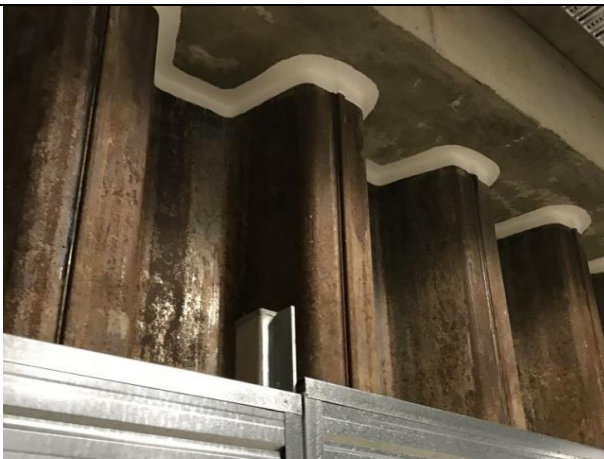
| 140S - Tunnel wall – steel | | Units |
|---|---|---|
| <ul style="list-style-type: none"> <li>The steel is in good condition with only minor rusting at the ends of sheets.</li> <li>There is no bulging of sheets between supports.</li> <li>The wall should be reasonable dry.</li> </ul> | <p>Steel sheet piling in good condition</p> | |

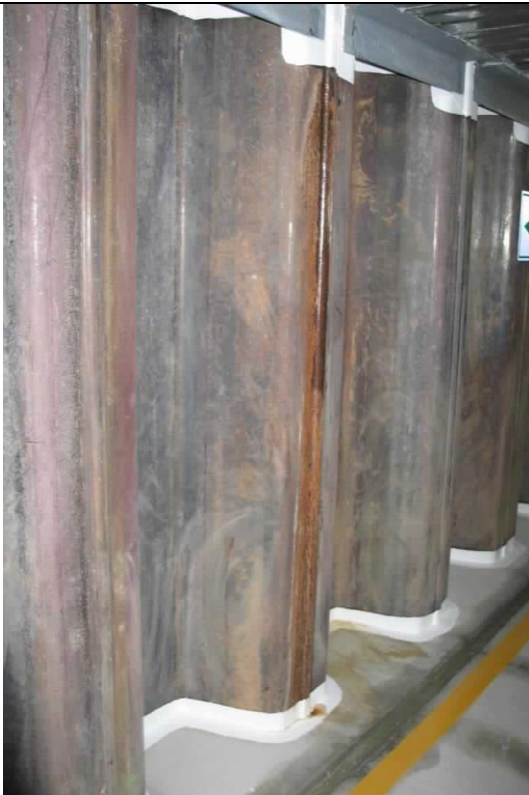
| 140S - Tunnel wall – steel | | Units |
|---|---|---|
| <ul style="list-style-type: none"> <li>There is minor corrosion at the sheet ends but no corrosion of the main body of the sheeting.</li> <li>Minor water seepage is evident.</li> </ul> | <p>Water leakage at sheet pile</p> | |

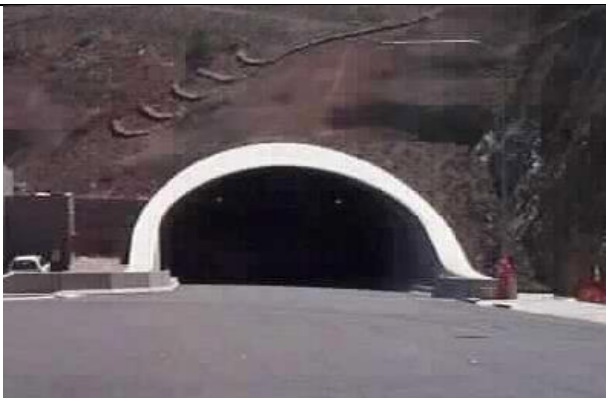
| 141C - Tunnel portal – concrete | | Units |
|---|---|---|
| <ul style="list-style-type: none"><li>• The portals are in good condition with only minor shrinkage cracking. Precast units are in good condition with only minor fine cracking of no consequence.</li><li>• Soil retention is effective with no loss of back fill material.</li></ul> | | |
| Tunnel portal in good condition | | |

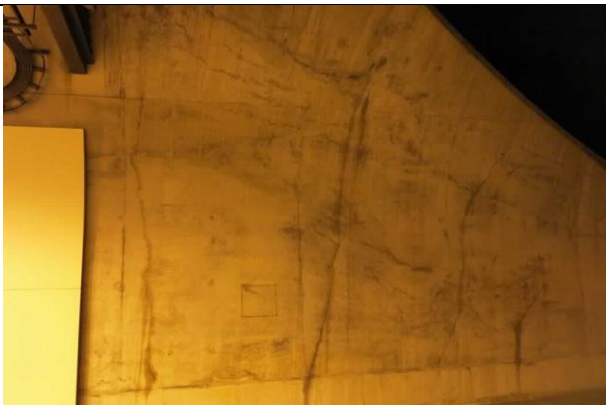
| 141C - Tunnel portal – concrete | | Units |
|---|---|---|
| <ul style="list-style-type: none"><li>• The tunnel portal may have minor cracking and spalling due to shrinkage or corroding reinforcement.</li><li>• Minor scour is having only a slight effect on back fill material around the outside edge of the portal.</li></ul> | | |
| Shrinkage cracks at tunnel entrance | | |

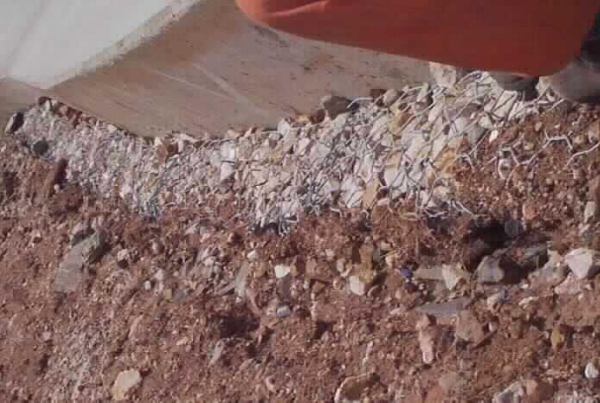
| Condition state 3 -Description | Photo |
|---|---|
| <ul style="list-style-type: none"> <li>• Minor cracking or spalling may be visible due to corroding reinforcement or earth pressure.</li> <li>• Moderate scour has allowed a minor loss of back fill material around the outside edge of the portal.</li> </ul> | <p data-bbox="794 593 1396 622">Minor scour of back fill material around portal</p> |

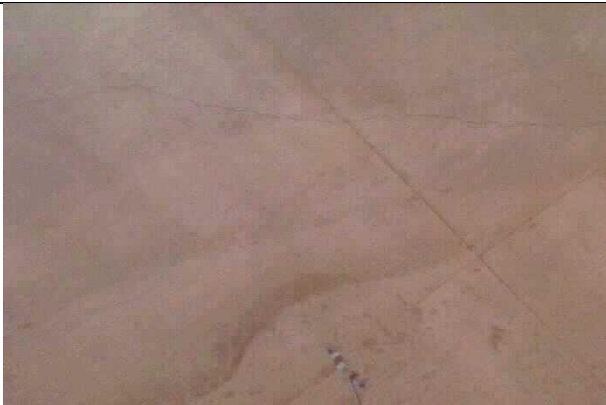
| 142C - Tunnel roof – concrete | | Units |
|---|---|---|
| <ul style="list-style-type: none"><li>• The tunnel roof is in good condition with only minor shrinkage cracking. Precast units are in good condition with only minor fine cracking of no consequence.</li><li>• The surface should be reasonable dry.</li></ul> | | |
| Minor cracking in roof lining | | |

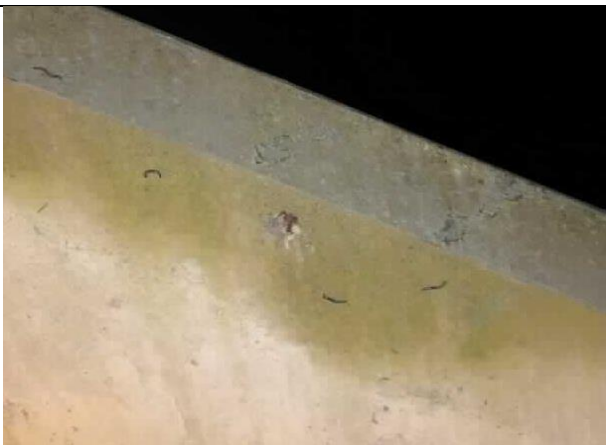
| 142C - Tunnel roof – concrete | | Units |
|---|---|---|
| <ul style="list-style-type: none"><li>• The tunnel roof may have minor cracking and spalling due to shrinkage or corroding reinforcement.</li><li>• Minor water leakage is evident along with some efflorescence.</li></ul> | | |
| Minor spall with exposed reinforcement | | |

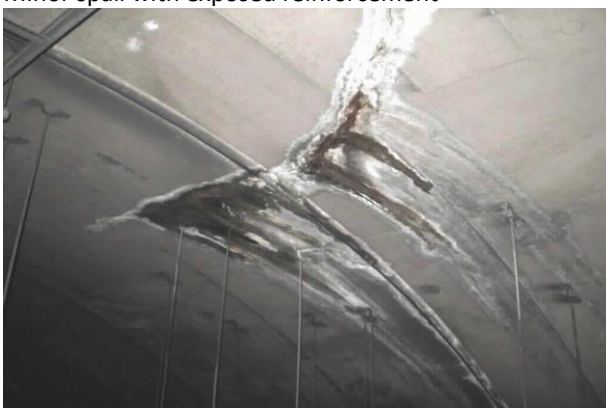
| 142C - Tunnel roof – concrete | | Units |
|---|---|---|
| Minor shrinkage crack with water leakage and efflorescence | | |

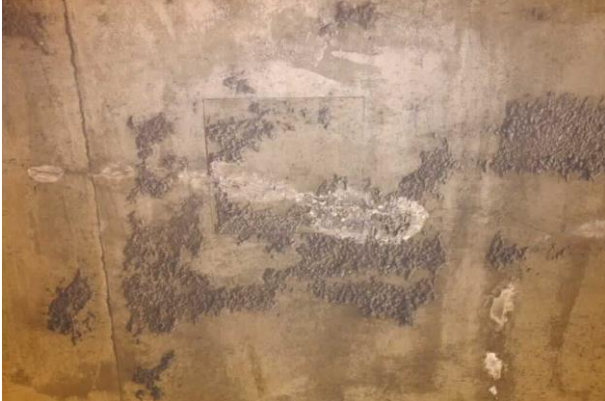
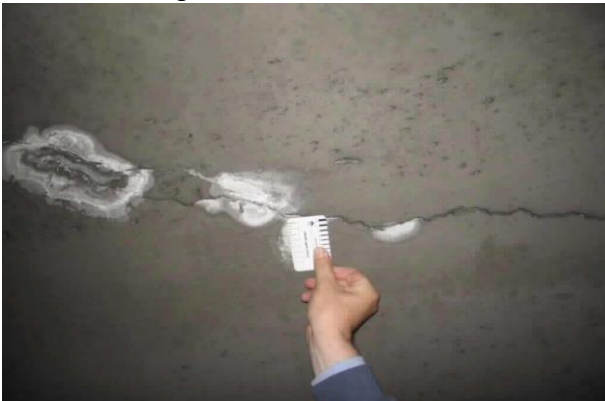
| Condition state 3 -Description | Photo |
|---|---|
| <ul style="list-style-type: none"> <li>Minor cracking or spalling may be visible due to corroding reinforcement or earth pressure.</li> <li>Moderate water leakage and efflorescence is evident with some dripping water.</li> </ul> | <p>Concrete fretting in roof</p> <p>Shrinkage cracking up to 4mm and efflorescence in roof lining</p> |

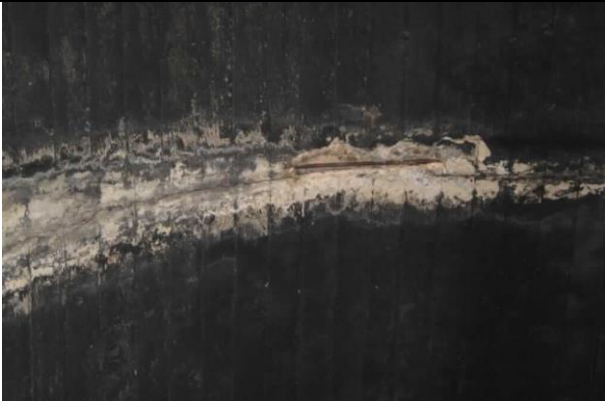
| Condition state 3 -Description | Photo |
|---|---|
| <ul style="list-style-type: none"> <li>More advanced cracking and spalling may be visible due to corroding reinforcement or earth pressures.</li> <li>Significant water leakage and dripping water with large areas of efflorescence are evident.</li> </ul> | <p>Exposed reinforcement and spalling in tunnel roof</p> |

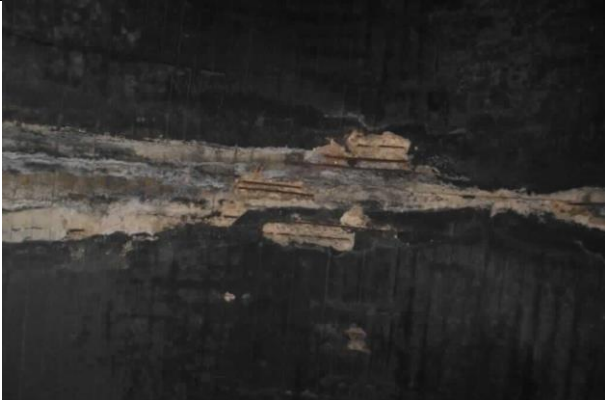
| Condition state 3 -Description | Photo |
|---|---|
| <ul style="list-style-type: none"> <li>Severe cracking and spalling due to reinforcement corrosion or earth pressure is evident in tunnel roof.</li> <li>Excessive water leakage, dripping water and extensive areas of efflorescence are evident.</li> </ul> | <p>Heavy spalling with exposed reinforcement</p> |

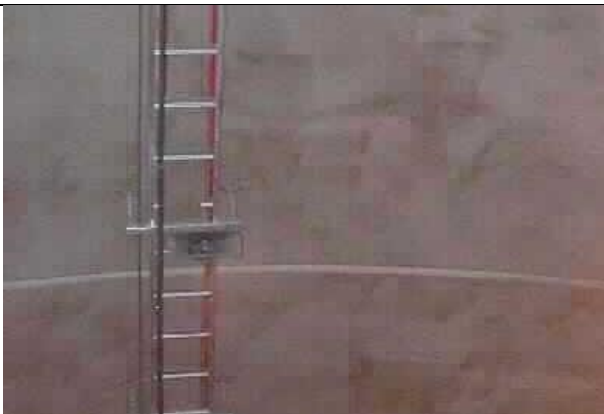
| 1460 - Construction joints – other | | Units |
|---|---|---|
| <ul style="list-style-type: none"> <li>The joint is in good condition with no deterioration.</li> <li>There is no moisture penetration of the joint.</li> </ul> | <p>Construction joint in good condition</p> | |

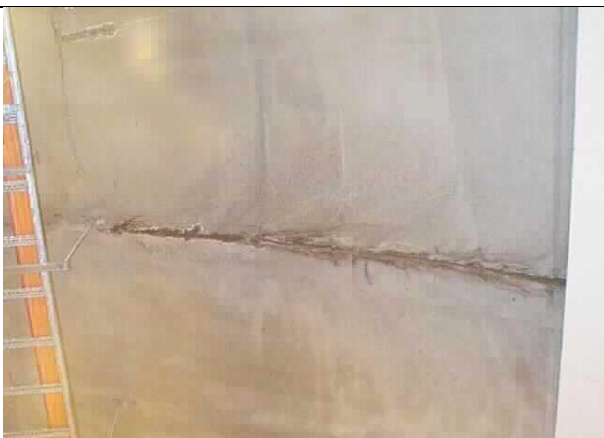
| 1460 - Construction joints – other | | Units |
|---|---|---|
| <ul style="list-style-type: none"> <li>Minor deterioration of the joint may have occurred, including minor spalling along the joint edge.</li> <li>Minor moisture leakage and efflorescence is present.</li> </ul> | <p>Leaking construction joint</p> | |

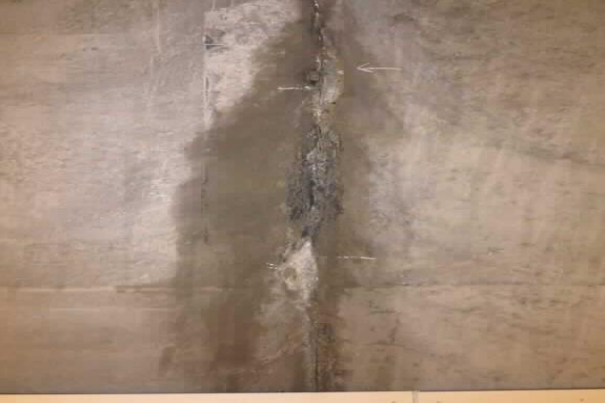
| Condition state 3 -Description | Photo |
|---|---|
| <ul style="list-style-type: none"> <li>• Moderate deterioration of the joint may have occurred, including spalling along the joint edge.</li> <li>• The joint may have opened up allowing moderate moisture leakage and areas of efflorescence are present.</li> </ul> | <p data-bbox="794 593 1404 622">Spalled control joint</p> |

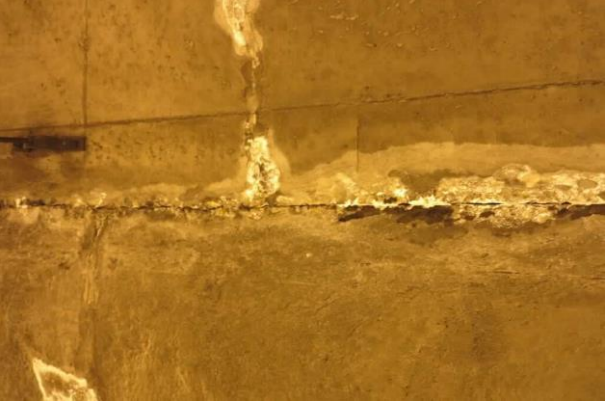
| Condition state 3 -Description | Photo |
|---|---|
| <ul style="list-style-type: none"> <li>• Medium deterioration of the joint has occurred.</li> <li>• The joint has opened up allowing significant moisture leakage and large areas of efflorescence are present.</li> </ul> | <p data-bbox="794 1064 1404 1093">Spalling and leakage/efflorescence at joint</p> |

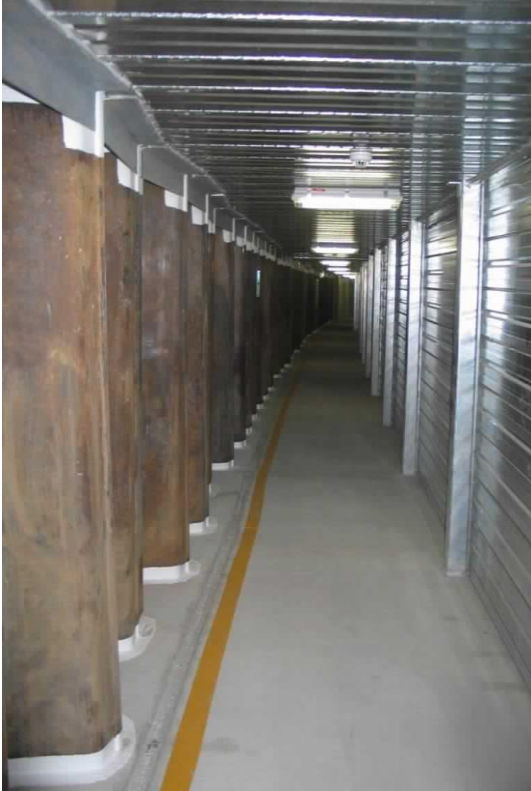
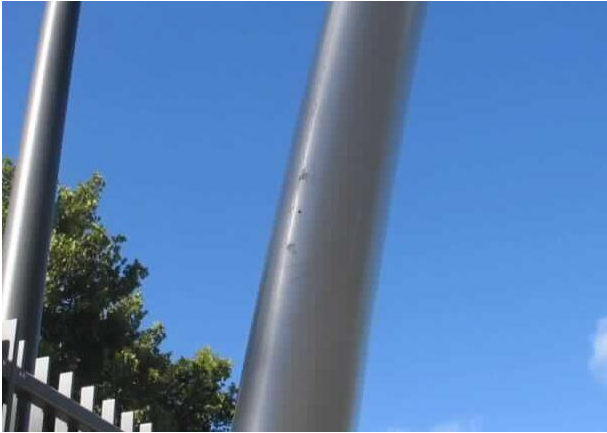
| 1470 - Additional elements – concrete / steel / other | Units |
|---|---|
| <ul style="list-style-type: none"> <li>• The attachment is in good condition. There is little or no evidence of corrosion or deterioration. The protective coating, if any, may be chalking, peeling, checking or showing other early evidence of distress but there is no exposure of metal.</li> <li>• The structural connections fixing the attachment to the tunnel are in good condition. Ladders, gantries or access ways are in good condition.</li> <li>• Bolts and nuts are generally in good condition, all connections are tight with full thread engagement by nuts and nuts and washers are present on all bolts.</li> </ul> | <p>Access corridor with steel sheet piles, steelpanel cladding and concrete floor all in good condition</p> <p>Unused holes in new canopy/portal arch frame (to be filled)</p> |

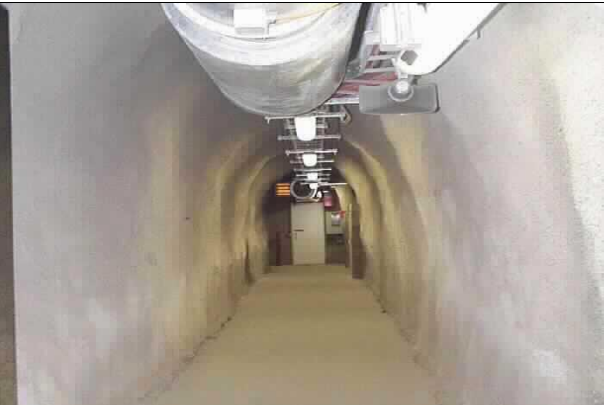
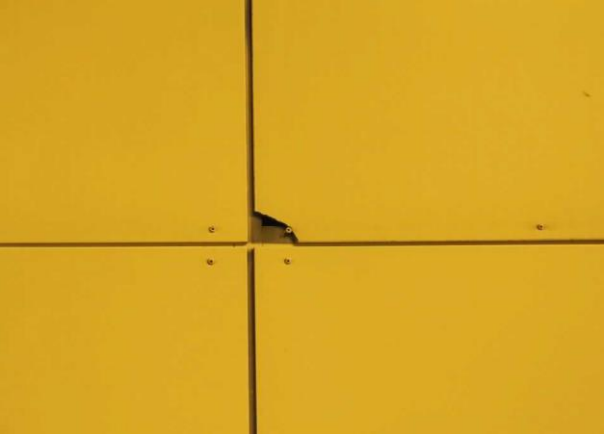
| Condition state 2 -Description | Photo |
|---|---|
| <ul style="list-style-type: none"> <li>• <b>Concrete:</b> Minor cracks or spalls. No exposed reinforcement or surface evidence of corrosion of reinforcement.</li> <li>• <b>Metal:</b> Surface or freckled rust has formed or is forming. The protective coating, if any, is losing effectiveness and there may be exposed metal but there is no loss of section.</li> <li>• The structural connections fixing the attachment to the tunnel are in good condition. Ladders, gantries or access ways have small defects but are safe to use.</li> <li>• Bolts and nuts may have minor rust spotting to the surface area and the connections may be slightly loose. Connection bolts may be tight but too short and not fully threaded, nuts may be loose and washers may be absent.</li> </ul> | <p data-bbox="794 595 1345 656">Cross passage in generally good condition but with minor leaking</p> <p data-bbox="794 1097 1219 1120">Minor damage to composite wall panel</p> |

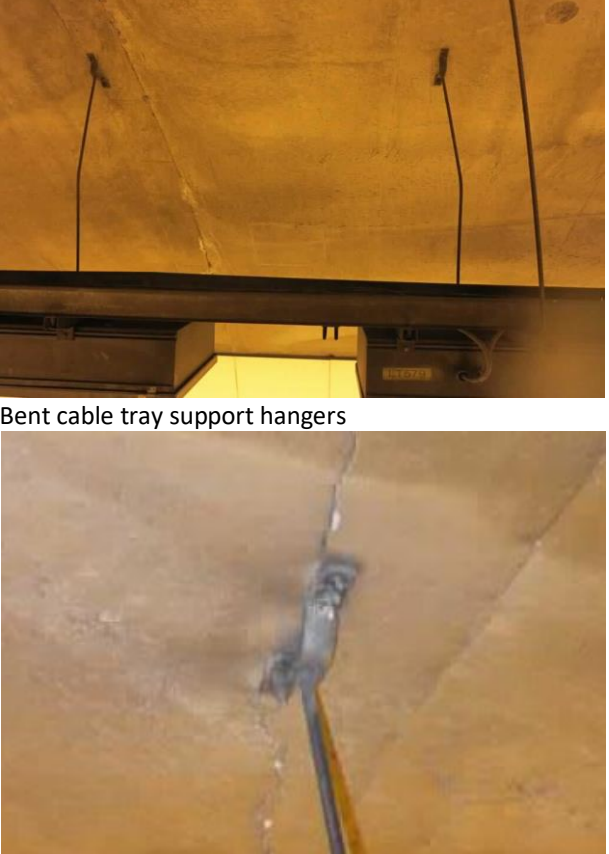
| Condition state 3 -Description | Photo |
|---|---|
| <ul style="list-style-type: none"><li>• <b>Concrete:</b> Moderate cracks or spalls. There may be small areas of exposed reinforcement with minor corrosion but no loss of section.</li><li>• <b>Metal:</b> Surface or freckled rust has formed. The protective coating, if any, is no longer effective and there may be exposed metal but any section loss is minimal.</li><li>• The structural connections fixing the attachment to the tunnel are in sound condition. Ladders, gantries or access ways have minor defects but are safe to use.</li><li>• Bolts and nuts may have moderate rust spotting to the surface area and the connections may be loose.</li></ul> | <p data-bbox="794 600 1141 631">Bent cable tray support hangers</p> <p data-bbox="794 1055 1061 1086">Fixing loose due to crack</p> |

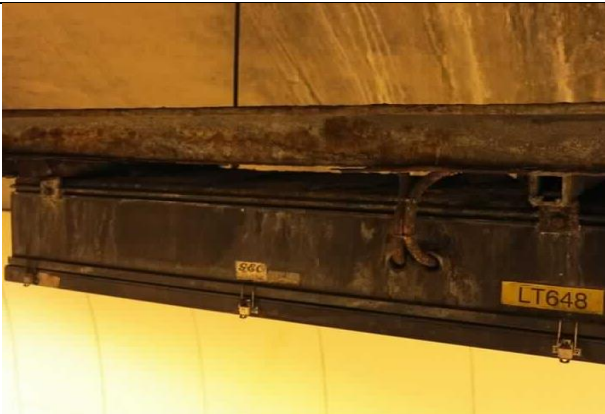
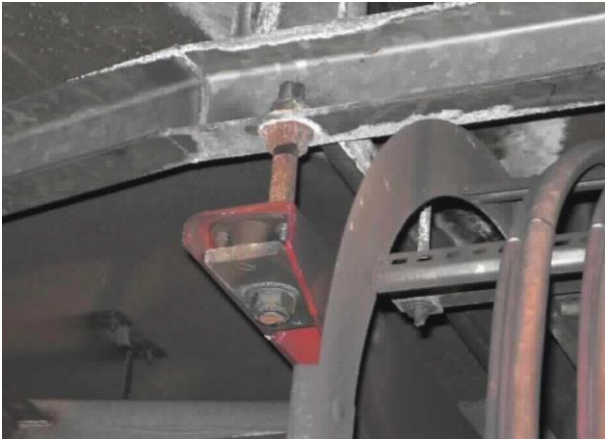
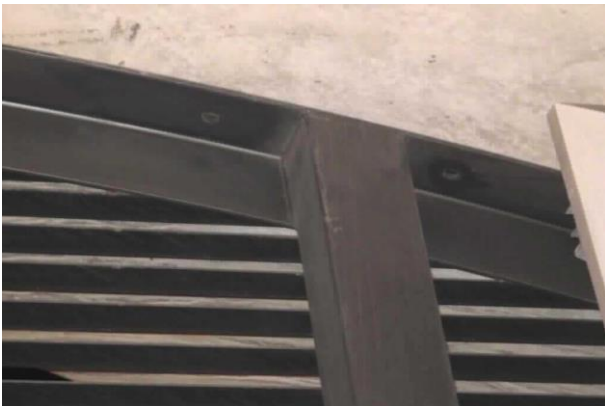
| Condition state 4 -Description | Photo |
|---|---|
| <ul style="list-style-type: none"> <li>• <b>Concrete:</b> Some delamination or corrosion of reinforcement may be present.</li> <li>• <b>Metal:</b> Surface pitting may be present but any section loss is minor.</li> <li>• Any section loss or deterioration does not affect the strength or serviceability of the element.</li> <li>• The structural connections fixing the attachment to the tunnel are in fair condition although there may be some corrosion evident.</li> <li>• Ladders, gantries or access ways have moderate defects and there is doubt about adequacy of them for intended purpose.</li> <li>• Bolts and nuts have medium corrosion and the connections may be moderately corroded, loose or only half threaded. One nut may be missing.</li> </ul> | <p>Corroded cable tray and support brackets</p> <p>Corrosion of threaded rod</p> <p>Louvre support frame bolts missing</p> |
