Incident Details

Critical Risk: Powered Mobile Plant

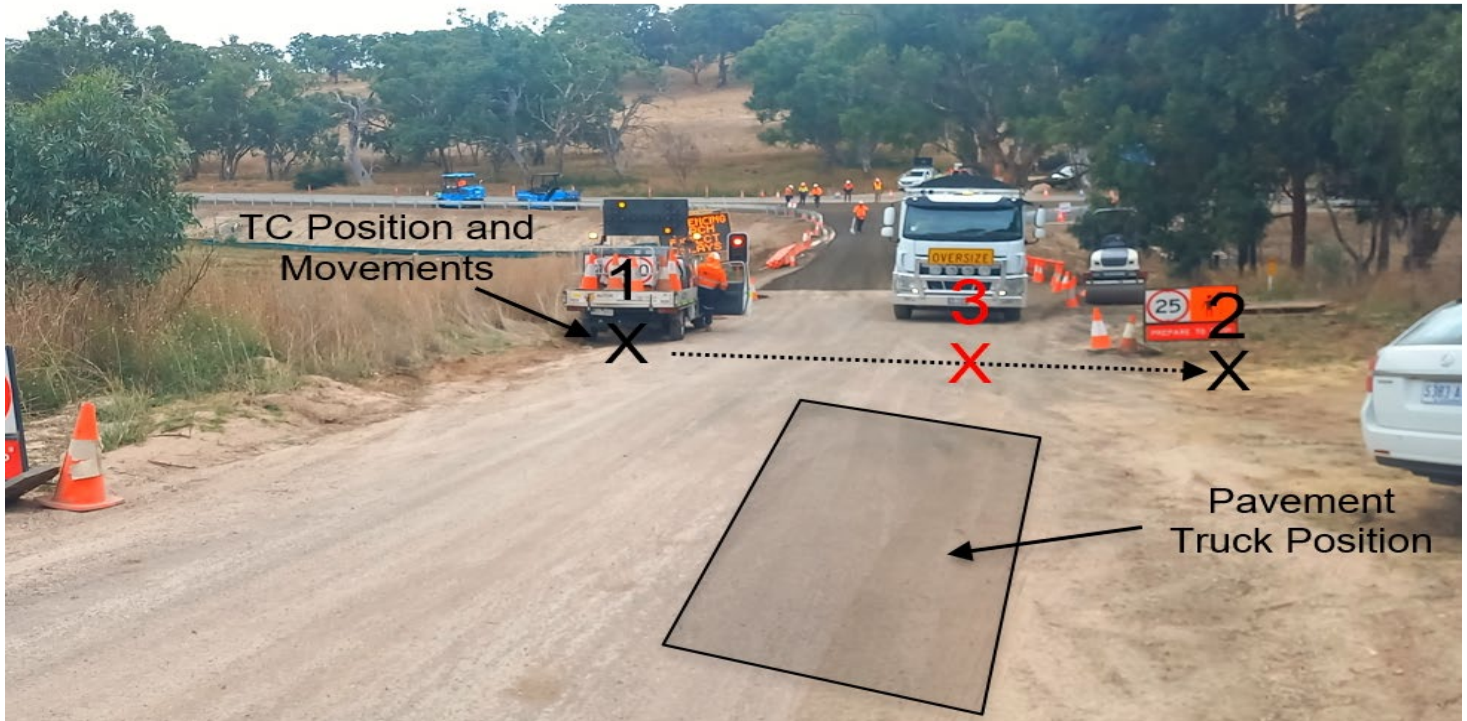
A Traffic Controller (TC) temporarily placed themselves in the “line of fire” behind a truck that had commenced reversing. A ground spotter for the truck, saw the truck reversing and contacted the driver over UHF radio to stop all movements. The TC was unaware of the situation and that they had their back to the truck. No one was injured.

- Spotter contacted truck driver over UHF radio to stop reversing and all works ceased.
- Site Supervisor / Safety Advisor / Client / Safety Manager notified.
- Post incident drug / alcohol test conducted.
- TC re-located further uphill to separate TC from line of fire risks which improved the line of sight for traffic management.
- Exclusion zone was extended to accommodate truck parking within the work zone.

- Work zone layouts should be well planned to avoid worker / mobile plant interaction.
- Workers must always remain vigilant when working near powered mobile plant and be aware of the tasks that are going on around them.
- Use of the Take 5 process could have prevented this Near Miss.
- Before reversing any plant / vehicle, a driver must be 100% certain that it is safe to do so.
- If there is any uncertainty that the path behind a mobile plant / vehicle is unclear, a combination of control methods should be used.
- Positive communications between mobile plant and spotters should not always be the only risk control relied on by drivers.
