Kidman Park (Metcash) Residential and Mixed Use Code Amendment

ENVIRONMENTAL CONDITION – SITE CONTAMINATION STUDY

Document Quality Management Details		
Report Name:	Environmental Condition – Site Contamination Study	
Site Details:	Cnr Findon & Valetta Roads, Kidman Park	
Project Number:	J174764	
Client Name:	Fairland Group Pty Ltd	
Signatures:	Prepared By:   Andrew Durand Principal Environmental Engineer	Reviewed By:   Sarah Walkley Senior Environmental Scientist

Environmental Condition – Site Contamination Study

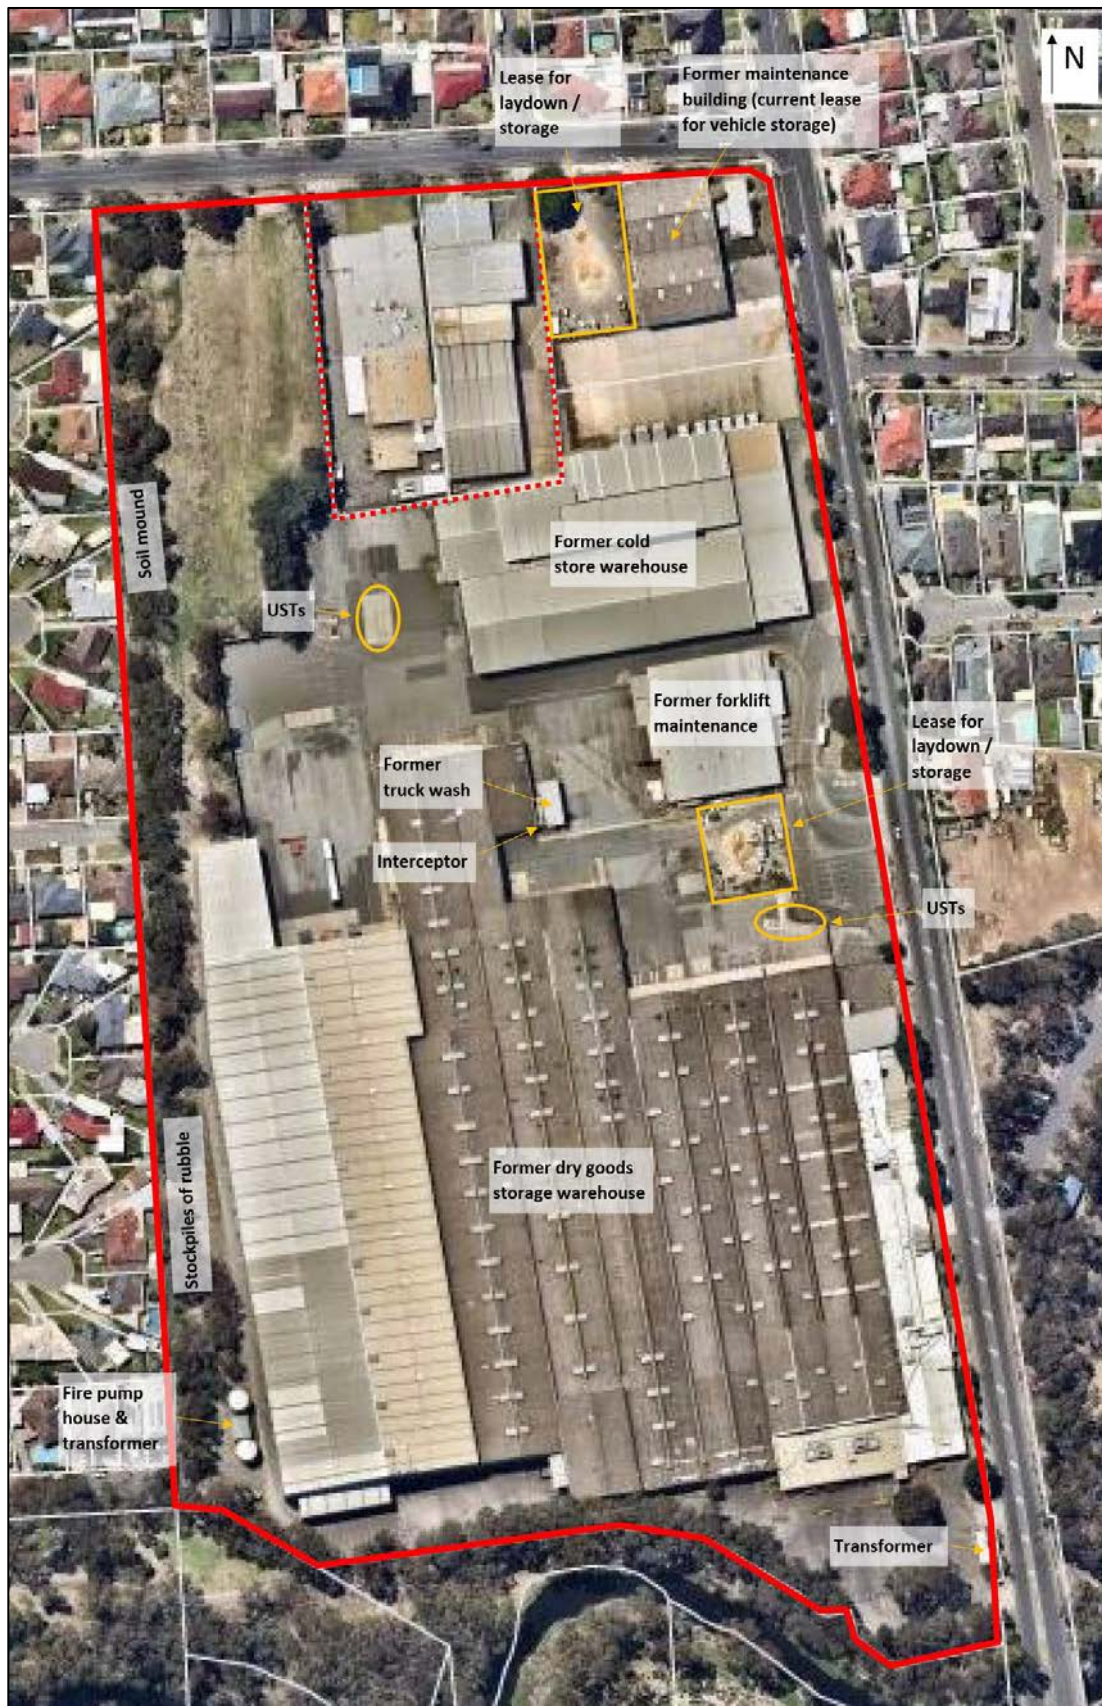
Figure 4 – Area 1 Layout (including historical uses)

A plan showing the layout during the site's most recent use as a distribution centre (based on information presented in the 2015 report is presented as Figure 4.

Although most of Area 1 is currently disused, Figure 4 also shows the two areas currently leased to third party civil companies for use as laydown areas/storage.

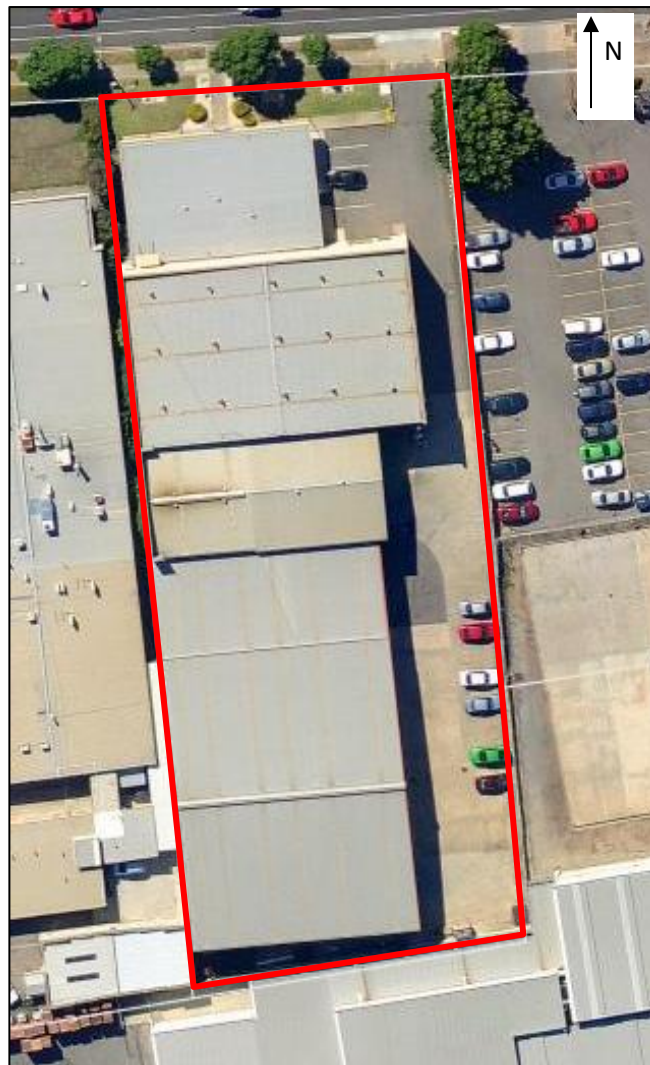
Figure 5 – Area 2 Layout

Greencap notes that no site inspection has been completed for Area 2 as the site is owned by a third party. Greencap is not aware of any proposals for redevelopment of this area. During the inspection of Area 1, the adjacent properties were viewed from accessible locations. There was some evidence of chemical storage

(1,000L Intermediate Bulk Containers (IBCs)) under a large canopy in the central portion of the site (refer Photograph 4). The nature of chemicals stored is not known but there was no evidence of leaks or spills in the areas visible.

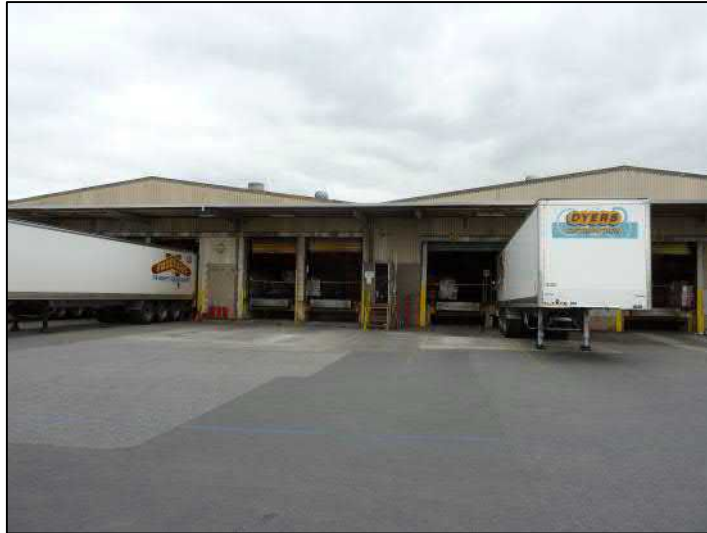
Photograph 7 – View of the dry goods warehouse truck loading area in the centre of the site from north to south

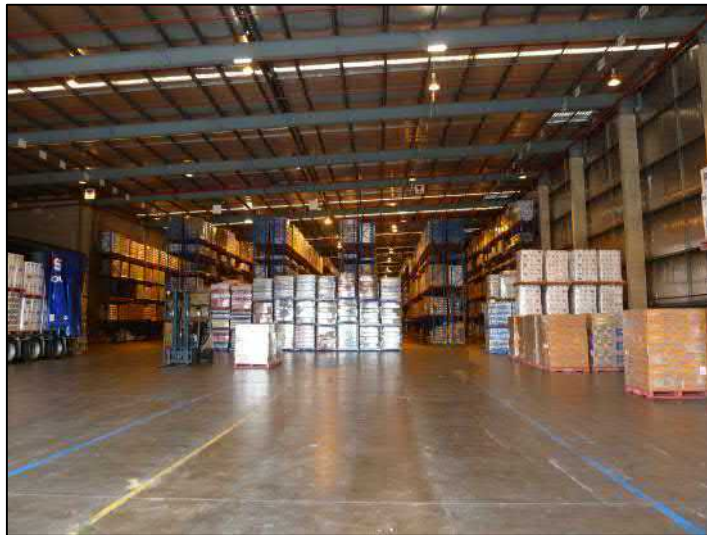
Photograph 8 – View inside the dry goods warehouse

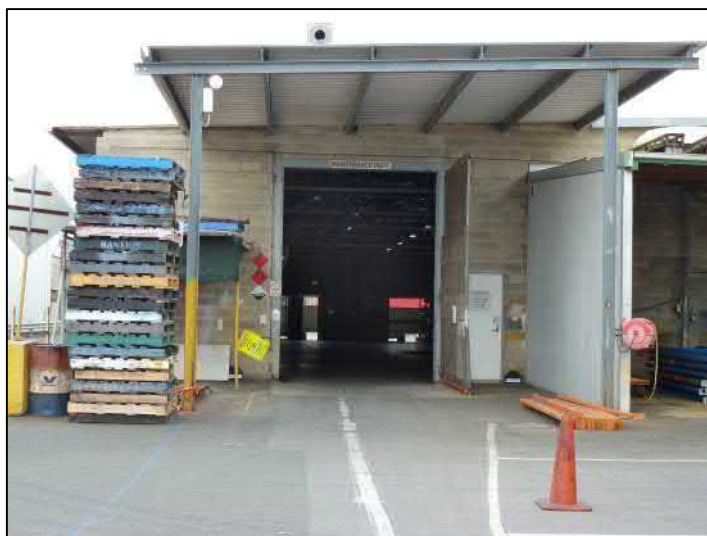
Photograph 9 – View of the Maintenance Building in the northern portion of the site from west to east

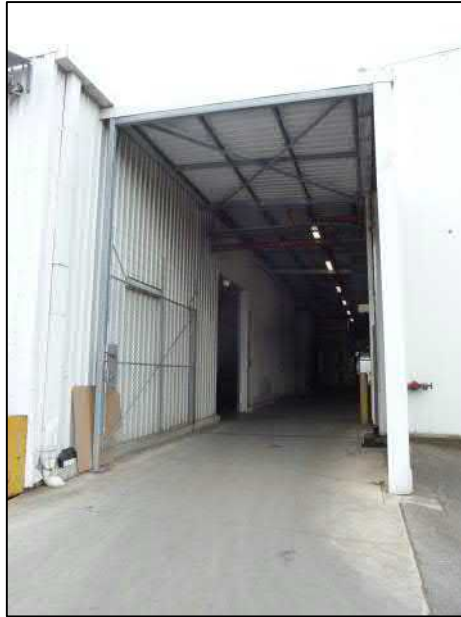
Photograph 10 – View of the cold store warehouse in the north eastern portion of the site from west to east

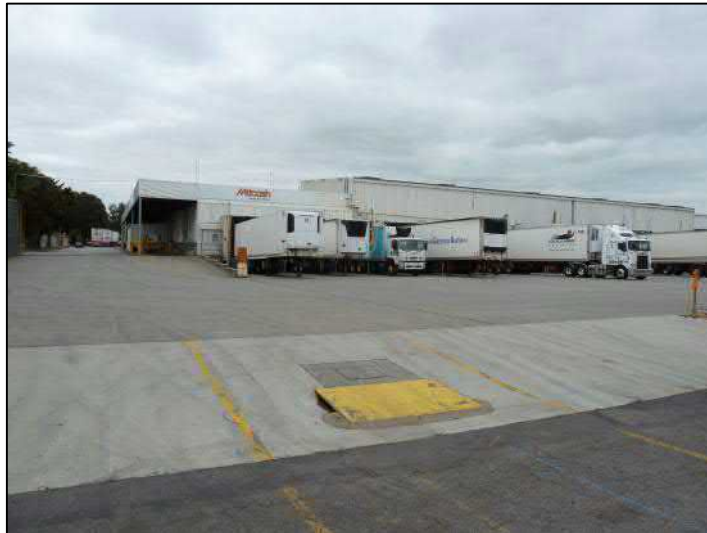
Photograph 11 – View of the cold store warehouse loading area in the north east of the site

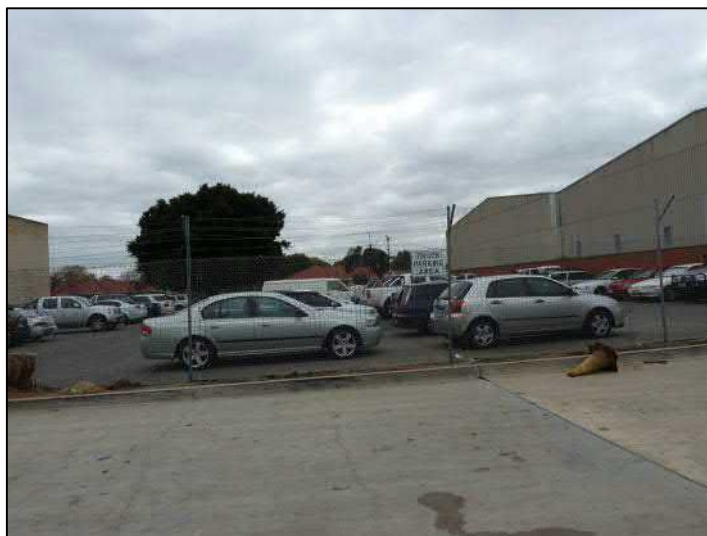
Photograph 12 – View of the car park in the north east of the site

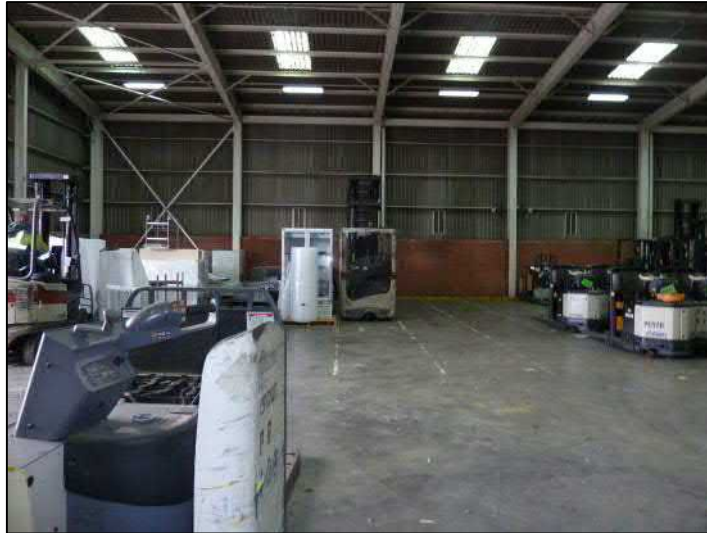
Photograph 13 – View inside Building 404 in the north eastern portion of the site

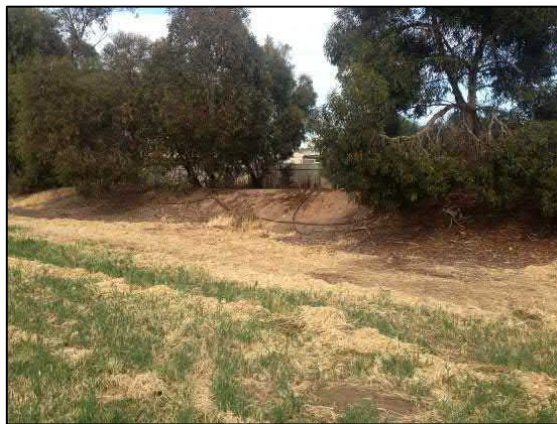
A soil mound is present along the north western boundary of the site.

Photograph 15 – View of the soil mound in the north west of the site

- A sump and an interceptor trap were noted within and adjacent to the truck washing area.
- Fill material – An elongated soil mound (approximately 100 metres long and 3 metres high) was located on the north western boundary of the site. In addition, areas of fill material were noted on the ground surface on the northern portion of the site (where exposed soil is evident). It was also noted that the land adjacent to the southern boundary of the site was at least five metres lower than the site. This was thought to likely be a result of fill being brought onto the site for site levelling and build up.

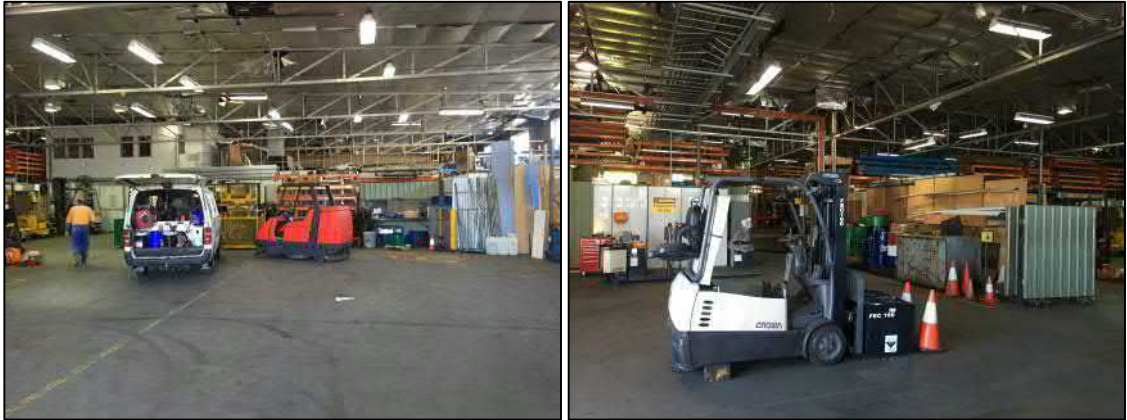
A workshop used for the maintenance of forklift trucks (and formerly trucks) is present in the northern portion of the site.

Photograph 22 & 23 – View of the forklift maintenance area in the north of the site

- Workshop – The workshop area located in the central portion of the site was utilised as an area to conduct maintenance on the on-site forklifts. A small chemical / waste oil store was noted on shelves in an unbunded area with a concrete floor.

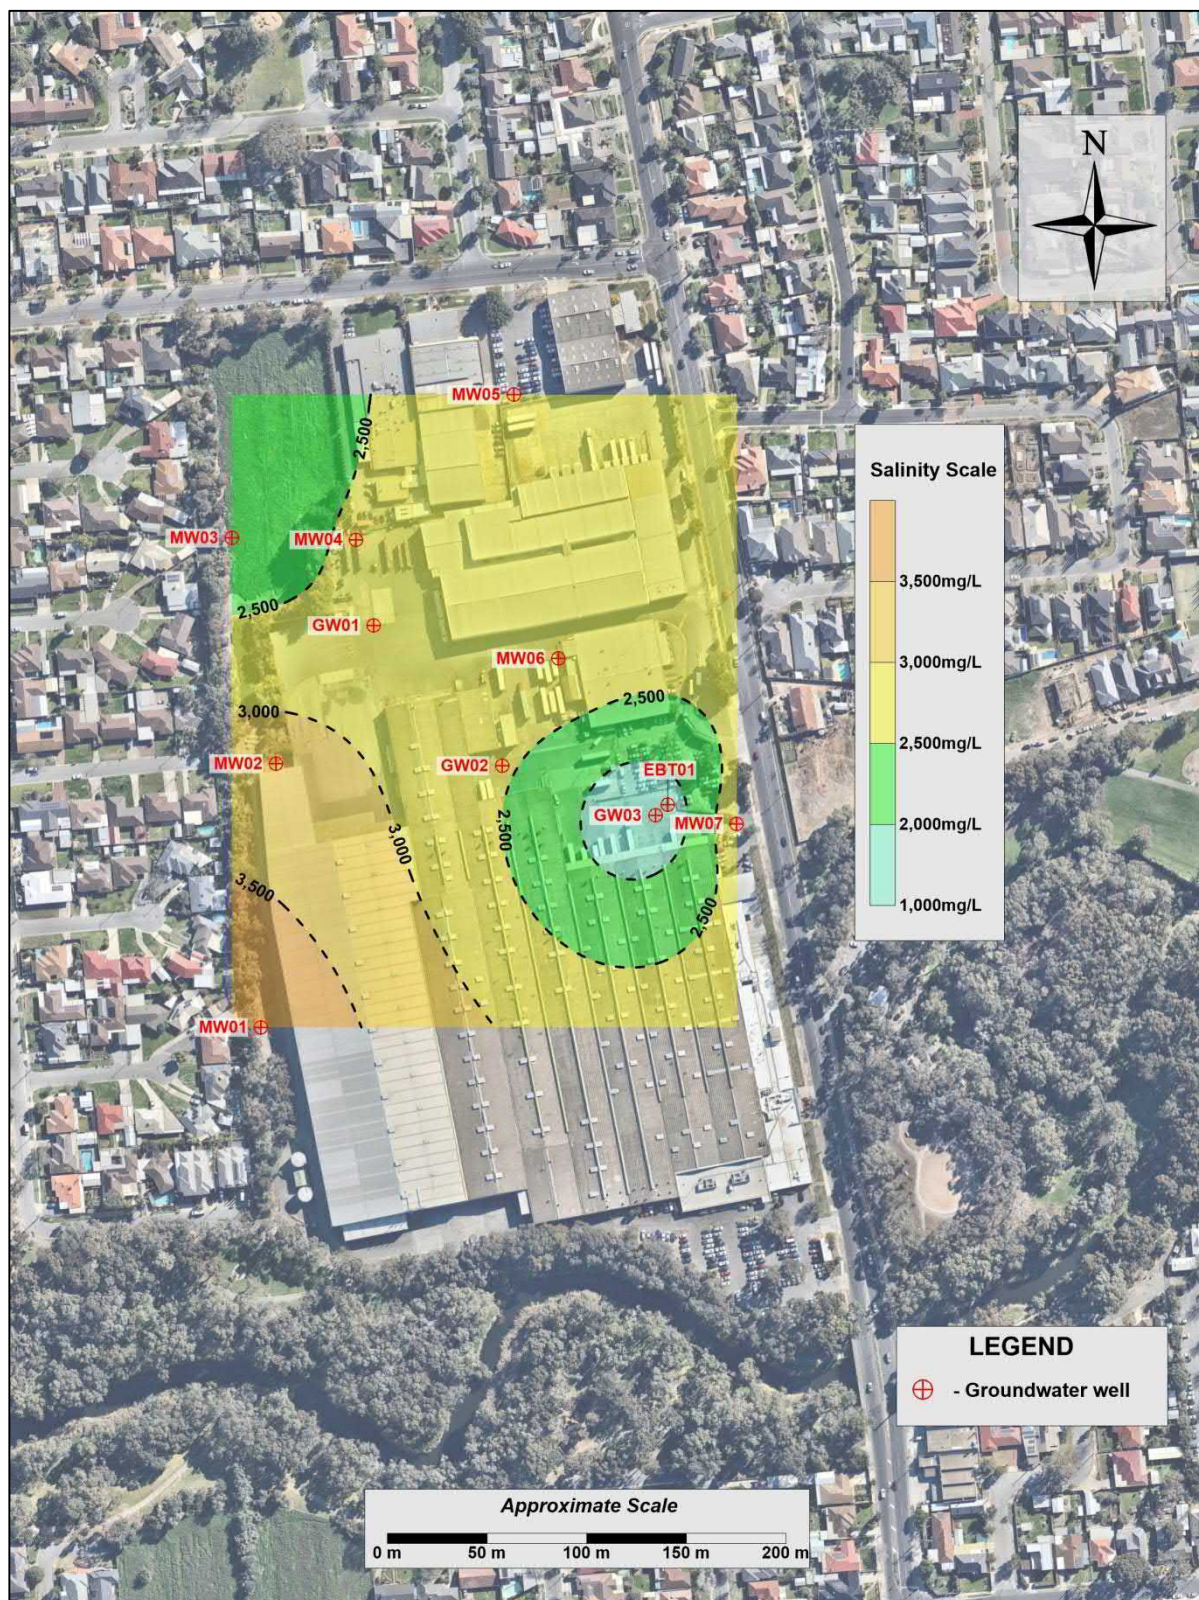
Figure 15 - Groundwater Salinity Contours (field data October 2015)

The groundwater TDS ranges between 1,400 and 3,900 mg/L which is generally consistent with the expected regional groundwater salinity (refer Section 9.1.2). The groundwater salinity distribution in the Q1 aquifer at the site area is presented on Figure 15. The extent of the fresher groundwater with salinity less than 2,000 mg/L was only observed at the locations of EBT01 and GW3 indicating a localised groundwater recharge at this location.
